Bundesstelle für Seeunfalluntersuchung
Federal Bureau of Maritime Casualty Investigation
Federal Higher Authority subordinated to the Ministry of Transport,
Building and Urban Development

Investigation Report 301/09

**Occupational accident on board the
TMV ECE NUR K
on the Lower Elbe
on 1 August 2009**

1 March 2012

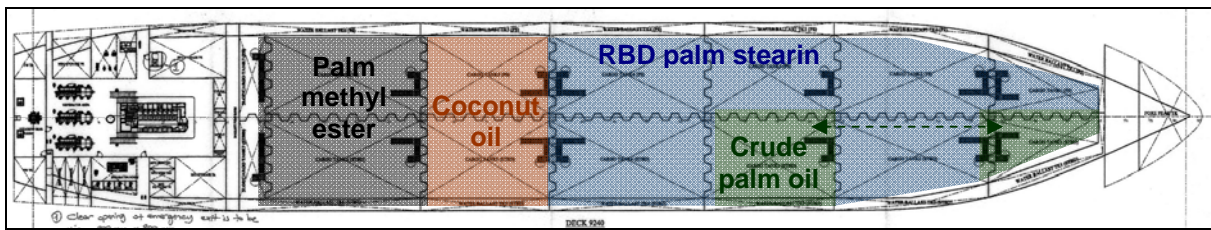
Figure 11: Previous cargo distribution

Originally, the ECE NUR K was to load caustic soda in ten of her twelve cargo tanks. The previous cargo in six of the tanks, including tank no. 1 p/s, the tank subsequently involved in the accident, was RBD¹⁰ palm stearin. Untreated palm oil, coconut oil and palm methyl ester (biodiesel) were previously transported in the other tanks (see Fig. 11). All the cargo tanks were empty when the ECE NUR K entered the Lower Elbe.

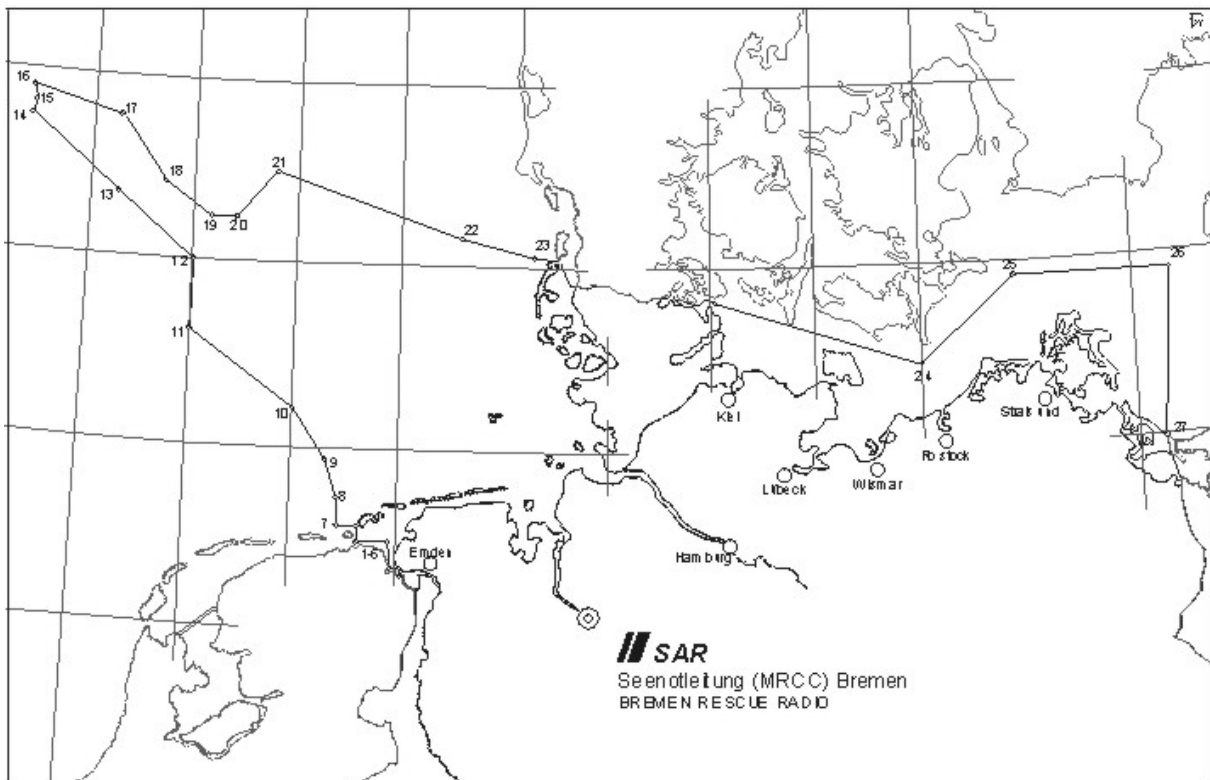
Figure 12: German SAR area

Provision of the necessary search and rescue service¹⁴ for distress situations involving seagoing shipping is incumbent on the federal government. This obligation follows the relevant provisions of international law, in particular, the SOLAS Convention and the SAR Convention¹⁵. The German SAR area was established by the former Federal Ministry of Transport (BMV) and notified to the International Maritime Organisation (IMO). According to the reported coordinates, it covers the territorial waters and the Exclusive Economic Zone (EEZ) in the North Sea and Baltic Sea (see Fig. 12), but does not explicitly include the navigable maritime waterways.
