Investigation Report 413/10

**Marine Casualty**

**Personal accident on the aft manoeuvring  
station of the hopper dredger  
WATERWAY while making fast in the port of  
Emden on 21 September 2010**

1 March 2012

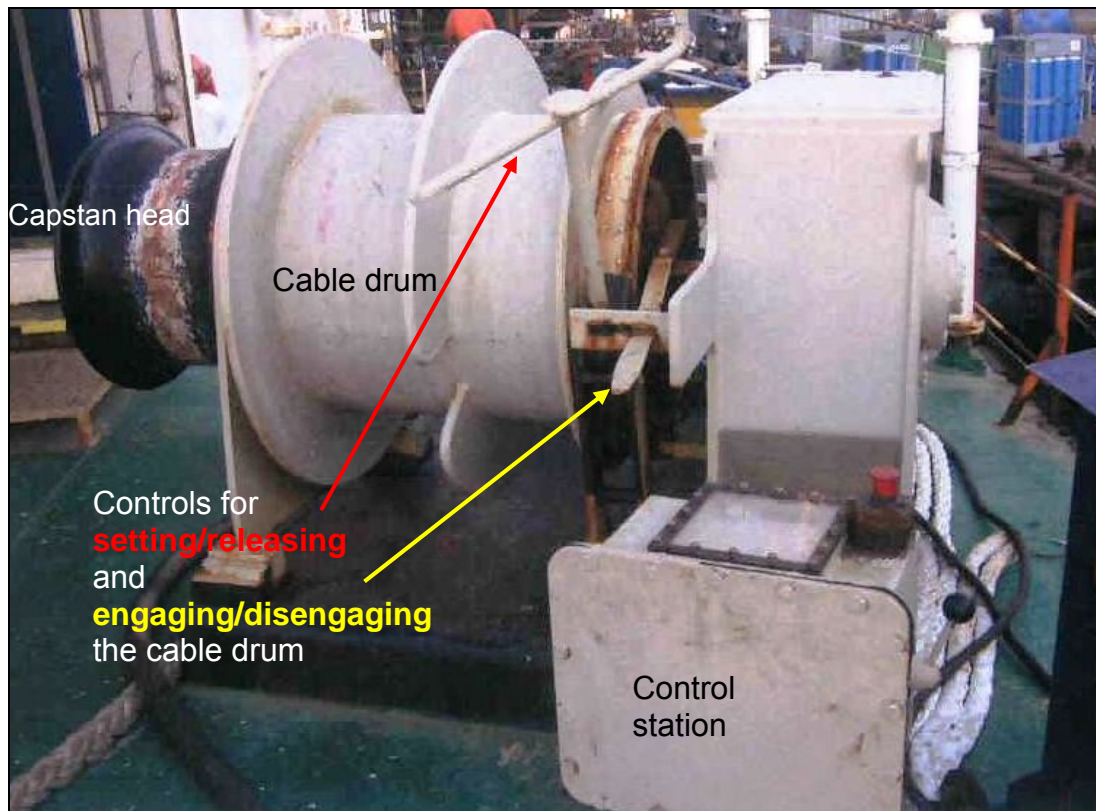
Figure 8: Winch

The winches on board the WATERWAY operate with a closed oil-lubricated reduction gear, which is driven by a hydraulic motor. The reduction gear drives a cable drum, which can be engaged and disengaged as well as set by means of a mechanically operated band brake. In addition, a permanently rotating capstan head is positioned on the drive shaft. The winch has a hydraulic spring-loaded disk brake, which acts on the drive shaft of the hydraulic motor.

*The Federal Bureau of Maritime Casualty Investigation recommends that the owner of the hopper dredger WATERWAY, Royal Boskalis Westminster N.V., Papendrecht, contact the manufacturer of the winches installed on board the dredger and discuss the possibility/necessity of shortening the stopping time.*
