Investigation Report 445/10

Very Serious Marine Casualty

**Fire on the
ro-ro passenger vessel
LISCO GLORIA
on 8 October 2010
north-west of Fehmarn**

1 February 2012

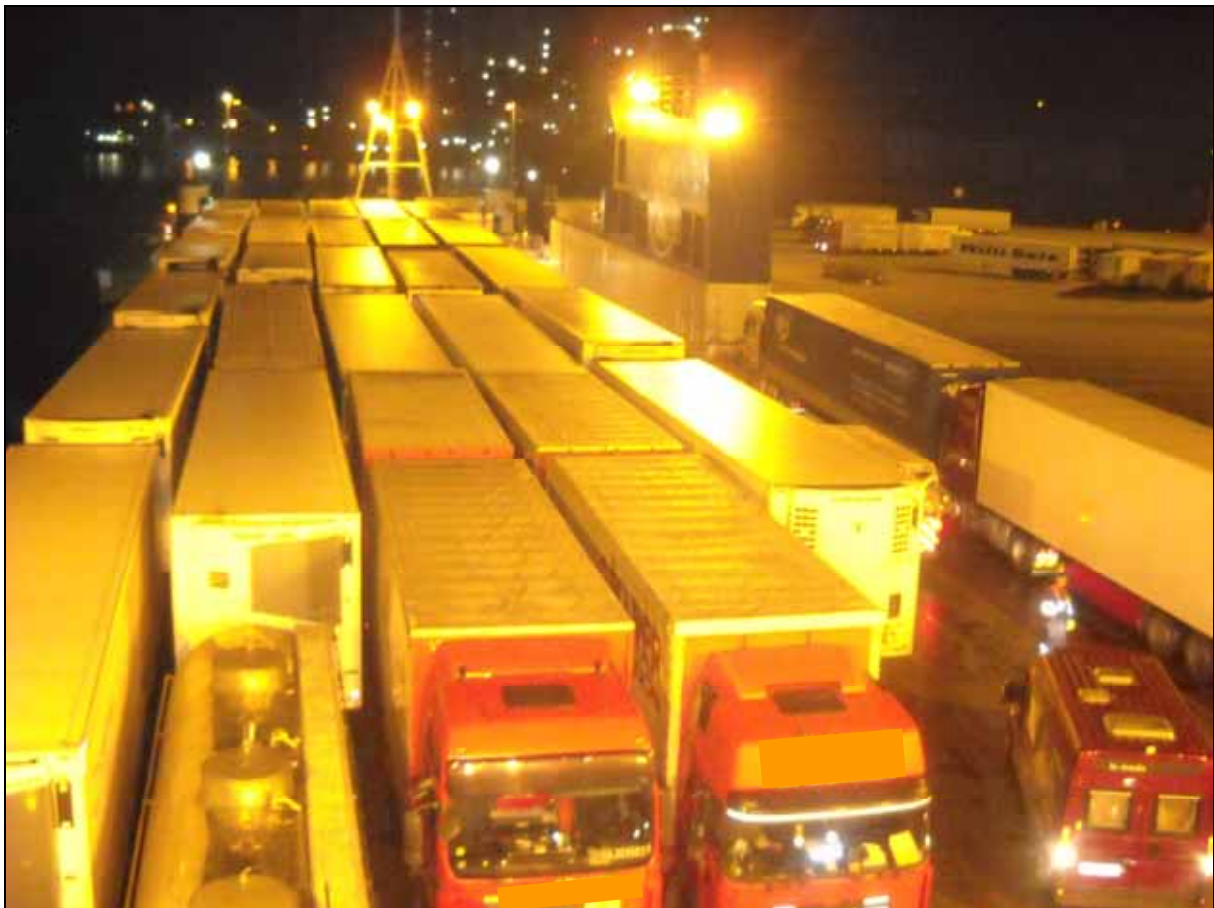
Figure 3: Part of the upper deck of the LISCO GLORIA during the loading operation on the night of the accident

Depending on the vehicle widths, the distances between individual cargo transport units were between almost 30 cm (at the maximum admissible width of 2.60 m for refrigerated transporters) and almost 38 cm (average width of a cargo transport unit of 2.50 m). Accordingly, the accessibility of individual cargo transport units was – as is usual on ro-pax ferries – restricted (see Fig. 3).

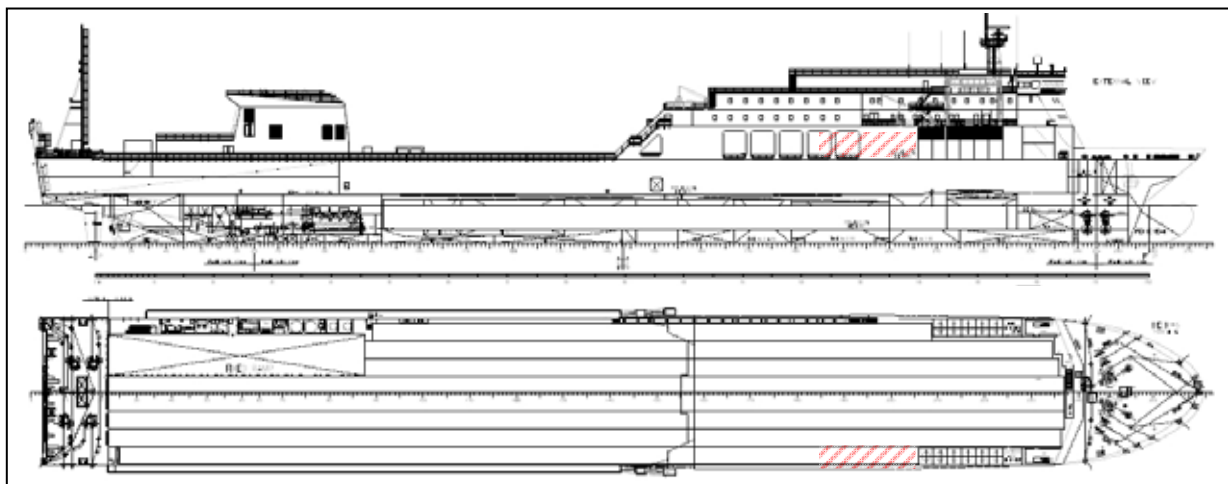
Figure 4: First parking position on lane 8 of the upper deck

At 2300, the watch was taken over by the chief officer and an AB (able-bodied seaman). The helmsman left the bridge, but the master remained for a short period, as did the third officer who was carrying out administrative tasks. The duty seaman was ordered by the master to commence his inspection on the upper deck (deck 6). The actual temperatures of the refrigeration units loaded there were to be compared to a list of required values. The AB began the inspection on the upper deck at 2307. The chief engineer, the electrician and a motorman, who were on their way from the engine control room, had passed deck 6 shortly before and found no irregularities. At about this time, the ferry passed Kiel Lighthouse. On the advice of the master, the speed was reduced from 18/19 kts to 17 kts. The master and third officer then left the bridge. The AB began his round in the forward, garage area on the far right parking lanes. The refrigeration unit of the truck parked in the front of lane 8 (see shaded area in Fig. 4) was one of the first to be inspected.

The refrigeration unit was connected to the shipboard electrical system. According to the list entry, a temperature of -20 °C was to be maintained; however, -28 °C was displayed. The AB made a note of this inconsistency, but in accordance with general procedures on board did not inform the officer on watch or the driver because the specified temperature was not exceeded. The inspection was continued towards aft.

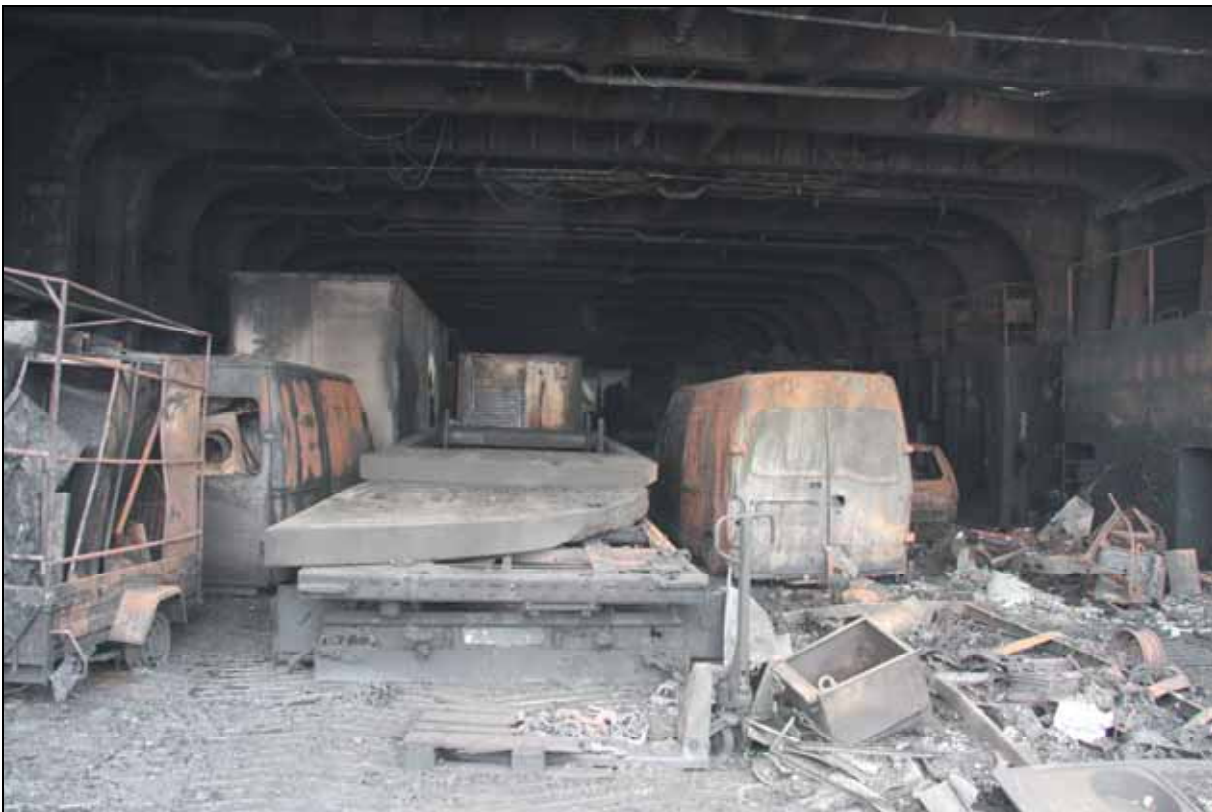
Figure 10: Deck 4 after the fire, looking forward from the stern ramp

Most of the cargo was completely destroyed by the fire. This concerned both the upper deck (see Fig. 9) and deck 4 (see Fig. 10) below it. The cargo loaded on deck 2, however, was not affected by fire but partly by smoke and water used for cooling the deckhead and preventing fire spread.

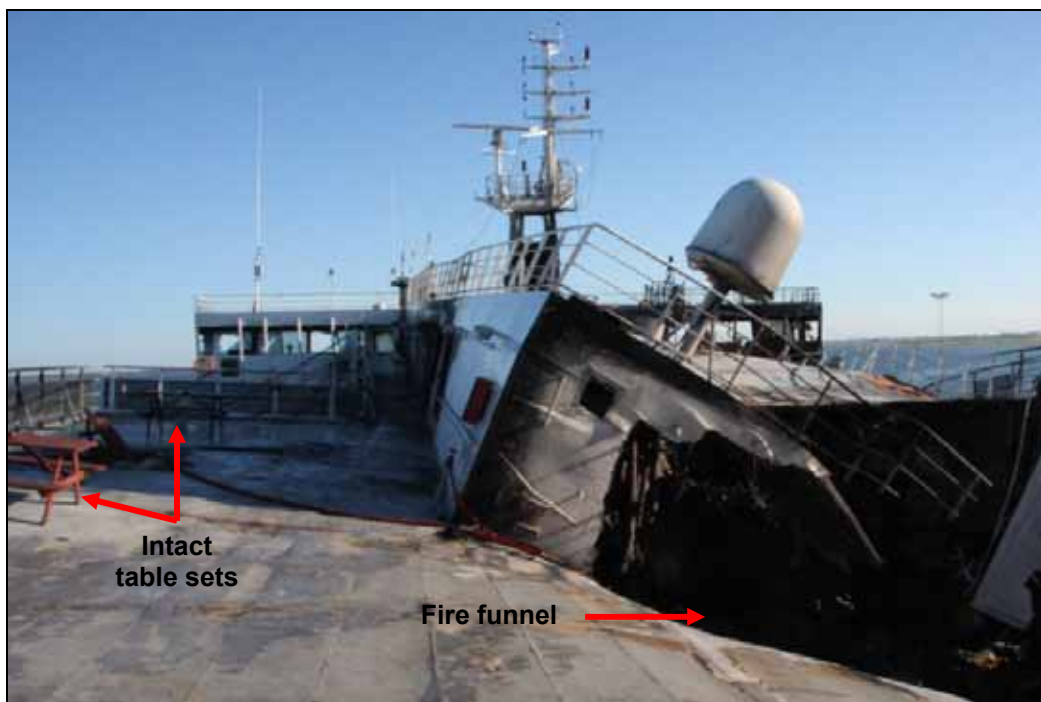
Figure 18: Outside area on deck 9, view to the bow

The starboard side had sustained far more severe structural damage than the port side. In relation to the longitudinal axis, the fire funnel (origin: frames 210 to 220) was offset slightly to starboard. On the other hand, the outside area on the port side on deck 9 showed only limited damage, was still passable and partially equipped with intact wooden table sets (see Fig. 18).

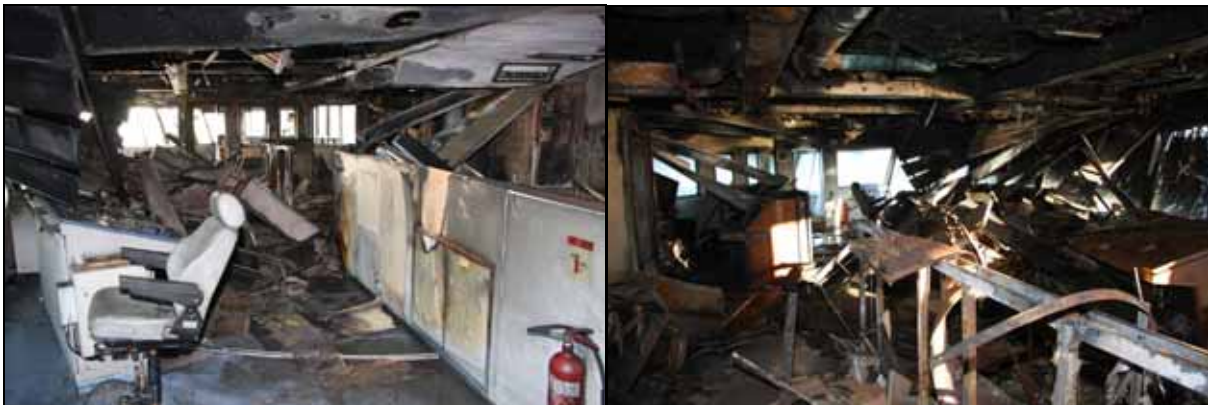
Figure 20: Wheelhouse, view from port and from starboard

The affect of the fire in the wheelhouse increased from port to starboard (see Fig. 20). All navigation systems and other equipment were destroyed.

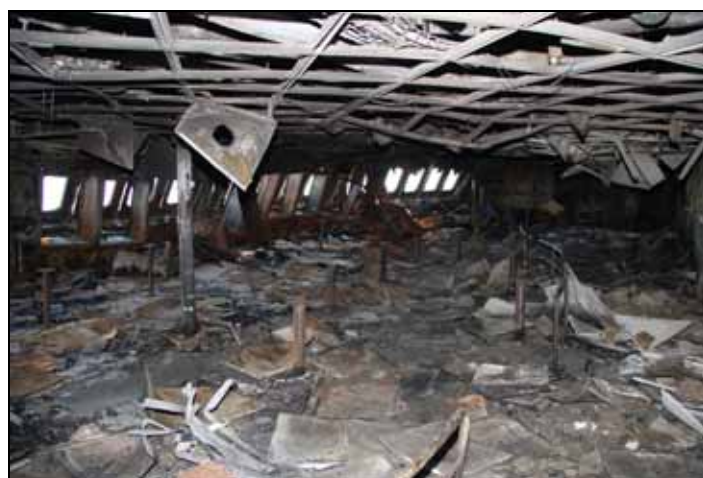
Figure 21: Burned-out bar area

On deck 7, parts of the completely gutted bar area were still passable (see Fig. 21).

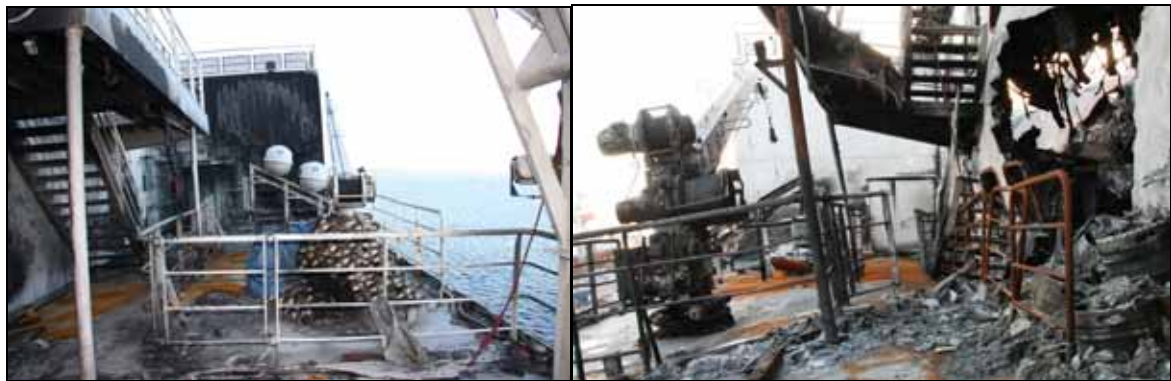
Figure 23: Lifeboat station to port and to starboard, view to the stern

The severity of fire damage suffered by the lifeboat station on deck 7 was considerably less to port than to starboard (see Figs. 22 and 23).

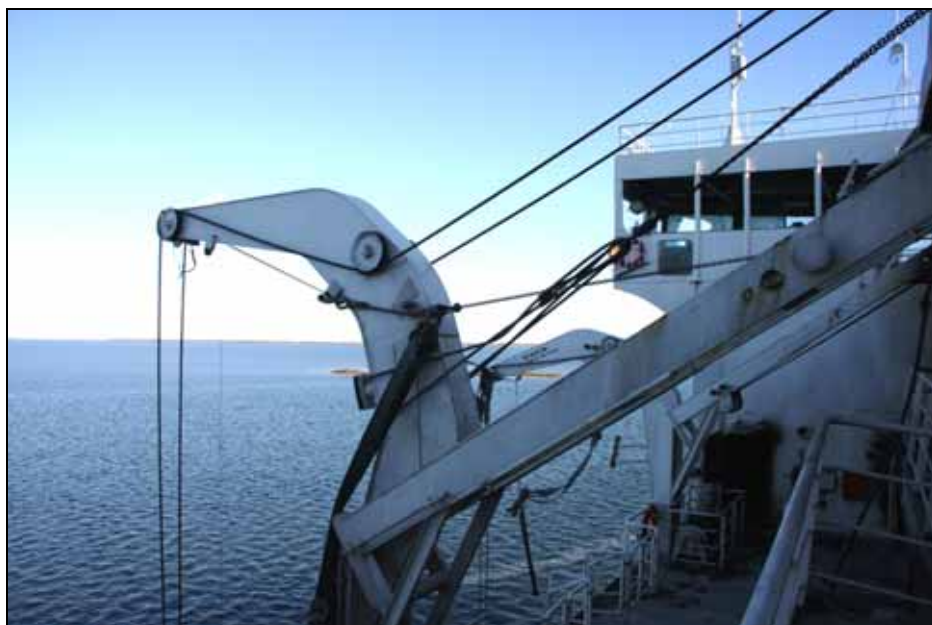
Figure 24: Davit system, port side lifeboat station

The gravity davits were swung out on both sides (see Fig. 24) but, at the time of the survey in Munkebo, the hoisting hooks were no longer in their original position because the ferry was moored at the pier.

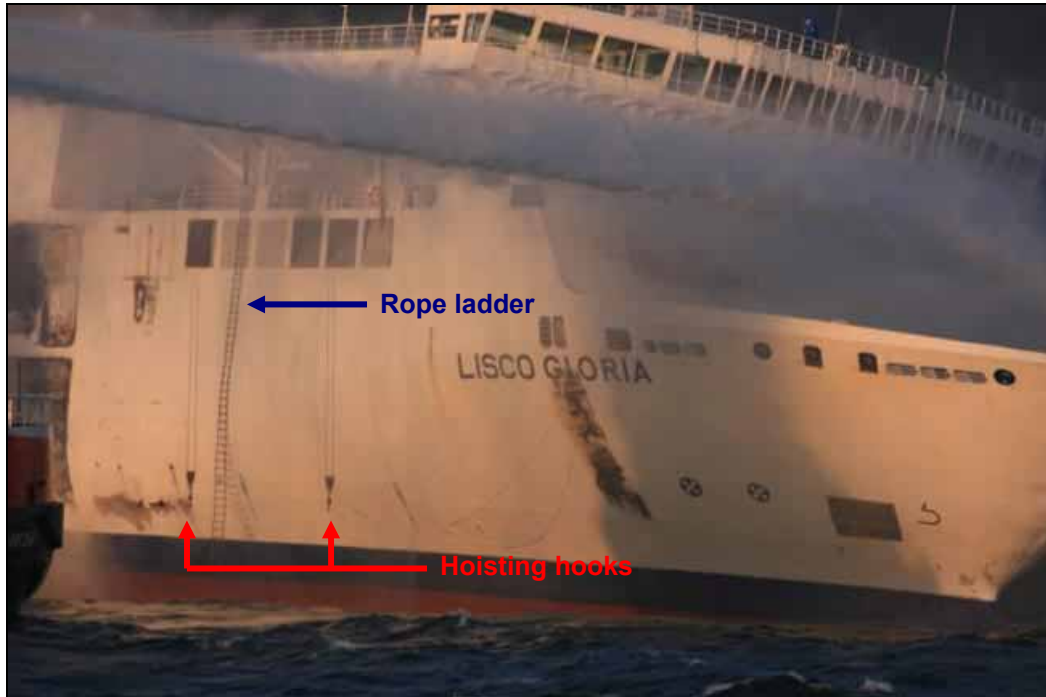
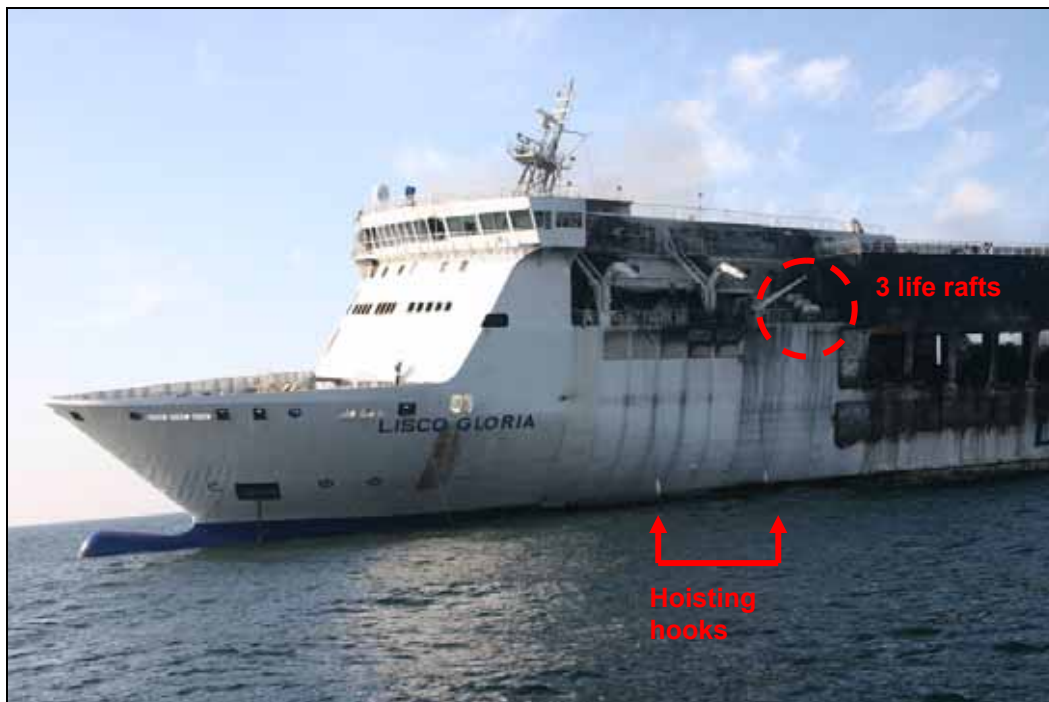
However, the original position of the hoisting hooks was documented by photos taken when the LISCO GLORIA was still at sea. One can see in the images that the two hoisting hooks were lowered parallel to just above the waterline both on the port and on the starboard side; however, the starboard hoisting hooks are hanging significantly higher due to the considerable heel of the LISCO GLORIA at the time the images were taken (see Figs. 25 and 26).

Figure 25: Lowered hoisting hooks on the starboard side, taken on 9 October 2010

Figure 26: Lowered hoisting hooks on the port side, taken on 10 October 2010

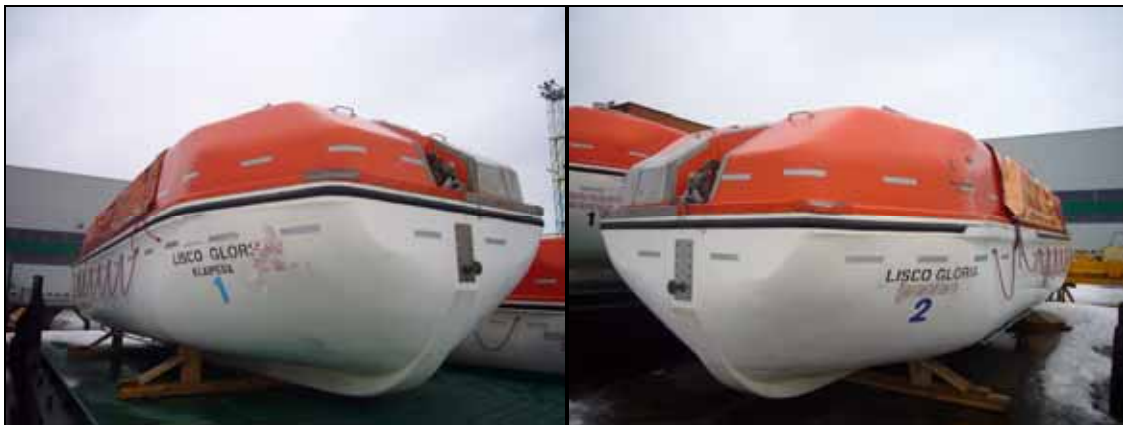
Figure 27: Salvaged lifeboats of the LISCO GLORIA

Each lifeboat was able to accommodate 150 people. Both boats on the LISCO GLORIA were taken to Klaipėda after the accident and examined there by the Lithuanian investigating authority (see Fig. 27). Here, damage was found on the stern of Boat 1 on the port side (see Fig. 28). A video, which was recorded on board the NEUSTRELITZ, indicates that the damage resulted from the lowering of the boat at LISCO GLORIA. Other damage or deficiencies were not found.

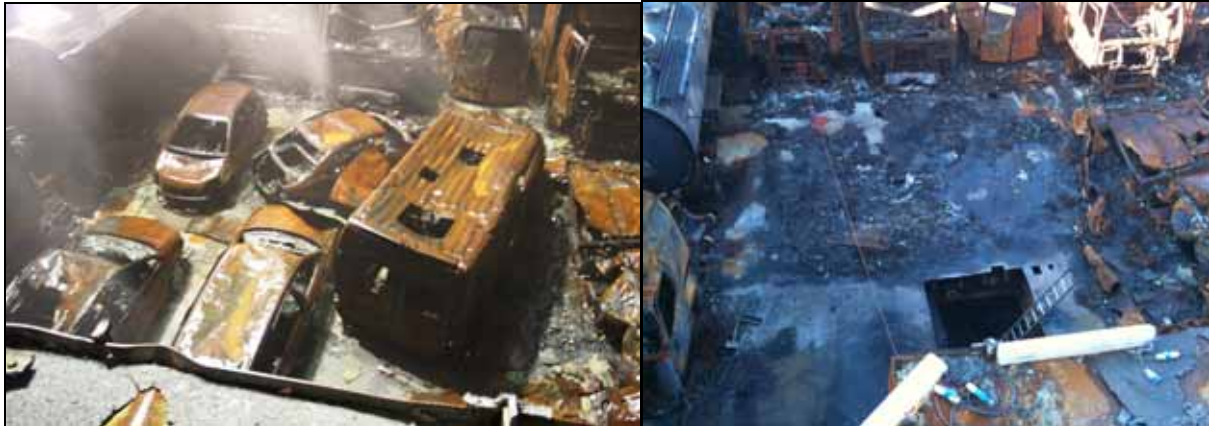
Figure 30: Area on the upper deck cleared for fire-fighting – before and after

A small area amidships on the weather deck had been cleared with the consent of the BSU prior to the arrival of the investigation team to create an access opening to the main deck (deck 4) for the last part of the fire-fighting operation (see Fig. 30).

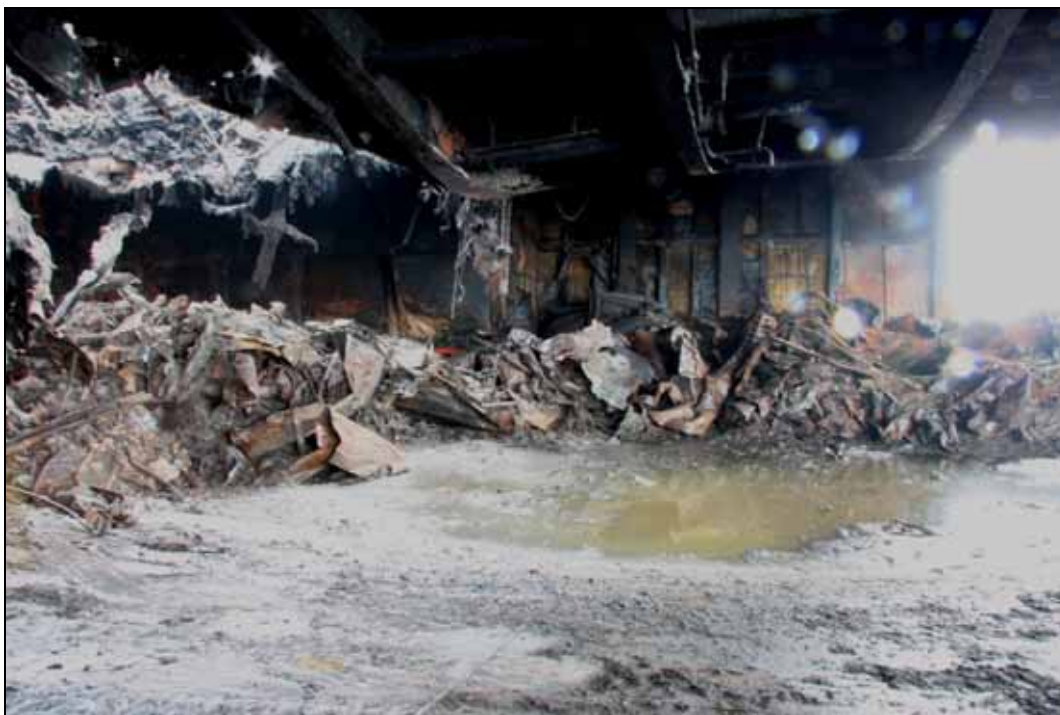
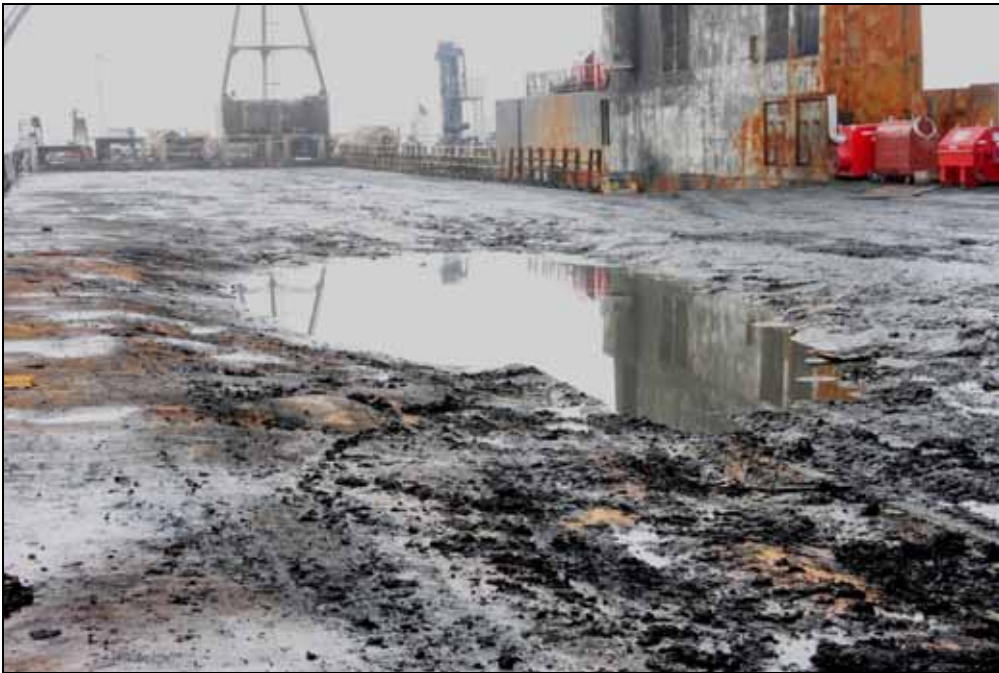
After the survey on 25 October 2010, the upper deck was cleared in stages in consultation with the BSU. Although the severity of the fire damage made it impossible to narrowly define the area of origin of the fire, the overall damage pattern suggested a tendency to the starboard side. Therefore, according to the assessment of the expert from the LKA, the overall pattern of fire damage was consistent with the descriptions of the duty crew member who discovered the fire. Consequently, a decision was taken to clear most of the remains of the cargo from the open part of the upper deck and lanes 1 to 5 in order to then be in a position to gradually move forward to the observed source of the fire. In the process, two vast deformations where the deck had sagged over a large area became apparent under the vehicle debris (see Figs. 31 and 32). In relation to the longitudinal axis, these two deformations were slightly offset to starboard.

Figure 31: Partly cleared deck 6, view of lanes 5 to 8 in the forward area

Figure 32: Cleared upper deck (amidships), view to the stern

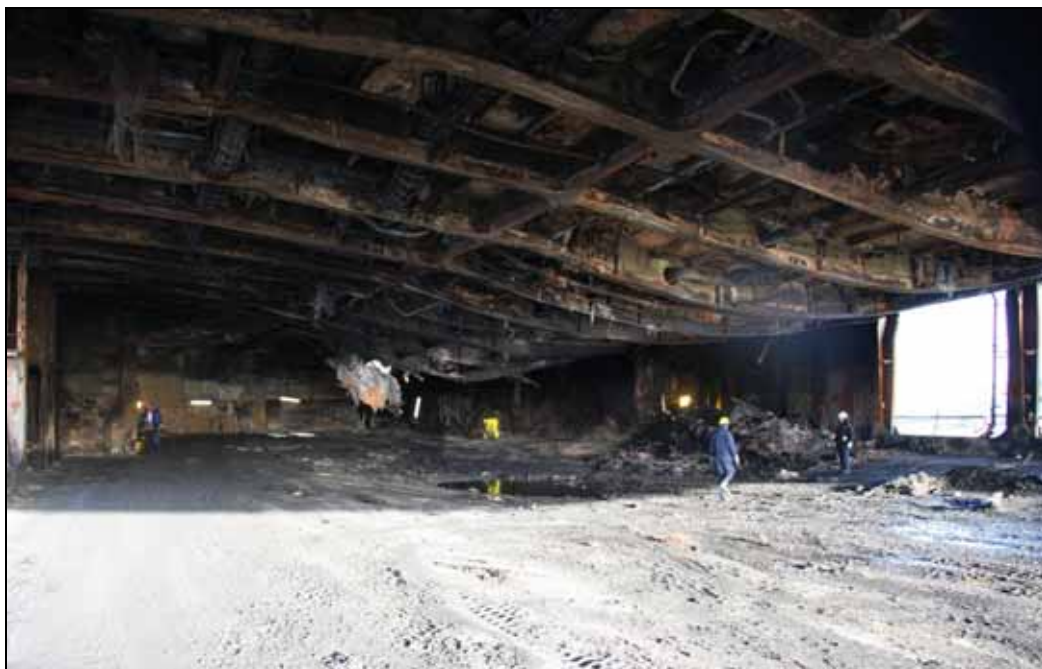
Figure 33: Partly cleared deck 6 with debris at the observed source of the fire

After the partial clearance, the investigation team worked its way forward through the remaining debris to lane 8 with the support of excavators and shipyard workers. Debris which could be moved by hand was assessed and if necessary documented photographically before being removed. Larger items of debris, especially chassis parts, could only be removed using an excavator after the chain retainers had been removed. This time-consuming procedure took several days before the front part of the upper deck was, with the exception of the observed source of the fire, finally cleared on 3 November 2010 (see Fig. 33).

Since the fire had raged on the LISCO GLORIA for two weeks, and even after brief successes in terms of fire-fighting had reignited several times, the level of destruction found on board during the first survey was too great to be able to make reliable statements with regard to the exact source of the fire. Generally, it was found that the damage, in particular, to the supporting structures, tended to be greater on the starboard side. The garage area on the upper deck was affected by the fire most of all, where on the starboard side, viewed from the longitudinal axis, the fire funnel towards the accommodation superstructure (see Figs. 17 and 18) and significant frame deformation towards the main deck (see Fig. 31) had formed. The truck on which the outbreak of fire was observed was also the one with the greatest fire damage. The investigating authorities and the fire experts rate the observed source of the fire as credible.

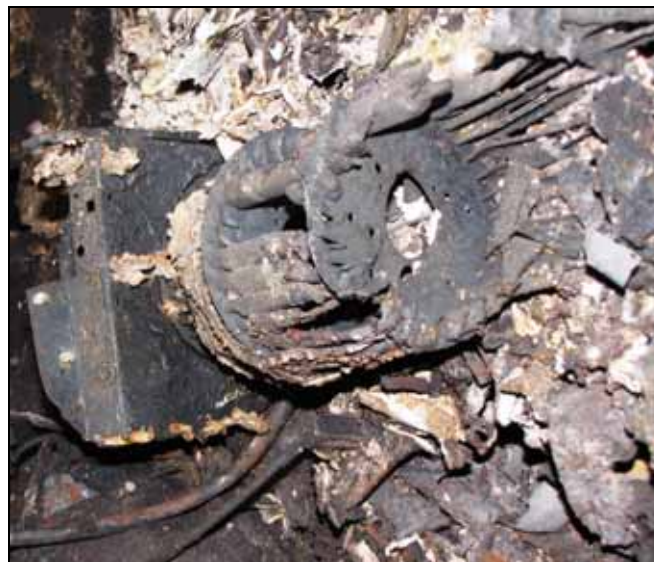
Figure 37: Remains of the refrigeration unit fan

Heavily thermally stressed parts of the fan (see Fig. 37) and other components were found.

However, the condition of the parts was so bad that a more detailed investigation of these items was not possible. The remains of the electrical system of the towing vehicle in question, the electronic control of the refrigeration unit, and the internal wiring of the refrigeration unit had been so badly damaged that a conclusive investigation was no longer possible with respect to an electro-technically induced fire.

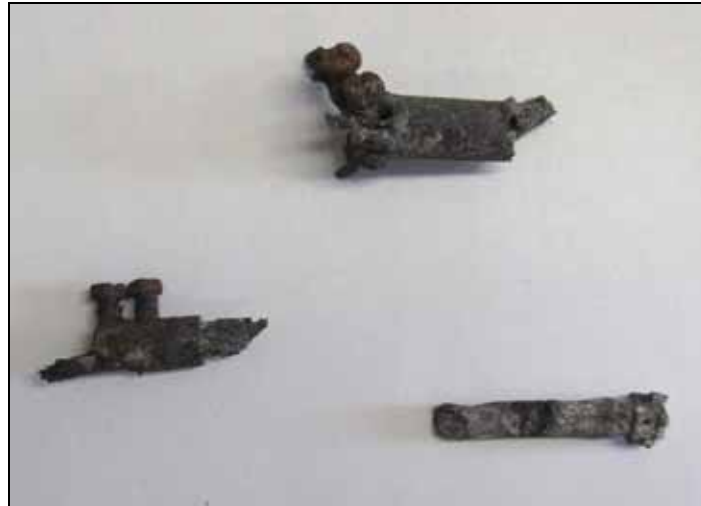
Figure 38: Fragments of the electrical contacts of a connector socket and plug

Three fragments of the electrical contacts of a connector socket and plug could be found below the refrigeration unit in the fire debris (see Fig. 38). Since, factory-made, the appliance inlet of the refrigeration unit is installed in this area, the remains were kept as evidence for a comparative investigation.

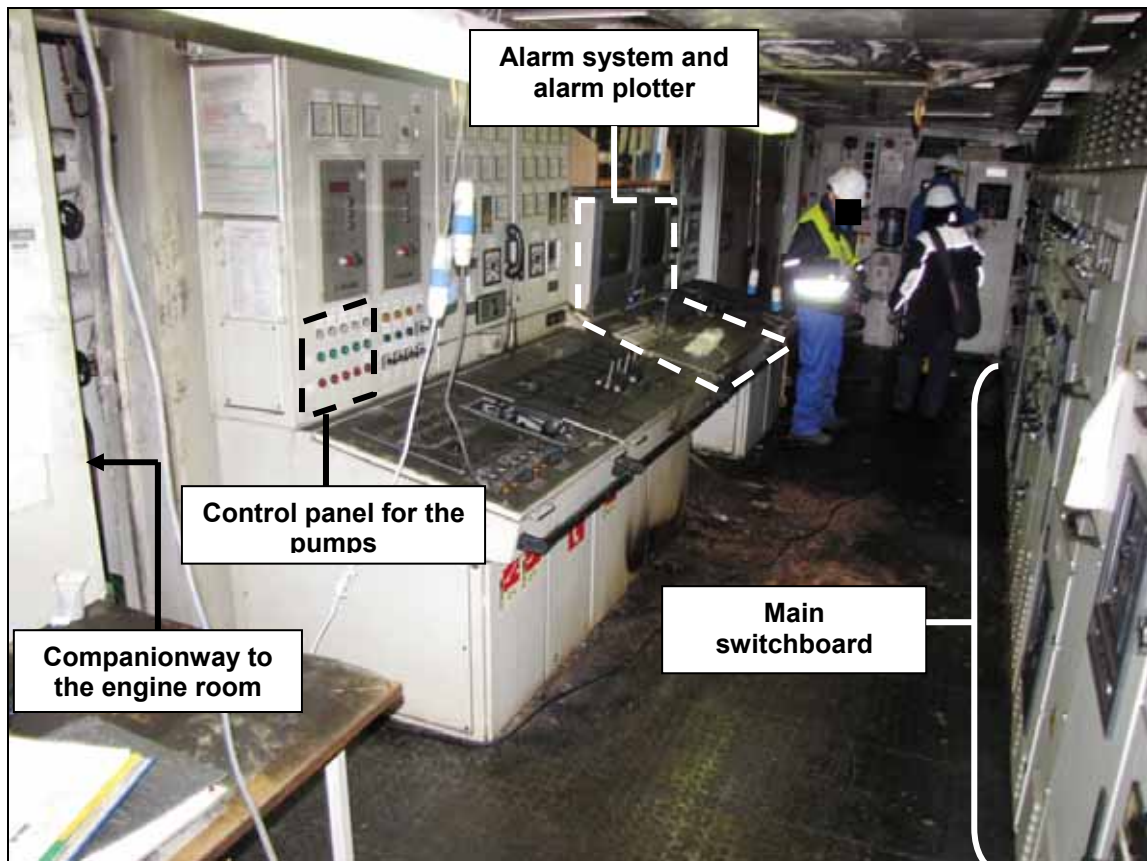
Figure 42: The engine control room of the LISCO GLORIA

The electrical supply for the switchable three-phase current power outlets was provided via the engine control room (see Fig. 42). The switch cabinets located there which served these circuits were visually inspected.

It was found later that, meanwhile, the switch settings on the main switchboard had been changed. On 11 October 2010, when the fire was under control, the salvage company was able to take a member of the crew into the engine room to assist them. During this inspection the crew member took photographs of the main switchboard. All the switches are in the 'Off' position on these photos; however, during the first inspection by the German and Lithuanian investigation team on 25 October 2010, the switches were, almost without exception, set to 'On' (see the right of the main switchboard on Fig. 43, for example).

The switch settings found on the main switchboard were therefore no longer conclusive for the investigation. It was not possible to clarify who changed the positions or when this happened. Since it was neither possible to restore the shipboard power supply at sea nor at the pier in Munkebo, the investigators could not see any need to operate any switches on the main switchboard.

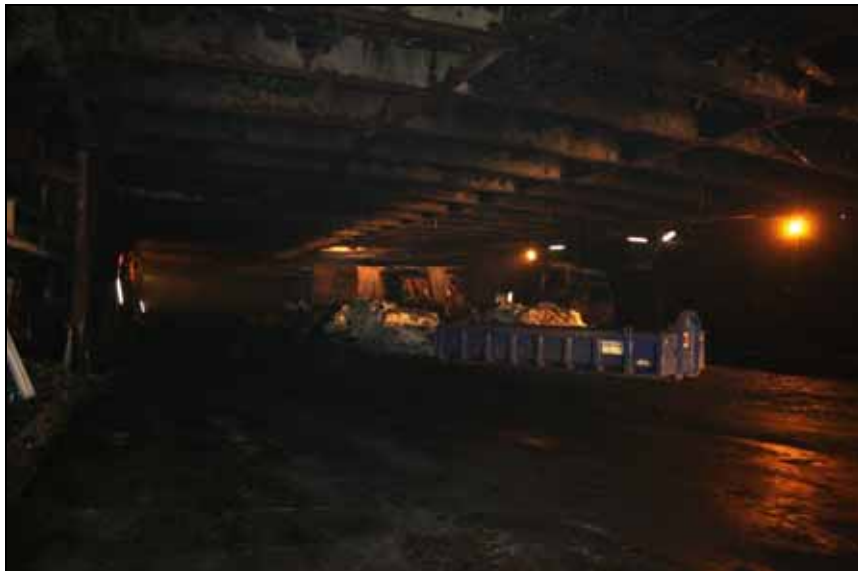
Figure 45: Partially cleared deck 4, view to the bow

It was not possible for the investigation team to enter the main deck (deck 4) during the first survey because of thick smoke. The deck was cleared after the last pockets of fire had been extinguished. Documentation proved to be difficult because the air was extremely dusty and in the forward part of the deck, in particular, only dim lighting conditions prevailed. Almost all the clearing work was completed on 9 November 2010 and temporary lighting was installed (see Fig. 45). It was found that the area on deck 4, beneath the parking position of the truck/trailer on which the fire outbreak was observed on deck 6, was empty (frames 196 to 206). The first truck with refrigerated trailer on the far right parking lane on deck 4 extended to frame 196.

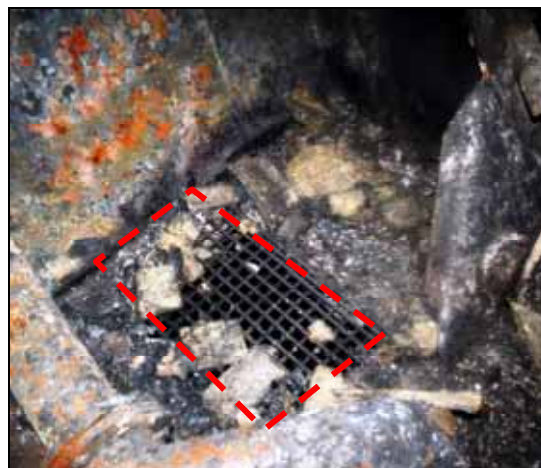
Figure 46: Scupper on deck 4

The scuppers on decks 4 and 6 were partly clogged (see Fig. 46) with debris from the fire (cargo, metal parts, etc.).

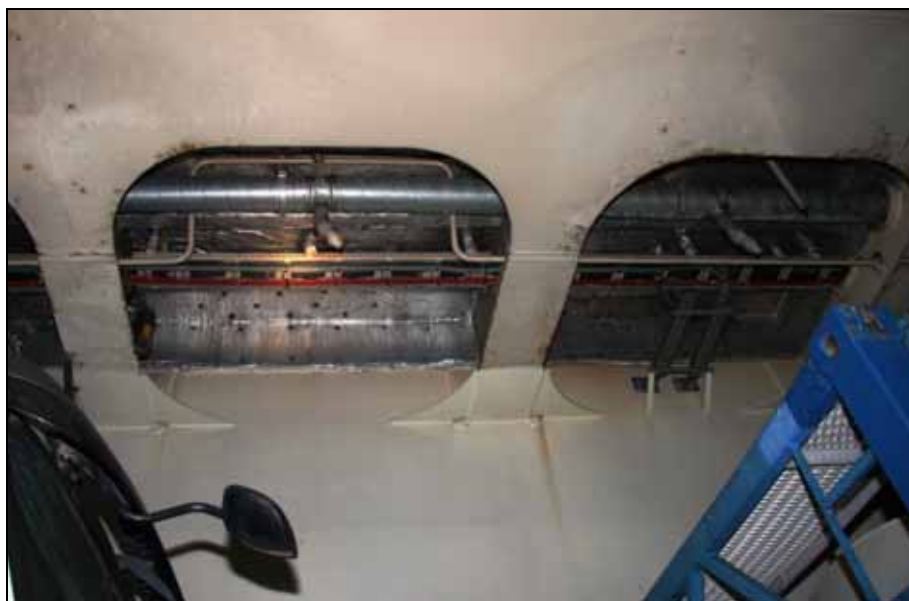
Figure 58: A-60 insulation on deck 2

During the survey on the LISCO GLORIA, the investigation team obtained an impression of the actual implementation of the fire insulation and its condition after the fire. There was no fire damage on deck 2 and the insulation was intact (see Fig. 58).

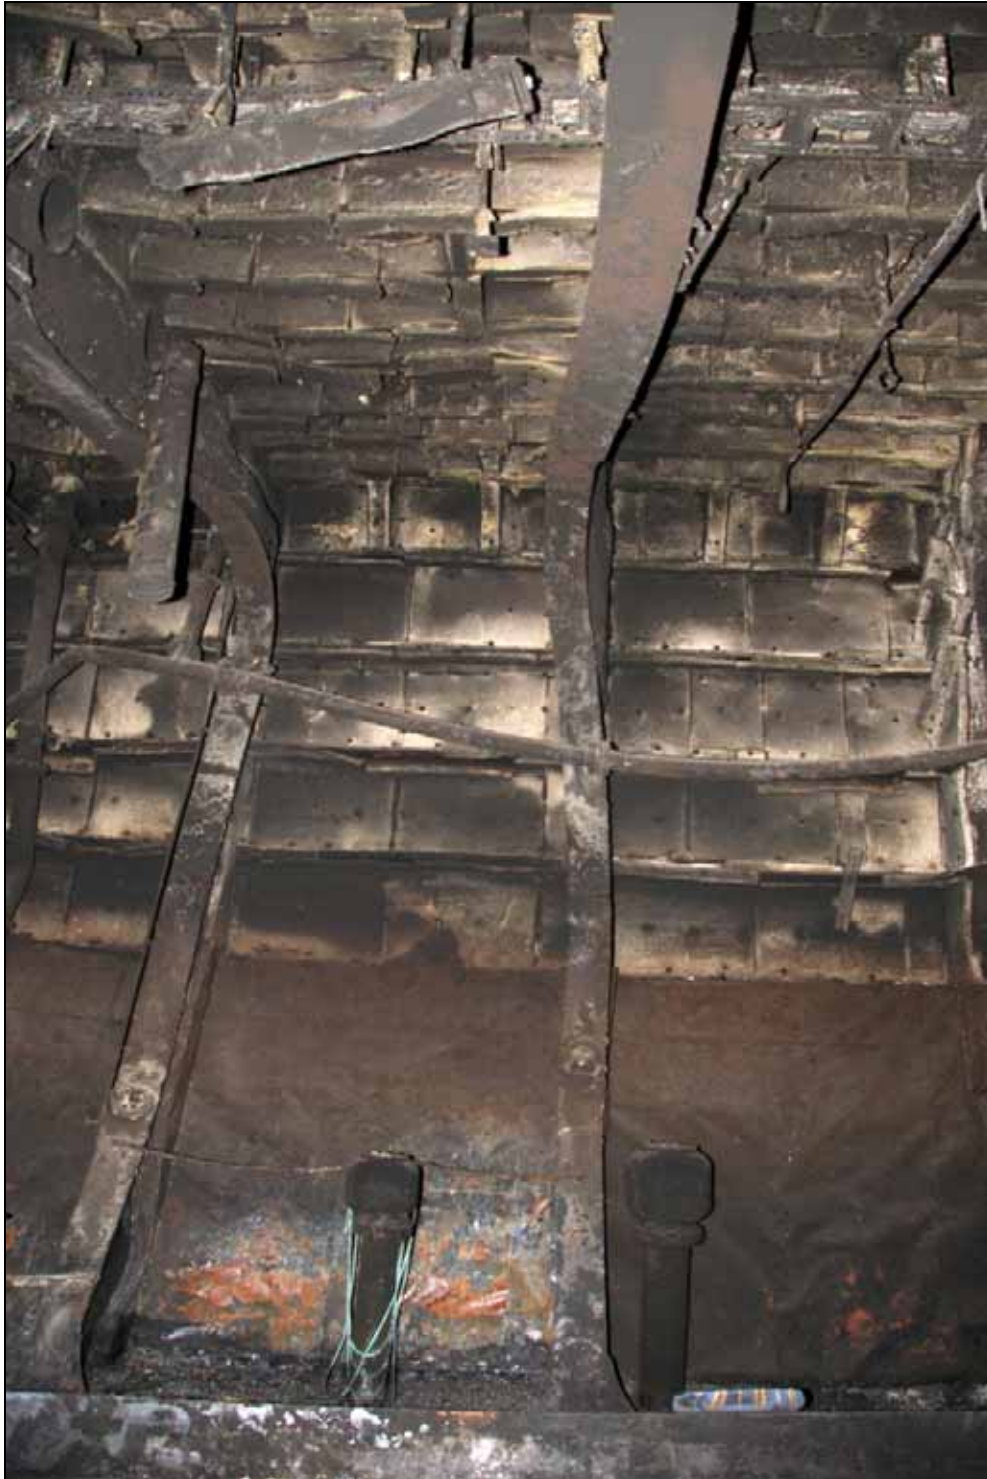
Figure 59: Remains of the A-60 insulation on deck 4

The insulation was largely destroyed on decks 4 and 6, where fires had been raging for weeks (see Figs. 59 and 60). The investigation team therefore went on board the LISCO GLORIA's sister vessel, the DANA SIRENA, to gain an impression of the comparable insulation (see Fig. 61) that existed there. The properties of the insulation found there were investigated in more detail during the expert analysis by LKA Kiel (see sub-para. 3.3.2.8 of the report).

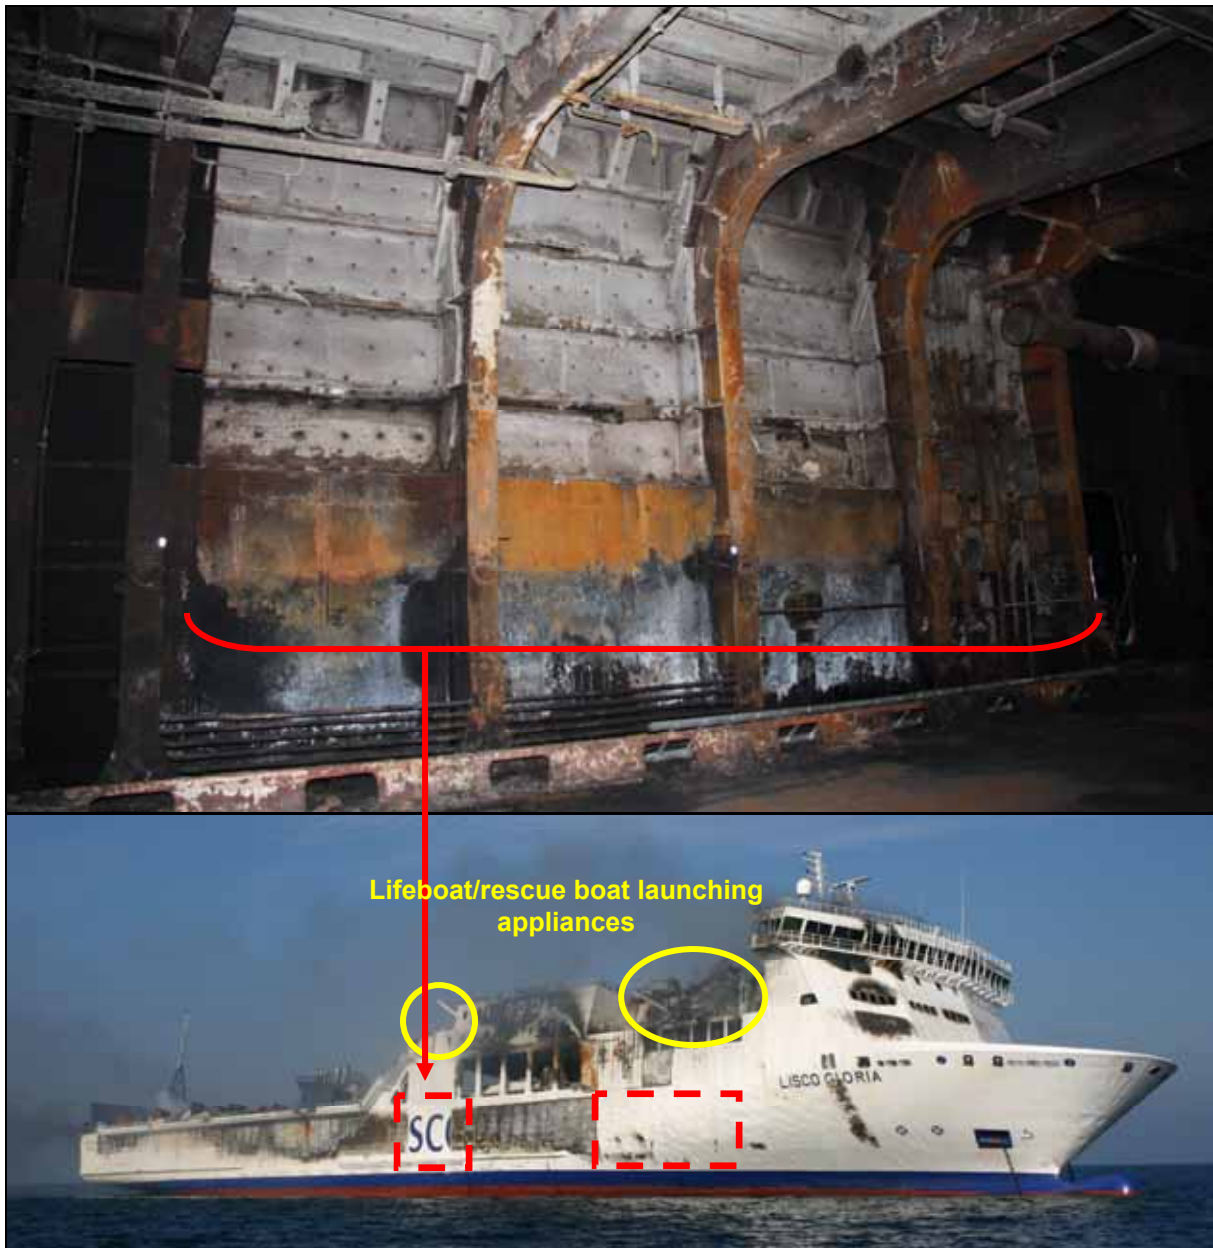
Figure 62: Reinforced insulation in the area of the life-saving equipment

During the inspection of deck 4 of the LISCO GLORIA, it was found that the additionally reinforced insulation in the areas below the lifeboat launching appliances

was still intact (see Fig. 62). Consequently, the external paint on the side of the LISCO GLORIA is still preserved in these areas.

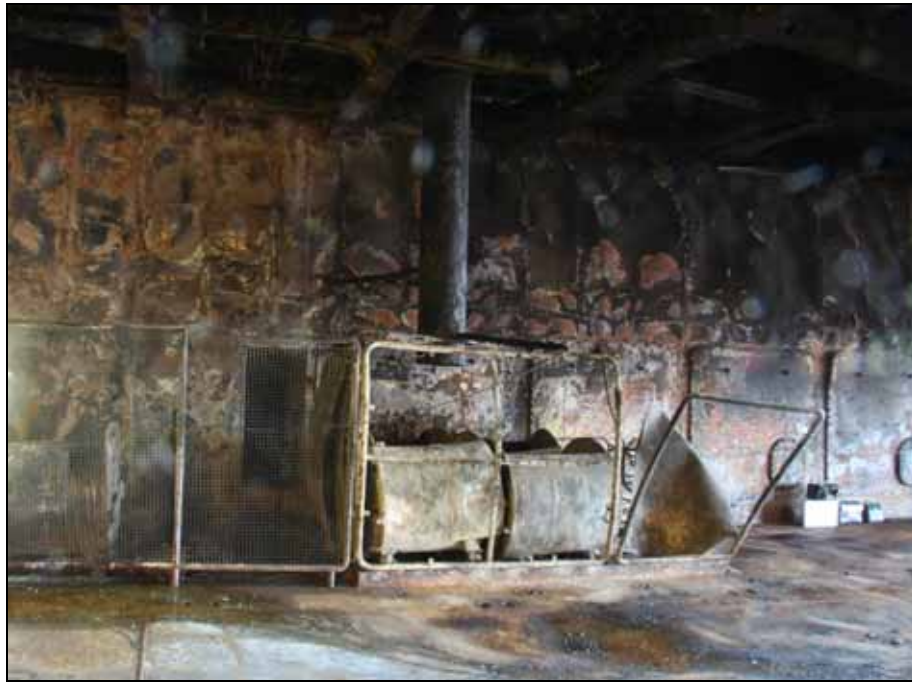
Figure 63: Waste containers and chute on deck 6 after the clearing work

The area intended in the design for waste collection on the upper deck is on lane 7 (starboard side) at frames 218 to 230 (see Fig. 63).

The waste opening was said to be properly closed and locked on the evening of the accident. In the course of the investigation, there was no evidence to suggest that the A-60 insulation was impaired in this area. The type and design of the waste containers on the upper deck complied with SOLAS.

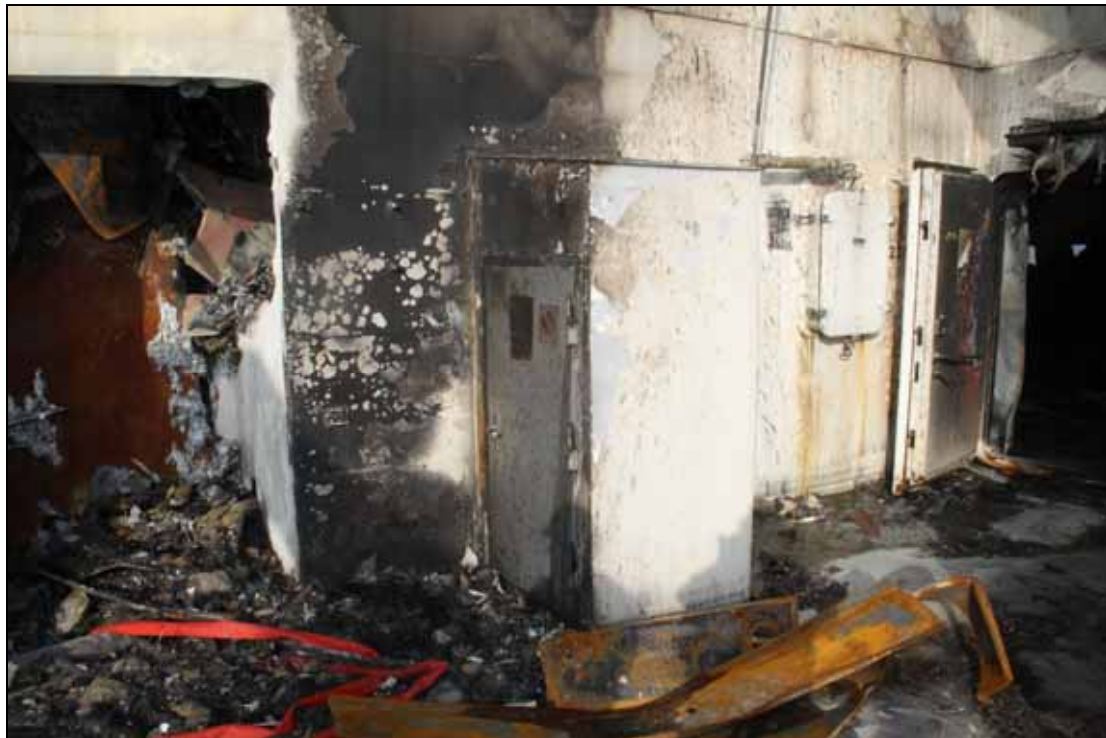
Figure 64: Area outside of the galley, starboard side of deck 7

The upper part of the waste chute level with frame 222 lead to a housing outside of the galley on deck 7, which was found completely intact and largely unaffected by fire (see Fig. 64).

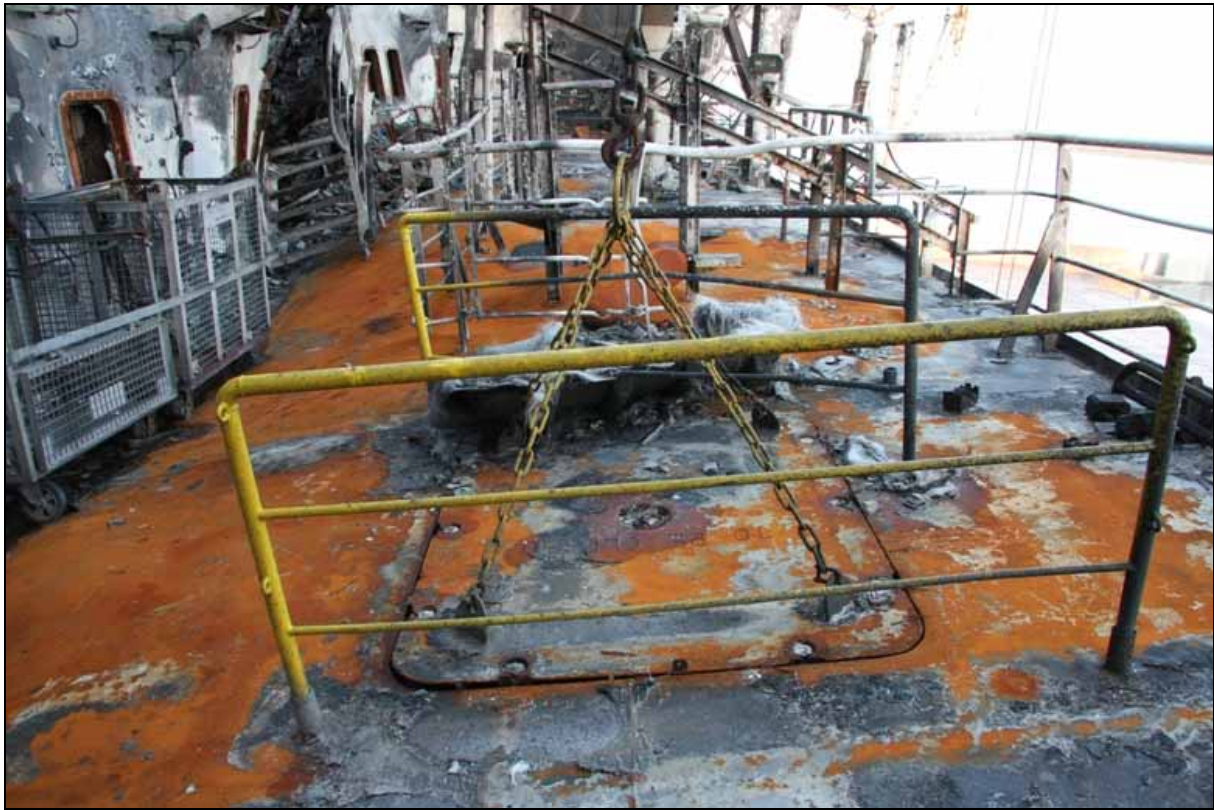
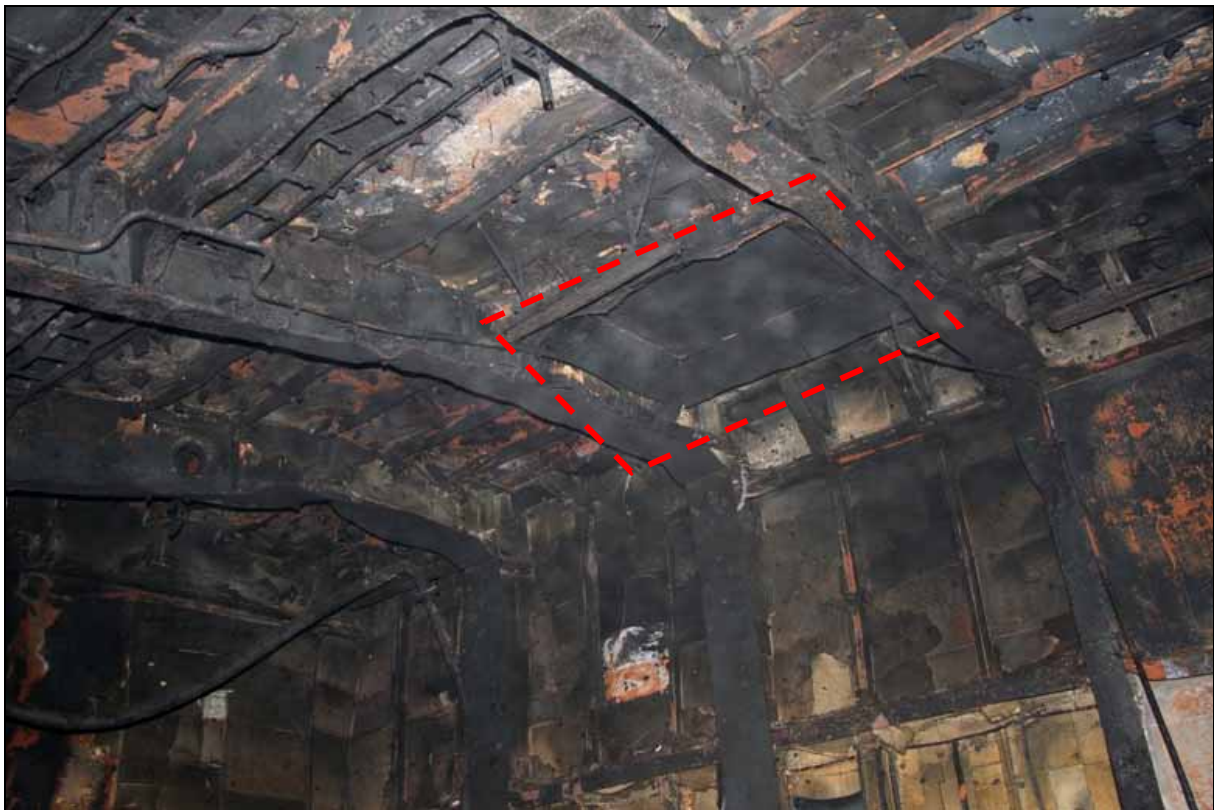
A hatch is located directly above the first parking position on lane 8 of the upper deck, where the outbreak of fire was observed (see Figs. 65, 66 and 67).

Figure 66: Hatch opening on deck 7 – after the accident

Figure 67: Hatch opening above the first parking position on lane 8 (upper deck)

No remains of A-60 insulation were found on the hatch during the surveys. The hatch was closed tightly.
