Investigation Report 445/10

Very Serious Marine Casualty

**Fire on the
ro-ro passenger vessel
LISCO GLORIA
on 8 October 2010
north-west of Fehmarn**

1 February 2012

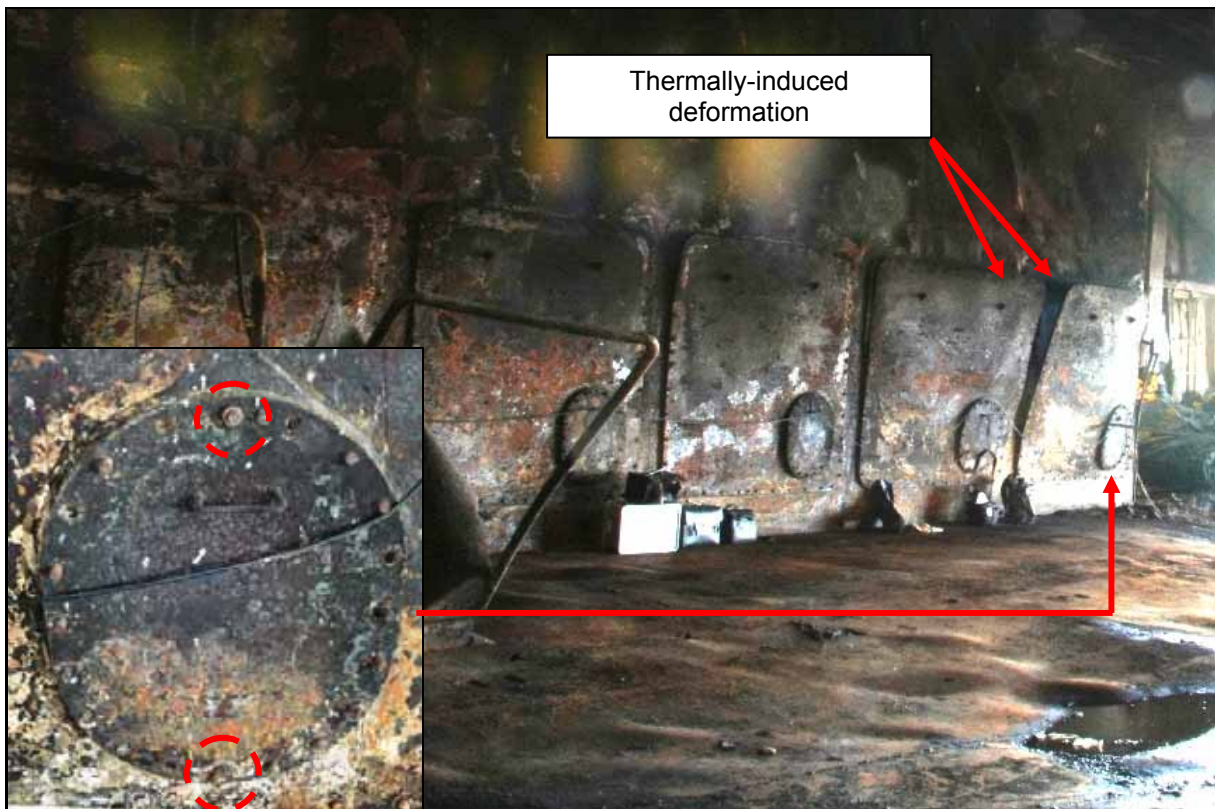
Figure 75: Manholes to the ventilation ducts on deck 6 – starboard side

Two of the six entrances to the ventilation ducts on the starboard side of the upper deck were deformed due to heat, causing openings to be formed (see Figure 75). Some of the bolts for the closing of the manholes were fastened only by a few nuts, to make it easier for the crew to open the access covers and carry out their routine inspections.

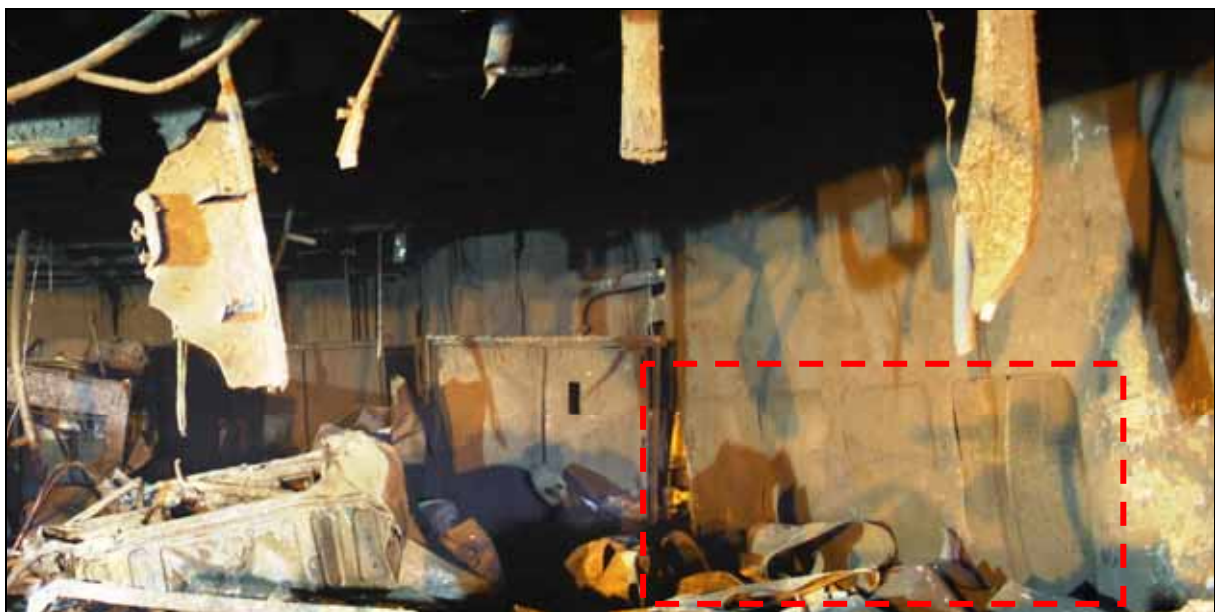
Figure 76: Ventilation ducts on deck 4 – starboard side

The ventilation ducts were covered by perforated mesh on deck 4 (see Fig. 76). An access for maintenance and inspection purposes was not provided for from this deck. The investigation team removed a perforated mesh to gain access to the ducts. It was found that the ventilation flaps were tightly closed, meaning no light penetrated from above (deck 6).

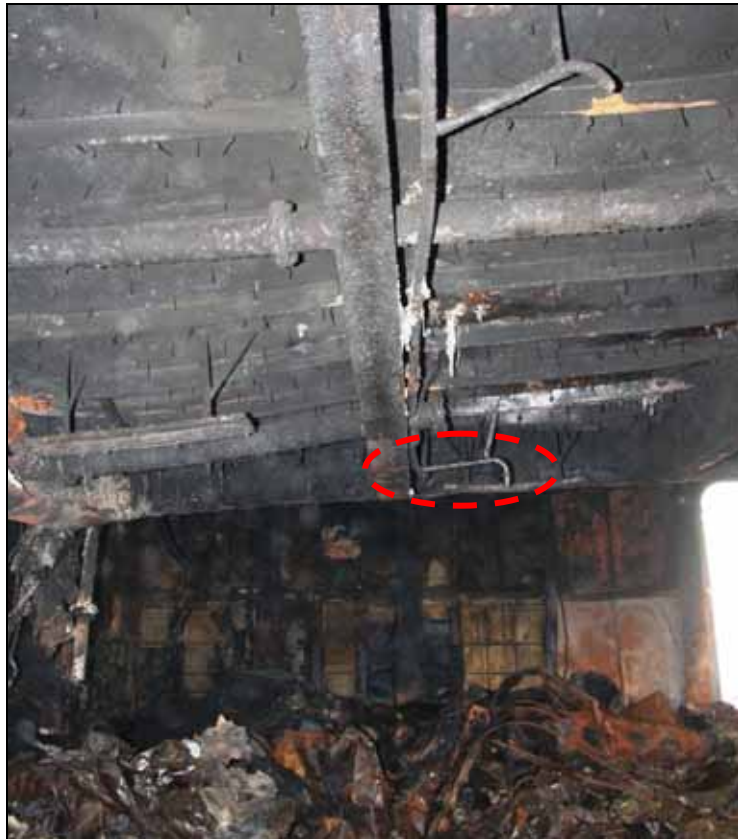
Figure 80: Extinguishing nozzles on the upper deck after the fire

The drencher system was divided into two sections on the upper deck (sections 31 and 32; see Fig. 79), into five sections on deck 4 (sections 21 to 25), and into two sections on deck 2 (sections 11 and 12). One extinguishing nozzle in Section 31 was almost directly above the observed source of the fire (see Fig. 79 and 80).

Both sections of the drencher system on the upper deck were triggered by the master at 0002 on 9 October 2010, just four minutes after the first fire alarm. However, the system did not deliver water; therefore, an order was issued to the duty engineer in the engine control room to start the drencher system from there.

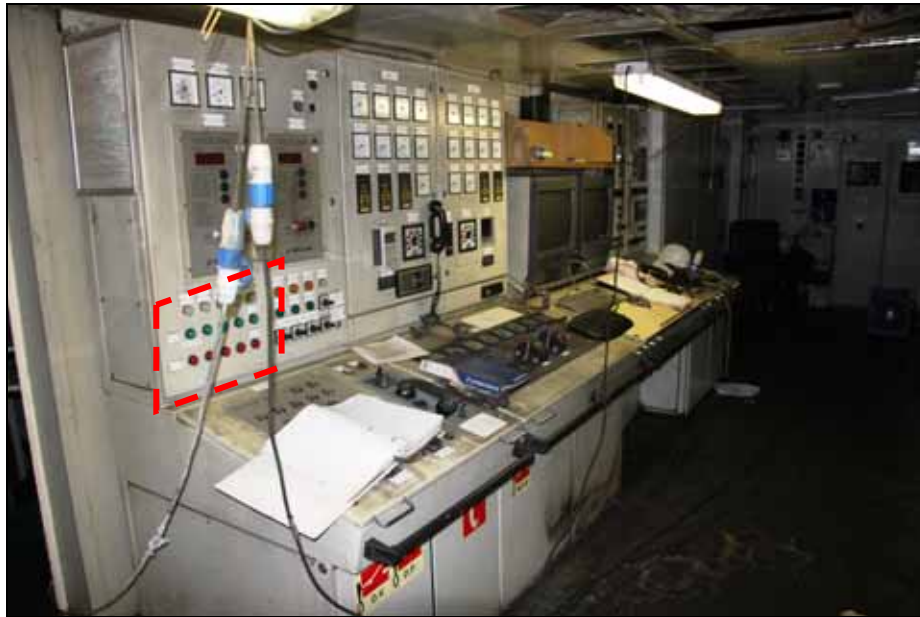
Figure 81: Control panel for the fire and drencher pumps in the engine control room of the LISCO GLORIA

In the engine control room, it was possible to check the functional capability of the pumps for the water supply, amongst other things to the drencher system, by means of indicating lights (see Fig. 81). The first attempt to start the pump for the drencher system was said to have failed. Following that, the pump control was reportedly switched to 'Automatic' on the main switchboard, which reportedly caused the indicating light for the pump to illuminate, after which the pump apparently started. No changes were reportedly made to the settings of the pump itself in the engine room.

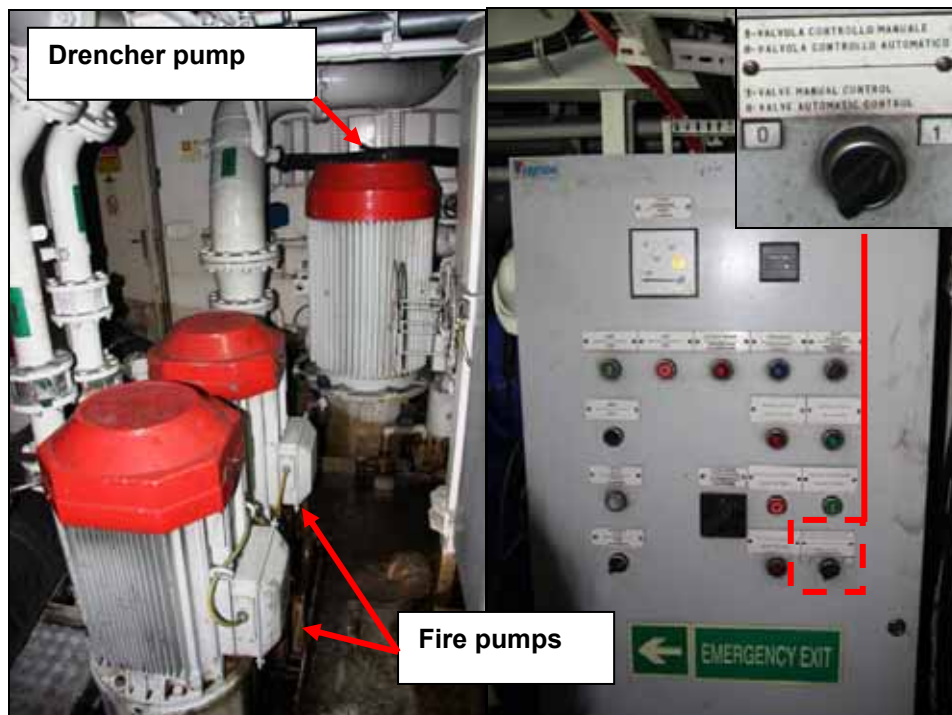
Figure 82: Drencher pump and switchboard in the engine room of the LISCO GLORIA

When the investigation team surveyed the engine room of the LISCO GLORIA, it was found that the valve for the water supply was set to manual mode on the switchboard for the drencher pump (see Fig. 82).

Therefore, after the tests on the DANA SIRENA the possibility of the drencher pump being activated successfully via the switchboard in the engine control room on the LISCO GLORIA on the night of the accident could be excluded, if the valve control on the switchboard for the pump in the engine room was not set to 'Automatic', but to 'Manual'. Regardless of that, the investigation on board the LISCO GLORIA could not exclude the possibility of the valve setting in the engine room being changed in the days following the accident, as was also proven in the case of the main switchboard in the engine control room.

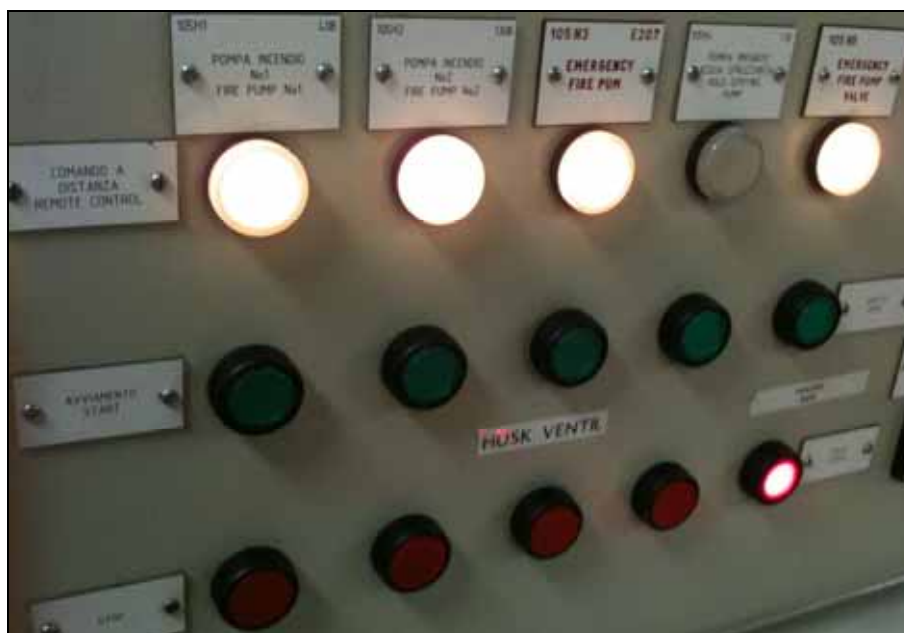
Figure 84: Control panel for the fire and drencher pumps in the engine control room of the DANA SIRENA when the valve setting on the switchboard for the drencher pump has been changed

However, if the switch for the valve is set to 'Manual' on the switchboard for the pump in the engine room, then the yellow standby indicator extinguishes in the engine control room and it is not possible to start the pump, i.e. although the green button can be pressed, it does not illuminate (see Fig. 84).

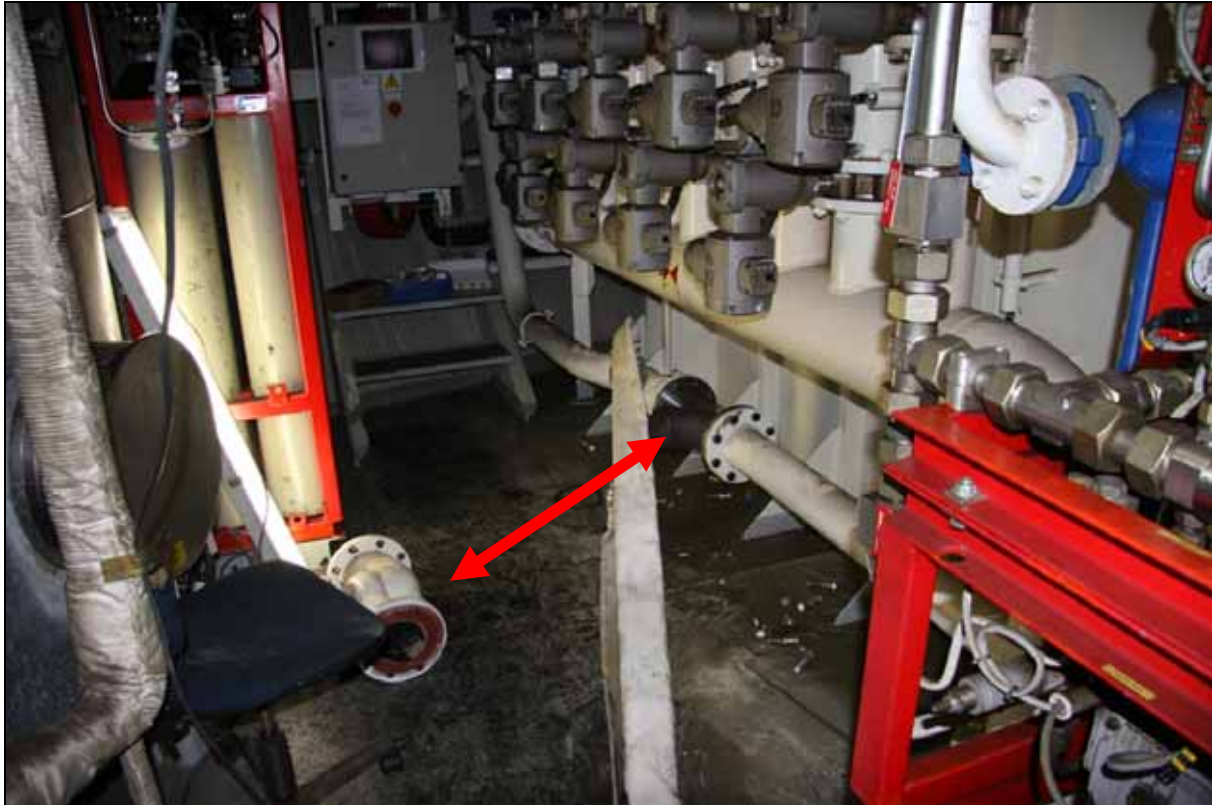
Figure 86: Setup for testing the drencher pump in the sprinkler room

A nautical officer of the LISCO GLORIA remained in the Sprinkler Room during the test, while the remainder of the party proceeded to the engine room. The first time an attempt was made to start the pump the motor started however the system did not produce any pressure or deliver water to the drencher system. A crew member present remembered that the main inlet to the seawater chest had recently been closed whilst operations were going on alongside with the ballast pump and other systems. The pump was stopped then using the control panel and this seawater chest valve was opened. Water was heard by the attendees rushing into the system. The drencher pump was started again. On this occasion the pump worked perfectly, and water was discharged through the hoses connected in the Sprinkler Room onto the forecastle. The pressure developed and maintained throughout the test was recorded as 11 bar. Further tests were carried out later on against a static head system. Those were carried out with the system closed at the Sprinkler Room and locally at the discharge from the pump. The drencher pump operated satisfactorily in both situations. Under these conditions the pump was started and left to run for a period of over five minutes during which time there was no increase in power consumption or any other observed effects.

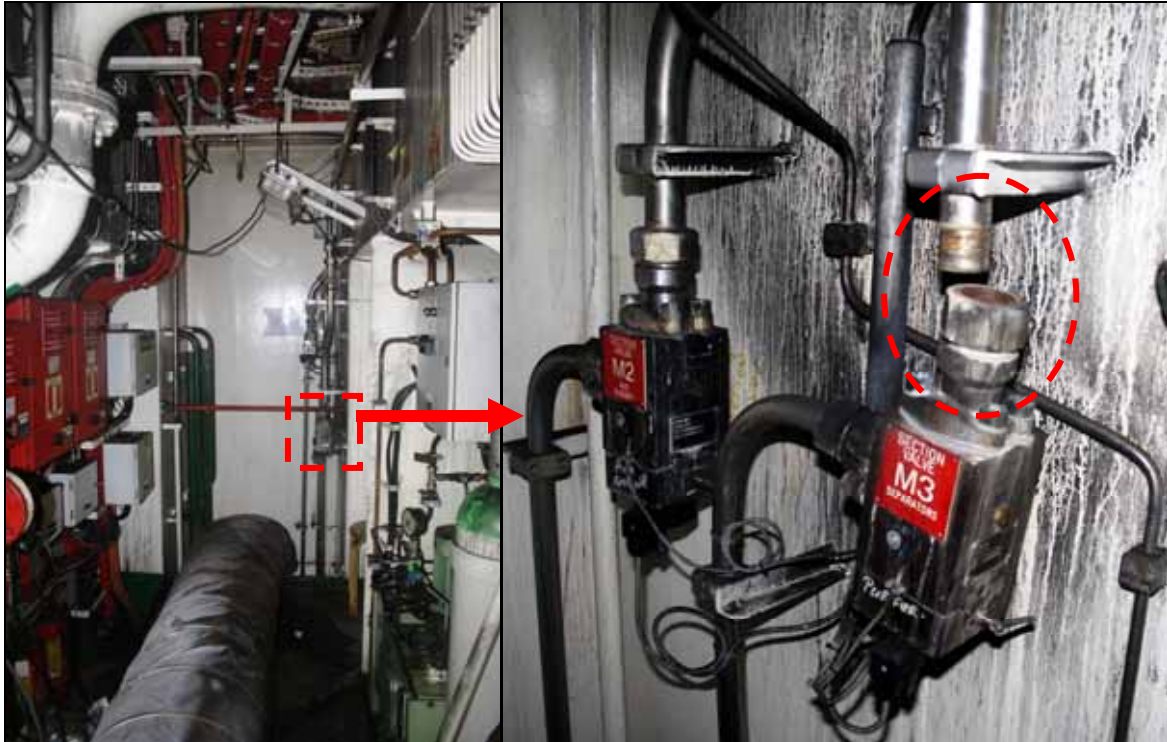
Figure 88: Parted sprinkler system pressure pipe near the engine control room

At the same time as the sprinkler system was triggered, the connection of one of the sprinkler system's pressure pipes (see Fig. 88) parted near the engine control room on deck 4, causing an uncontrolled flooding of this area with fire-fighting water.

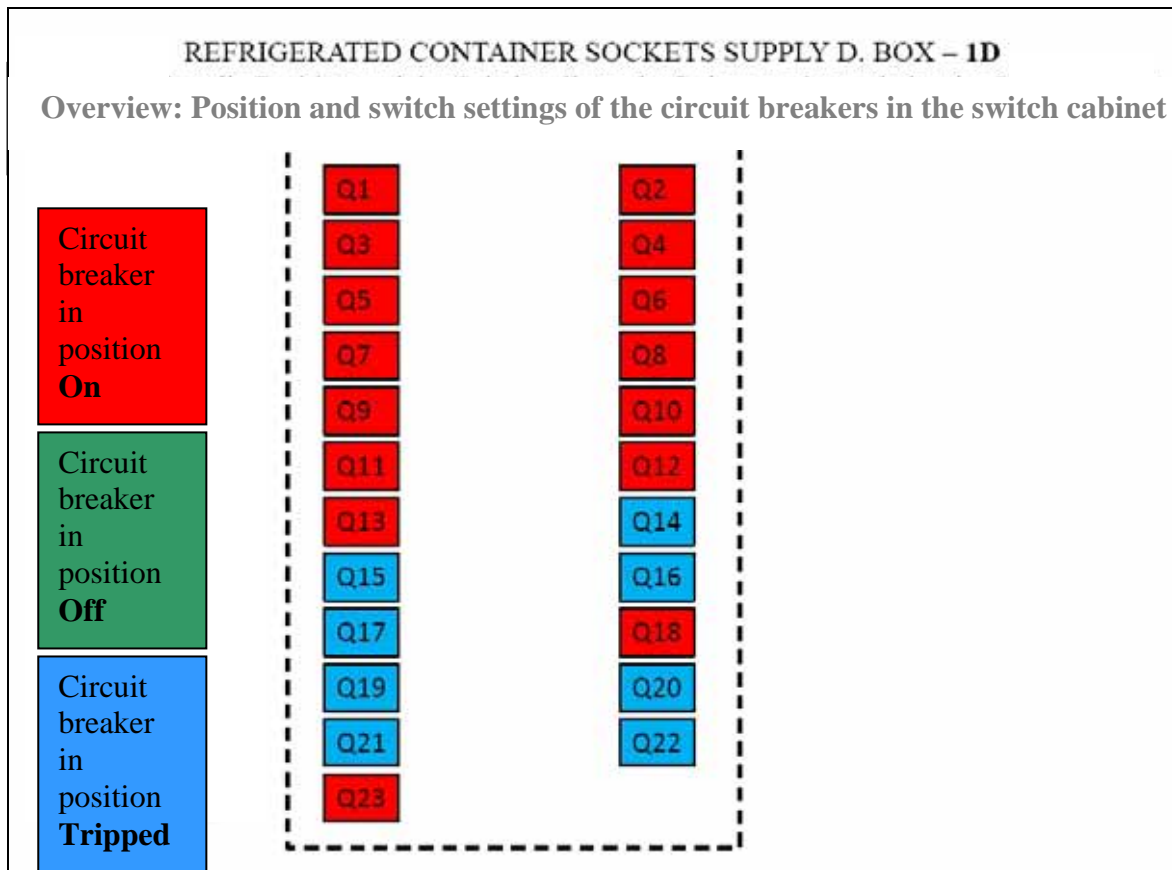
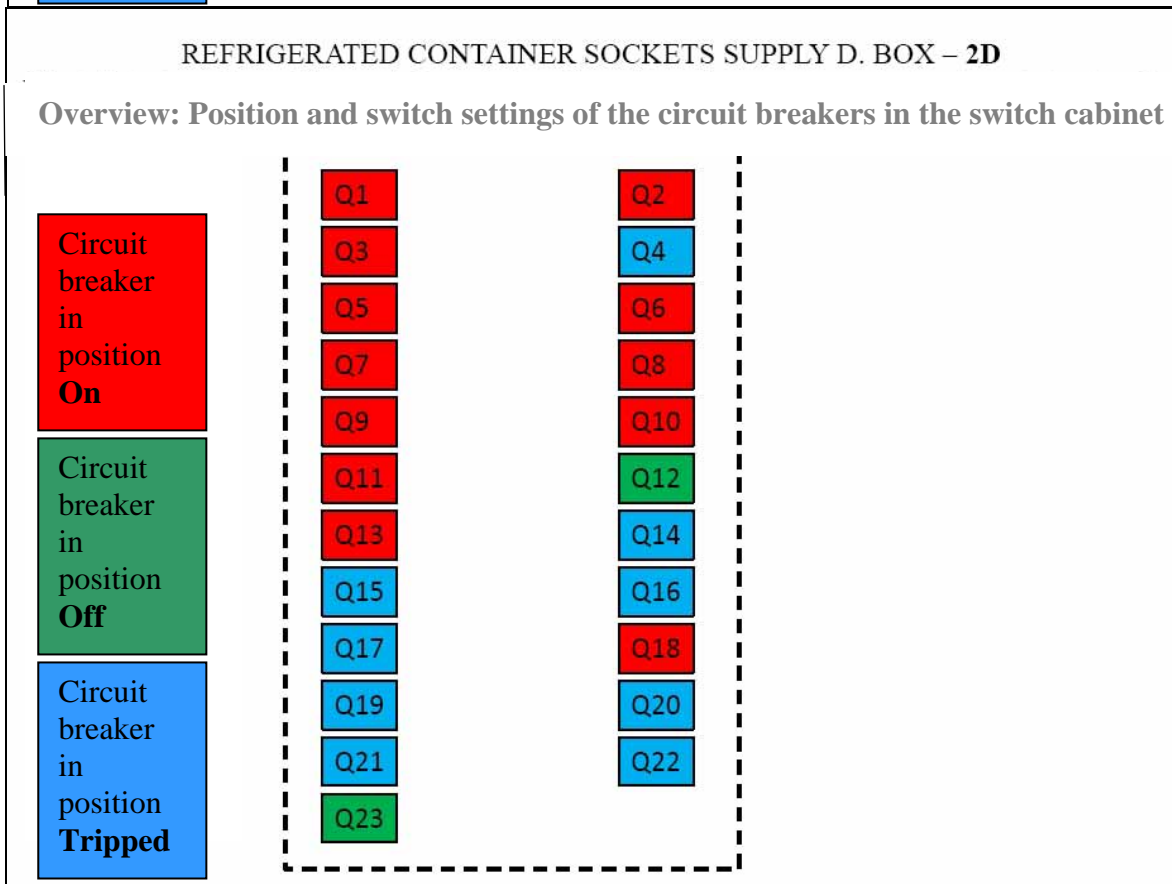
Figure 92: Overview of the position and switch setting of the circuit breakers

The tripping situation of the circuit breakers found was consistent with the witness' statement that the fire reportedly started on deck 6. At the time of the investigation, 16 of the 23 circuit breakers associated with deck 6 were in the position 'Tripped'.

In contrast, during the investigation of the tripping situation no evidence was found which indicated that the fire started on deck 4, as here only one circuit breaker, in the area of frame number 104 (starboard) in the aft section of the vessel, was in the switching position 'Tripped'.

This indicated that damage to the insulation of the supply cable to the switchable three-phase current power outlets did not take place in the course of the fire on deck 4 until after the electrical voltage had ceased to run through it.

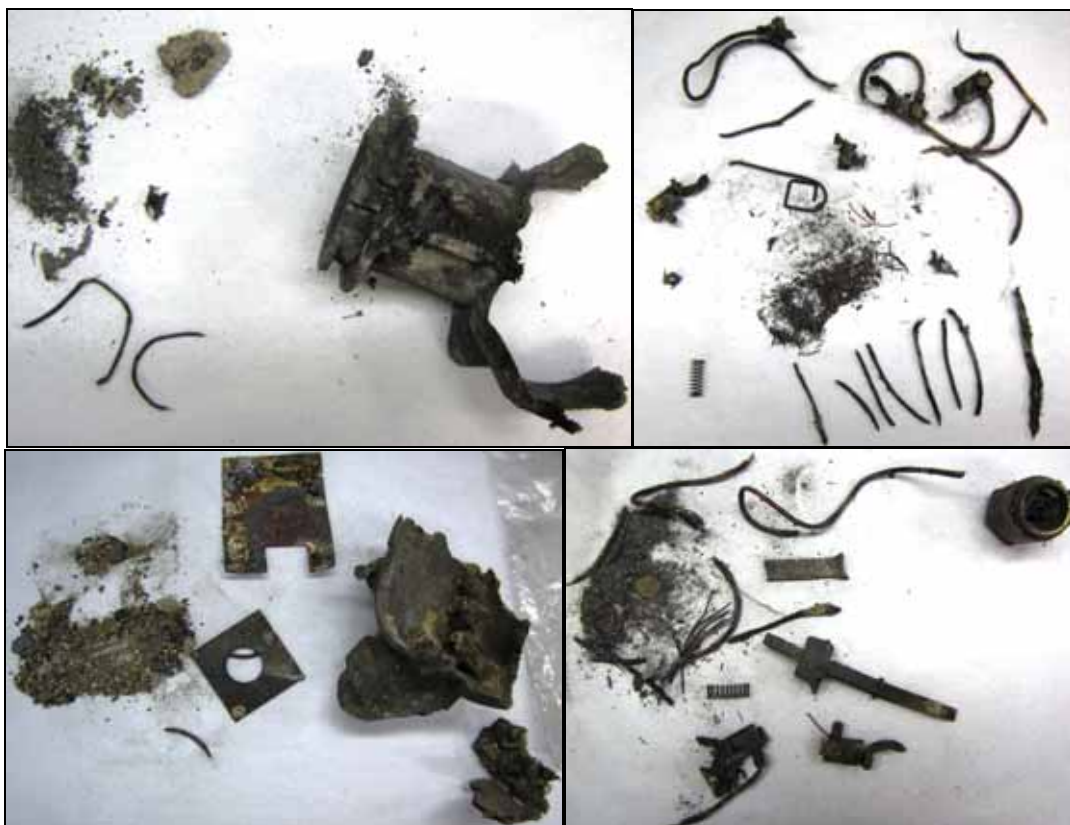
Figure 94: Remains of two switchable multiple sockets

The exhibits consisted of the remains of two switchable multiple sockets (see Fig. 94), the contact materials of the plug-in connectors (see Fig. 95), as well as the remains of the three contact pins of a connector socket and a plug found between the first truck and trailer on deck 6, lane 8 (see Fig. 96).

The fragments of the multiple sockets, and the discovered contact pins, gave rise to the conclusion that in this area a plug was inserted in both sockets. However, it was no longer possible to establish the switching position of the switch on the socket due to the high degree of destruction.

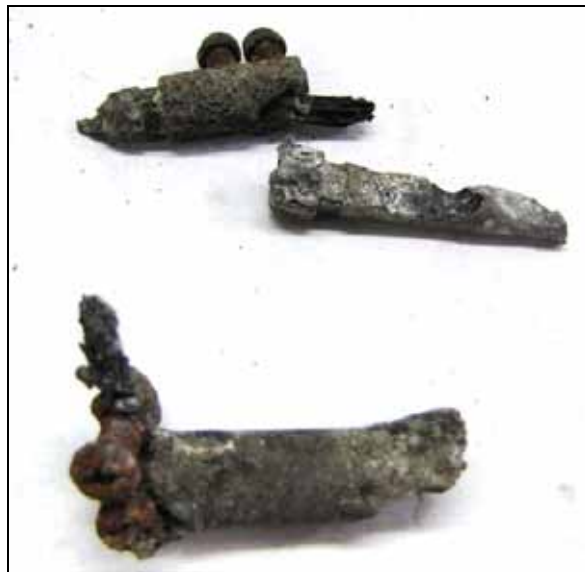
Figure 96: Remains of the contact pins found between truck and trailer

However, one contact pin differed from those with which the comparison was made and therefore could not be attributed to the mounted connector plug of the refrigeration unit. Therefore, the remains of the contact pins of a connector socket and a plug were found in the area between the trailer and towing vehicle on deck 6, lane 8.

When compared with a sample not affected by the fire, the external appearance of the contact pins found between the aforementioned towing vehicle and refrigerated trailer indicated that they belonged to the mounted connection plug of the refrigeration unit and a coupling socket.

Accordingly, an electro-technically induced fire in this area (e.g. insulation failure of conducting materials, contact heat via transfer resistance, failure of electronic components) could not be ruled out as the cause.

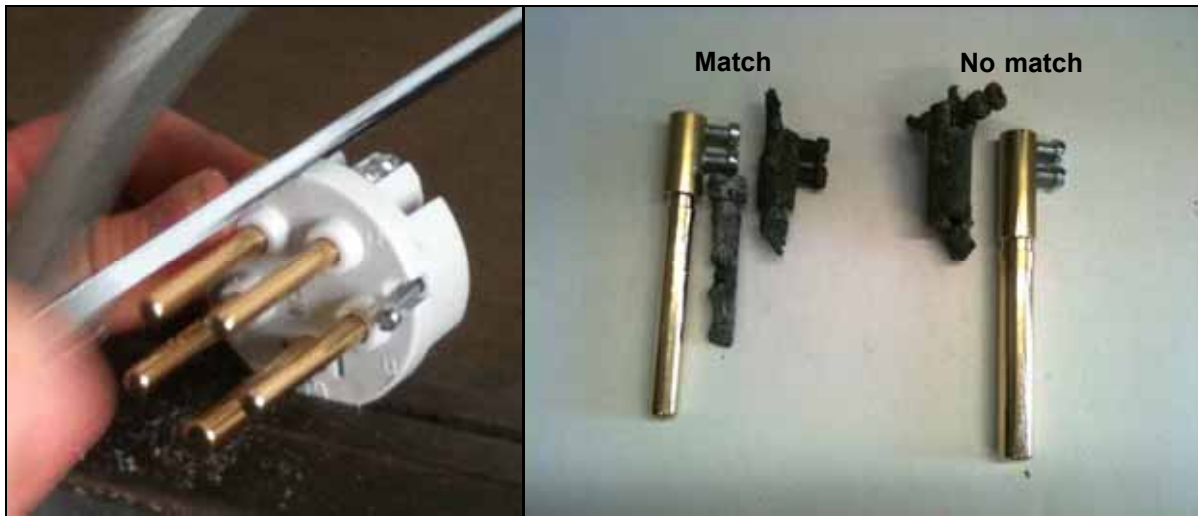
Figure 97: Classification of the contact pins kept as evidence in the laboratory test

To make it possible to match the individual contact pins with a plug or connector socket, an identical mounted connector plug was acquired. The contact pins of the phase conductor and the protective conductor were cut out of the plastic housing of the plug and compared with the exhibit. Here, based on the shape and outer dimensions it was apparent that two of the three contact pins could be matched with those of the plug (see Fig. 97).

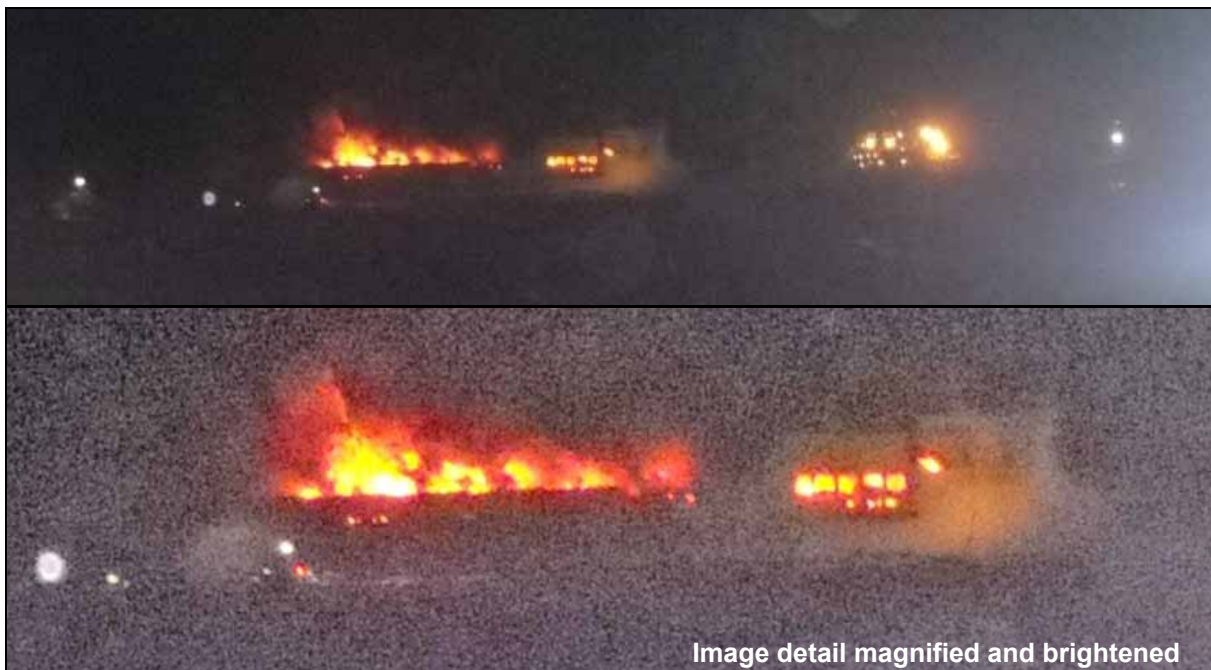
Figure 98: Extent of the fire on deck 7,
taken on 9 October 2010 at about 0100

The images of the sub-series 'Lifeboat' show that after the vessel was abandoned the fire had already spread across the upper deck, and seized the garage area below the cabin superstructure as well as parts of the upper deck behind it (see Fig. 98). The starboard side was windward.

Figures 98 and 99 give the impression that the destructive fire had also spread upwards into the outer area of the cabin superstructure. The red arrow marks a bright spot, which is situated approximately where an open part of deck 7 with crane jib and lifeboat was positioned. However, in this respect a definitive conclusion is not possible due to poor image quality.

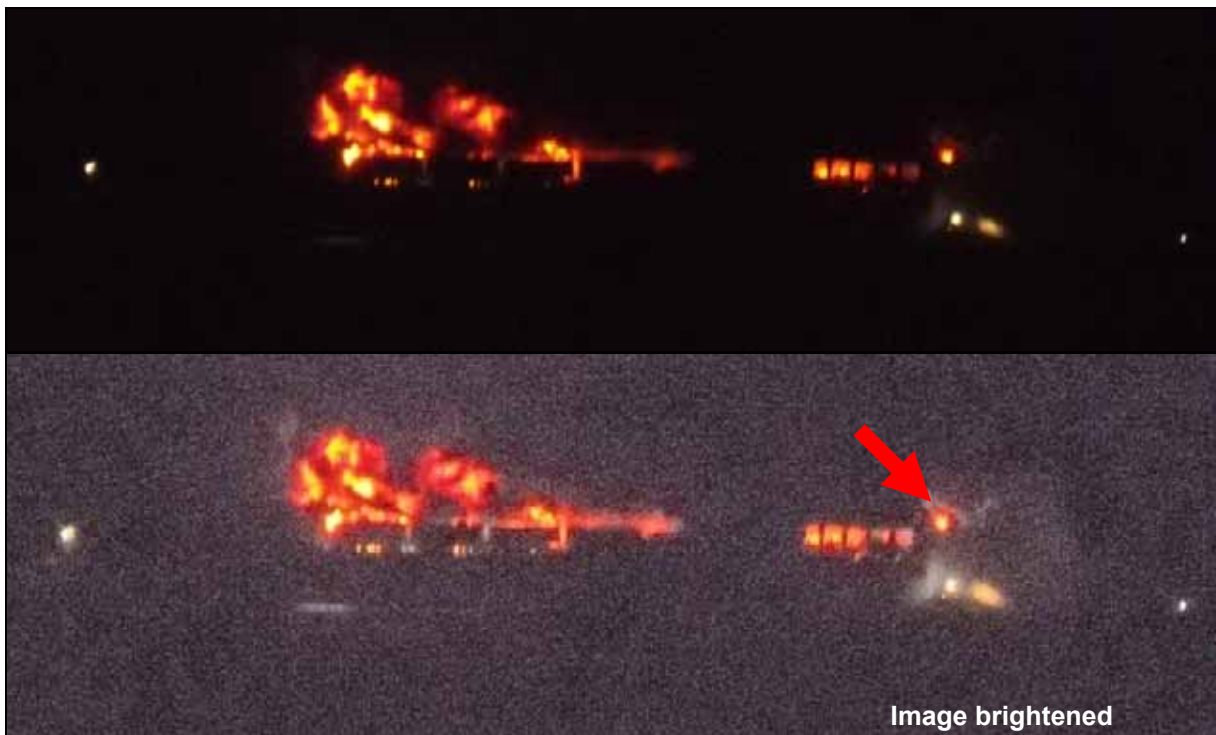
Figure 99: Extent of the fire on the upper deck,
taken on 9 October 2010 at about 0100

The stage of the fire documented in the photographs can be described as an extensive, fully developed fire. Nevertheless, as can be seen in Fig. 99, for example, the destructive fire had not yet covered the entire length of the upper deck. Here, the silhouettes of four trucks and trailers can be seen aft of the dark looking enclosure of the external ladder to the accommodation superstructure, that is the section of the vessel immediately aft of the five large ventilation windows. Based on the ferry's stowage plan, more stowing positions as well as the stern with mooring winches must have been behind that, in an area not yet affected by the fire. Structures can be dimly seen along the ventilation windows, which presumably belong to the first truck and refrigerated trailer parked in lane 8 (source of the fire) and a second trailer behind it. Further insights into the spread of the fire towards the port side cannot be gained from the photographs.

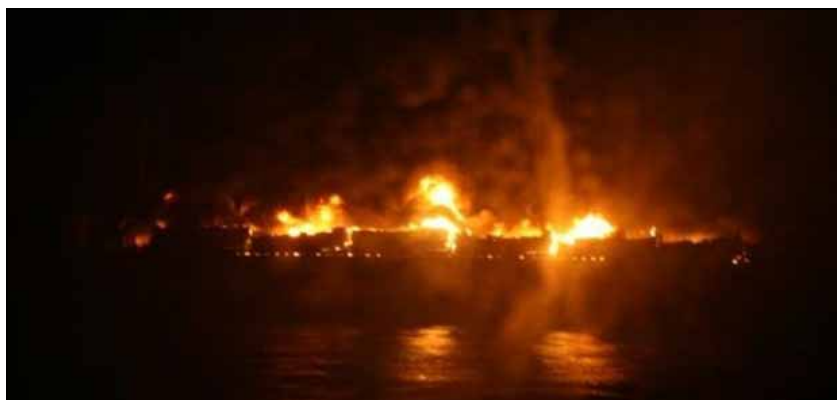
Figure 100: Fire continues to extend along the upper deck,
taken on 9 October 2010, exact time unknown

In Figure 100, the fire seems to have spread further towards the stern. There is, as silhouettes, an indication of six burning trucks and trailers on the open section of the upper deck. *The time the photograph was taken is unclear. However, since the ROTA was at the scene at 0105, the photograph could have been taken at about the same time as the witness photographs from the lifeboat.*

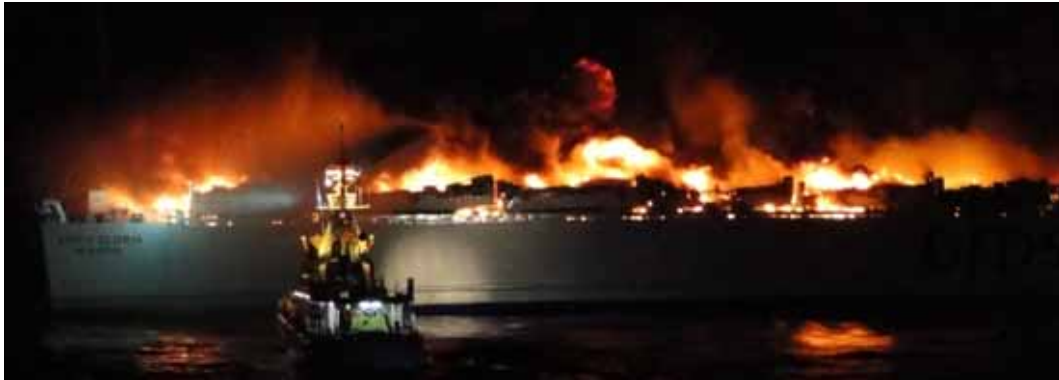
Figure 101: Fire extends across the whole of the upper deck, taken on 9 October 2010 at 0221

It was probably not possible to approach the burning ferry from the port side due to the smoke, which was blowing leeward. The entire length of the upper deck is now on fire. The stern and name of the ferry is easily visible in Figure 101.

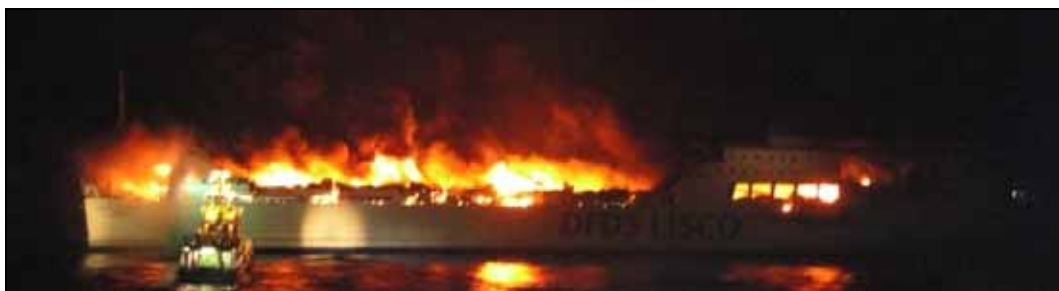
Figure 102: Full shot of the burning LISCO GLORIA, taken on 9 October 2010 at 0221

Figure 102 provides an overview of the entire length of the LISCO GLORIA. A bright spot can again be seen diagonally above the ventilation window, indicating a localised fire on deck 7.

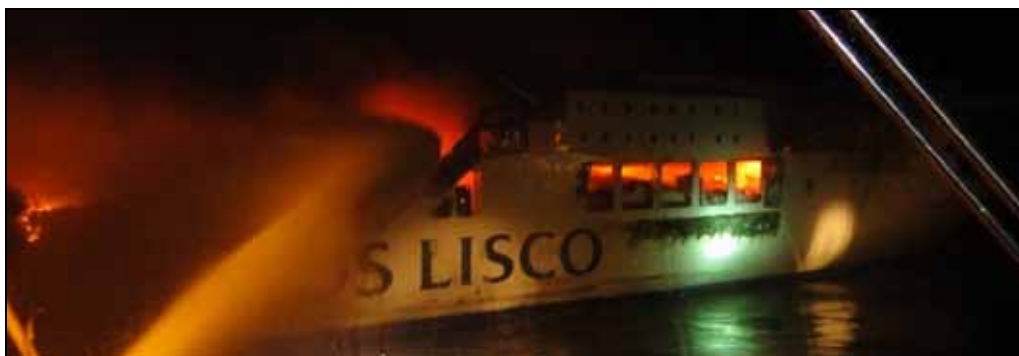
Figure 103: Onset of fire on deck 4, taken on 9 October 2010 at 0254

In Figure 103 it can be seen that deck 4 is also affected by the fire.

Below the ventilation windows, burnt coating had formed in a black line. It appears that the fire spread from deck 6 in the forward section, since no such fire traces had

formed further back. This is logical in view of the presumed source of the fire being immediately above. The discussed discolouration is sharply limited, at its top by the recessed upper deck and forward by the ventilation ducts. Since the hot combustion gases accumulated under the ceiling after the fire spread, the traces of the fire initially do not cover the entire height of deck 4.

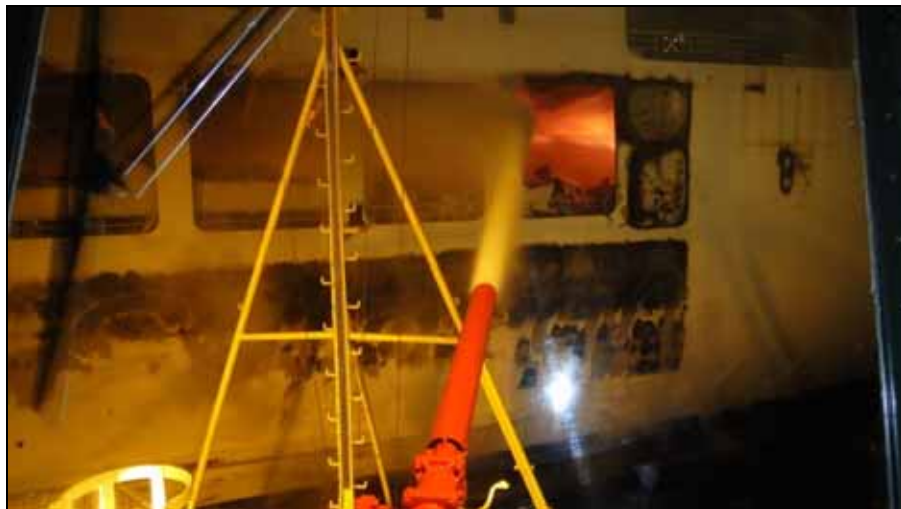
Figure 104: Development of fire damage to the side of the vessel, taken on 9 October 2010 at 0434

Figure 104 was taken at 0434:08. The fire damage on the shell plating has progressed further downward; its lower edge is limited by deck 4. There is no indication of the fire spreading to deck 2.

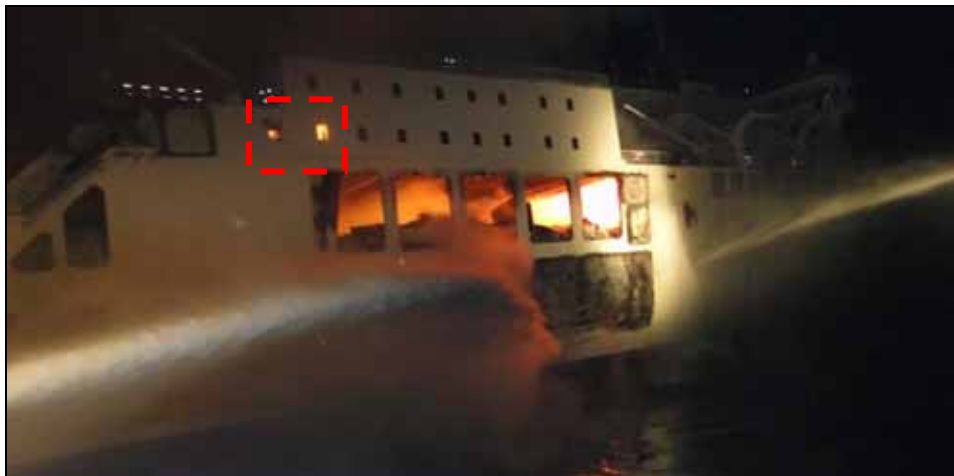
Figure 105: Fire spreads to the superstructure, taken on 9 October 2010 at 0628

The rear end of the refrigerated trailer on which the fire reportedly started is completely destroyed; only the rear tailboard has remained upright. The area in front of the trailer cannot be viewed. *However a fire marking at the position of the space between the cab and the trailer can be seen on the hull plating.* Figure 105 was taken at 0628:37. Another intensification of the traces of the fire is evident on deck 4. As illustrated by the glow from the last two windows on deck 7, it is now also burning in the rear section of the cabin superstructure.

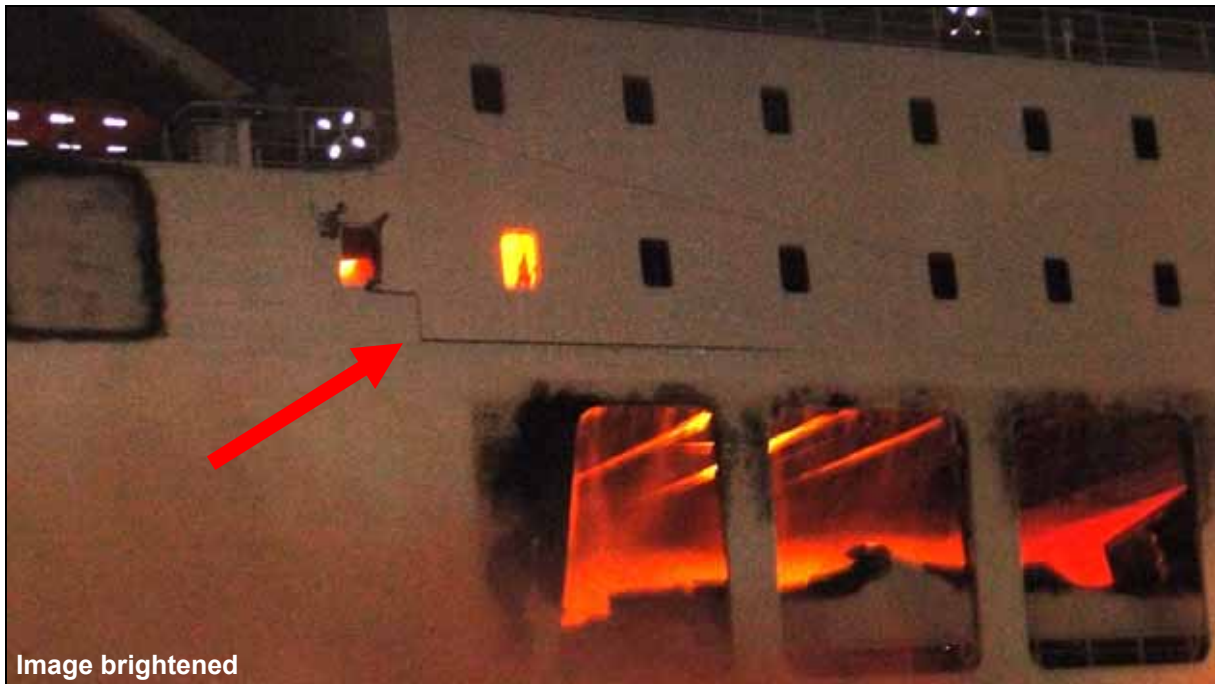
Figure 106: Crack forms between decks 6 and 7, taken on 9 October 2010 at 0629

A crack has formed between the cabin superstructure and the underlying structure (see Fig. 106).

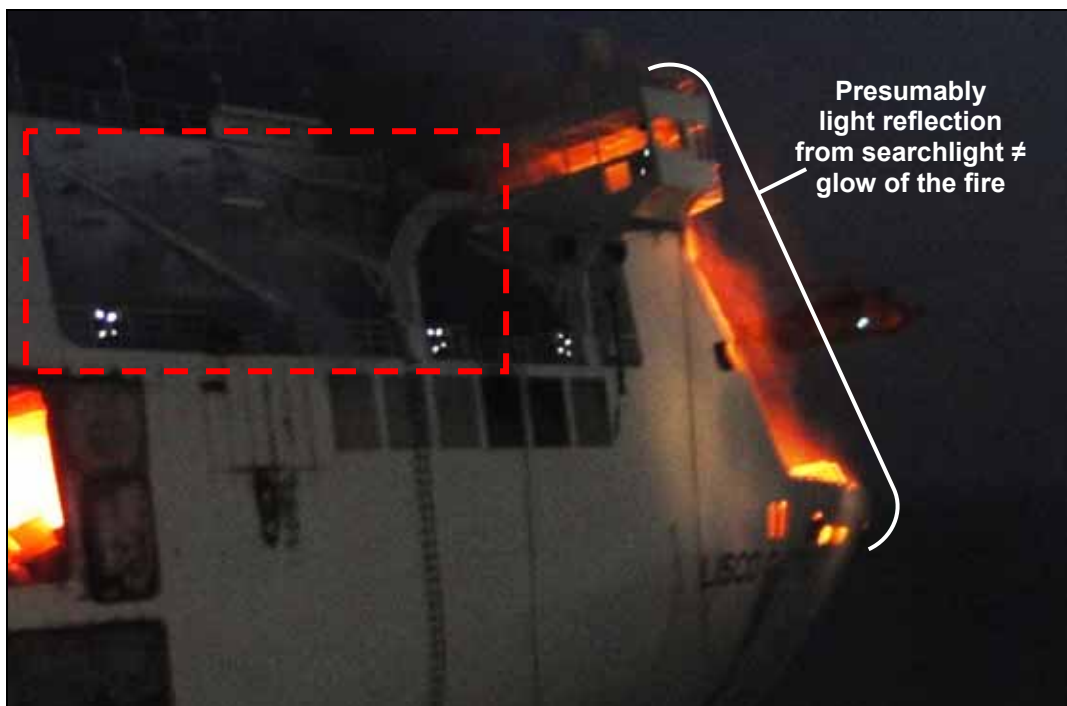
Figure 107: No fire at the lifeboat station on the starboard side, taken on 9 October 2010 at 0656

However, the open part on the side of deck 7, where the starboard lifeboat was stowed, appears to be dark. It is not possible to confirm the aforementioned signs of the fire spreading into this area with Figure 107.

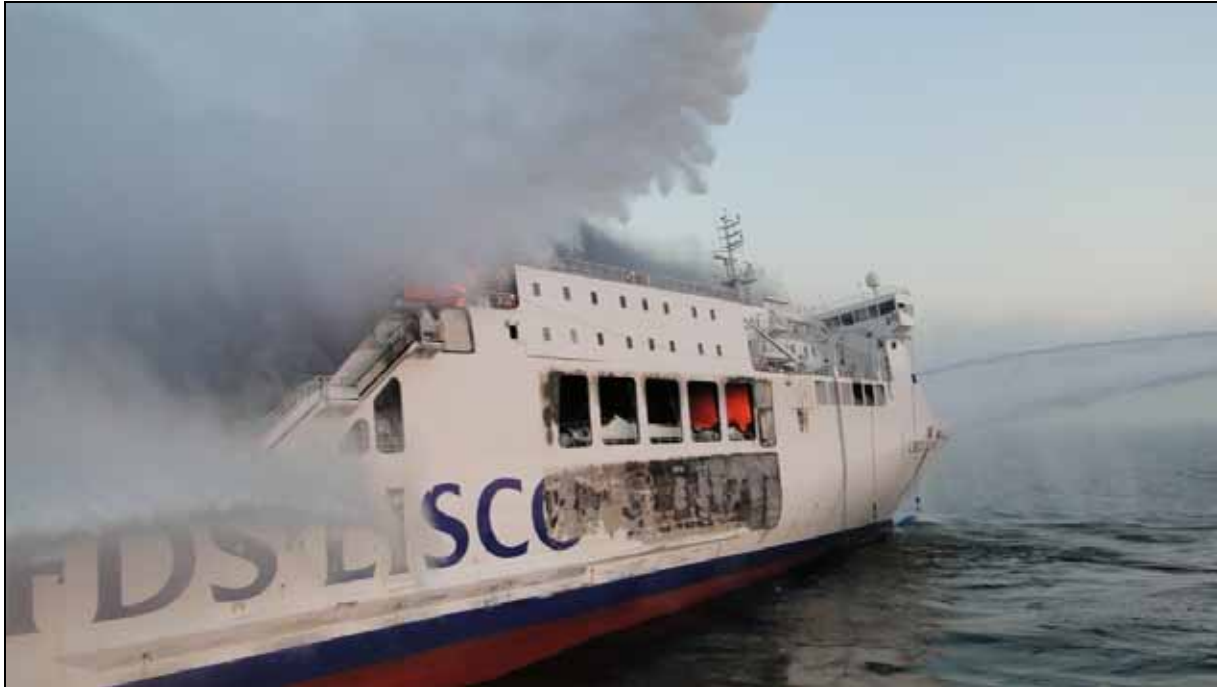
Figure 108: Evaporating fire-fighting water on the morning of 9 October 2010, taken at 0753

Figure 108 shows the condition of the LISCO GLORIA on the morning of 9 October 2010 at 0753:28. The lateral fire trace on with deck 4 has progressed further towards the stern and stretches to the name of the ferry.

The light grey smoke above the vessel indicates a high proportion of evaporating fire-fighting water. It can be clearly seen that the speed with which the fire developed on deck 4 was relatively slow. This is due to the lack of oxygen, which probably occurred on deck 4 after the fire spread resulting in a ventilation-controlled development of the destructive fire – in contrast to the course of the fire on the open upper deck. Dark smoke can be seen rising mainly from the upper decks in Figure 109. Other shots confirm the impression that all decks of the cabin superstructure were burning at 0840. It is only in the area of the bridge that no smoke is visible.

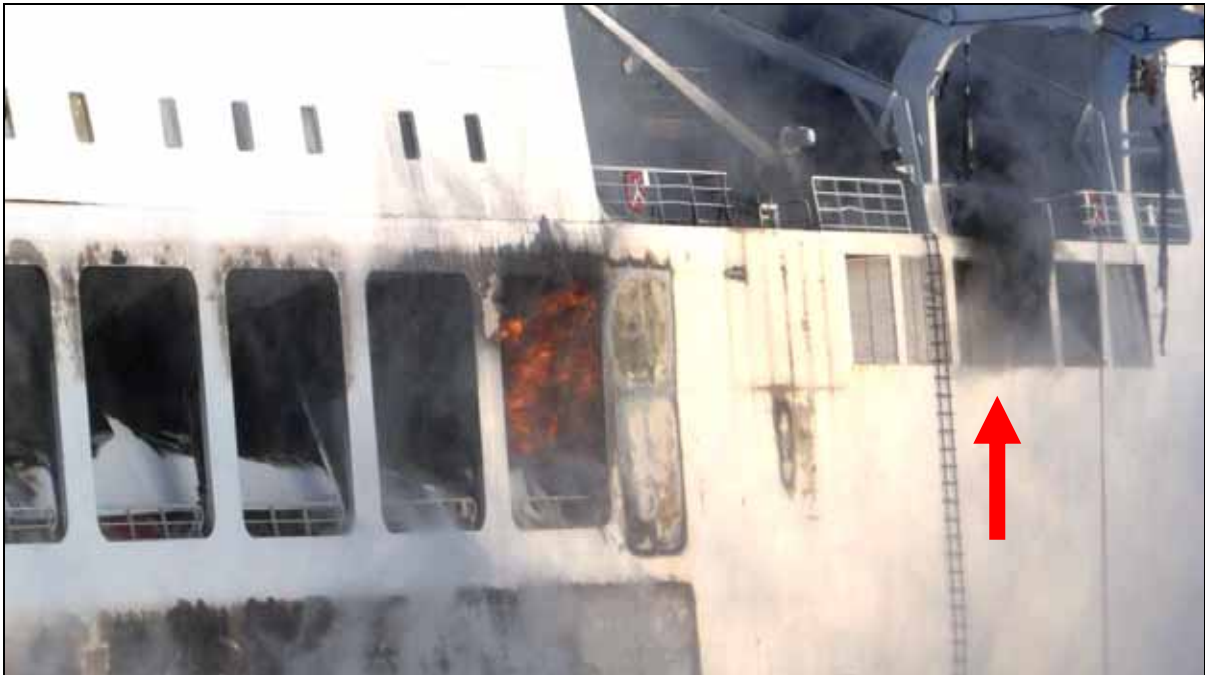
Figure 110: Fire on deck 6 on the morning of 9 October 2010, taken at 0839

Dark smoke is also emanating from a side vent and deck 6 is in flames at the first ventilation window (see Fig. 110).

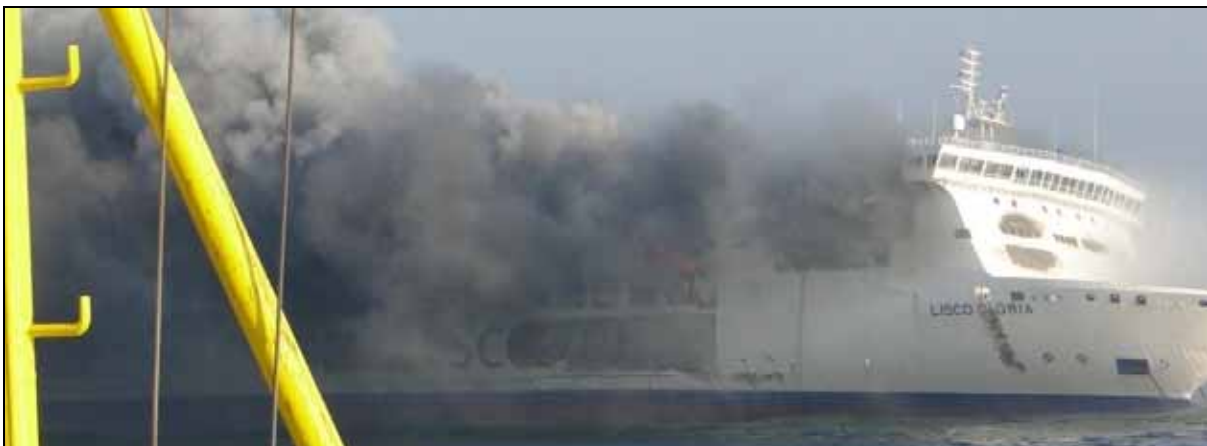
Figure 111: Photograph before the structural collapse of the superstructure, taken on 9 October 2010 at 0940

At 0939 on 9 October 2010, the LISCO GLORIA is lying at anchor. The wind is now blowing the fire smoke from the bow to the stern of the vessel. Figure 111 shows that at 0940:54 the mast on deck 10 (*wheelhouse top*) is still upright. At this point, it appears that the structural collapse of the superstructure is not yet complete.

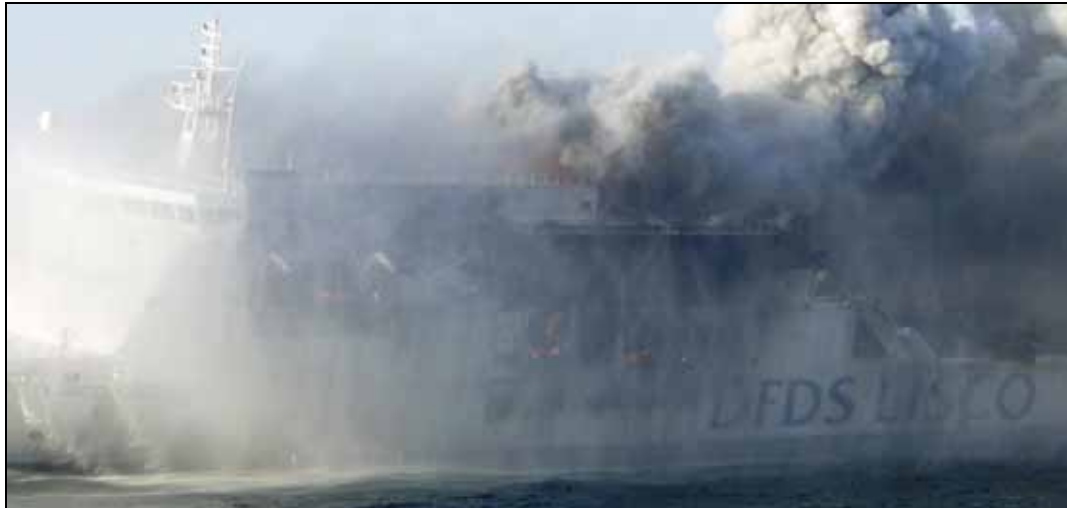
Figure 112: Fire on the port side in the garage area of the upper deck, taken on 9 October 2010 at 0946

Since the ferry was lying at anchor in the wind, the view on the port side was free. In several images, fire can be seen on the port side at 0946. It can also be seen that the signs of fire damage on the shell plating of deck 4 are not as prevalent on the port side as on the starboard side (see Fig. 112). This can be interpreted as an indication that the fire started on the starboard side.
