Investigation Report 445/10

Very Serious Marine Casualty

**Fire on the
ro-ro passenger vessel
LISCO GLORIA
on 8 October 2010
north-west of Fehmarn**

1 February 2012

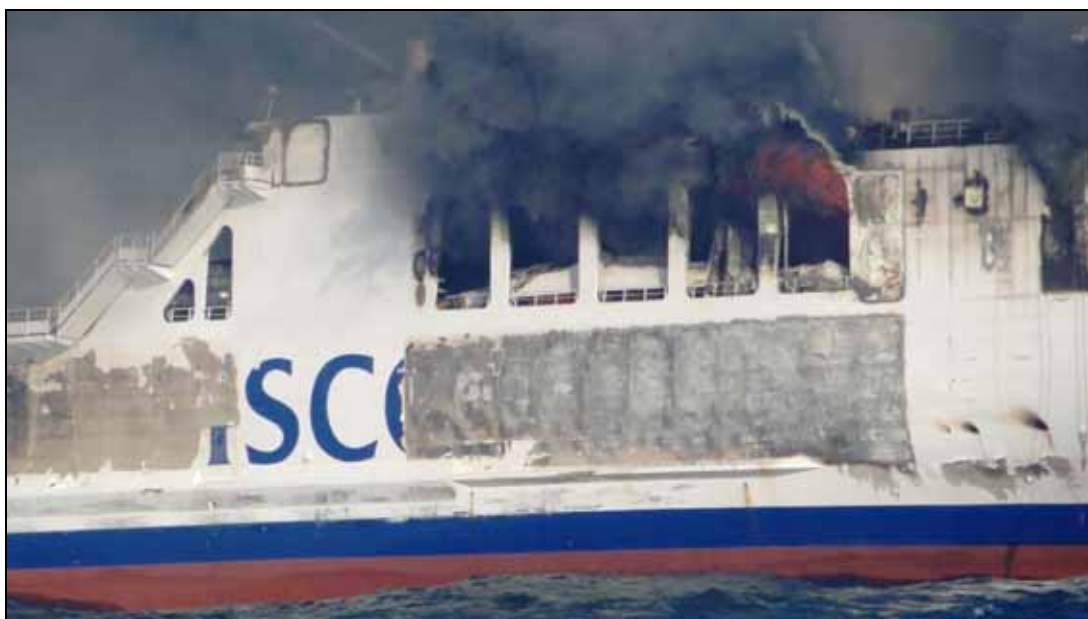
Figure 113: Material loss in the transition to deck 7, taken on 9 October 2010 at 1038

On further images, signs of the heat of the fire on deck 4 can be seen on the shell plating, up to behind the name on the side of the ferry. Figure 113 shows that above the first ventilation window on the starboard side a massive material loss has occurred on the lower edge of the aluminium cabin superstructure. This provides evidence of an effect that cannot be attributed to the early phase of the fire, but which occurred only during its subsequent development. Black smoke is emanating from the rear ventilation openings below the lifeboat station on starboard.

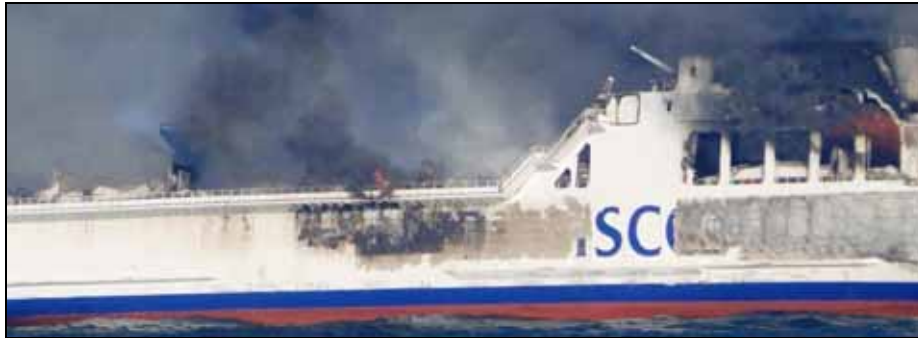
Figure 114: Another fire on the weather deck,
taken on 9 October 2010 at 1038

Flames can also be seen on the upper deck again (see Fig. 114).

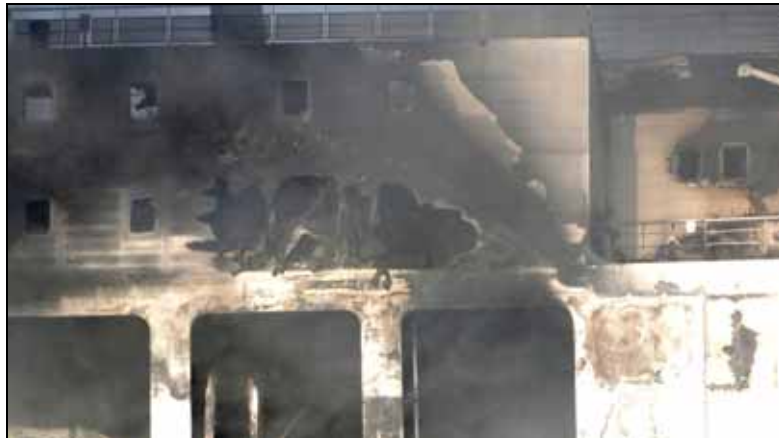
Figure 115: Hole in the outer wall on deck 7,
taken on 9 October 2010 at 1456

In Figure 115, the hole in the outer wall of the cabin superstructure above the first ventilation window on the starboard side is clearly visible. *This damage was most likely caused by flames venting out of the deck 6 windows*

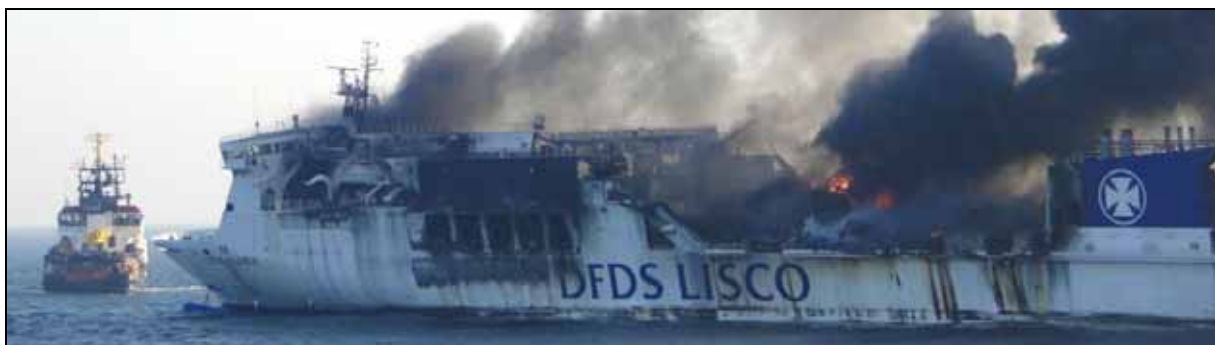
Figure 116: Fire on the weather deck and partially collapsed superstructure,
taken on 9 October 2010 at 1645

In Figure 116, it can be seen that the main intensity of the fire is shifting back to the open area of the upper deck. In contrast, the destructive fire in the area of the cabin superstructure is abating. It is possible that for the most part the flammable material has been consumed. At least the rear section of the cabin superstructure has collapsed at this point owing to prolonged exposure to heat.

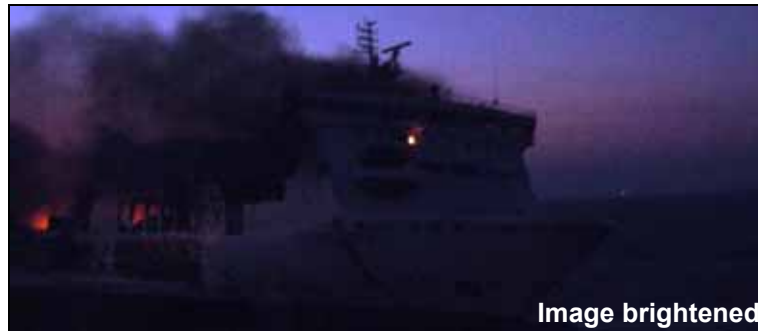
Figure 117: Fire on the evening of 9 October 2010,
taken at 1919

The fire continued to spread across the entire vessel during the ensuing night (see Fig. 117).

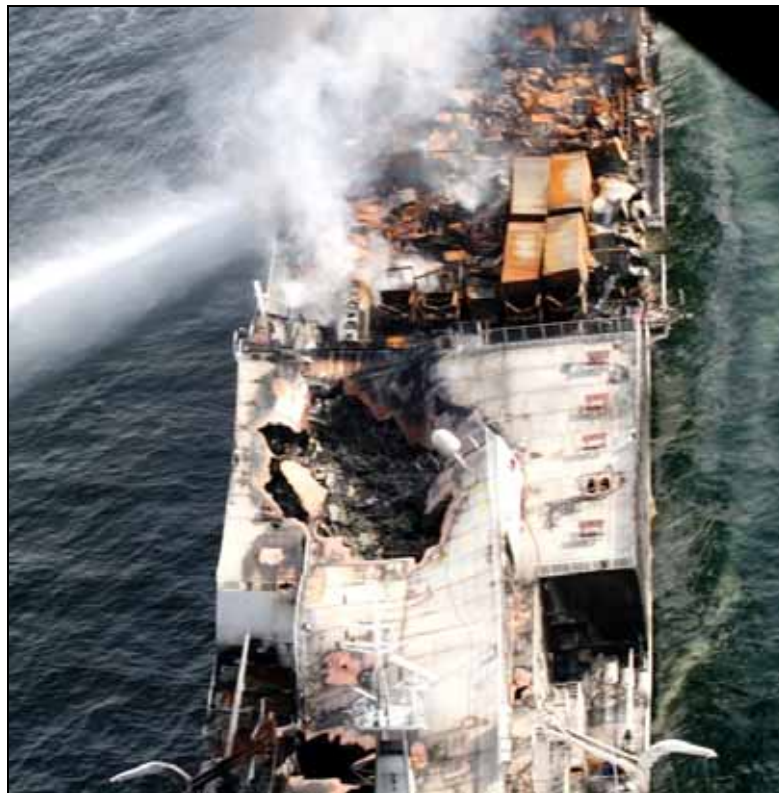
Figure 118: Fire funnel, taken on 15 October 2010 at 1139

On 10 October 2010, the LISCO GLORIA's degree of external destruction essentially corresponds with her condition during the subsequent investigation (see Fig. 8). The mast on deck 10 has tilted to the rear and the side superstructures inwardly. According to that, the vast fire funnel in the superstructure on Figure 118, as photographed from the air on 15 October 2010, was probably fully developed by this time.

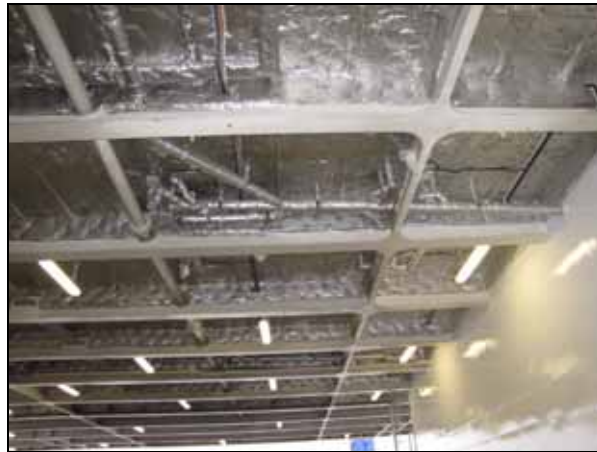
Figure 119: Ceiling covering on the sister vessel, DANA SIRENA

To obtain an impression of the original situation on board the LISCO GLORIA, her sister vessel, the DANA SIRENA, was visited in the port of Esbjerg on 25 January 2011. The structural parts of the cargo decks in the forward section of the vessel were clad with 4 centimetre thick aluminium laminated mineral wool (see Fig. 119).

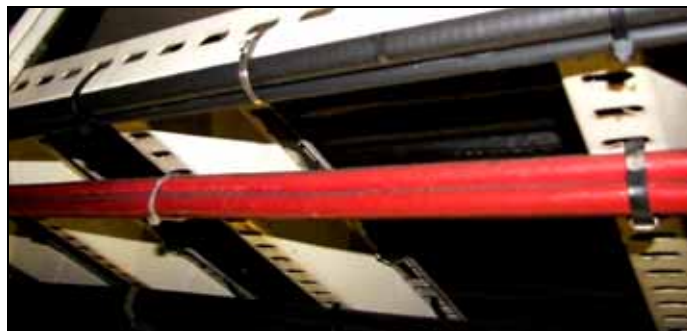
Figure 120: Metal and plastic cable ties used on board the DANA SIRENA

The insulating material was held in place by small metal plates. The piping in these areas was partially covered with black synthetic foam. Tape was used in several places for fastening. Electrical conducting materials were mounted on cable trays. Cables fastened to the bottom of these were fixed at large intervals with metal cable ties. Plastic cable ties were used between the metal ones (see Fig. 120).

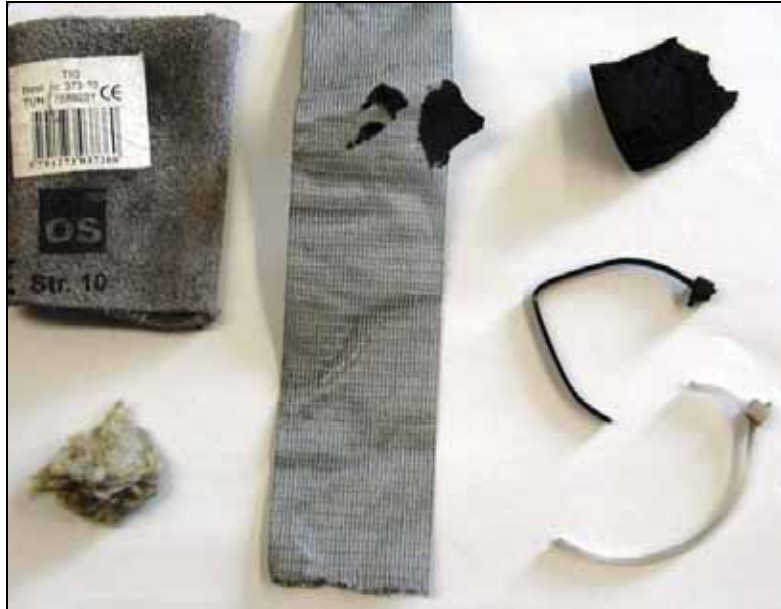
Figure 121: Material samples from aboard the DANA SIRENA

To roughly assess the fire performance of the aforementioned materials, samples were taken (see Fig. 121): one piece of a cut leather glove, one piece of grey-

coloured fabric tape, one piece of black synthetic foam material, one piece of greenish mineral wool material as well as one piece of a black and a transparent plastic cable tie.

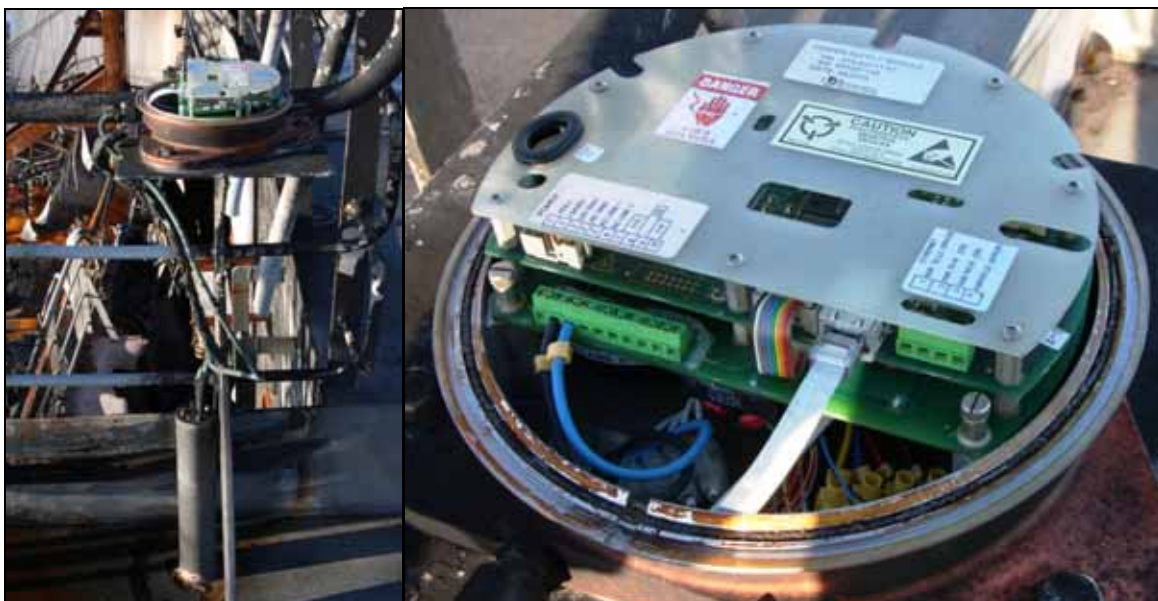
Figure 124: VDR interface on the observation deck of the LISCO GLORIA

The capsule was recovered by a boarding team from the ferry while she was still burning in order to prevent the recorded data from being overwritten or, as far as possible, otherwise damaged. During the recovery, only the upper part of the capsule was taken; this was subsequently handed over to the Danish Maritime Authority. The lower part – the interface required for exporting the stored data – remained on board (see Fig. 124).

The interface, which amongst other things is used to power the storage medium in the capsule, was exposed to the weather without protection until the investigation team's first survey on the LISCO GLORIA on 25 October 2010; therefore, the investigators decided against attempting to use this interface to export the data. Instead, the capsule was taken by BSU staff to the manufacturer of the VDR, Consilium, to minimise the risk of data loss by using the technical equipment with original components available there. The data stored in the capsule were exported in the presence of the BSU on 28 and 29 October 2010. This proved to be challenging as the capsule was a model from the second series, which differed fundamentally from the newer models available from the manufacturer in terms of the configuration of the data. It was finally possible to restore data for the period 8 October 2010 at 205346 to 9 October 2010 at 002345 with help from a software engineer. More data were not stored. The audio recording had already stopped at 002246. The stored data record contained, in particular:

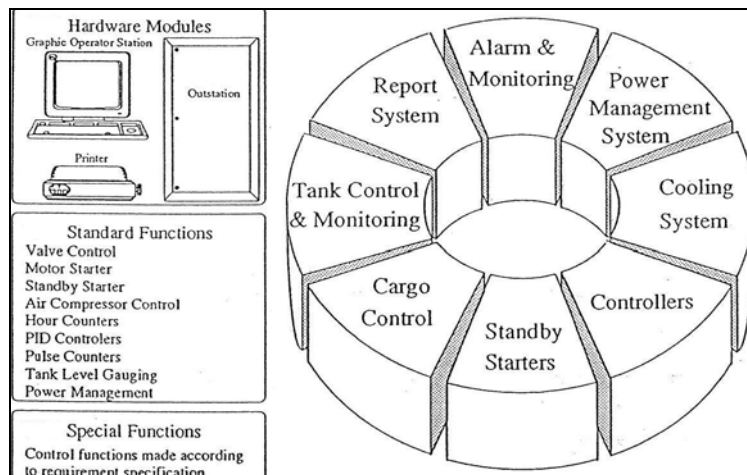
Figure 127: Overview of the components contained in the control system

One component of this system was monitoring the vessel's operating systems. Incoming alarms were logged by the system and were, in normal operation, output on a screen or printer (see Fig. 127).

There was no visible damage to the hard disks when they were secured. They were interrogated for the marine accident investigation by a distribution partner of the system manufacturer. This made it possible to restore an event list (see Fig. 128).
