**Bundesstelle für Seeunfalluntersuchung**  
**Federal Bureau of Maritime Casualty Investigation**  
Federal Higher Authority subordinated to the Ministry of Transport,  
Building and Urban Development

Summary  
Investigation Report 450/11

**Serious Marine Casualty**

**Ground Contact  
by the Container Vessel FIDUCIA  
off Cebu, Philippines  
on 16 September 2011**

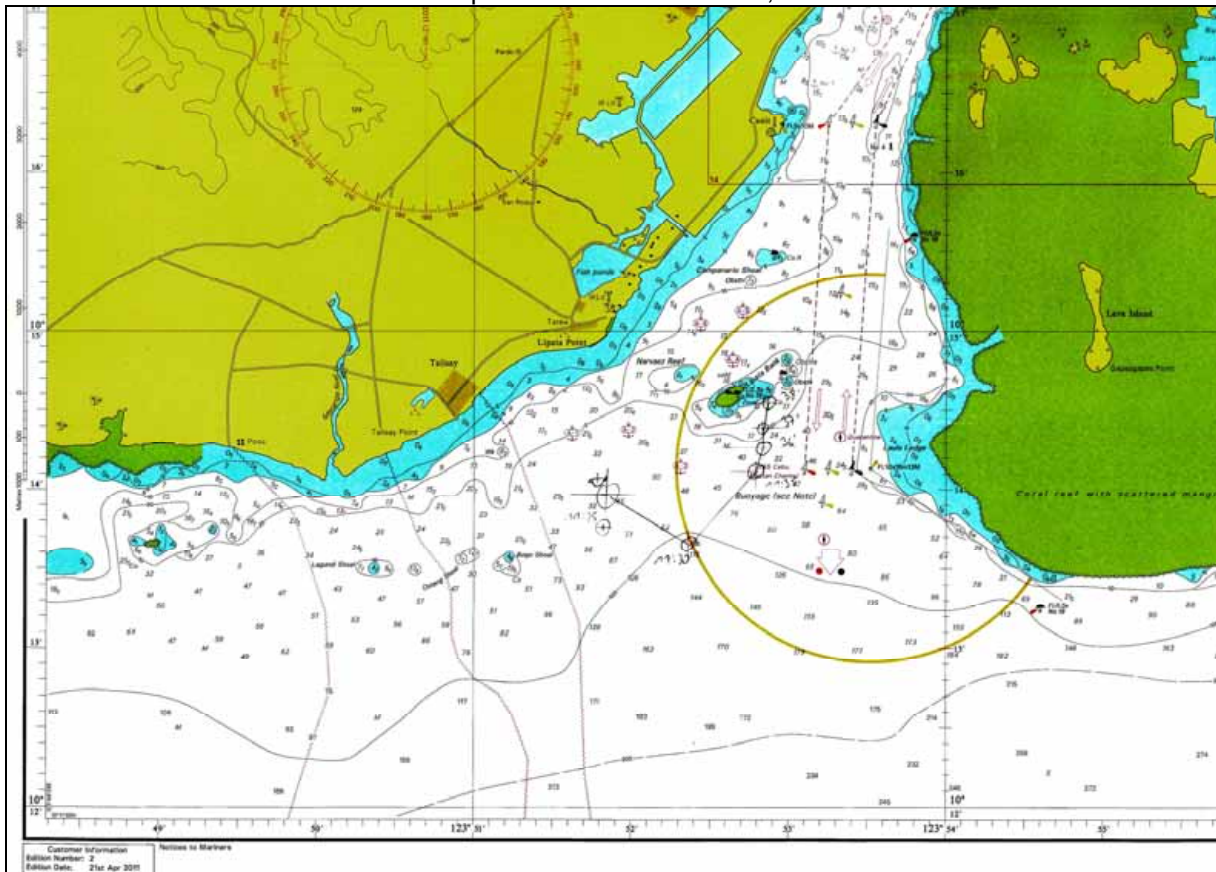
Figure 2: Nautical chart

Type of marine casualty/incident:	Serious accident, grounding
Date, time:	16 September 2011, 1140
Location:	Approach to the port of Cebu
Latitude/Longitude:	$\phi$ 10°14.56'N $\lambda$ 123°52.86'E
Ship operation and voyage segment:	Harbour mode Arrival
Place on board:	Fore section
Human factors:	Yes, human error Yes, violation
Consequences (for people, vessel, cargo, the environment and other):	Grounding of the vessel without further damage. Only possible to refloat vessel with tug assistance.

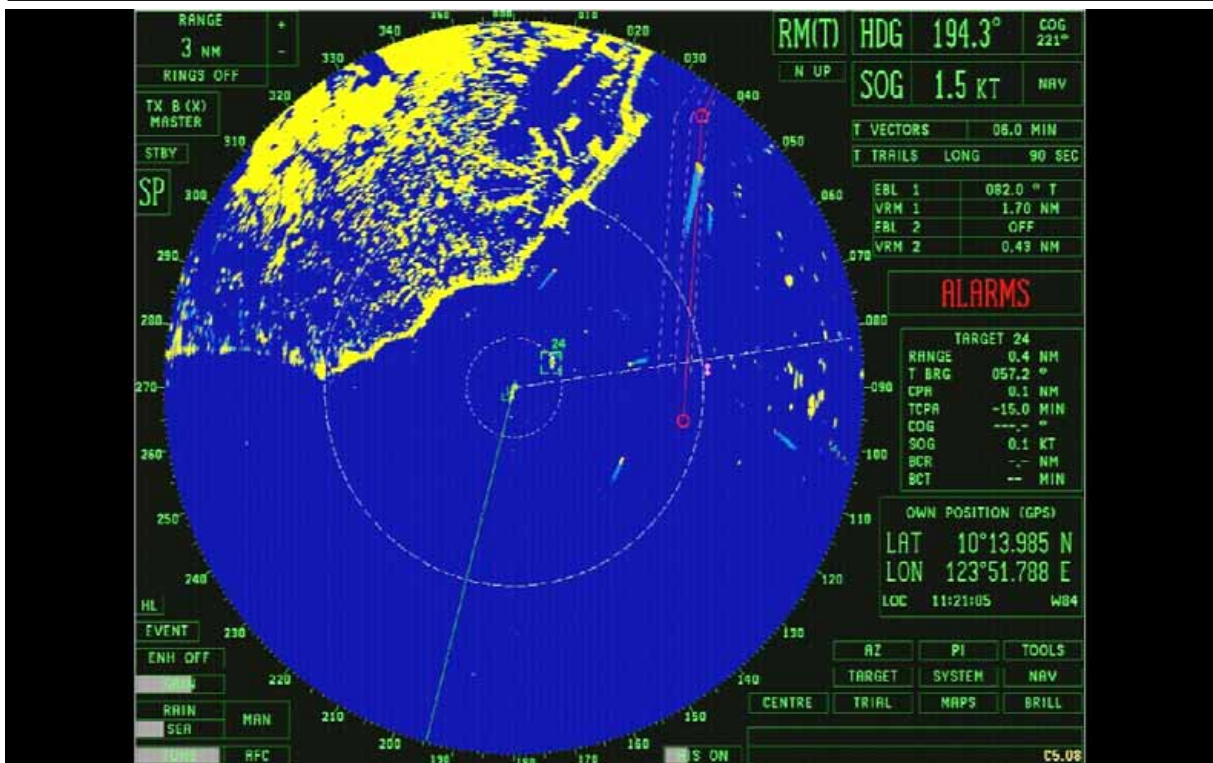
Figure 6: Anchor on deck

Figure 4 shows the initial situation. The vessel is lying at anchor with her bow pointing towards the southwest as the pilot station calls and gives notice of the pilot on VHF. The traffic separation scheme in which – approaching from the south – the vessel was to turn can be seen clearly on the eastern side of the radar image. With the exception of two lengths, the anchor is hoisted at 1114 and the pilot enters the bridge (Figure 5). In Figure 6, the anchor is on deck and the FIDUCIA slowly picks up speed in order to turn towards port and head for the TSS.

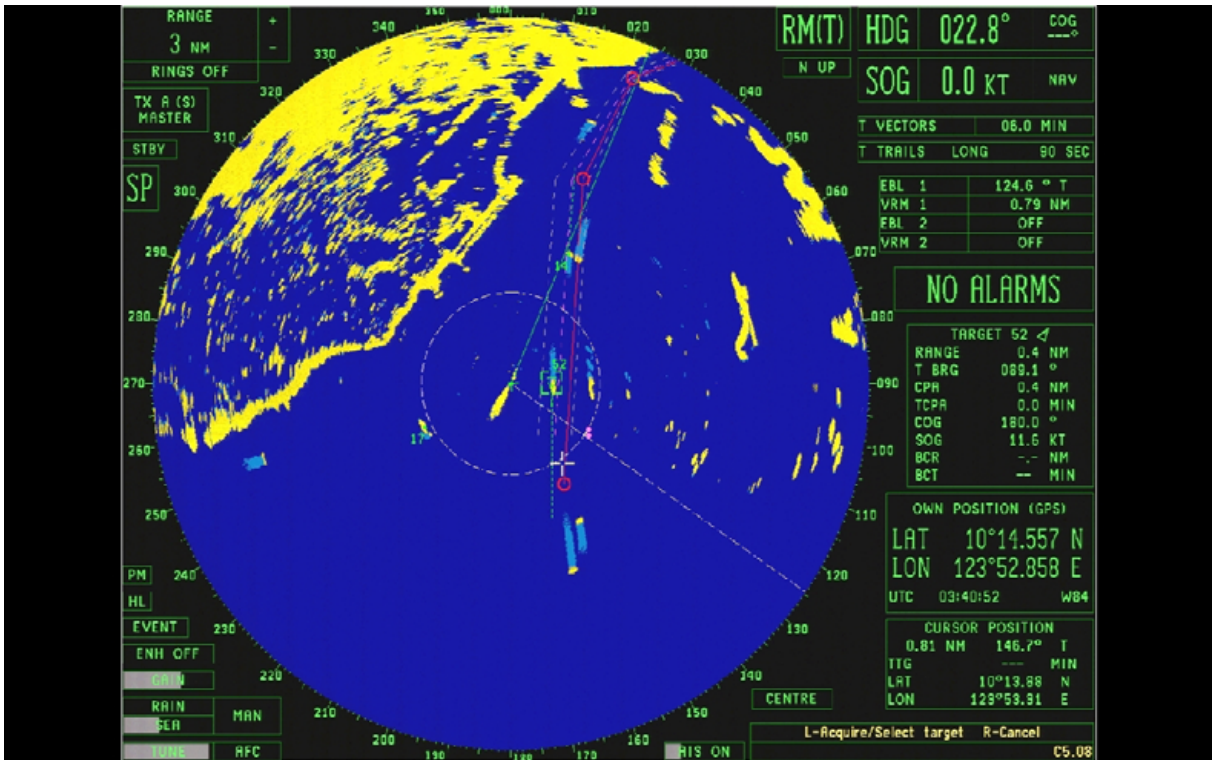
Figure 16: Radar screen after the grounding

Figure 14 shows the radar image at the time of the grounding. FULL ASTERN has already been set by the ship's command, but this has no effect. The audio recording of the VDR indicates that the pilot does not realise that the FIDUCIA has run aground until 1141. Figure 15 illustrates very clearly that all the instruments are at ZERO. Figure 16 shows the radar screen at that moment. Figure 17 demonstrates the passing distance to the CEBU TRADER with a CPA of 0.34 nm.
