Bundesstelle für Seeunfalluntersuchung
Federal Bureau of Maritime Casualty Investigation
Federal Higher Authority subordinated to the Ministry of Transport,
Building and Urban Development

Summary
Investigation Report 515/10

**Fire on a semi-trailer on board
the ferry MECKLENBURG-VORPOMMERN
on the Warnow river
on 19 November 2010**

1 November 2012

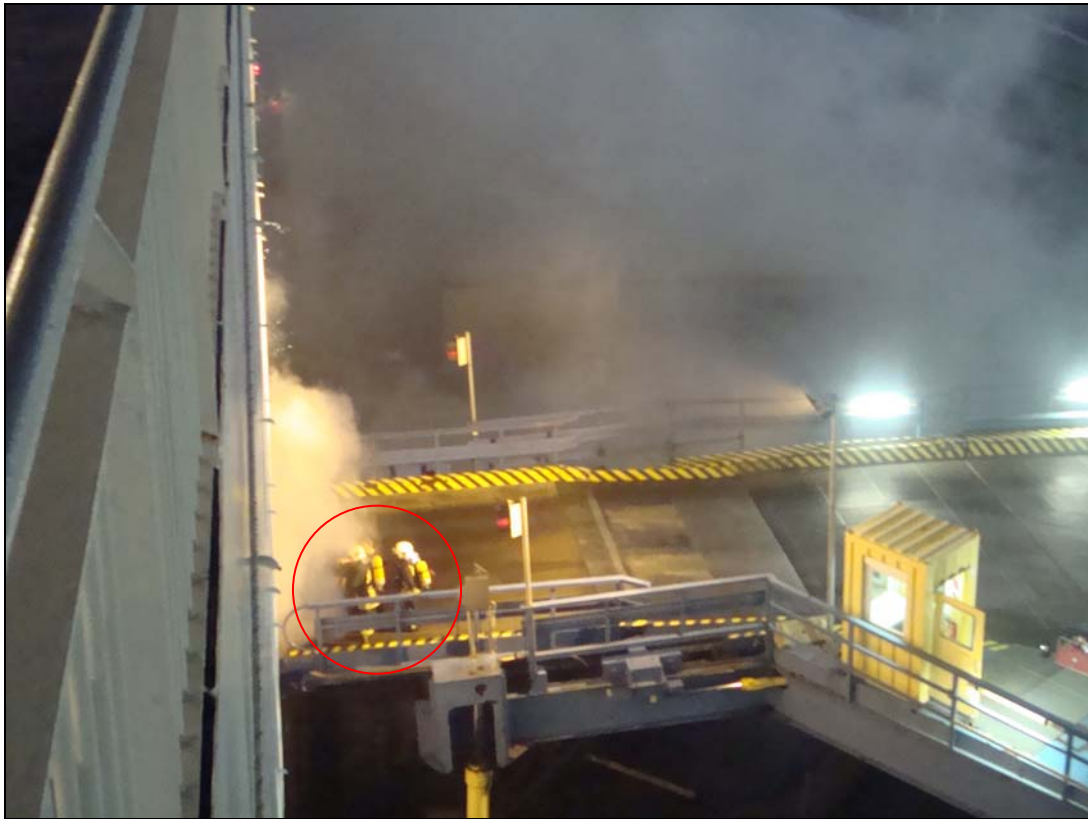
Figure 16: Fire brigade proceeding

The firefighting units of the crew were eventually replaced by the fire brigade as they had already changed breathing cylinders three times. Moreover, despite being reinforced by two operational units from the fire brigade in the interim, there was a realistic danger that the crew members would slowly reach their limits and possibly become a safety hazard themselves. The entire operation was complicated by the very heavy build-up of smoke.
