Bundesstelle für Seeunfalluntersuchung
Federal Bureau of Maritime Casualty Investigation
Federal Higher Authority subordinated to the Ministry of Transport,
Building and Urban Development

Investigation Report 154/12

Serious Marine Casualty

**Collision between the ro-pax ferry
NILS HOLGERSSON
and the ro-pax ferry URD
in the port of Lübeck-Travemünde
on 3 May 2012**

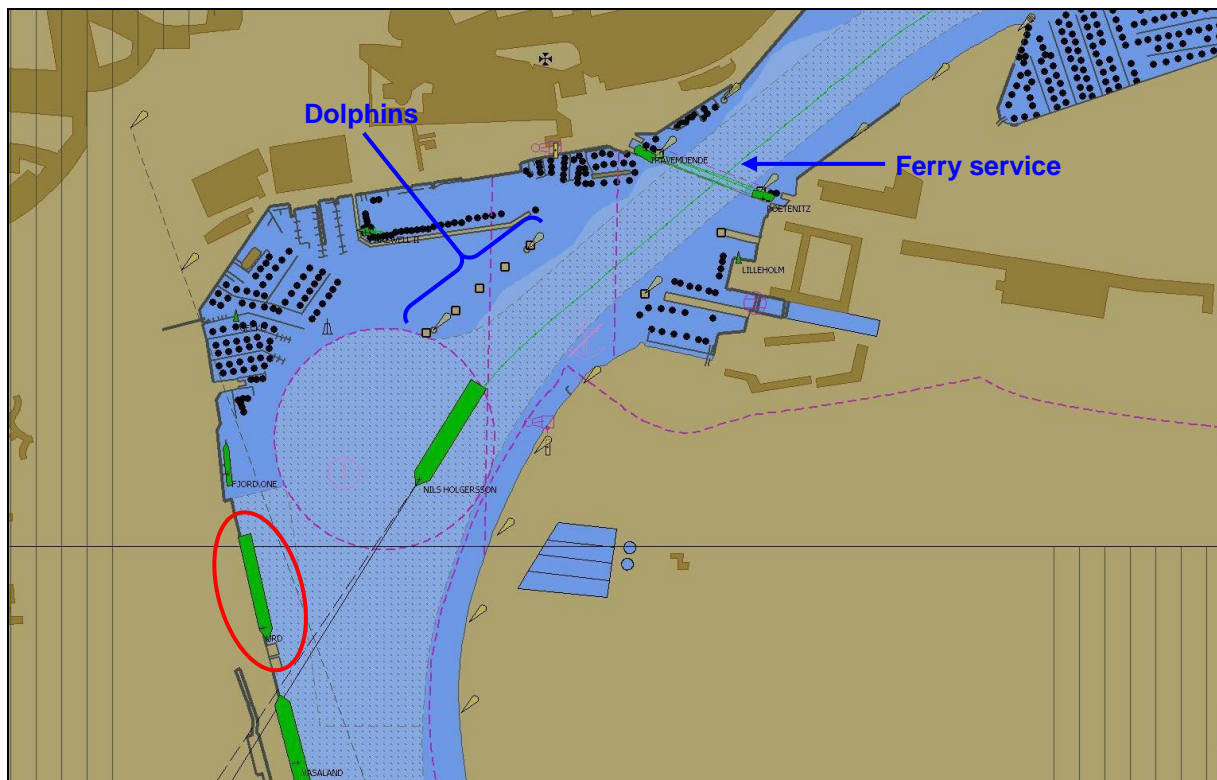
Figure 4: AIS recording from Trave Traffic

Due to the adjusted steering angle, the speed was slightly reduced. When the NILS HOLGERSSON reached the turning basin at 181203, the speed over ground still stood at 6.9 kts with a heading of 226° and a course over ground of 227°. The master instructed the chief officer to push 50 % to starboard with the bow thrusters. However, use of the bow thrusters had little effect due to the high speed. As a result, the NILS HOLGERSSON did not turn as expected, but continued to move towards the opposite pier (see Figure 4).

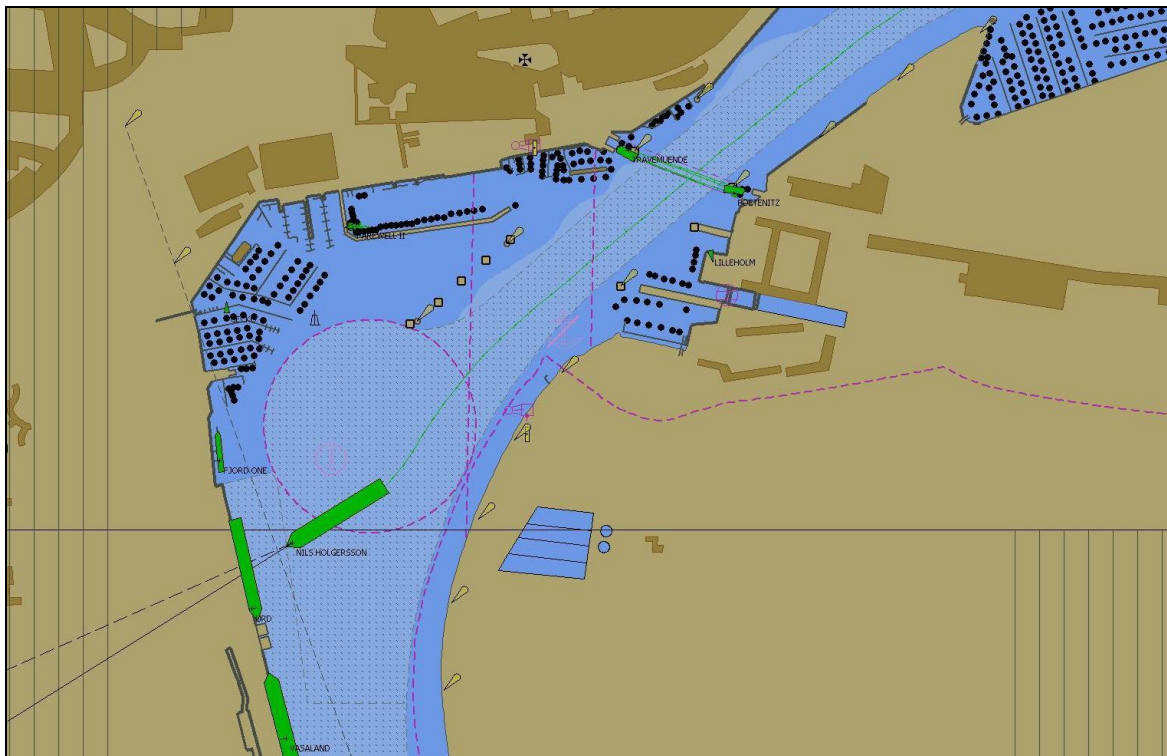
Figure 5: AIS recording from Trave Traffic shortly before the collision

The chief officer was instructed to set the bow thrusters to starboard. This increased the power level to about 70-80 %, after which the ship started to vibrate severely. However, the NILS HOLGERSSON's speed over ground was still 5.85 kts.

It was possible to reduce the speed over ground slightly to 5.74 kts by 181345; however, a few seconds it climbed back to 5.89 kts. At 181413, a ship's deck rating on the forecastle reported a distance of approx. 30 m from the URD by ship radio.

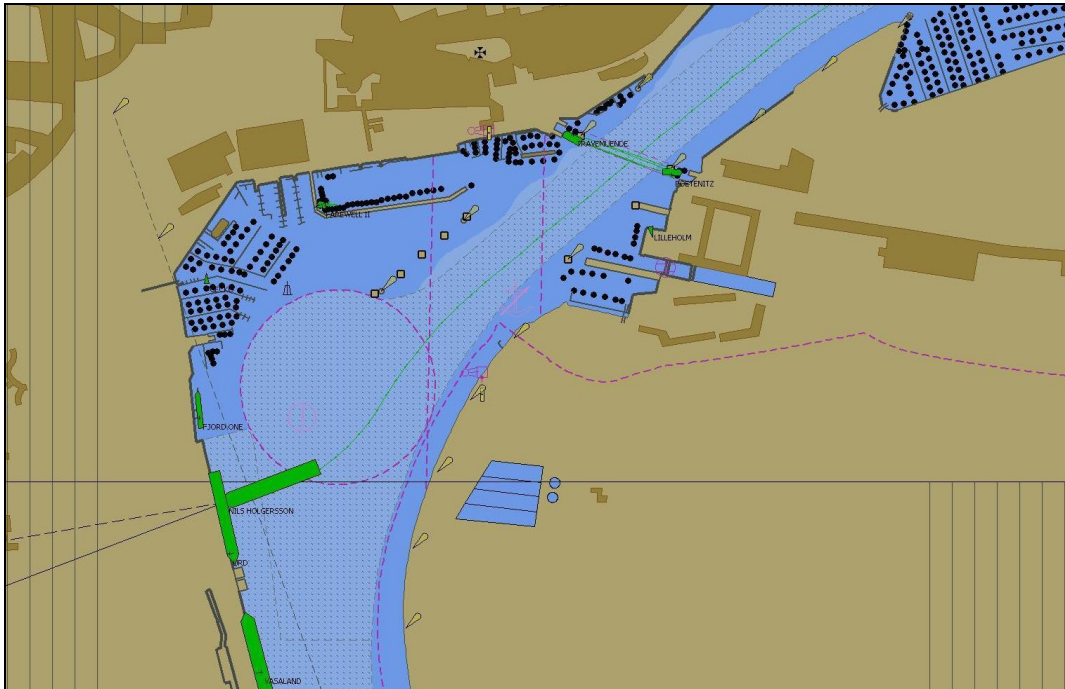
Figure 6: AIS recording from Trave Traffic, collision

The collision occurred at 181437. At that point, the NILS HOLGERSSON's speed over ground was 6.51 kts.

The shell plate of the URD (to port level with the weather deck and main deck) was pressed in by the bow of the NILS HOLGERSSON. The bulbous bow of the NILS HOLGERSSON ripped a hole in the URD level with the water line.

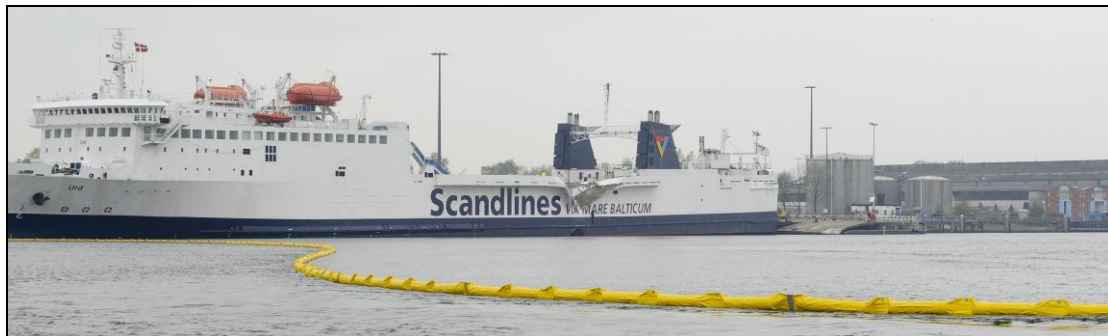
Figure 13: Deployed oil barrier

The Lübeck fire brigade was deployed at the URD with pumps from 1900 and subsequently joined by the THW with its own pumps. However, it became clear at 1930 that there was not enough pump capacity to stabilise the URD. The water ingress in the lower cargo hold resulted in the fore section of the URD slowly beginning to drop. Therefore, the CCME was requested to assume overall control of the operation. An oil barrier was deployed as a precaution to make it possible to contain any eventual water pollution (see Figure 13).

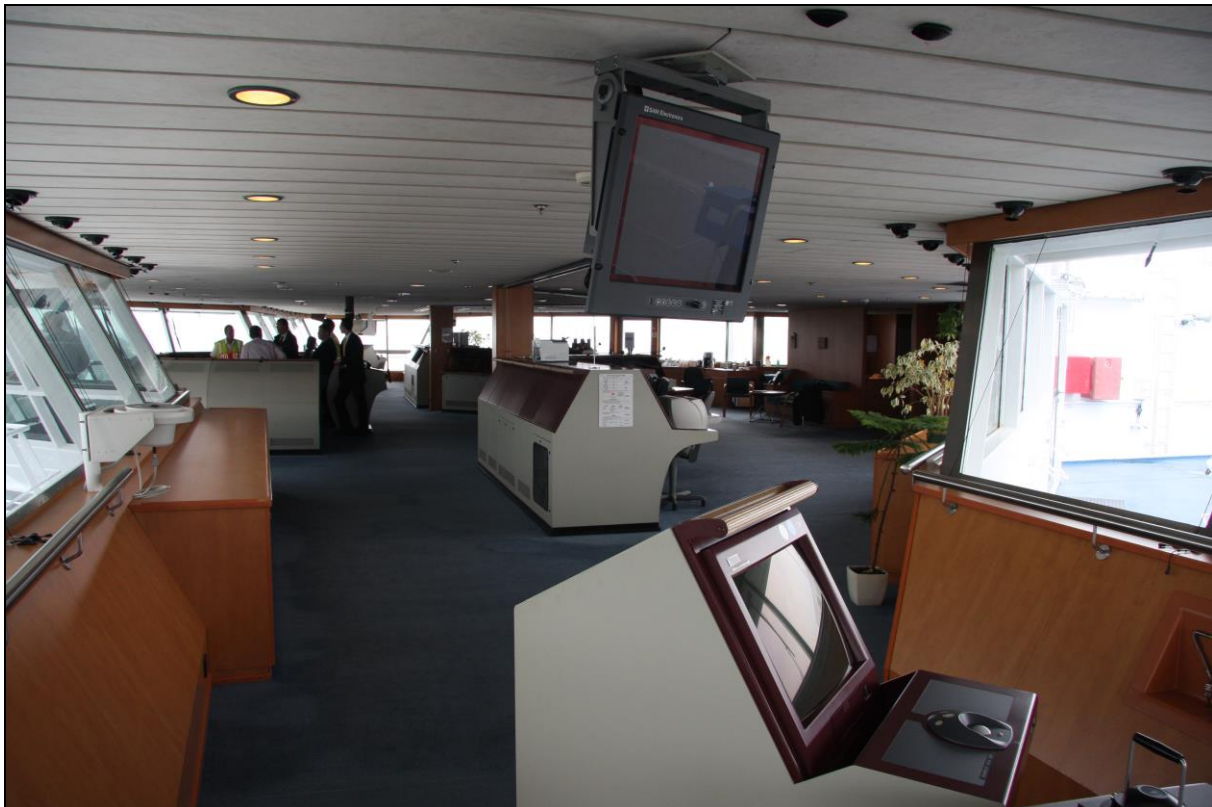
Figure 17: View of the bridge of the NILS HOLGERSSON from the port wing

The port and the starboard wing are integrated with the bridge (see Figure 17) on the NILS HOLGERSSON.

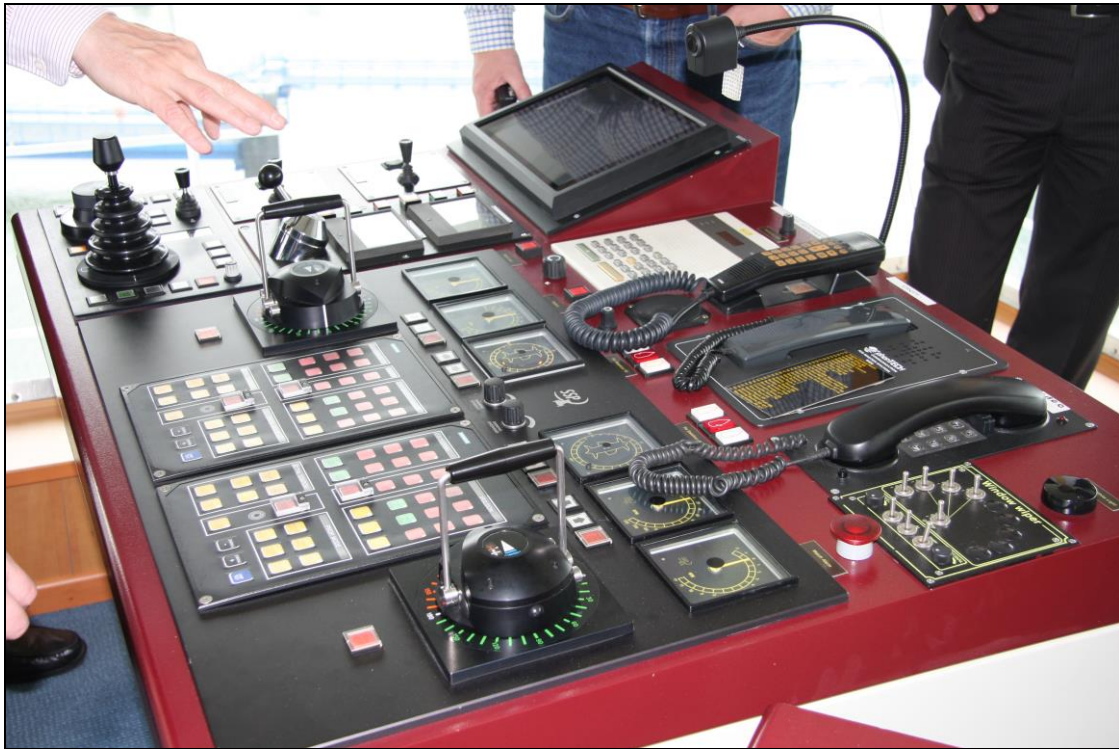
Figure 18: Control position in the port wing

Practically any ship manoeuvre can be carried out from the control position in the port wing (see Figure 18). The exception is, inter alia, the emergency anchoring manoeuvre, which must be activated from the central control position.

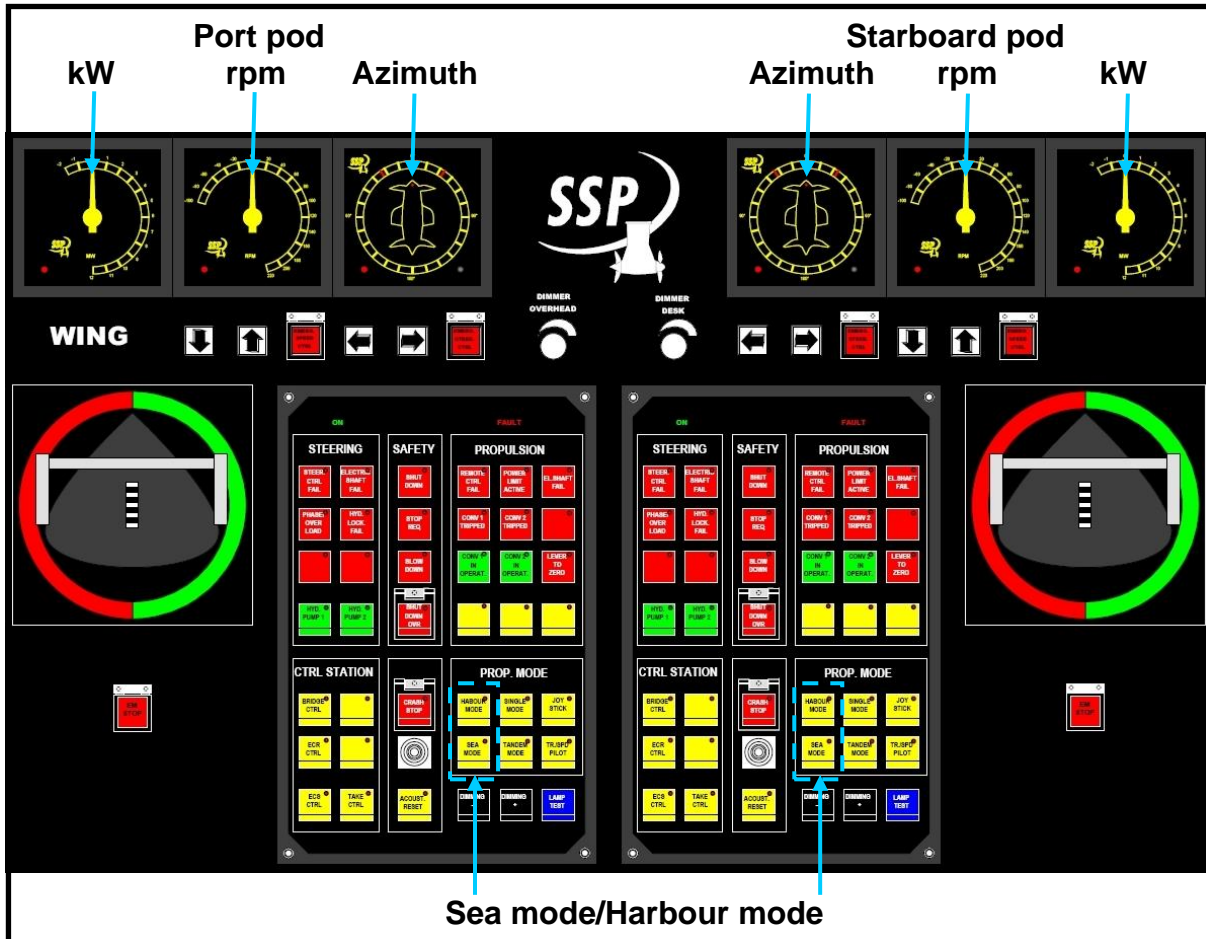
Figure 20: Control panel in the wing, schematic representation

On the day of the accident, the pods were operated from the control position in the port wing for the intended turning manoeuvre. The following figure (20) provides an overview of the pod displays available there as well as the arrangement of the control levers and push-buttons.

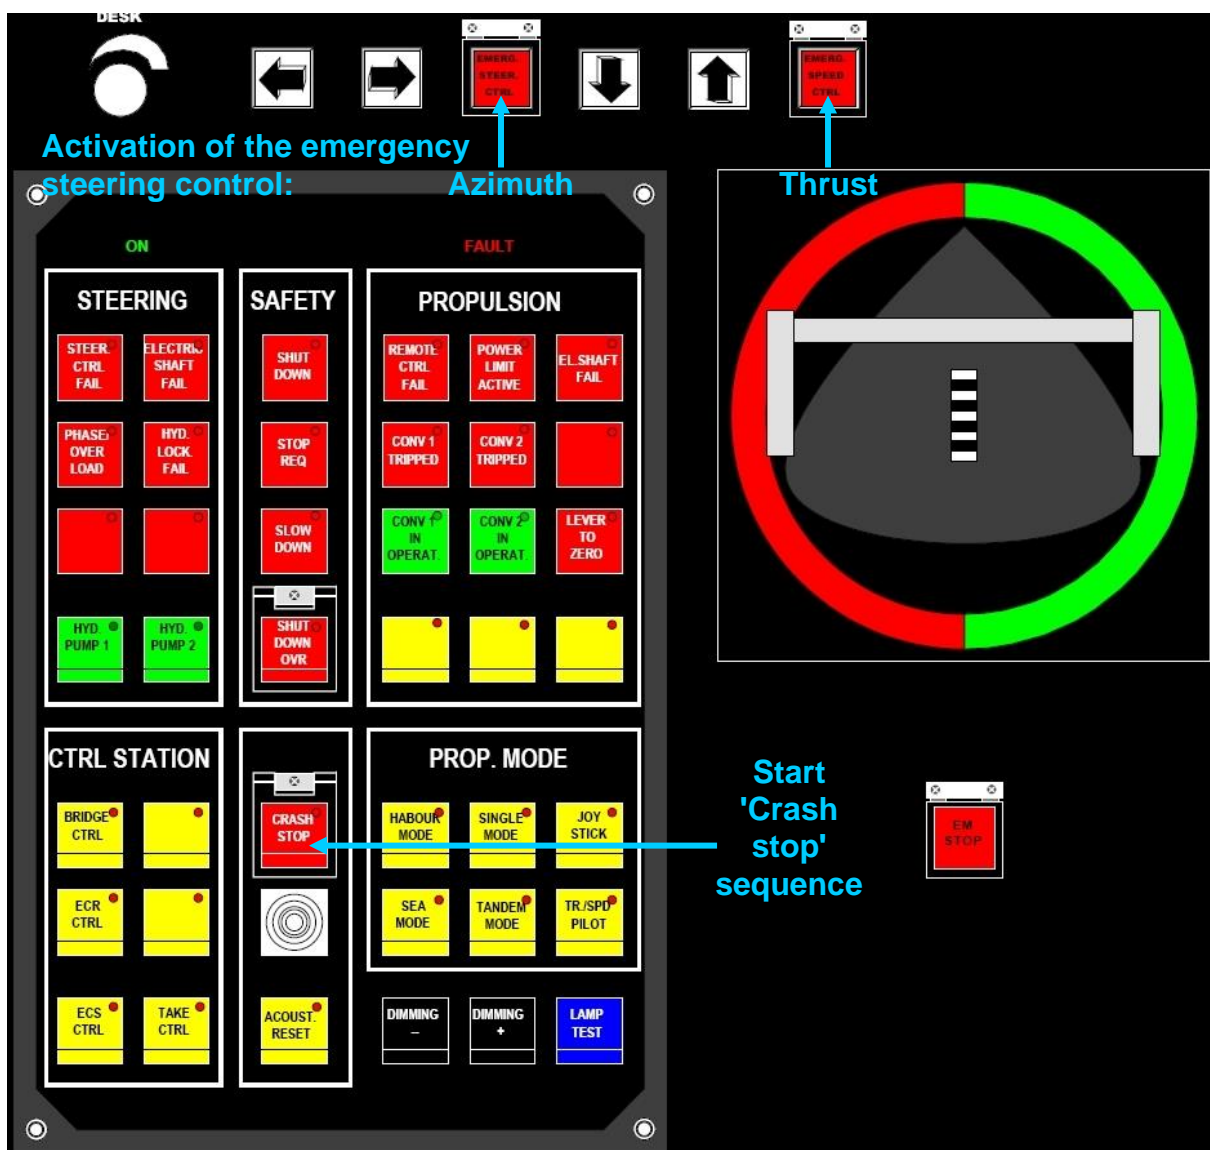
Figure 21: Excerpt from the wing control panel, starboard pod, schematic representation

In normal operation, especially when the control lever malfunctions, the emergency steering control can be activated separately for each pod by pressing the 'Emergency speed control' and 'Emergency steering control' buttons. Regardless of that, an automated sequence for executing the shortest advance distance can be initiated by pressing the 'Crash stop' button on the control panel. Both the 'Crash stop' and the buttons for activating the emergency steering control have protective covers to prevent unintentional operation (see Figure 21).

The 'Crash stop' sequence was not initiated as a manoeuvre for the 'shortest stopping distance'. Pressing the 'Crash stop' button (see Figure 21) would have caused the following steps to be automatically executed:

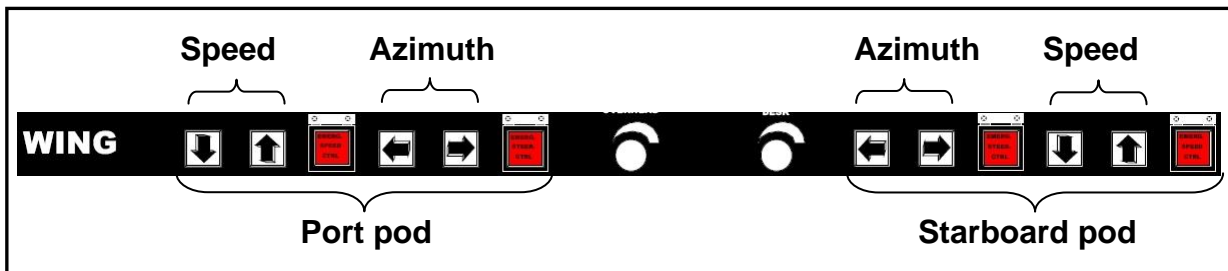
Figure 22: Excerpt from the wing control panel (emergency steering control for the pods), schematic representation

After activation of the emergency steering control, the pods are controlled using the direction buttons: for each pod, two for the azimuth (thrust direction target 'Emergency steering control', left/right direction buttons) and two for the speed target

('Emergency speed control', up/down direction buttons for higher or lower thrust; see Figure 22).

The buttons for the azimuth target act directly on the valves for the control hydraulics. The buttons for the thrust target are wired directly to the speed controller. At the moment that the emergency steering control is activated, the thrust direction target limitation (Azimuth) to +/- 35° in 'Sea mode' ceases to apply and the pods can be rotated freely using the azimuth push-buttons.

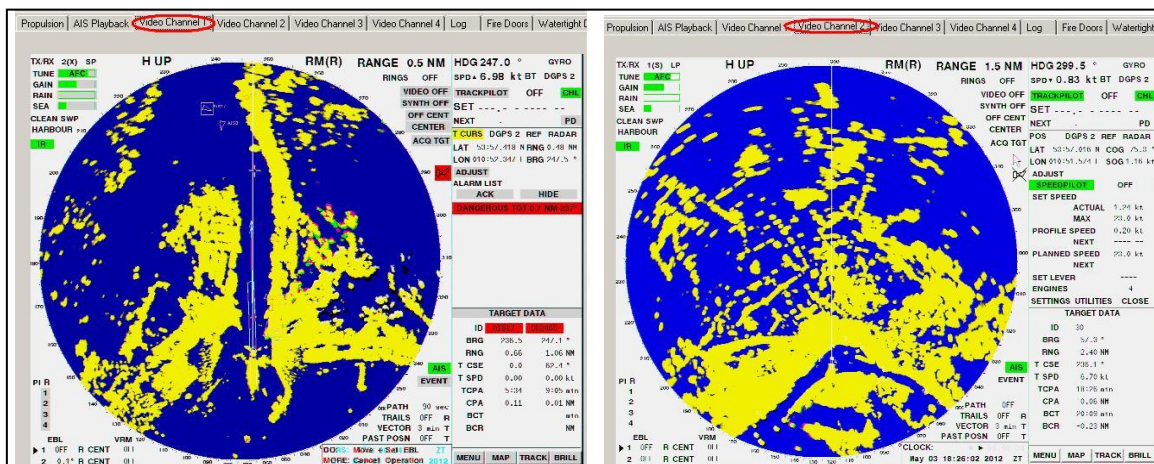
Figure 23: Radar recordings from the NILS HOLGERSSON

The VDR recorded the information from both radar displays (X-band and S-band, see Figure 23).

The master predominantly used the X-band radar during the approach and turning manoeuvre (head-up display, off-centre). In accordance with the instructions in the owner's bridge handbook, the radar range was adjusted to 0.5 nm and 0.25 nm with increasing proximity.

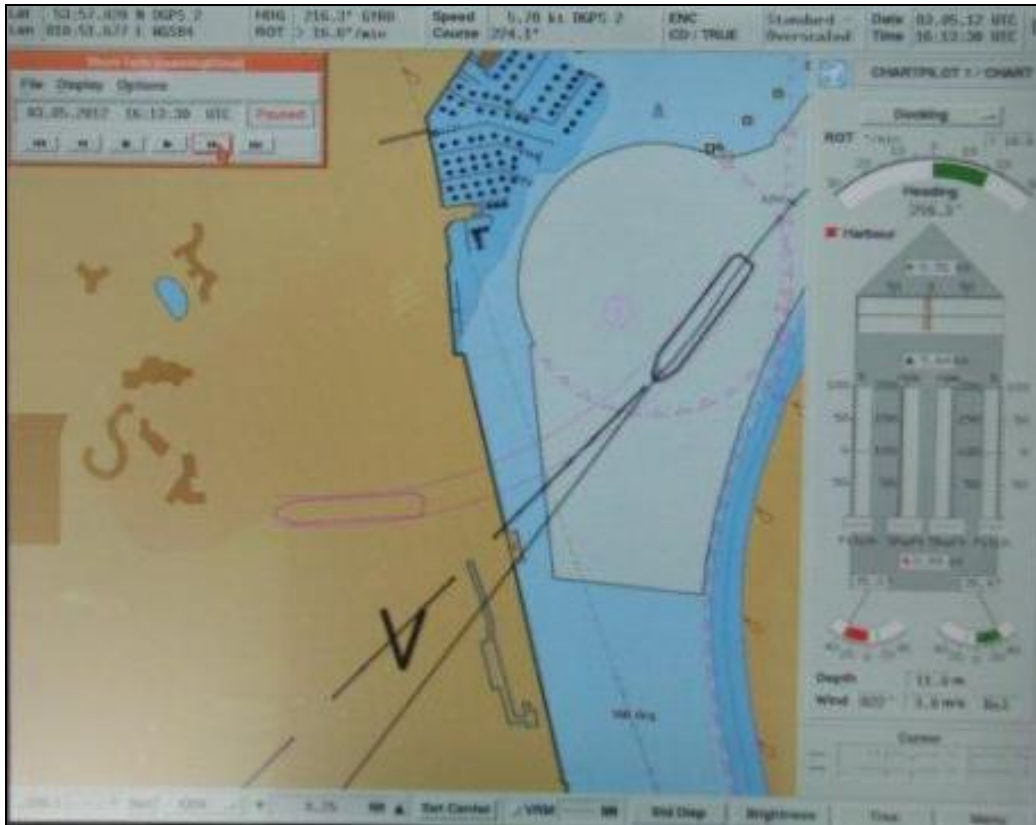
Figure 24: ECDIS plot with accident track of the NILS HOLGERSSON

The course of the voyage of the NILS HOLGERSSON was stored by the ECDIS¹⁷ and retrieved in the aftermath of the accident (see Figure 24).

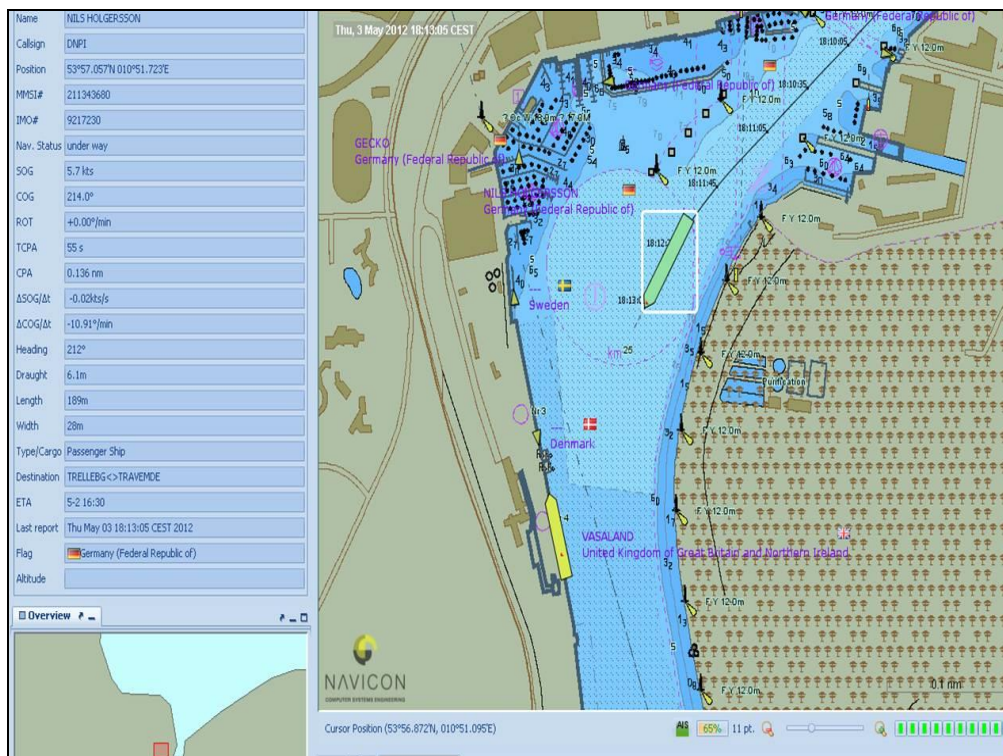
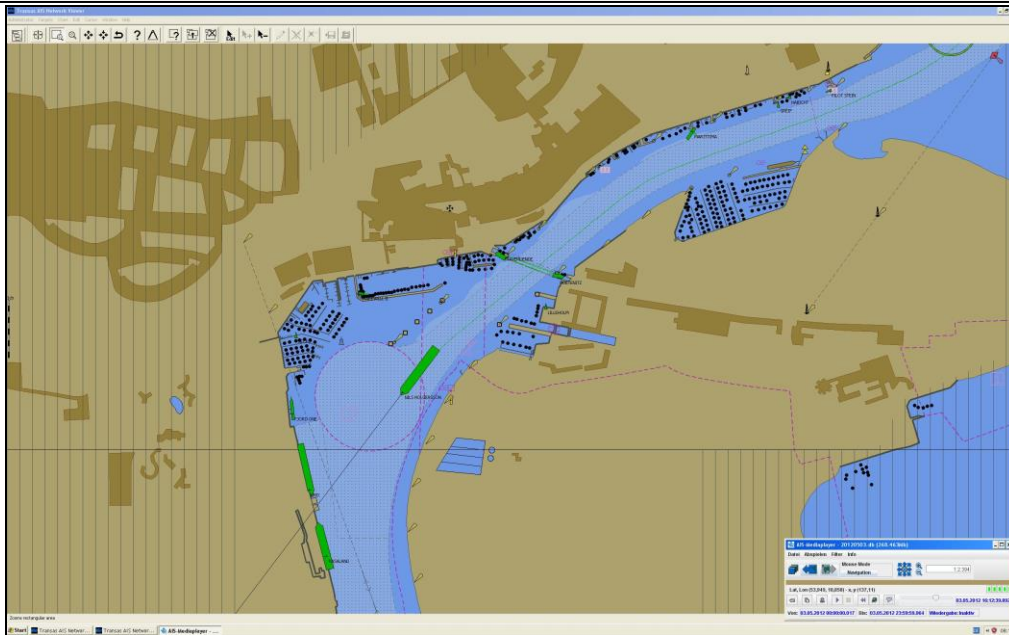
The VDR on the NILS HOLGERSSON did not record any AIS data. However, data from the waterway police control centre in Cuxhaven and Trave Traffic were available for the investigation (see Figures 25 and 26).

The recordings from Trave Traffic were used for the investigation report because for technical reasons it was not possible to depict the URD in hull shape in the plots of the WSP control centre.
