**Bundesstelle für Seeunfalluntersuchung**  
**Federal Bureau of Maritime Casualty Investigation**  
Federal Higher Authority subordinated to the Ministry of Transport,  
Building and Urban Development

Investigation Report 301/11

**Accident with four casualties on board**

**SEUTE DEERN**

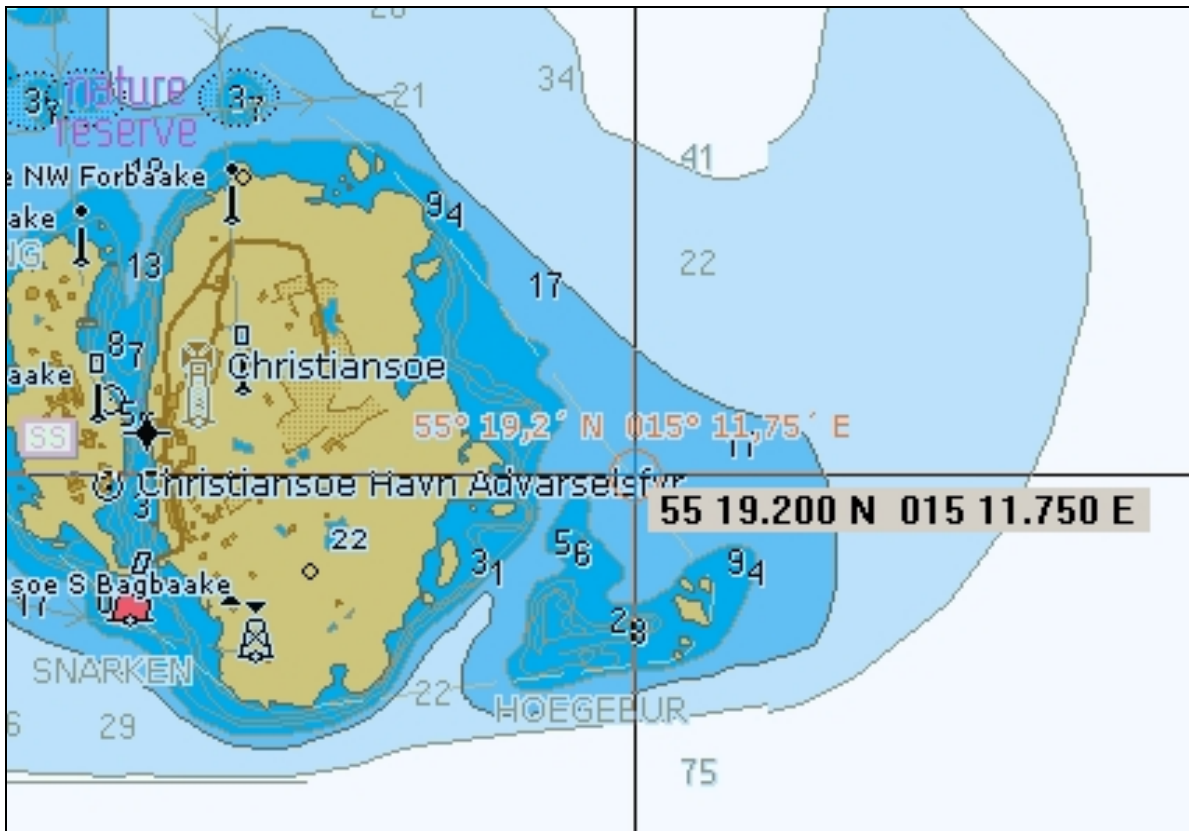
Figure 3: Scene of the accident

Type of marine casualty/incident:	Serious marine casualty, 4 injured
Date, time:	28 July 2011, 1510
Location:	Christiansø
Latitude/Longitude:	$\phi$ 55°19.2'N $\lambda$ 015°11.7'E
Ship operation and voyage segment:	At anchor
Place on board:	Forecastle
Human factors:	Technical fault
Consequences (for people, vessel, cargo, the environment and other):	Four injured

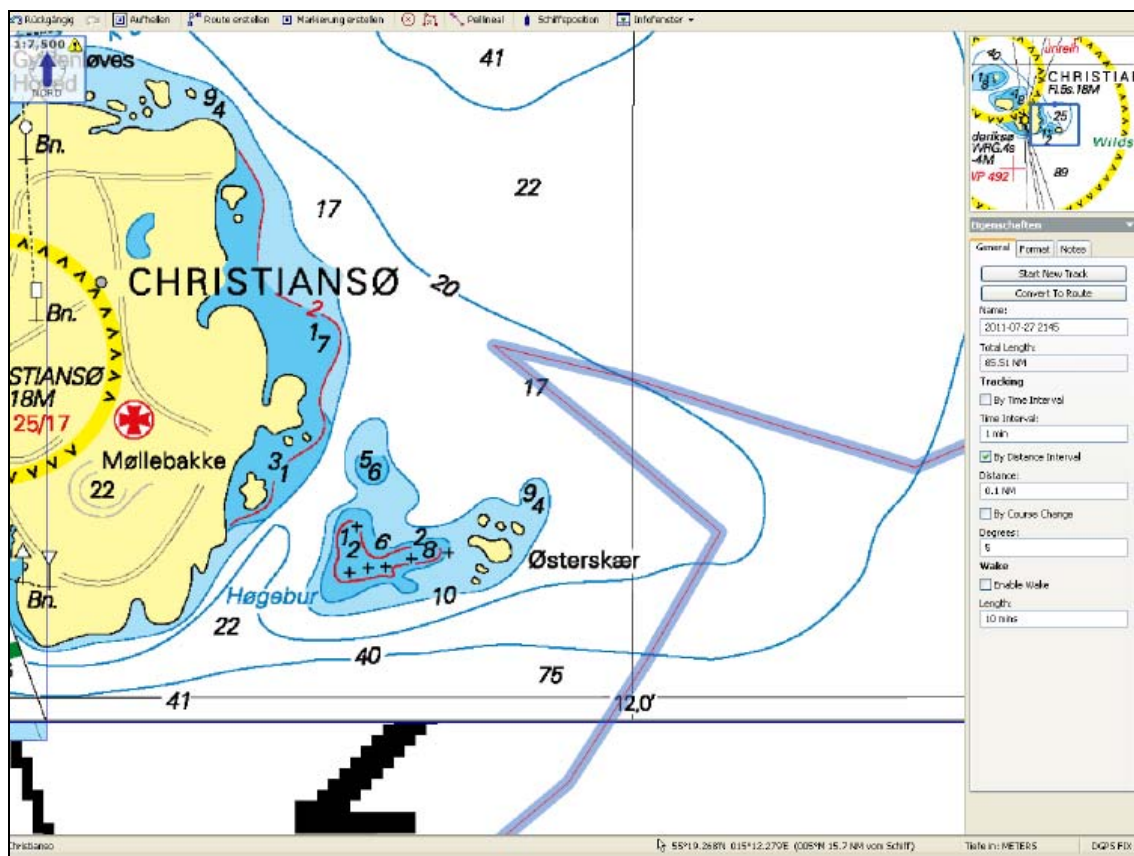
Figure 4: Anchorage, ECS recording

At 1510 on 28 July 2011, an accident involving four people, two seriously injured and two slightly injured, occurred in the sea area north of the Østerskår and east of the Christiansø islands while the anchor was being hoisted. The starboard anchor was immersed (two shackles/25 m) at a depth of 14 m on stony ground. Prior to the anchoring manoeuvre, the main and mizzen sail had already been reefed (first and second reef) at the anchorage, but not set. A strong NW wind of 6 Bft was blowing. The two crank handles of the capstan were each manned by four people (two at the front and two at the back). There were a total of eight people on the forecabin. The winch is equipped only with manual drive. During the hoisting procedure, the engine was used – in consultation with the mate on the foredeck using VHF transceiver – to help relieve the anchor chain. After about one chain length was hoisted in, there was a jolt and both crank handles started to rotate rapidly in the opposite direction. Four crew members were hit by the two rapidly turning crank handles and lay injured on deck. Part of the chain ran out. Following that, the vessel started to drift. After initial coordination of measures to assist the casualties, the anchor was hoisted completely at about 1630. One fluke was missing.

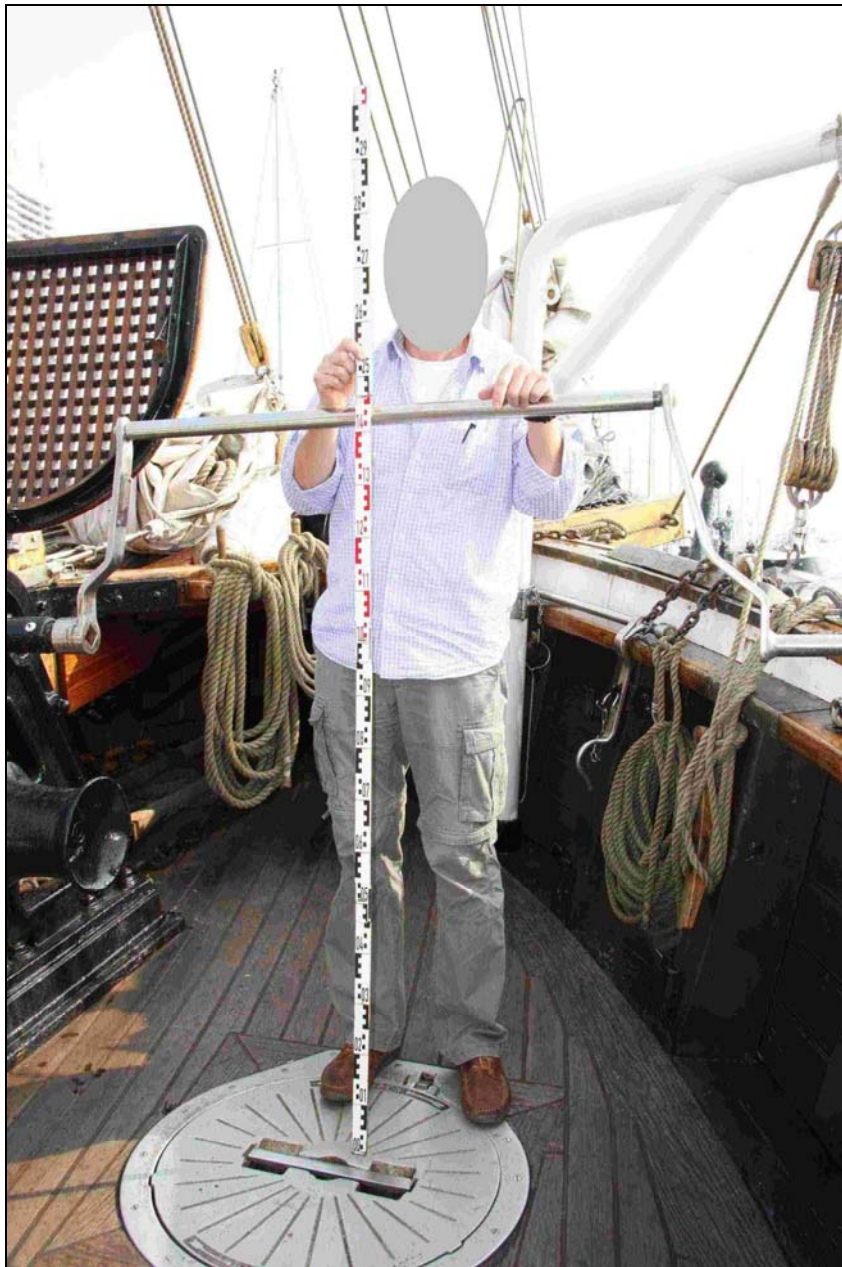
Figure 5: Crank handle

The winch only has a manual drive system and is designed for the operation of two anchor chains/anchors. According to the representative of the owner, this winch is part of the original equipment of the vessel. One removable crank handle is situated on the port side and one on the starboard side; these are pushed onto the winch and also mounted firmly on the bulwark. According to the owner's representative, the crank handles can be operated on each side by four people, with two standing in front of each crank and two behind alternately.

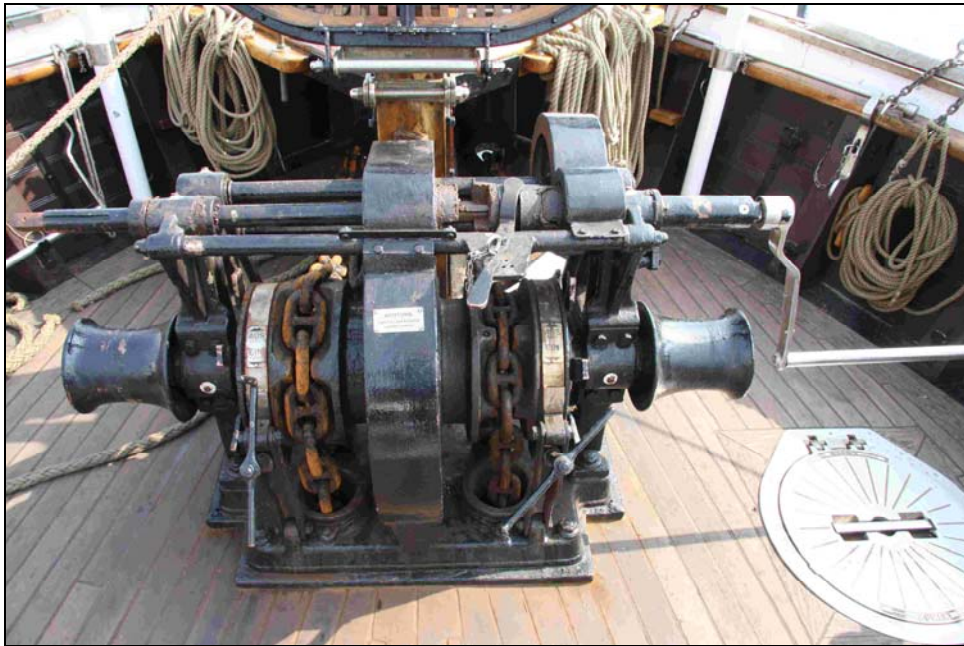
Figure 6: Capstan

For hoisting, each chain drum can be coupled with the manual system on its own. Furthermore, each drum is fitted with a manual brake.

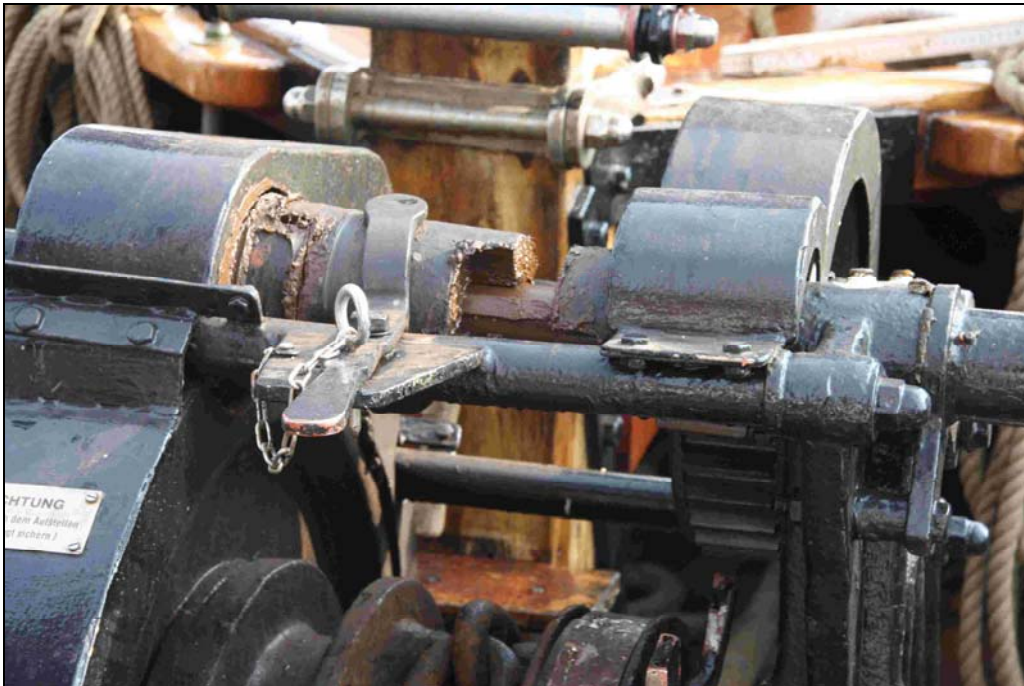
Figure 8: Engage and disengage

In each case, two different rotational speeds can be set by means of a gear lever that can be locked. Pushing to the right results in a slow hoisting speed: low gear, three cogwheel tips per crank handle revolution or about a third of a chain link per crank handle revolution. Pushing to the left results in a faster hoisting speed: high gear, nine teeth per crank handle revolution or about one chain link per crank handle revolution. Conversely, if engaged the crank handles can be subjected to these speeds in the form of revolutions when lowering is unchecked. The unintentional lowering speed is about three times higher in low gear.

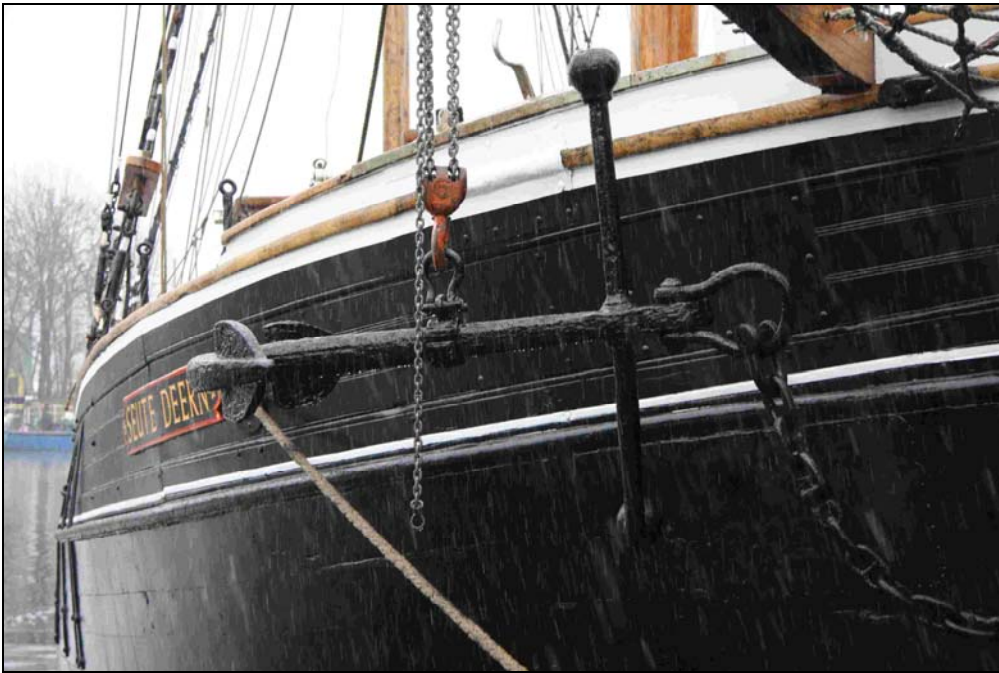
Figure 10: Stock anchor hoisted

The vessel is equipped with two stock anchors. Each stock anchor is hoisted onto the railing by means of a boom and lashed using wire and chain. The specified weights of the anchors are 300 kg on the port side and 310 kg on the starboard side.
