Investigation Report 422/11

Serious Marine Casualty

Accident involving a person on board

TAUCHER O. WULF 5

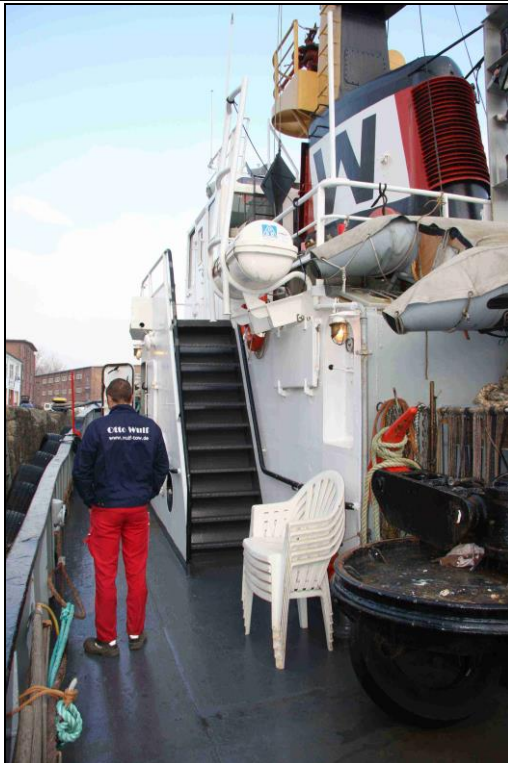
Figure 3: Port side companionway

As can be seen in Fig. 5 (towing connection), the deckhands were within the snap back zone. While one of the deckhands managed to jump on to the port side companionway, the other was struck by the towline as it snapped back. The casualty was experienced and has worked on the tug since March 2000. His safety area by the companionways has reportedly already been tried and tested. The only other possible safety area on the deck of an aft tug would be the forward edge of the bridge (see Fig. 9). However, the towing connection cannot be controlled from there, e.g. to trigger the slip device (see Fig. 8) with a lever. A second set of towing gear is available for the event of the towing connection breaking. A parted towline is unpredictable in that when it snaps back it moves faster than the speed of sound. In the present case, this means that the accident had already happened before the bang was heard on the aft deck and the deckhands could not move to safety if they were still within the danger area. The best protection is located in the superstructure. At the same time, it should be noted that there is room for only two people on the bridge while towing because the entire stern is only controllable by continuously moving backward and forward and more people would interfere with each other. The funnel obstructs the view astern due to a large blind spot. In this situation, the skipper usually steers the tug and the chief officer monitors the towing connection. The procedures of the owner's quality management system do not define safety areas for the crew. During the task, the doors must be closed and crew members wear protective clothing.

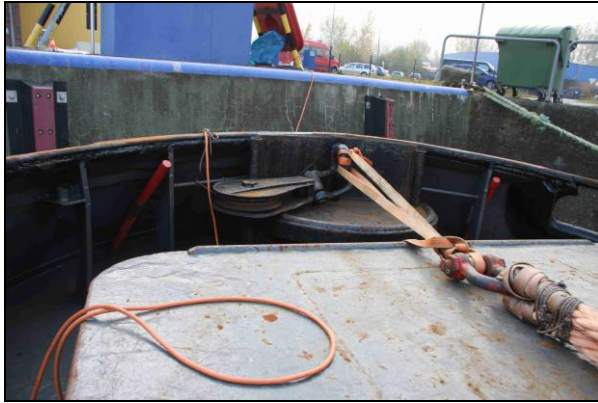
Figure 6: Gob rope roller

The BSU surveyed the TAUCHER O. WULF 5 on 25 October 2011. The accident was reconstructed and the towing connection explained (see Fig. 5). According to the crew, its length was 50 m, it was configured for a breaking load of 50 t and guided by the towing hook and a gob rope, which was controlled aft by means of a winch and attached to the towline via a roller (see Fig. 6) using a round pin anchor shackle, to the towing hook (see Fig. 7). The towline consisted of three parts: 10 m bridle to seagoing ship, 28 mm cable (62 t), connected with round pin anchor shackle (35 t), 20 m stretcher (supposedly) polypropylene (64 mm, 49.8 t), parted towards the middle, 20 m UHMWPE² rope (84.3 t), mated eye to eye, as well as a 28 mm tricing cable (62 t), which was attached to the towline using a round pin anchor shackle and controlled by means of a tricing winch. The tug assisted at the stern at an angle of approximately 90° and was reportedly straightening herself when the stretcher parted.

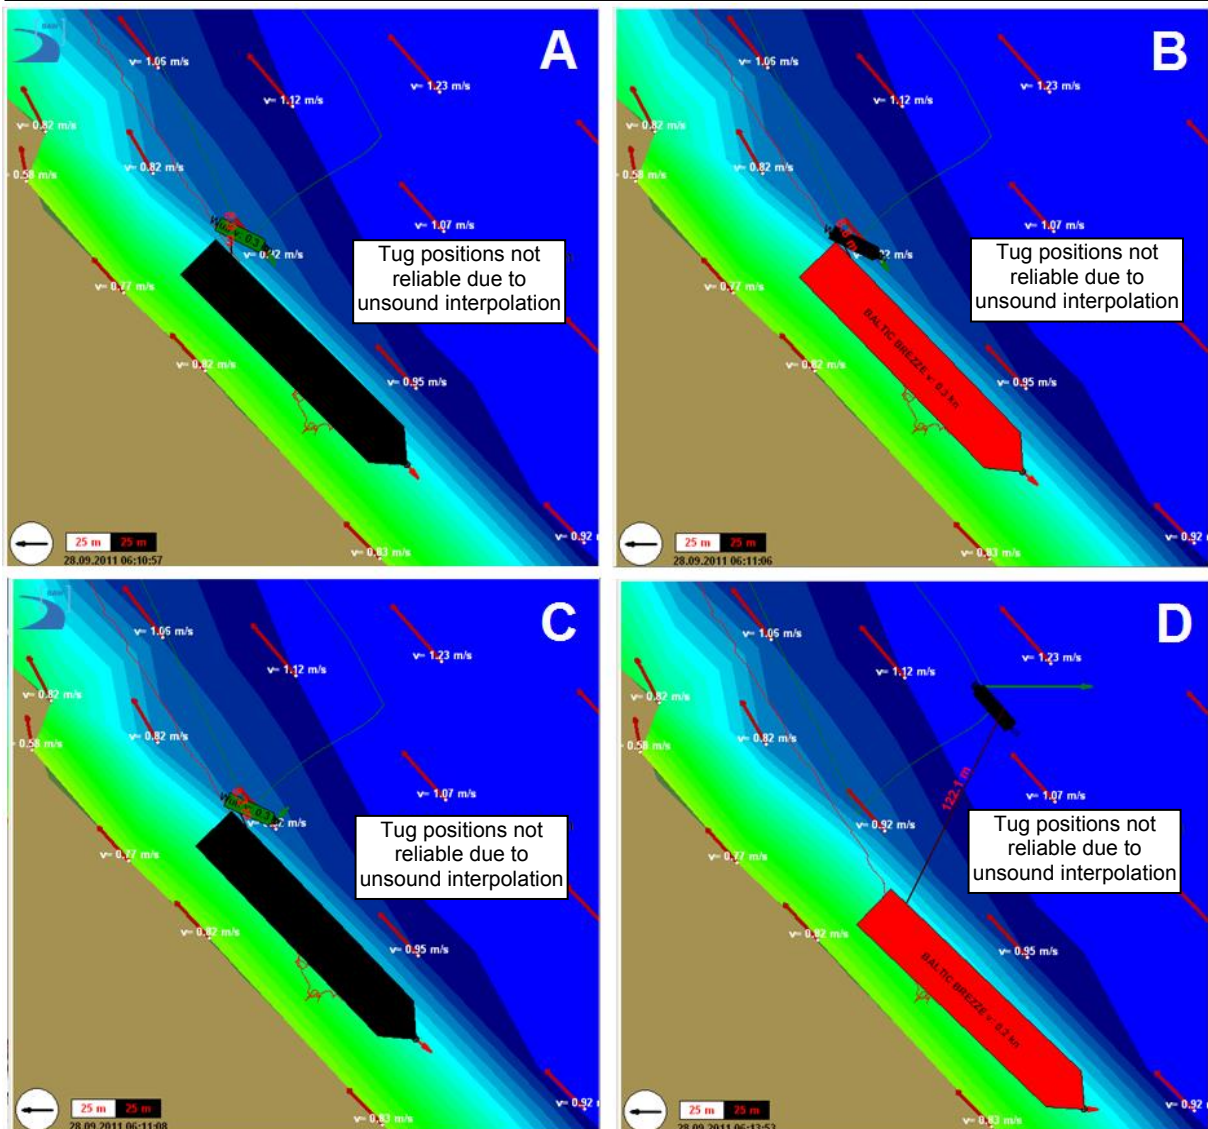
Figure 17: AIS positions

Substantiated by means of AIS data are positions of the BALTIC BREEZE (061057, A), the TAUCHER WULF 5 (061106, B), following that the BALTIC BREEZE (061108, C), as well as the next substantiated position of the TAUCHER WULF 5 (061353, D).

At the time of the accident, the positions of the TAUCHER WULF 5 substantiated by means of AIS data are 167 s apart (e.g. Fig. 17, B and D). The linear interpolation in terms of time between the substantiated positions of the TAUCHER WULF 5 (Fig. 17, B and D) is based only on assumptions because no additional manoeuvring information (e.g. rudder angle, rated speed, heading) is available. Therefore, the TAUCHER WULF 5's direction of turn to port between 061106 and 061353 based on the substantiated AIS data should be seen only as a presumption.

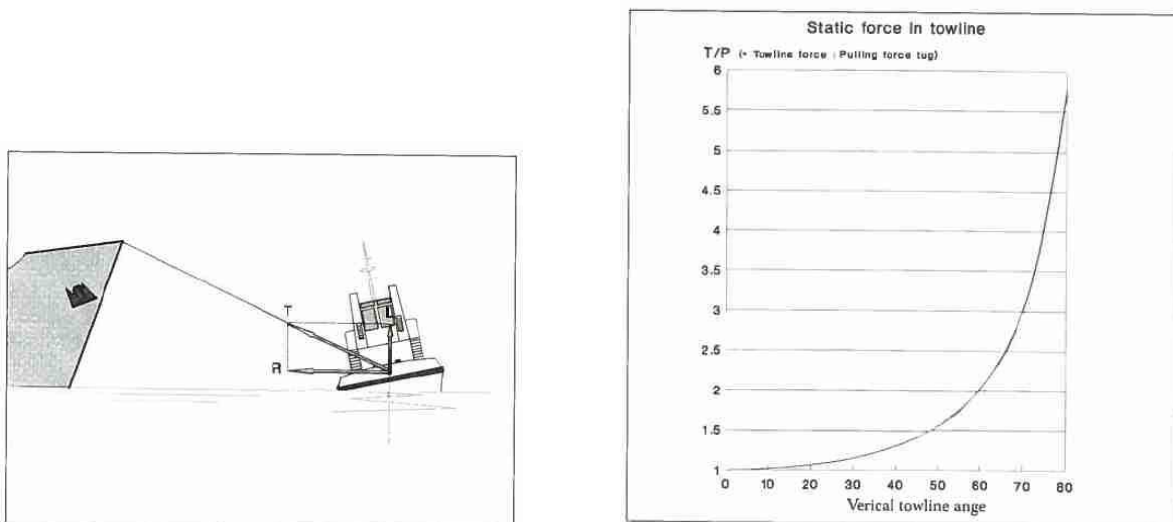
Figure 21: Load on towing connection⁵

The forces and/or loads acting on the towing connection consist of the static and dynamic element. The static element can be calculated from the bollard pull and the angle of the towing connection to the seagoing ship. A bollard pull of 25 t and a reconstructed angle of 10° results in a proportion of $25 \cdot \text{factor } 1 = 25 \text{ t}$. Here, the slope of the towline is relevant. At an angle of about 60° , the load already equals twice the bollard pull. The expert appraisal of the BAW indicates a dynamic load of 3.5 t due to the existing weather and flow conditions. Consequently, theoretically the total load on the towing connection should not have exceeded 28.5 t.

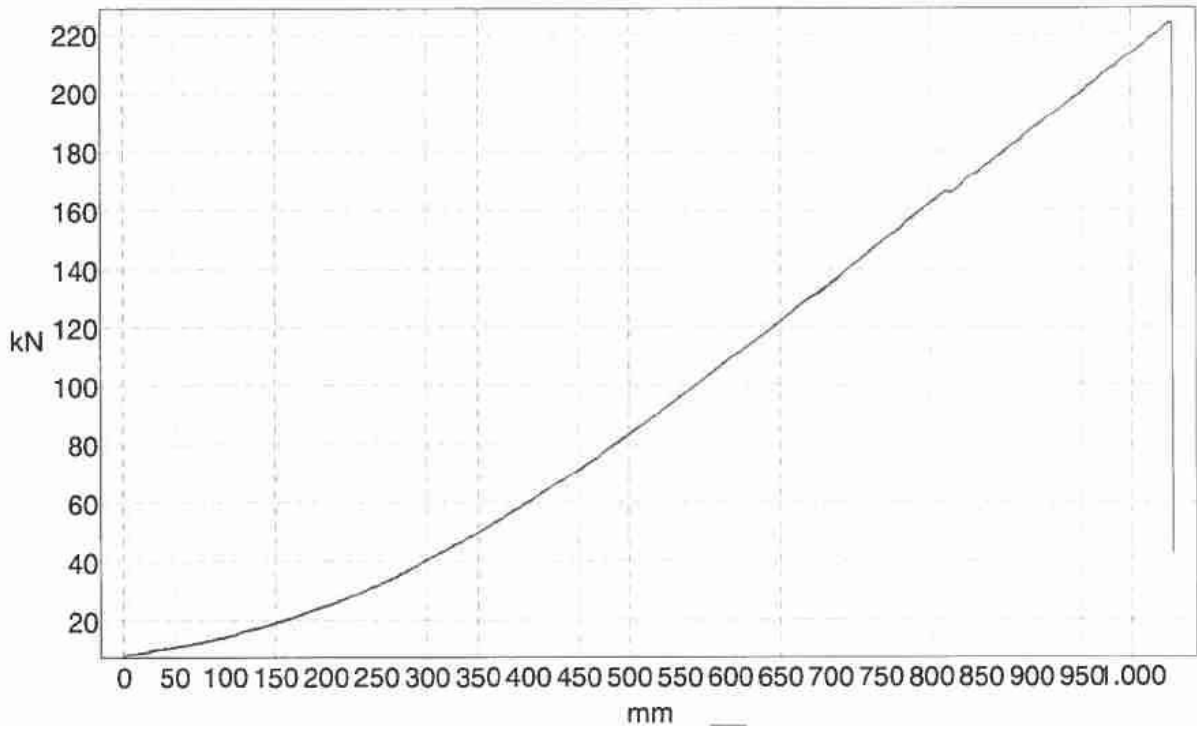
Figure 23: Measurement of tensile strength and elongation, Messrs Seil Hering

Since the rope's condition is virtually new in terms of its internal and low wear and it reveals no other traces of a continuously high load, the actual rope diameter is confirmed at 381 kN (splice), correspondingly 419 kN in the rope, by means of the value determined by a tensile test on an intact part of the rope.

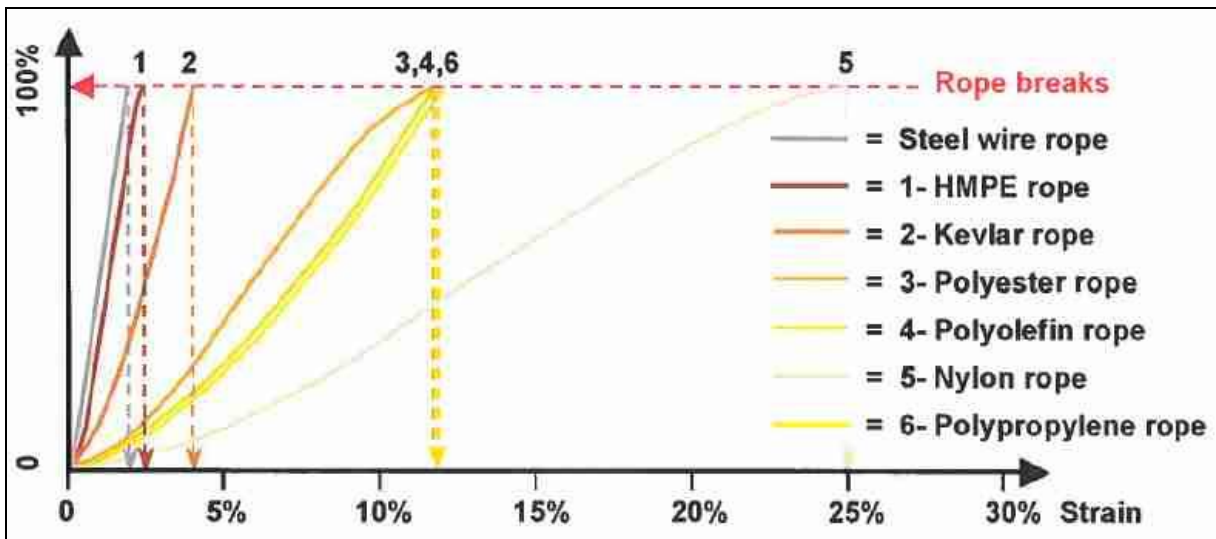
Figure 24: Rope elongation curves

Questions arise due to the rope diameter and corresponding tensile strength, as well as the length of the rope and corresponding ability to absorb kinetic energy. Although there are no mandatory provisions for the dimensioning of towing gear, the stretcher should never be the weakest of the components that make up the towing connection. Only then is it possible to prevent the energy stored from being released, the rope ends from snapping back, and generally, as in this case, too, serious injuries being caused to members of the crew if it suddenly fails.
