Bundesstelle für Seeunfalluntersuchung
Federal Bureau of Maritime Casualty Investigation
Federal Higher Authority subordinated to the Ministry of Transport,
Building and Urban Development

Summary
Investigation Report 507/11

Serious Marine Casualty

Collision
between the MOL EFFICIENCY and the
SPLITTNES
on 22 November 2011 at 2013
on the Weser

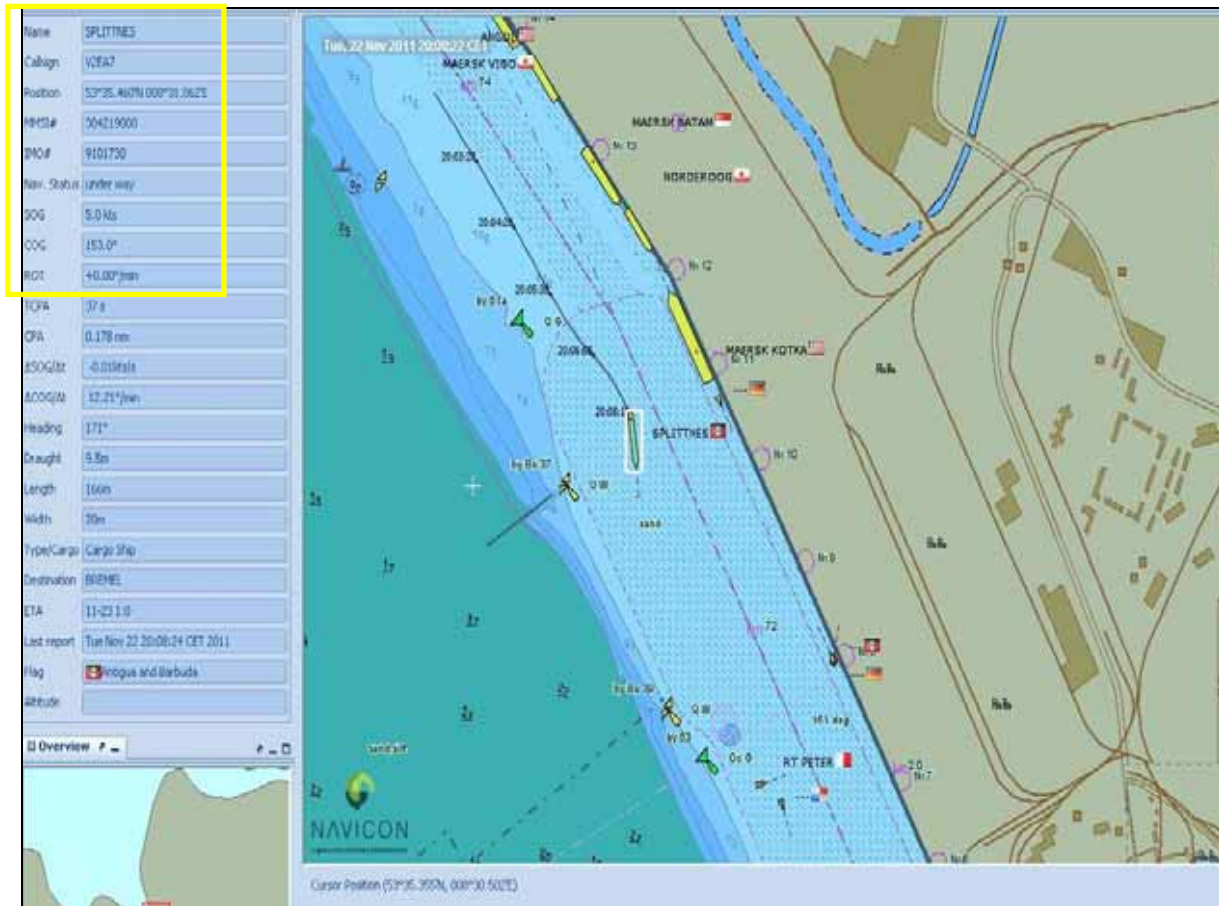
Figure 10: AIS display at 200822

Figure 10 shows the time (2009) at which the pilot of the MOL EFFICIENCY suggested that the SPLITTNES ought to pass when the OCEAN PEGASUS had passed and before the MOL EFFICIENCY began to turn after all. The shore-based radar guidance conveyed this suggestion to the SPLITTNES. The vessel's command of the SPLITTNES (under pilot's advice) agreed and then increased her speed again. This can be seen in figures 11 and 12.

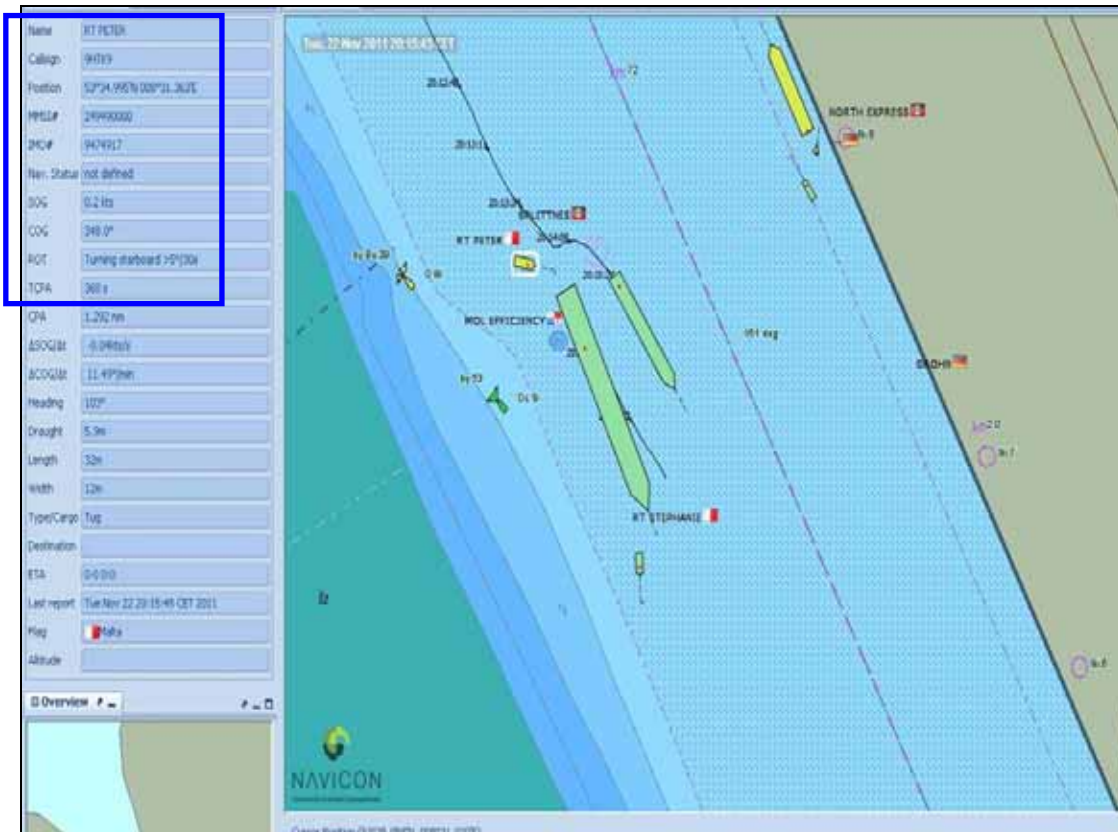
Figure 20: AIS display at 201543

While Figure 20 shows the position of the aft tug, RT PETER, shortly after the collision, Figure 21 shows the position of the forward tug, RT STEPHANIE, at 2016. The two vessels involved in the collision have just separated. Figure 22 shows the final stages of the collision. At this point, the SPLITTNES is already taking on so much water that she is heeling heavily to starboard. The ship's command takes focused action to keep the vessel afloat and get her to the pier as quickly as possible.

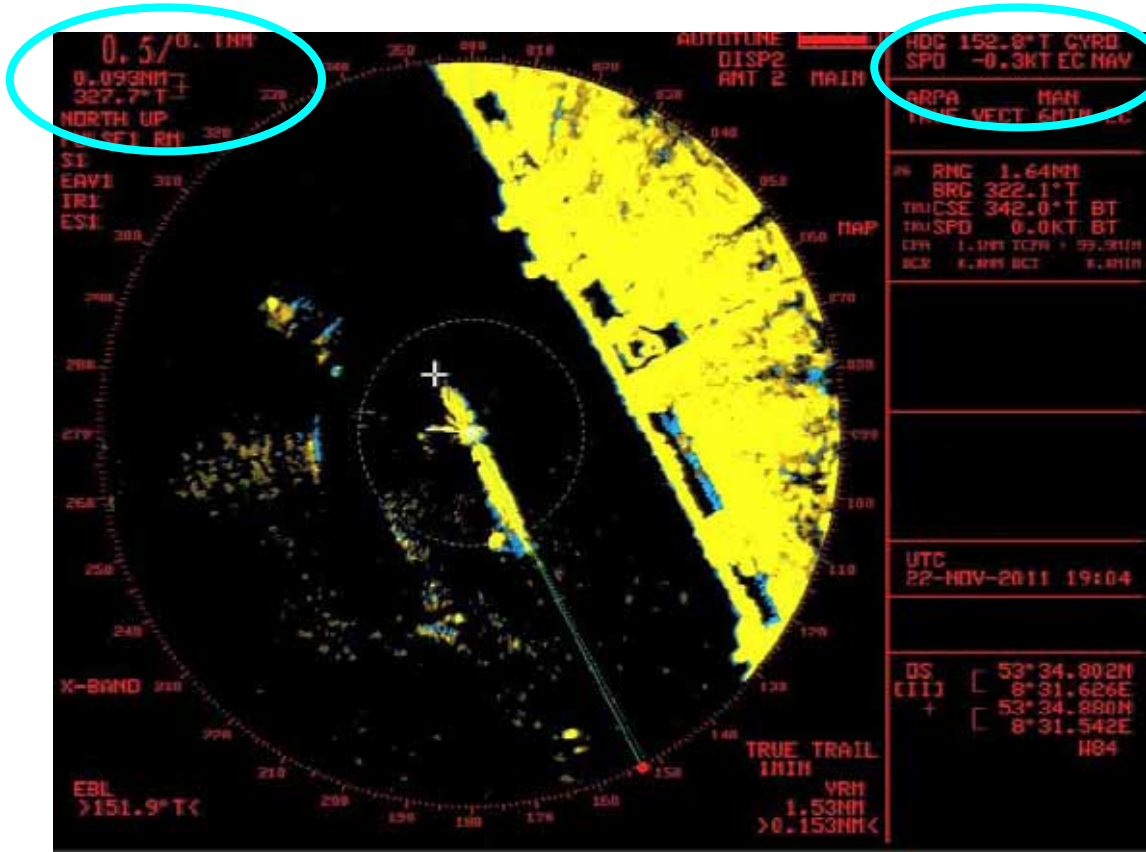
Figure 29: Radar image of the MOL EFFICIENCY at 200440

In Figure 29, (at about 2005) the COG stands at 327.7° and the speed over ground rises to 0.3 kts – astern. The parties involved consulted further. Here, it was arranged that the SPLITTNES is going to wait until the MOL EFFICIENCY had berthed. Both tugs are already made fast to the MOL EFFICIENCY. She intends to keep her position in the turning circle.

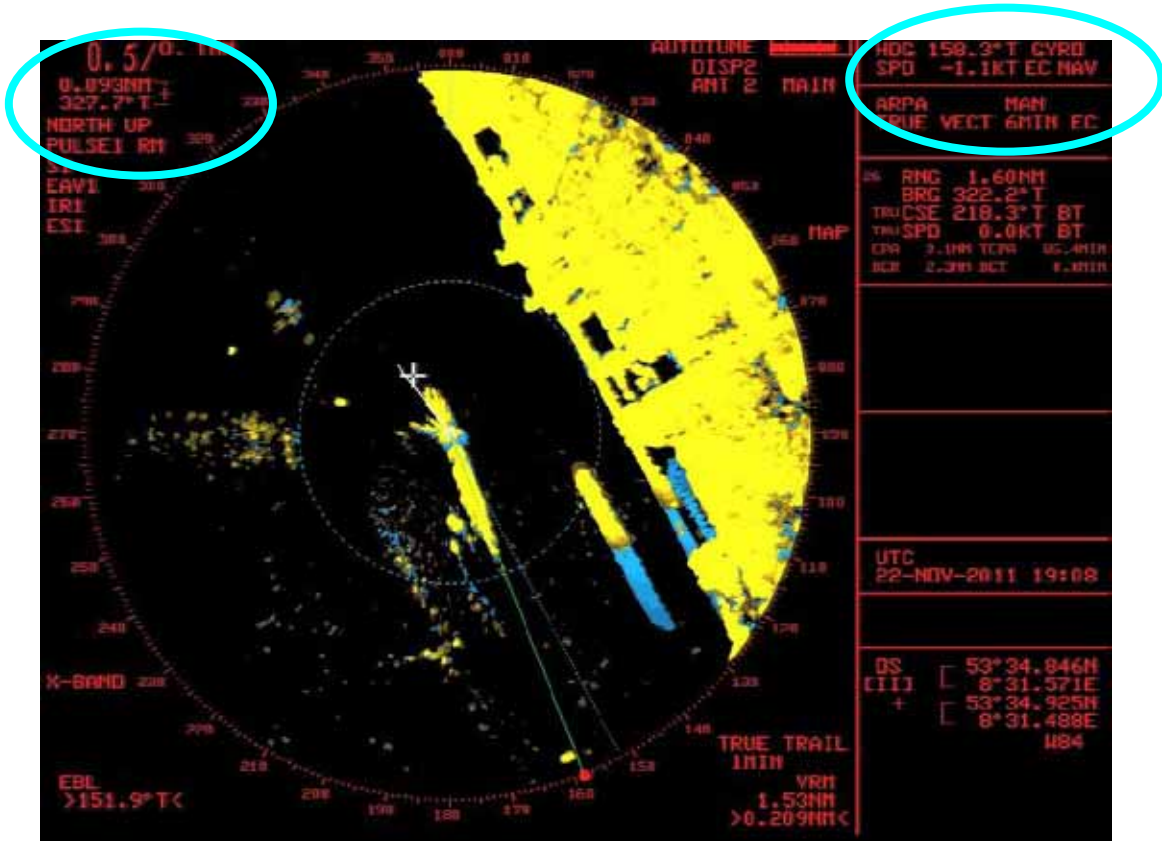
Figure 30: Radar image of the MOL EFFICIENCY at 200835 – second round of planning

At 2009, the pilot of the MOL EFFICIENCY called Blexen Radar and suggested to let the SPLITTNES pass him as soon as the OCEAN PEGASUS had passed. The radar pilot conveyed this suggestion to the pilot of the SPLITTNES and he agreed. Figure 30 shows that the speed over ground of the MOL EFFICIENCY has risen to 1.1 kts – astern. The speed continues to increase to 2 kts up until the collision, as shown in Figure 31.

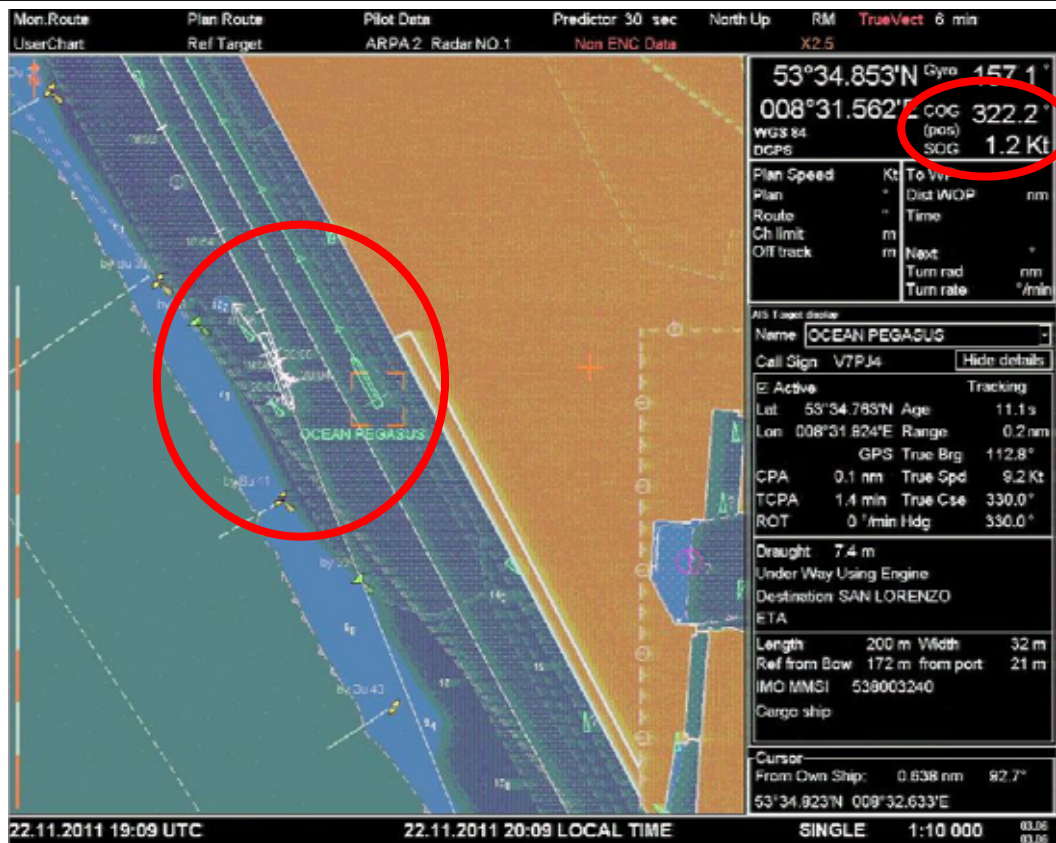
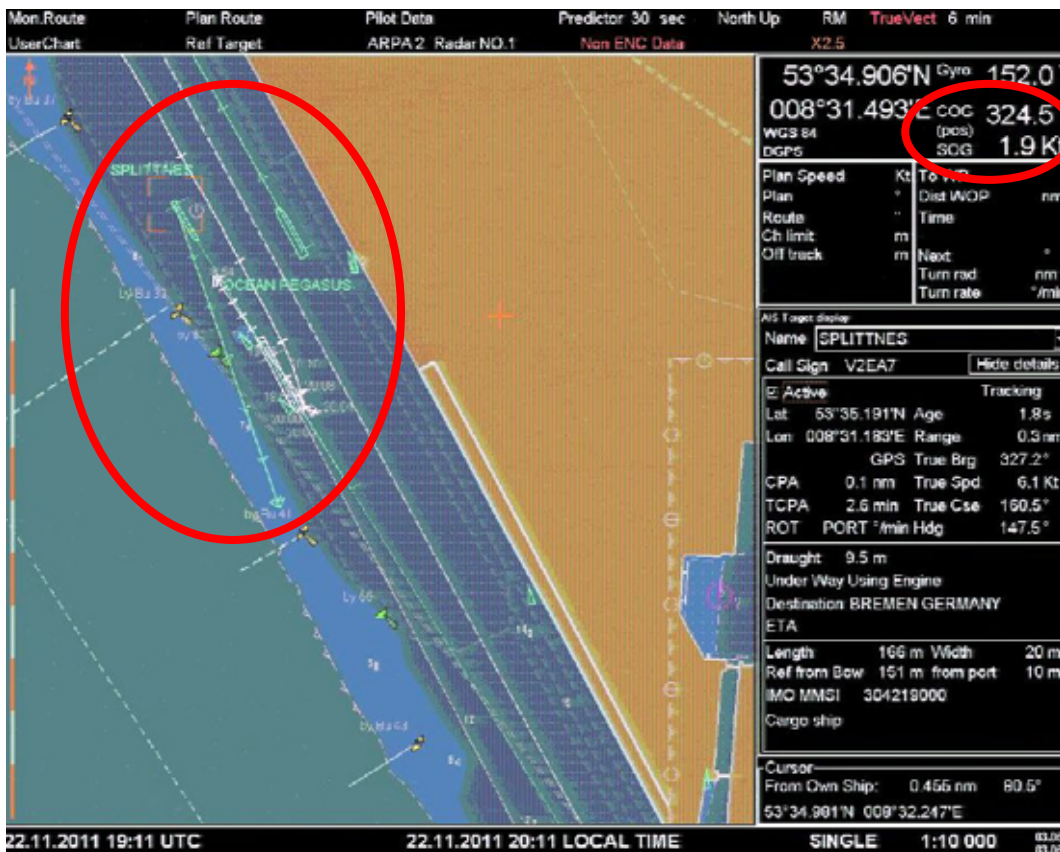
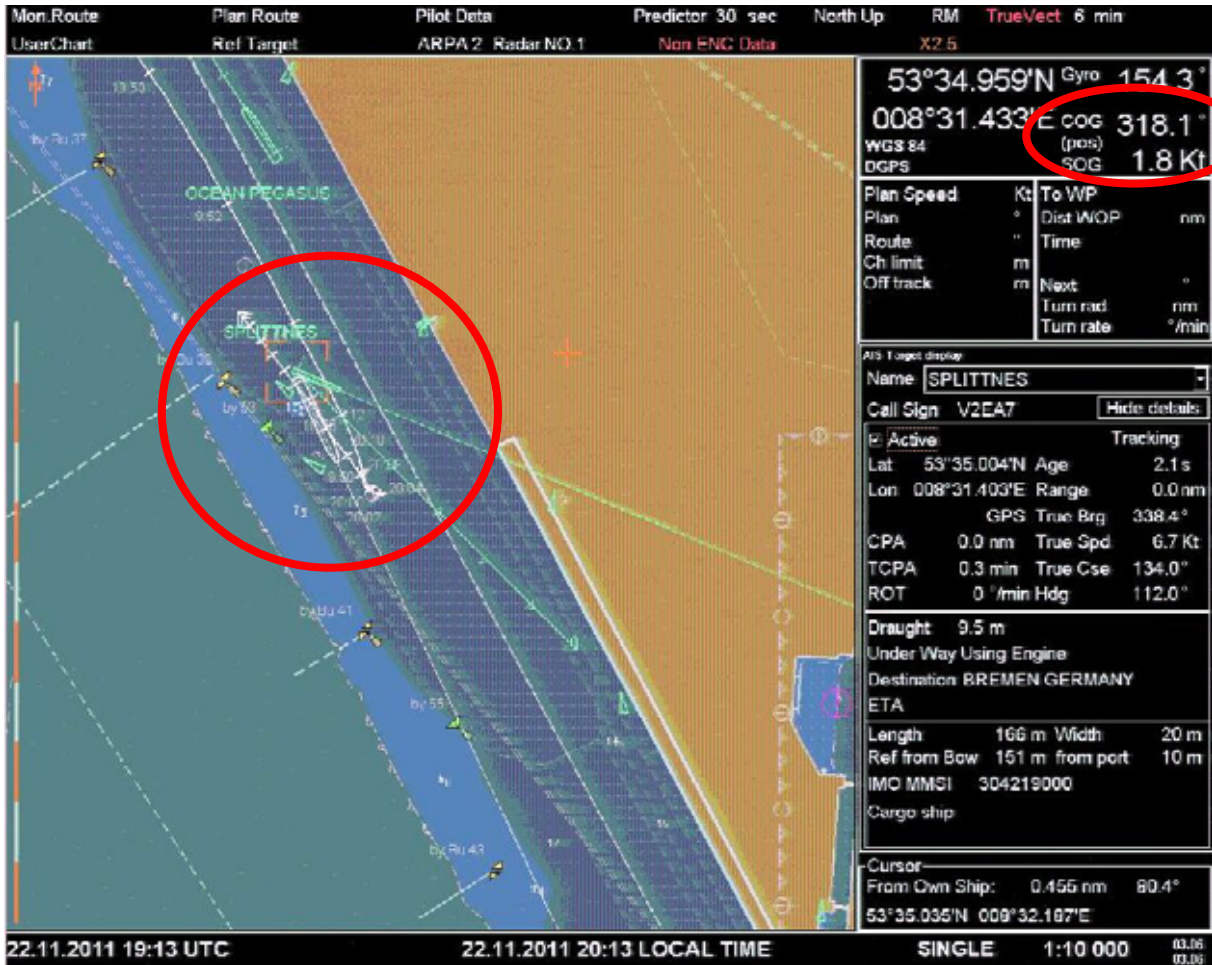
The images of the electronic chart system can be interpreted even more clearly. The speed vectors of all vessels are shown on these synthetic images. In particular, the MOL EFFICIENCY's own speed vector clearly shows the SPLITTNES moving towards her, as can be seen below in Figure 32, 33 and 34.
