Bundesstelle für Seeunfalluntersuchung
Federal Bureau of Maritime Casualty Investigation
Federal Higher Authority subordinated to the Ministry of Transport
and Digital Infrastructure

Summary Investigation Report 10/11

**Accident involving a person on the FRISIA II
while casting off at Norddeich
on 7 January 2011**

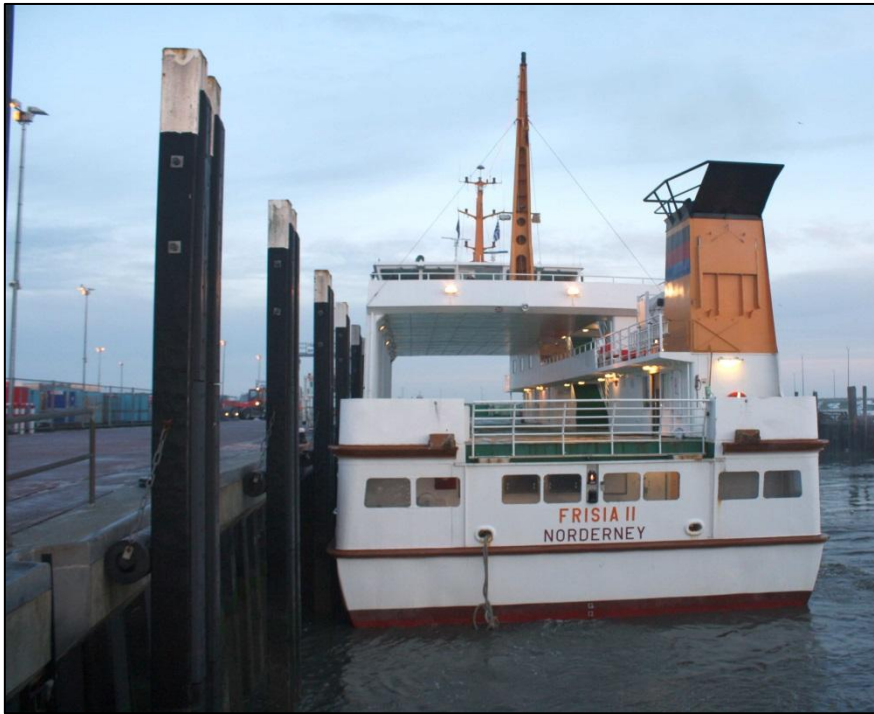
Figure 8: Stern of the FRISIA II with both stern lines

The statements given during the initial enquiries by the WSP gave rise to the assumption that only one of the two stern lines became caught in the propeller. However, parts of each line were found in the port propeller during the diving operation to remove the line from the propeller. The witnesses on board the ship then corrected their statements.

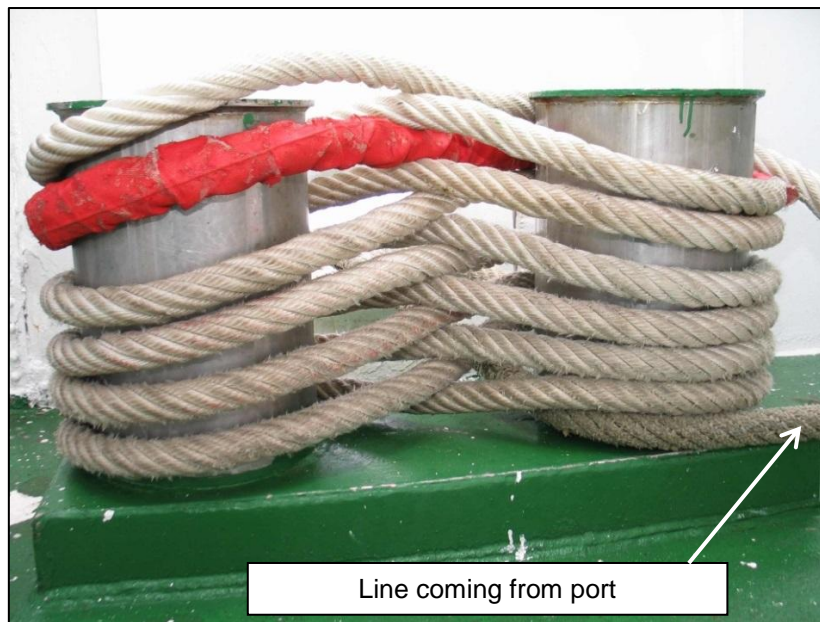
It follows that both stern lines had to be taken hold of in the area between the fairlead and bitt to haul them in (see Figure 10 – gripping position). The result of this is that both crew members worked in a very confined space and it was necessary to move extremely close to the bitt. When the later casualty took hold of the line for the second time, he moved the leg that was supporting him close to the bitt. His leg became trapped when the propeller caught and tightened this line at this very moment. The procedure was responsible for the lines that became caught by the propeller not simply slipping out but tightening in the manner described and subsequently parting, as they were still placed over their bitts.

Figure 11: Illustration of the line setup
