Investigation Report 15/13

Serious Marine Casualty

**Collision between the MV CORAL ACE
and the MV LISA SCHULTE
at the Neue Weser Nord-roadstead
on 31 January 2013**

2 October 2014

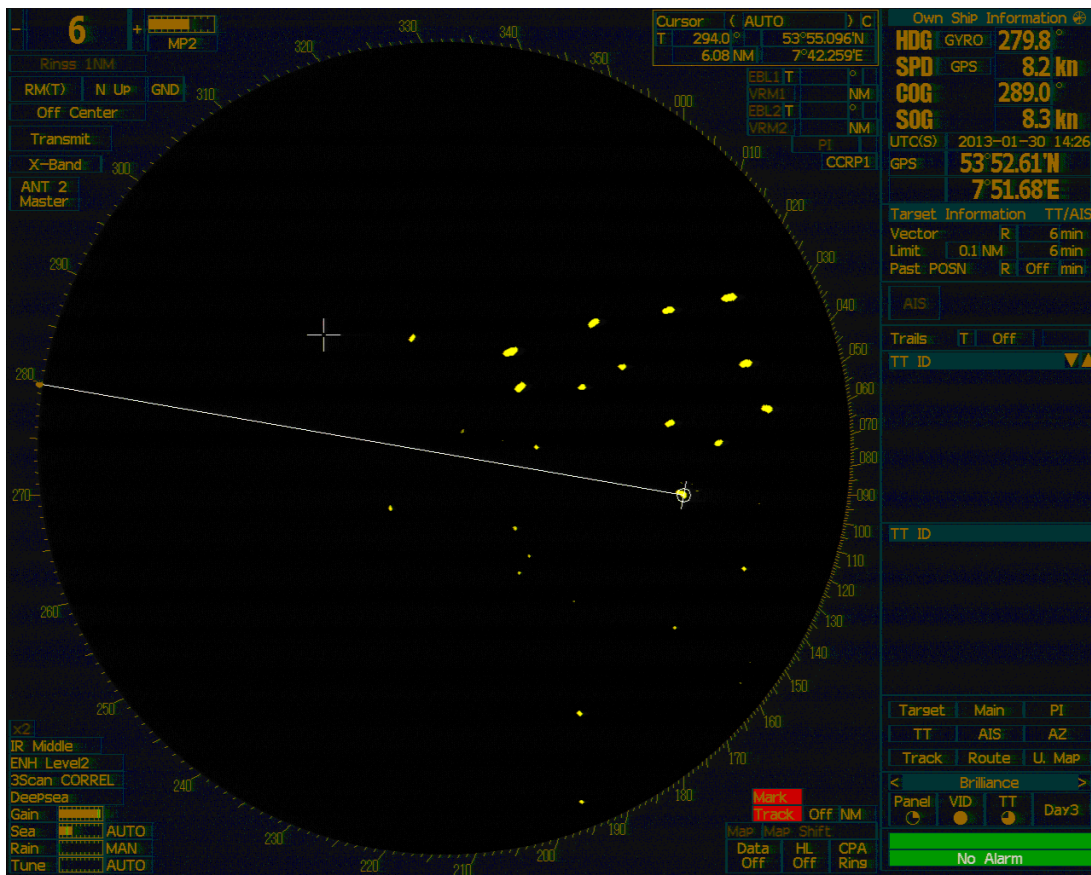
Figure 4: Radar image of the CORAL ACE at 151011

The sea pilot disembarked just short of the roadstead at 1512. The master and the second officer manned the bridge. From 1519 onwards, the CORAL ACE was shifted significantly towards the east by swell, wind, and current. This necessitated appropriate countersteering. The ship's command decided to proceed on a northerly course to the middle of the field of vessels laid up at anchor and anchor there roughly on the position of the anchor radar marker (see Figure 5).

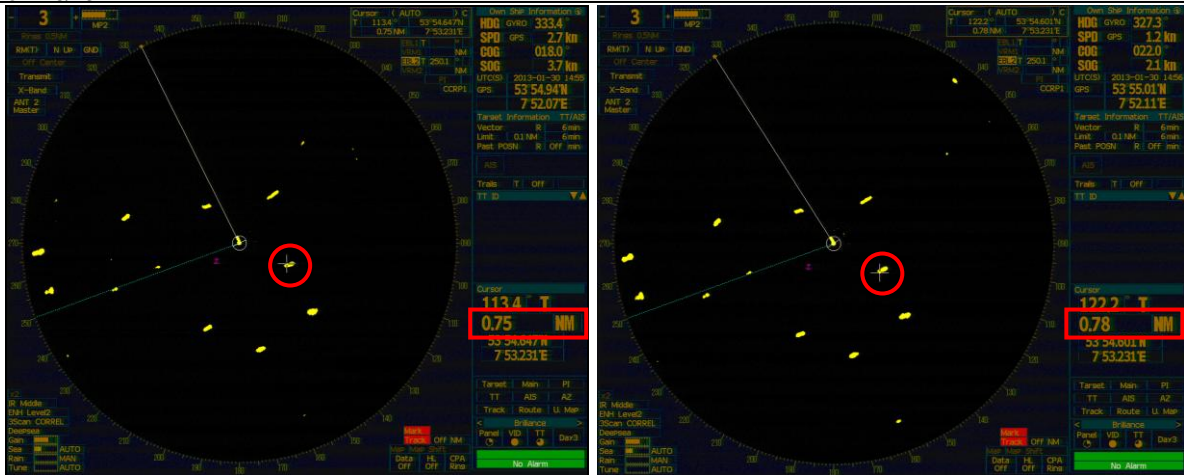
Figure 7: Radar images of the CORAL ACE at 153911 and 154041

Following that, while monitoring the distance to the LISA SCHULTE on the radar a port turning manoeuvre was initiated (see Figure 7). The LISA SCHULTE had already been laid up in the roadstead for several days.

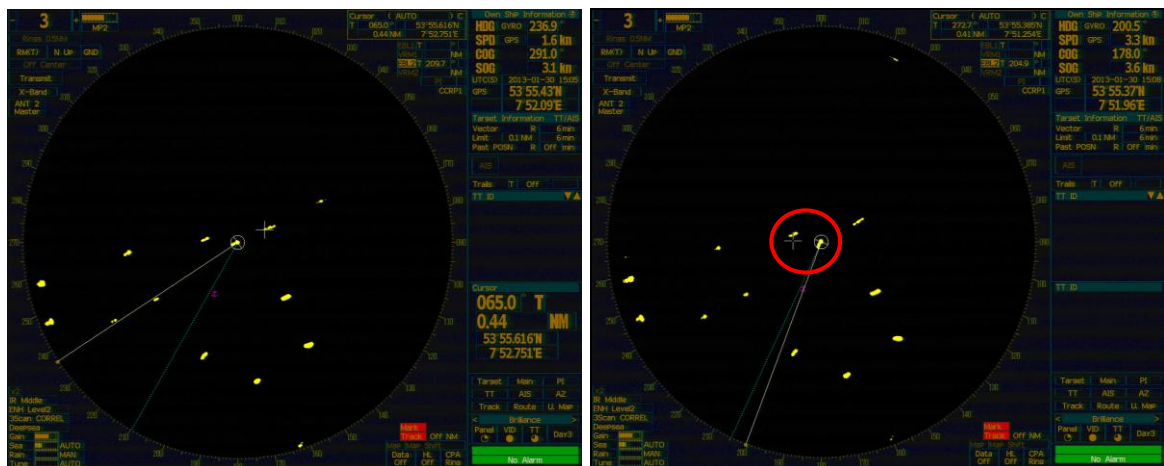
Figure 9: Radar images of the CORAL ACE at 154956 and 155226

The manoeuvre took the CORAL ACE to a distance of up to about 2 cbl from a different laid-up vessel: the IRMA (see Figure 9).

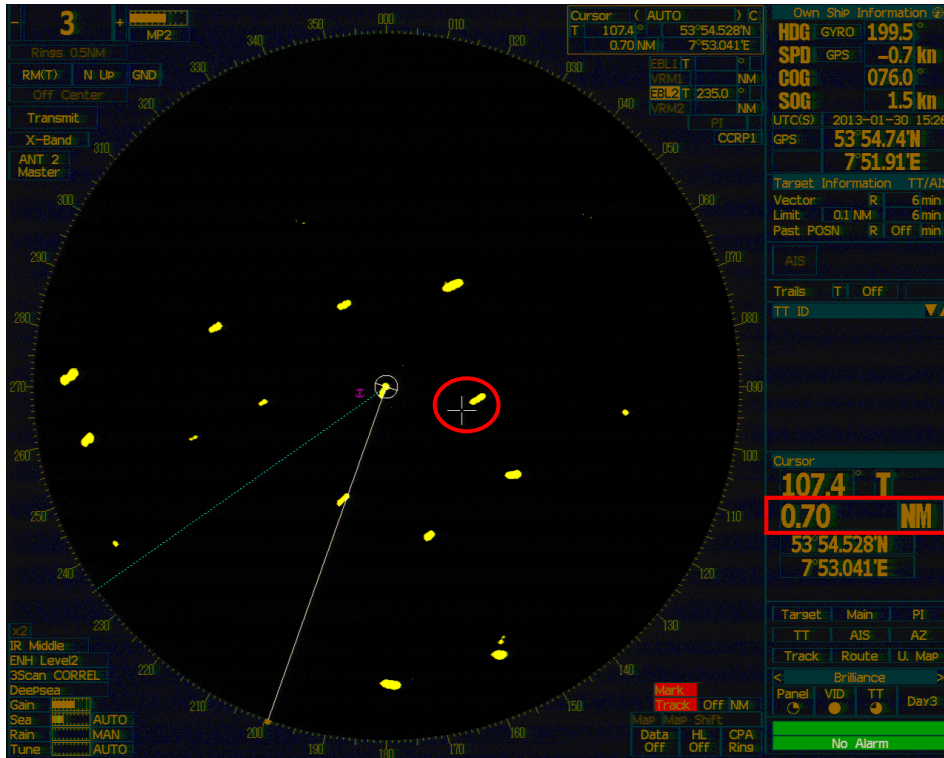
Figure 10: Radar image of the CORAL ACE at 161011

Eight starboard anchor shackles were deployed at 1600. According to the bridge log, the wind force stood at 6 Bft at this point. The CORAL ACE set anchor at a distance of 7 cbl from the LISA SCHULTE, which was anchored to the east (see Figures 10 and 11).

Overall, the selected range of 7 cbl to the LISA SCHULTE does not merit any criticism from a navigational or regulatory perspective. However, appropriate maritime precautions were required to ensure a safe anchoring because of the predicted storm. The master of the CORAL ACE and the OOWs knew about the expected meteorological conditions at sea on the night of 31 January 2013 due to NAVTEX and navigational warnings. Indeed, this knowledge was reflected in the master's instruction to inform him as soon as the weather deteriorated in the night order book. However, basic practices of seamanship were ignored as regards implementation of the procedures for anchoring (see section 3.2).

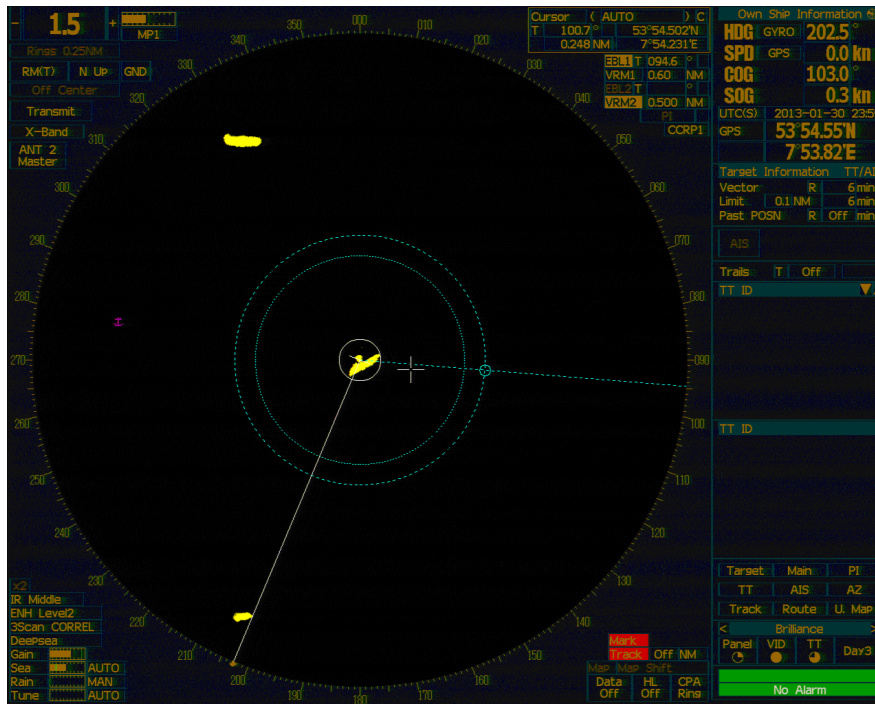
Figure 15: Radar image of the CORAL ACE at 004356

Water ingress occurred on both ships because of the collision. The port side of the CORAL ACE had pushed into the bow of the LISA SCHULTE. The ships were initially wedged together (see Figures 15 and 16).

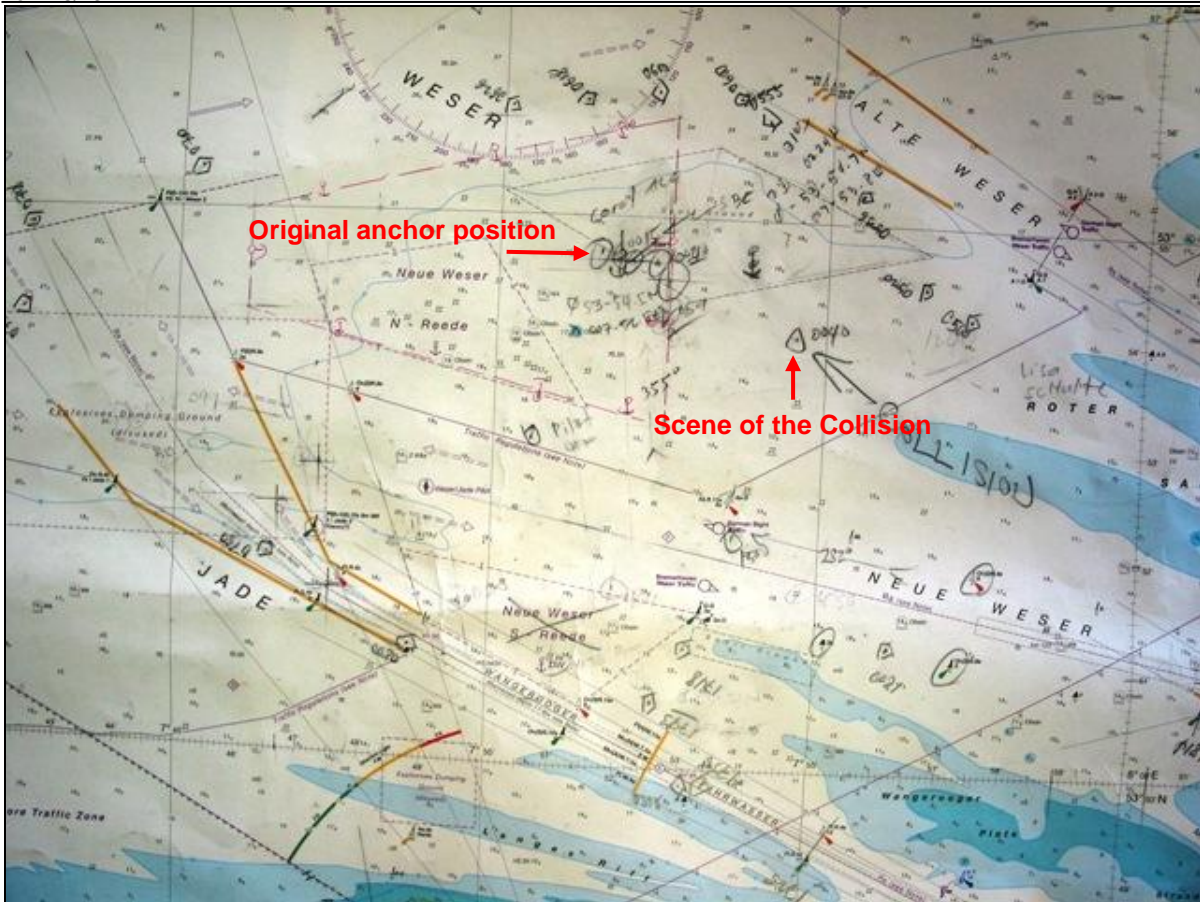
Figure 25: Excerpt from Nautical Chart 3617 with ship positions plotted

The official BSH Nautical Chart 3617 – Approaches to The Jade and Weser – (current issue and revision status) was used for navigation (see Figure 25).

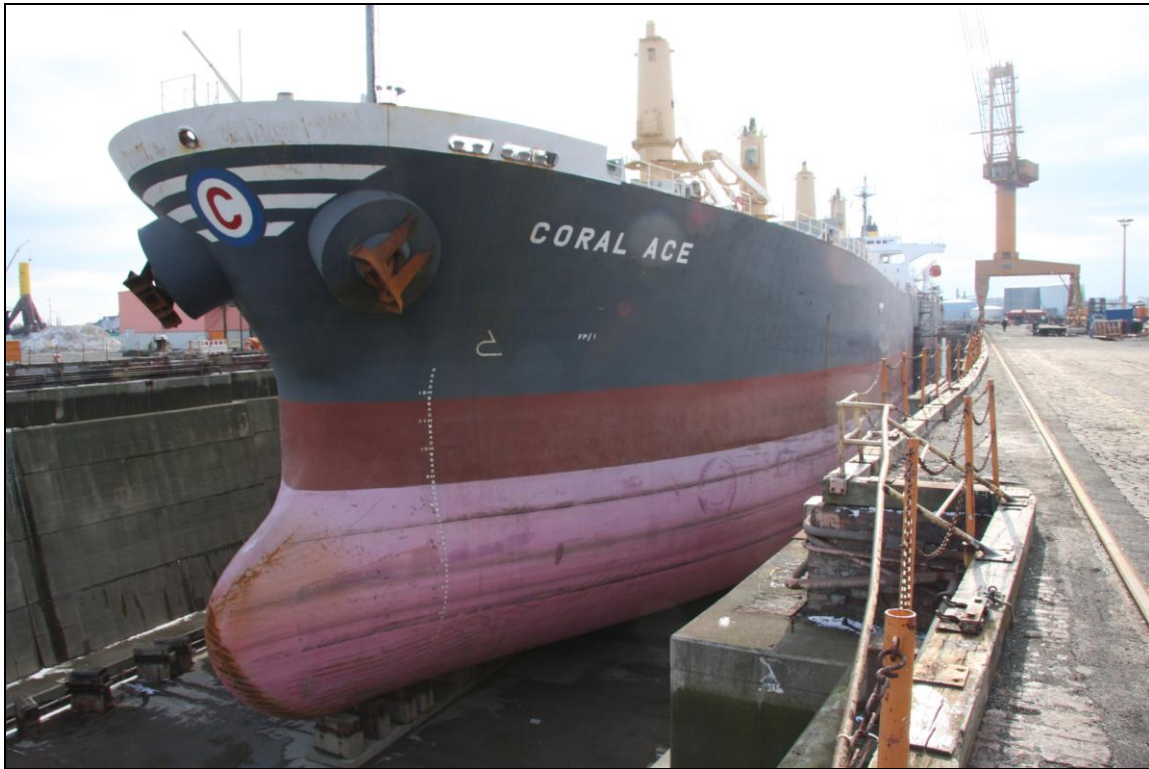
Figure 29: Stockless anchors on the CORAL ACE

The investigators also viewed the class approval for the two anchors and anchor chains. The two stockless anchors (see Figure 29) made of carbon steel⁵ were categorised as 'High holding power KHAC-14' and had a total weight of 5,840 kg each. On 2 March 1999, load testing at a proof test load of 861 kN was rated 'good' by the classification society, NKK, in a certificate.

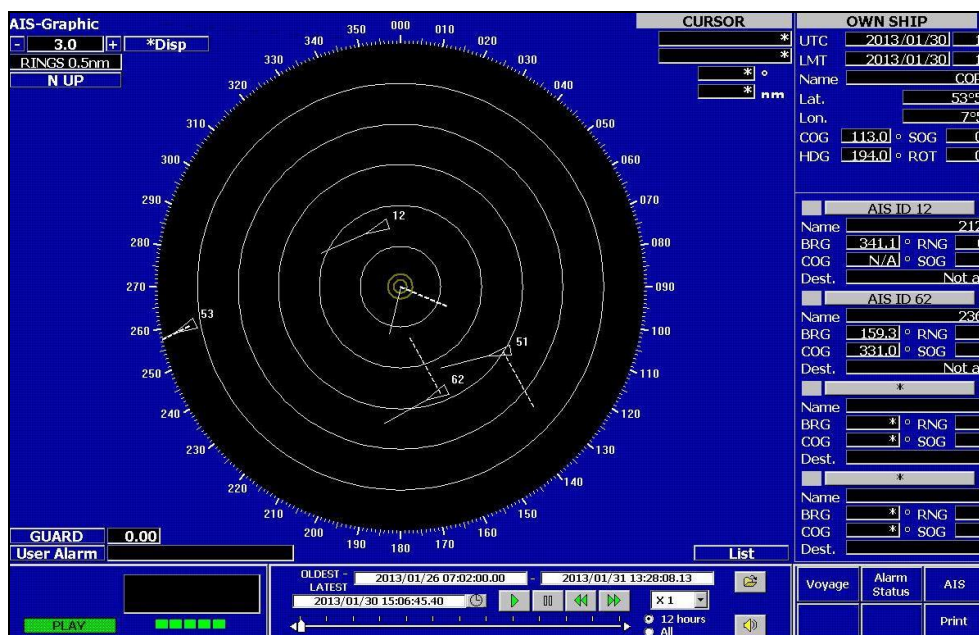
Figure 30: AIS plot of the CORAL ACE

The CORAL ACE's S-VDR recordings were limited to the X-band radar plots and AIS plots (see Figure 30) with relevant information on the ship's position, courses and speeds, steering gear data, as well as bridge microphone and VHF audio recordings.

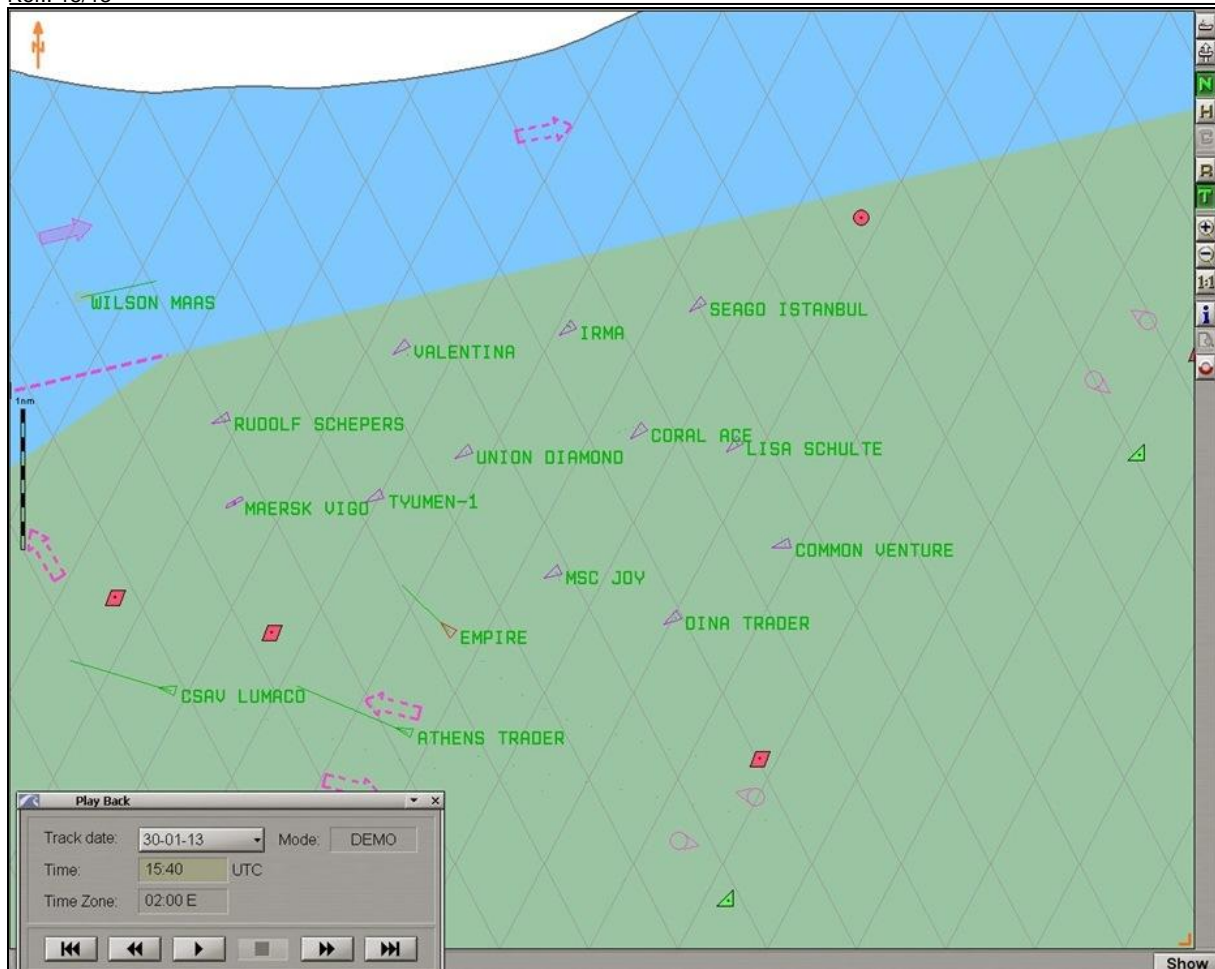
Figure 31: AIS plot of GBT

The Directorate-General for Waterways and Shipping (GDWS), branch office Northwest, assisted in the investigation with remarks on the traffic situation and specific nature of the Neue Weser Nord- roadstead. With the CORAL ACE, 12 ships were at anchor in and to the east of the roadstead on 30 January 2013 (see Figure 31).

The depth of water in the area where the CORAL ACE dropped anchor is between 16 and 18 m. GDWS Northwest describes the roadstead ground as morphologically position stable. GDWS Northwest, whose duties include supervising the vessel traffic services, did not express any concerns about the fact that several ships, including the CORAL ACE and the LISA SCHULTE, anchored to the east of the actual roadstead.
