Investigation Report 160/13

Serious Marine Casualty

**Water ingress on the traditional vessel
RAKEL
on 21 June 2013 in the
North Sea about 10 nm south of Heligoland**

25 February 2014

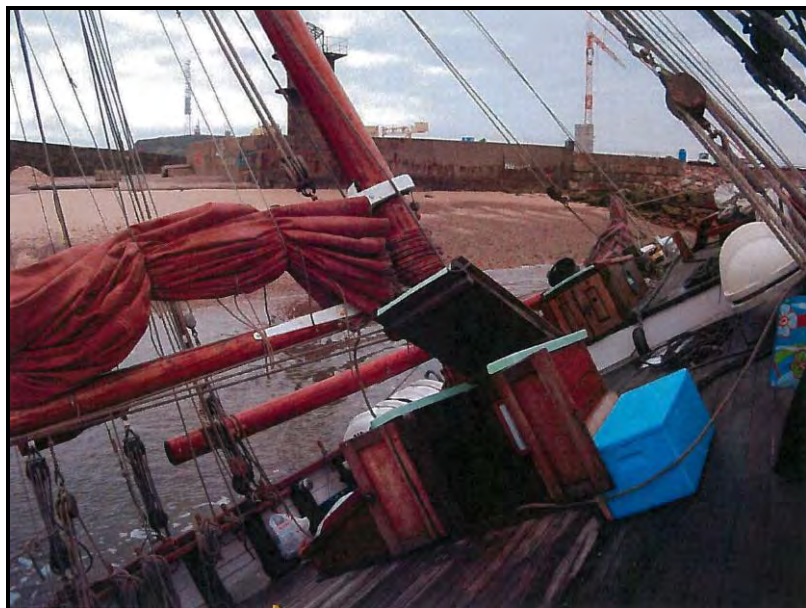
Figure 4: Grounding in the port

The fire brigade assisted the RAKEL in shifting to the designated grounding area in the outer port at about 2030. The DGzRS finished its mission at about 2112. A leak on the port side just below the waterline was re-caulked² and treenailed with the application of lead strips during low tide on 22 June 2013. The shifting manoeuvre was unsuccessful after she was re-floated on the night of Saturday to Sunday. The RAKEL ran aground again and listed at 45 degrees to port, which resulted in the need for renewed intervention by the fire brigade due to water ingress.

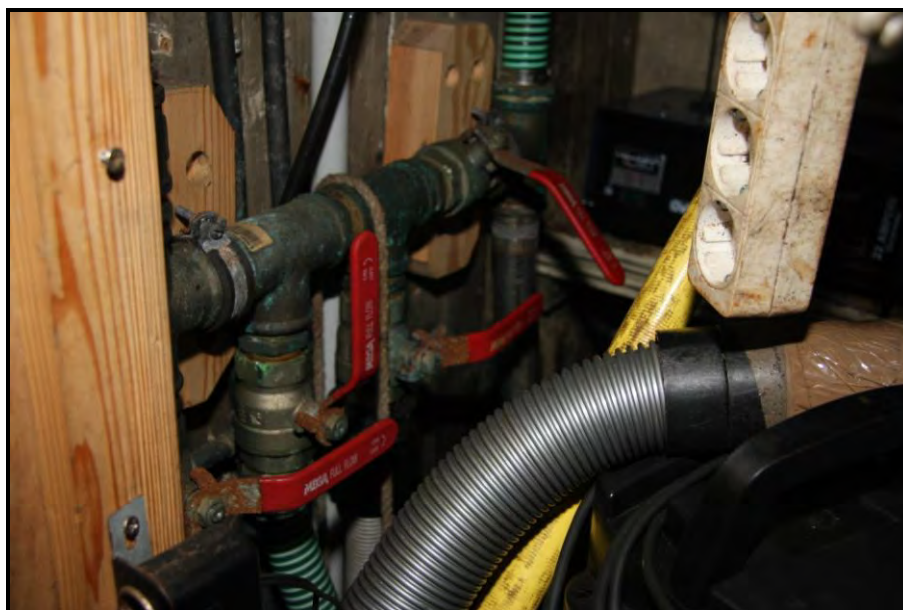
Figure 13: Valve group

However, the pump on the bulkhead did not work because the bolt connecting the pump diaphragm to the handle had broken off.

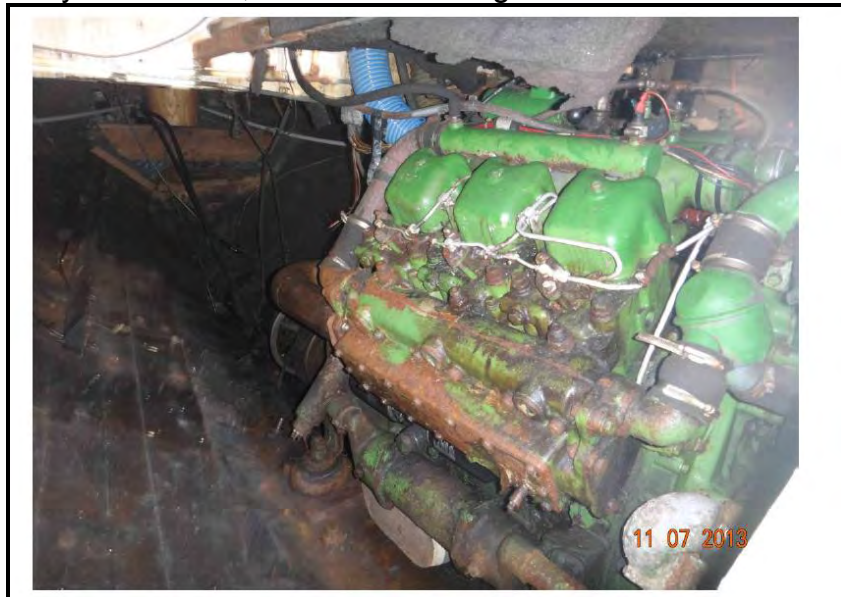
Figure 21: View of the engine (starboard side)

During the survey of the engine room, it was noted that the floors and frames, the ceiling boards, as well as the deck beams and planking were not coated with foam-forming paint designed to develop an insulating, protective layer in the event of fire. Similarly, the foam-forming paint is not substituted by non-combustible insulation or encapsulation of the main engine. Moreover, no brackets or mounting holes were found for the attachment of lateral insulation and encapsulation of the main engine. No additional bilge pump is attached to the main engine. Moreover, the generator, which is driven by a drive belt, is fixed to the engine base.

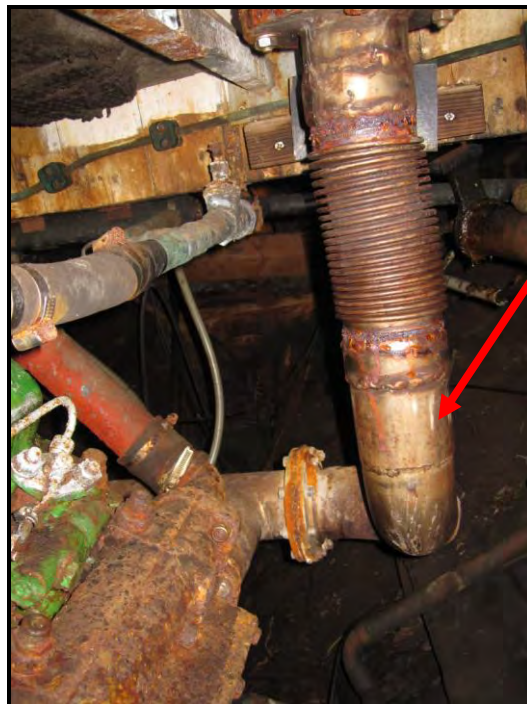
Figure 22: Engine (port side)

The exhaust pipe is not sufficiently insulated and the filling pipe for the diesel tanks located on the port and starboard side is not connected with the filler neck on deck:

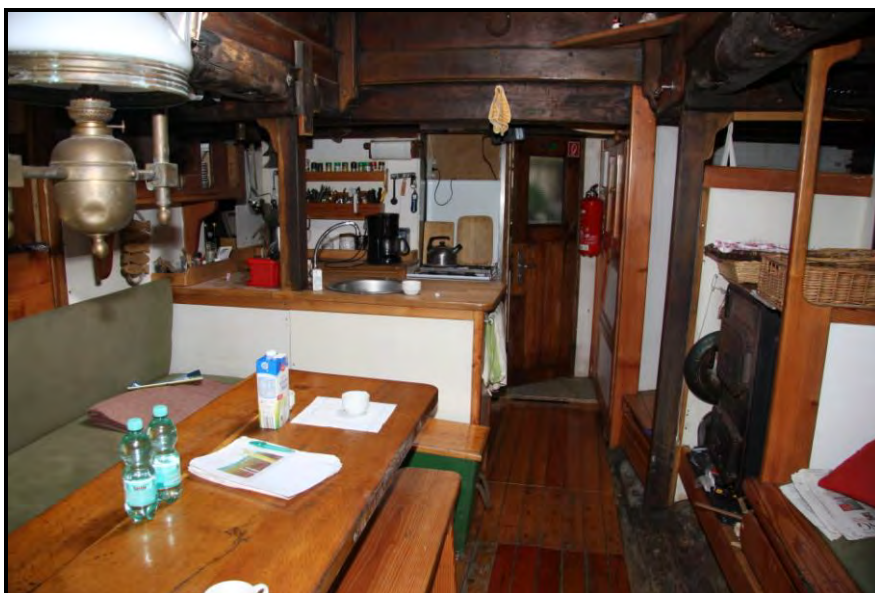
Figure 24: View of the engine room door

The engine room is separated from the galley and accommodation space only by a wooden bulkhead and simple wood door fitted with a wired glass window. Fire extinguishers are available below and on deck for firefighting.

In the drawing submitted in 2003 to the GSHW for evaluation, the forward bulkhead is shown as a bulkhead, and a door with window is located in the aft engine room bulkhead (see Fig. 6). Such a door – made out of wood, window, no sliding bolt – in a non-watertight bulkhead and bordering with the engine room is not permitted.

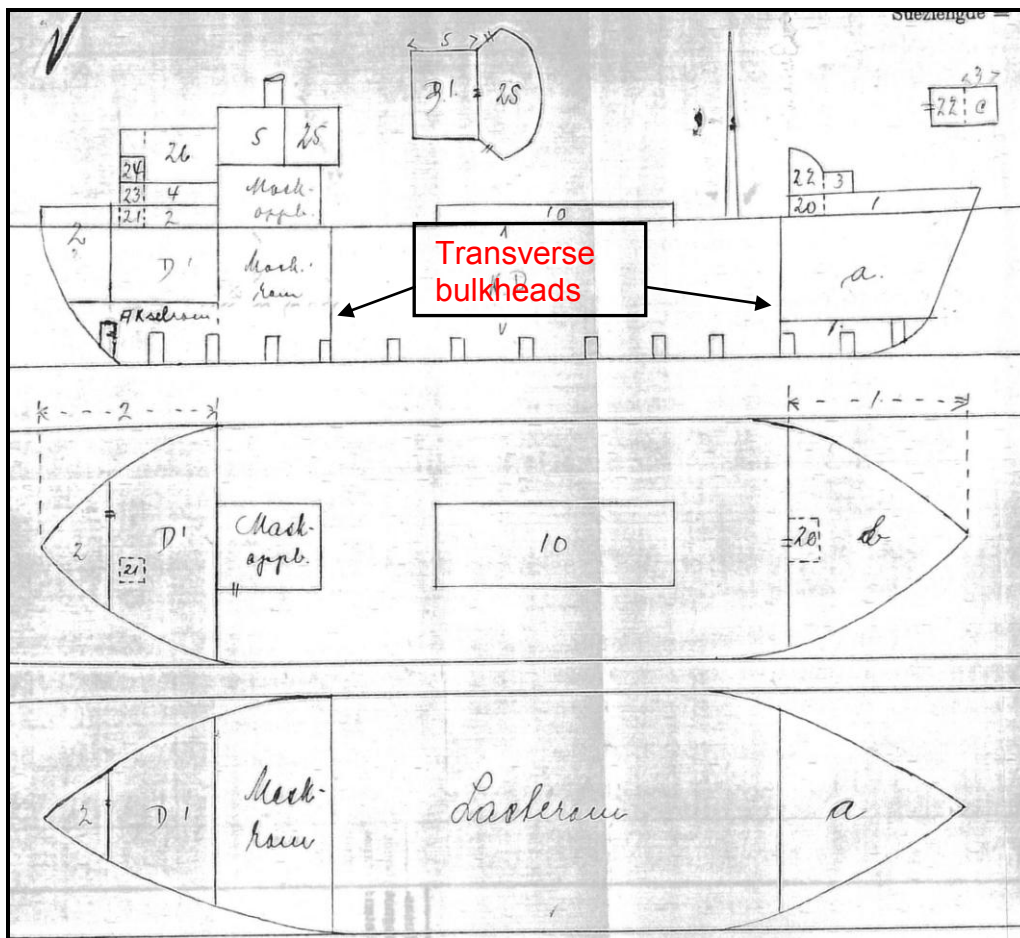
Figure 27: Rating certificate drawing

A Tonnage Certificate issued in 1948 was found in the vessel's documentation at the Federal Maritime and Hydrographic Agency. According to the drawing in the rating certificate, the RAKEL had a forward engine room bulkhead, which was also the aft cargo hold bulkhead, and a bulkhead towards the forward accommodation space/cable-tier (the forward cargo hold bulkhead).

These bulkheads divided the vessel into three sections. In the event of leakage, seaworthiness is enhanced if each section can be drained individually. However, the transverse bulkheads have not been watertight since the RAKEL was converted back to a gaff ketch, meaning the vessel consists of only one section.
