Bundesstelle für Seeunfalluntersuchung
Federal Bureau of Maritime Casualty Investigation
Federal Higher Authority subordinated to the Ministry of Transport
and Digital Infrastructure

Investigation Report 19/12

**Grounding
of the passenger ship DEUTSCHLAND in
Chile near the Italia Glacier
on 15 January 2012**

21 March 2014

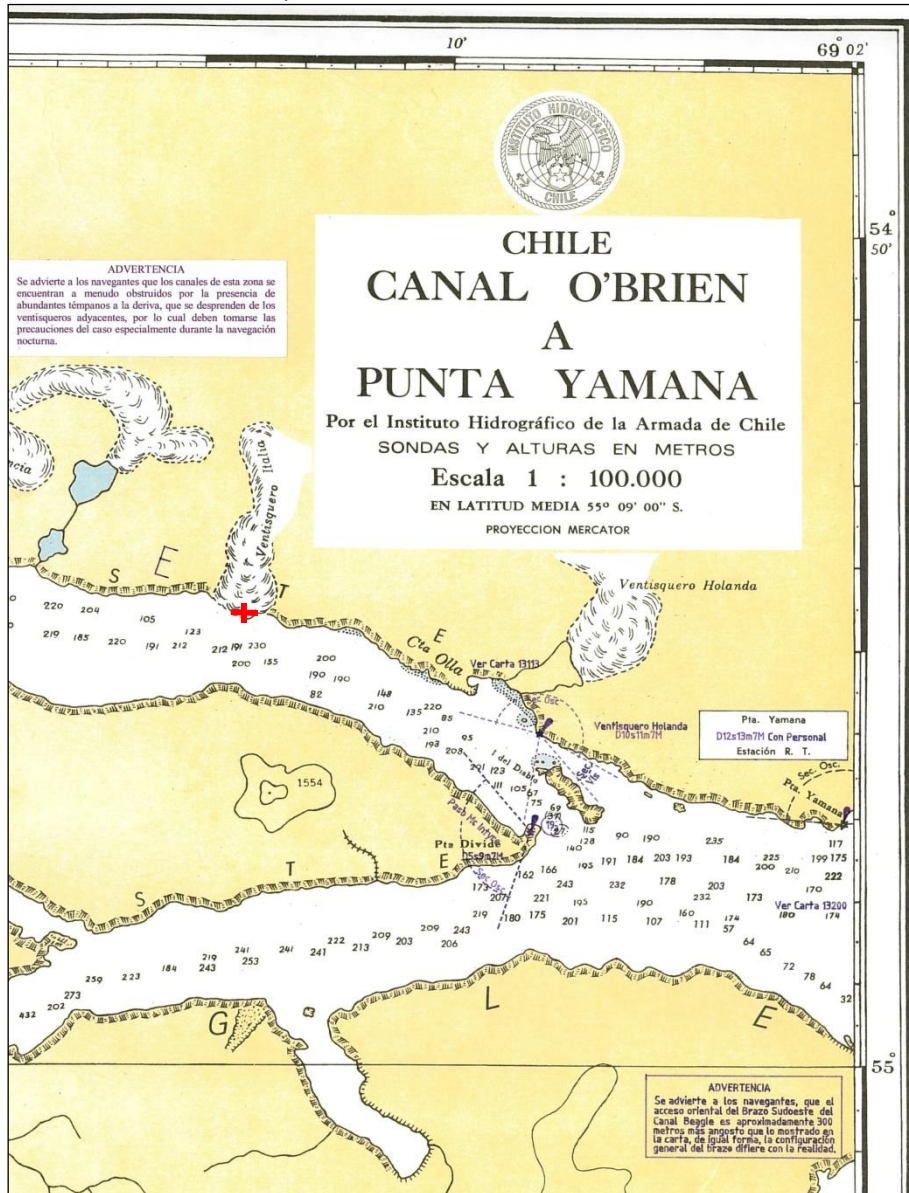
Figure 2: Excerpt from nautical chart showing the scene of the accident

Excerpt from Nautical Chart 12700, SHOA

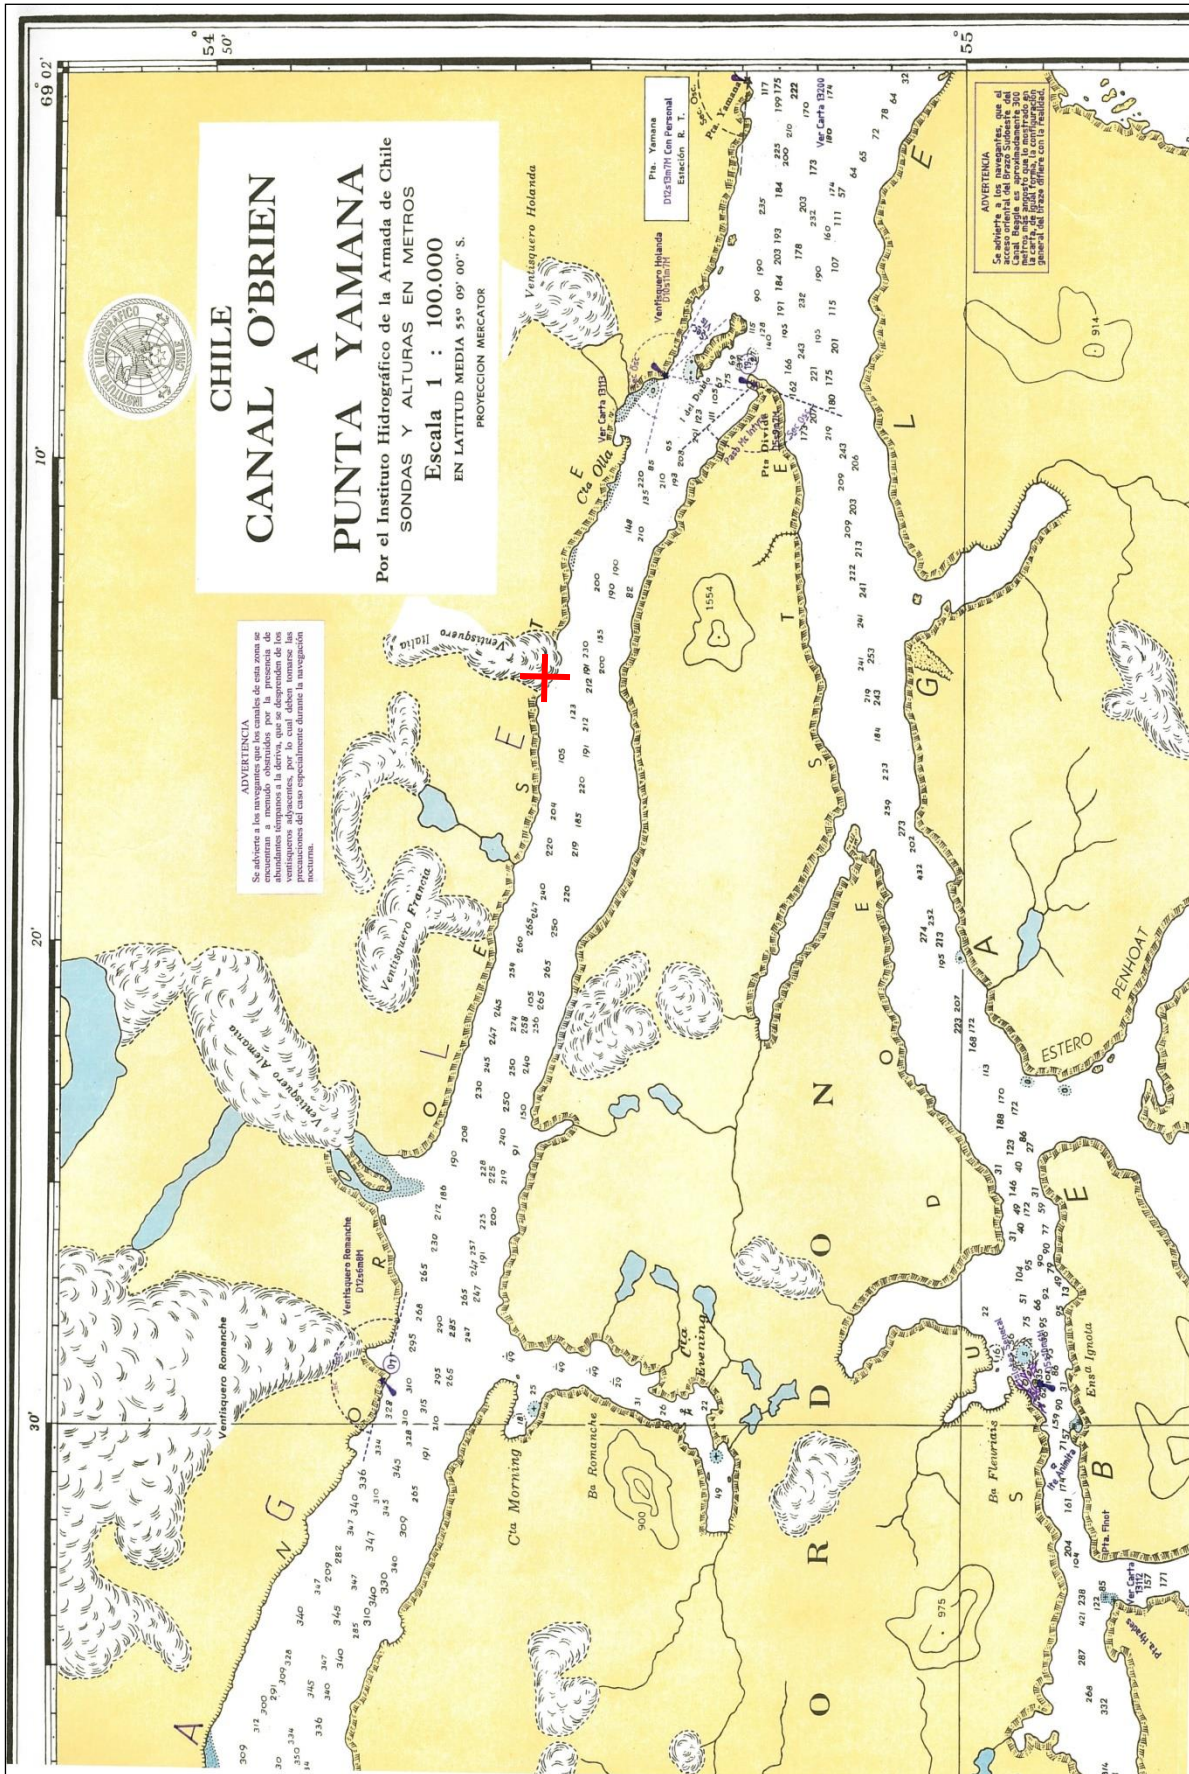
Figure 3: Chilean nautical chart

"From the perspective of the Chilean investigators, the SHOA 12700 nautical chart satisfies all the standards of the International Hydrographic Organization (IHO), is up to date, and was not the cause of the accident.

d) The chart contained two warnings in Spanish; these did not constitute the cause of the grounding incident. If these warnings were in English, they would have moved to a different channel than the one the DEUTSCHLAND sailed on and to other warnings in respect of floating ice.

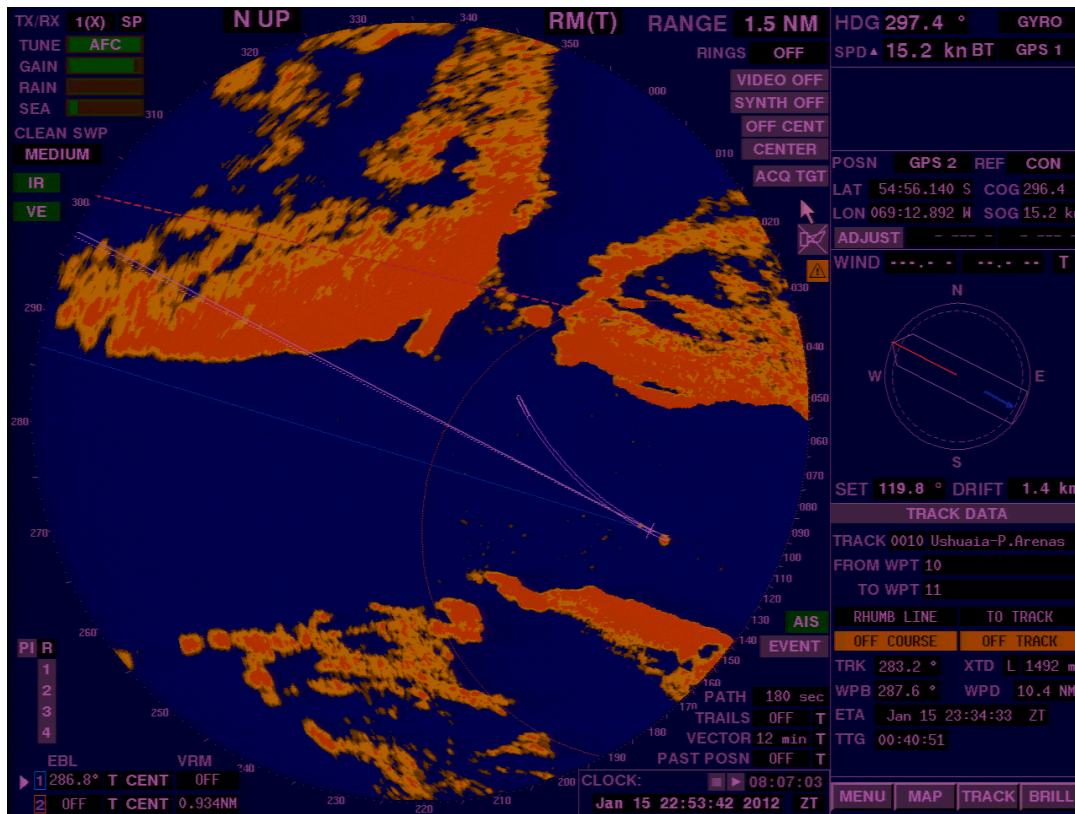
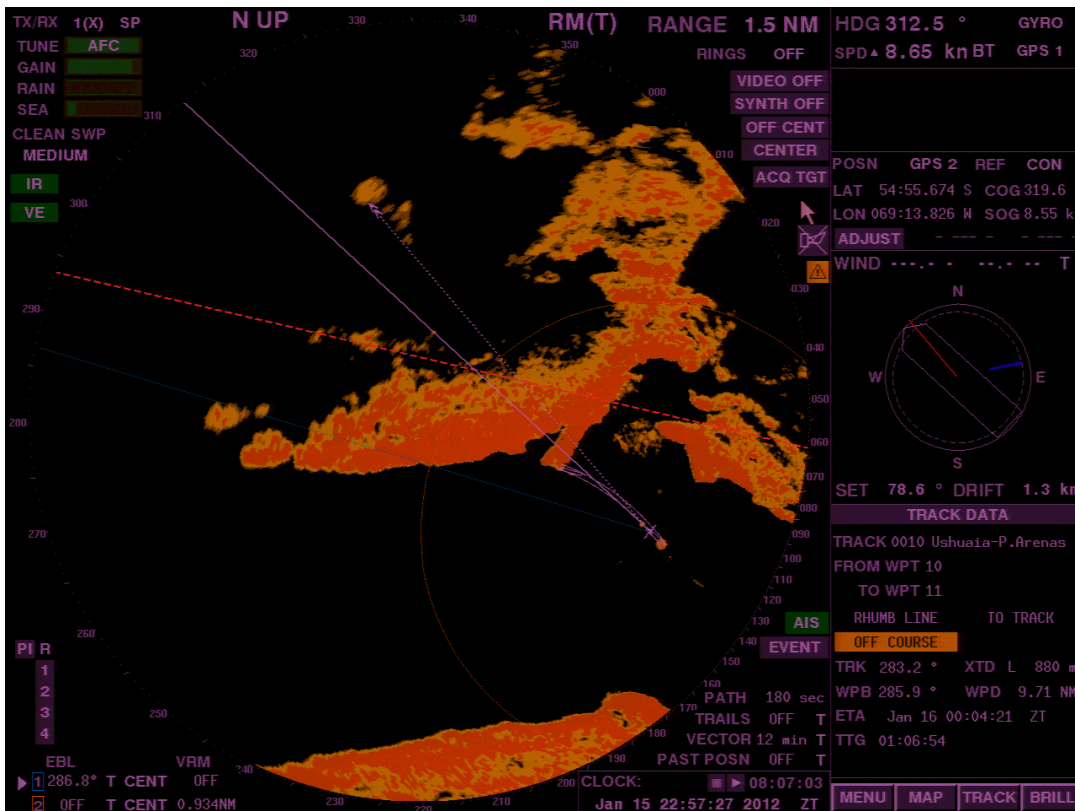
Figure 5: VDR recording of the radar image at 225342

A Rutter VDR-100 voyage data recorder (VDR) was on board. The data were backed up and made available to the BSU by the owner. Figure 4 shows the initial situation. At 225327, the DEUTSCHLAND is approaching the Italia Glacier at almost 16 kts. Her course over ground is 293°. The audio recording clarifies that the ship's command asks the pilot whether it would be possible to sail closer. The pilot confirms this immediately and reduces the speed. This can be seen in Figures 5 and 6 below.

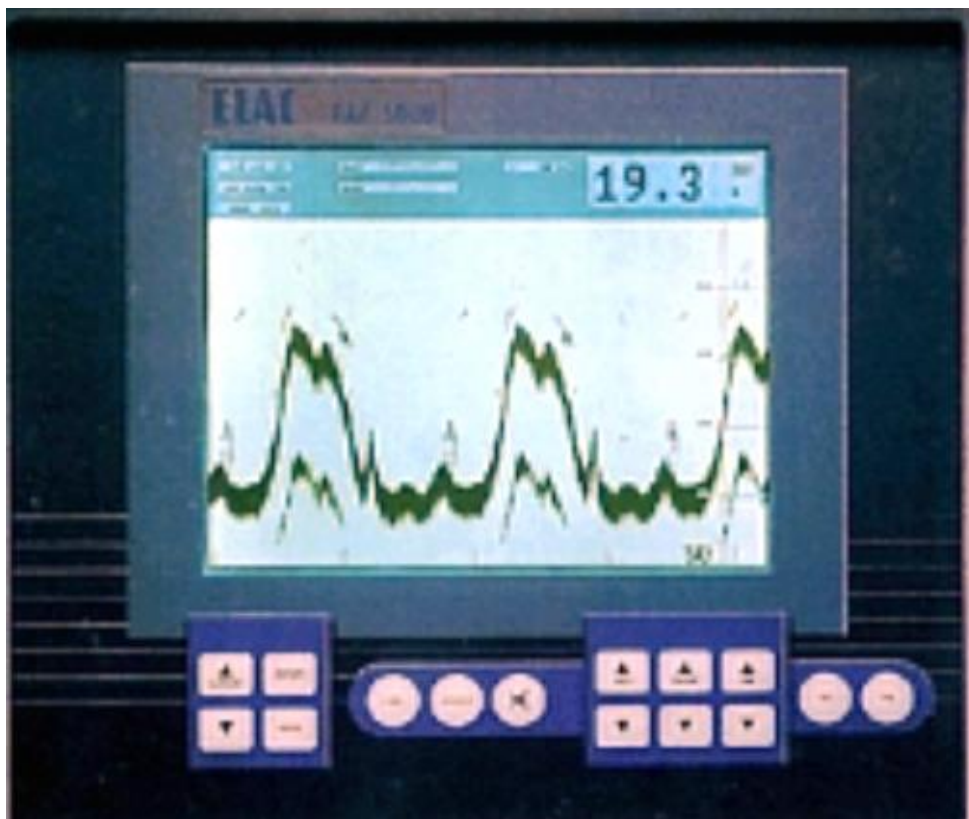
Figure 11: Example of echo sounder's display

An ELAC Laz 5000 echo sounder (made by L-3 ELAC Nautik GmbH) was on board; its data were saved to the VDR directly. It can be seen that this device continuously displayed depth values of more than 100 m beneath the keel, until they dropped to less than 100 m about one minute before the grounding incident occurred. The values then dropped rapidly to 5.7 m. Here, the ship's command stated that it observed the depth on the display to the left of the helmsman. Unlike the main unit in the chartroom, where tendencies are easier to recognise, only the current values are shown there. The audible alarm (so-called safety depth) in the echo sounder was reportedly set to 10 m so as to have at least 4 m of water beneath the keel at a maximum draught of 6 m.

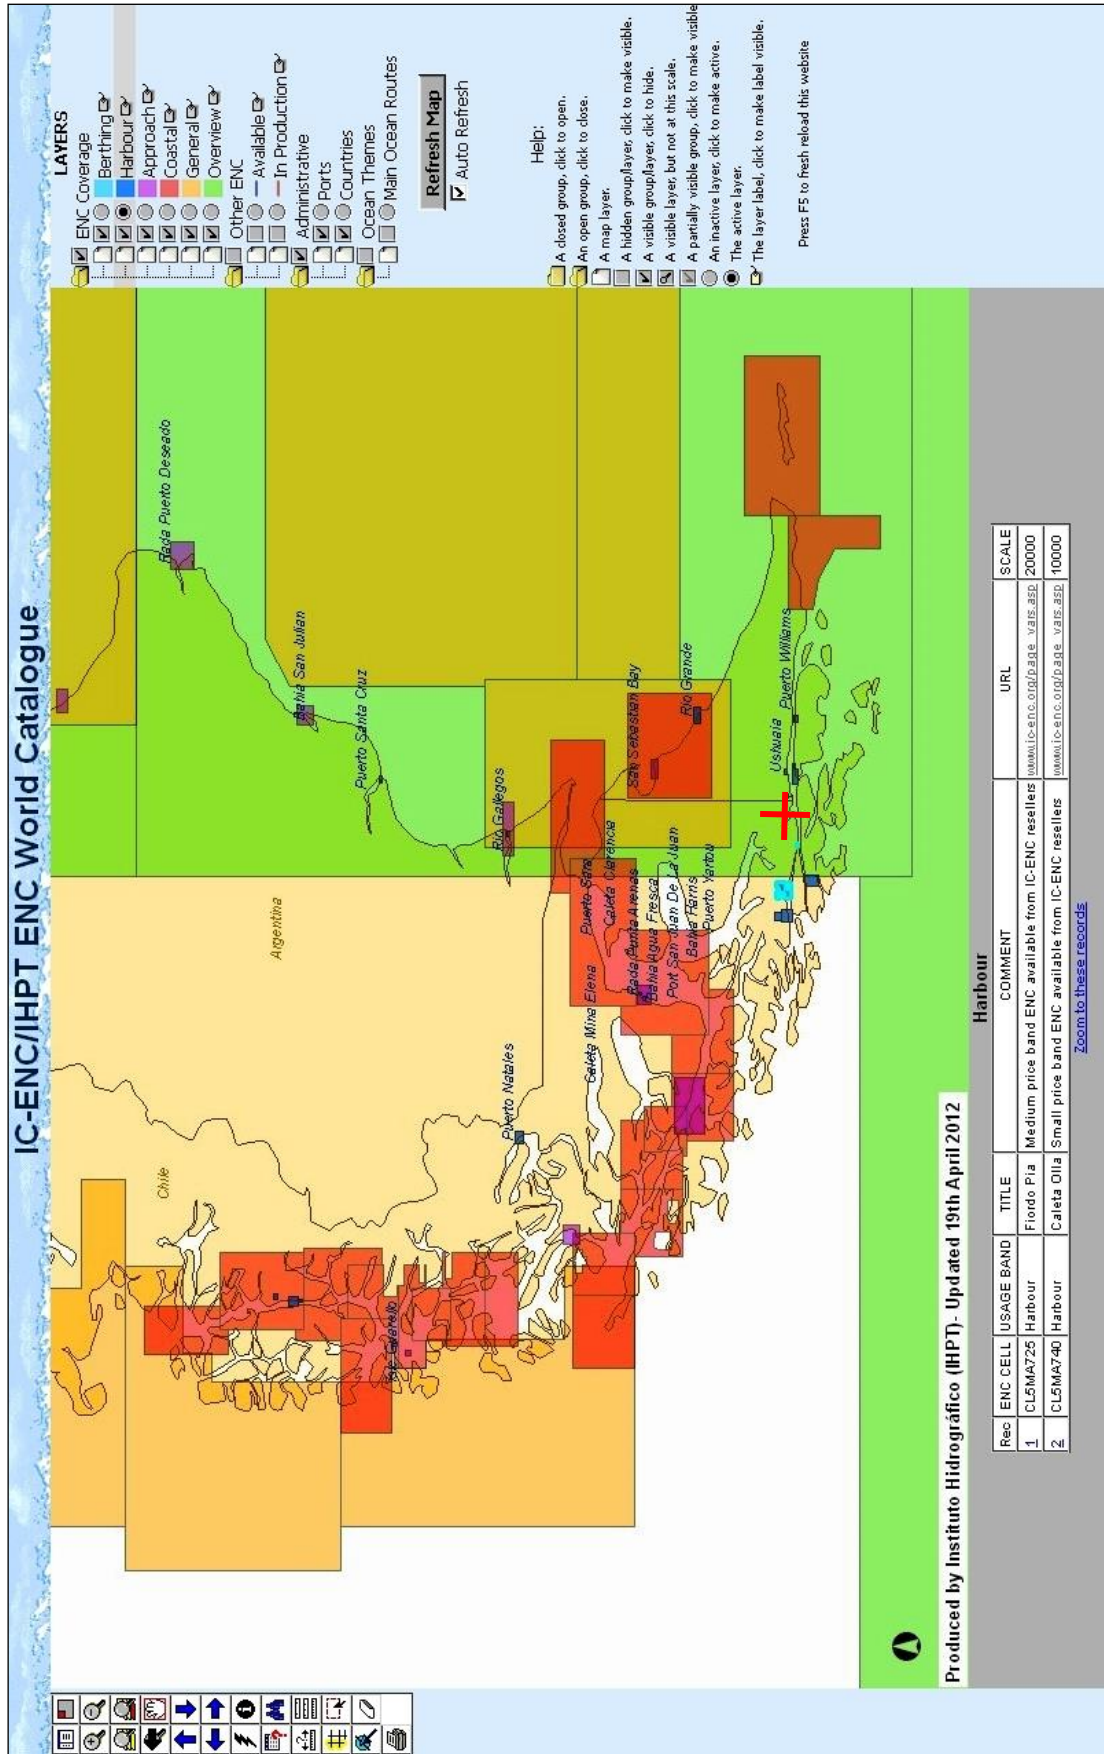
Figure 14: Display with existing ENC data for South America

The Hydrographic Institute of Portugal has been requested by the International Hydrographic Organization (IHO) to record the current state of this digitisation and publish it on its website⁷. It is evident from Figure 14 that only a rough outline chart exists for the accident area around the Italia Glacier.
