Bundesstelle für Seeunfalluntersuchung
Federal Bureau of Maritime Casualty Investigation
Federal Higher Authority subordinated to the Ministry of Transport
and Digital Infrastructure

Summary
Investigation Report 250/11

**Collision between the CMV CCNI RIMAC
and CMV CSAV PETORCA on 21 June 2011
in the area of the approach to the port of
Yangshan**

31 March 2014

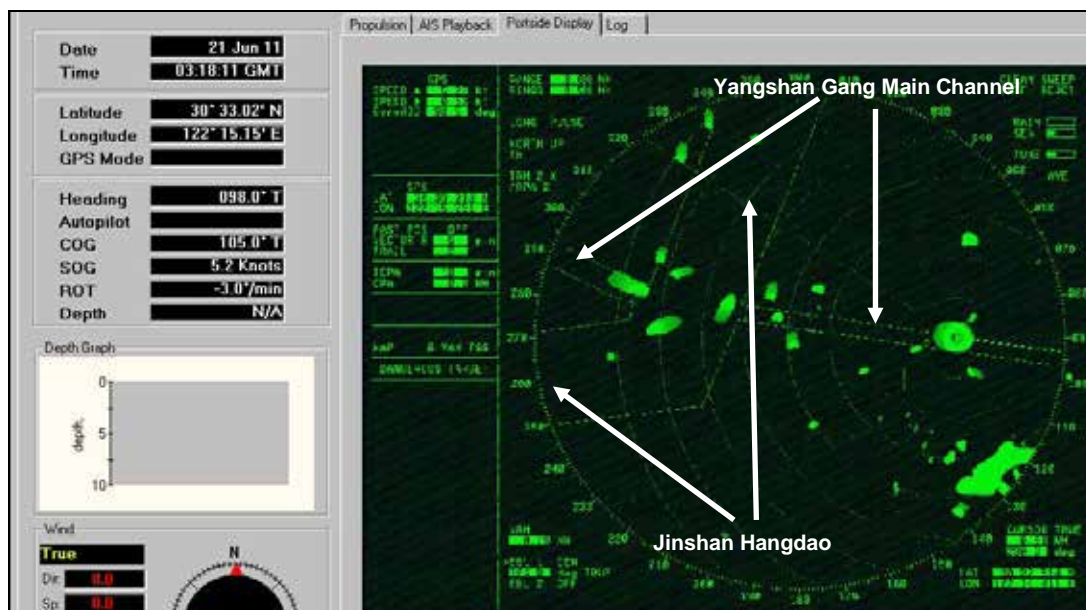
Figure 4: CCNI RIMAC – radar image at 1118¹⁴

The 2,524-TEU¹³ container ship CCNI RIMAC sailed out of the port of Yangshan, which is located about 18.5 nm west of the subsequent scene of the accident, under pilotage at **1018**. She then followed the course of the buoyed Yangshan Gang Main Channel fairway, which has an average width of only about 0.3 nm, on a south-easterly and later easterly heading. At **1118**, the pilot left the ship about 2.5 nautical miles east of where the fairway referred to and the Jinshan Hangdao fairway, which runs crossways, intersect (see **Fig. 4**).

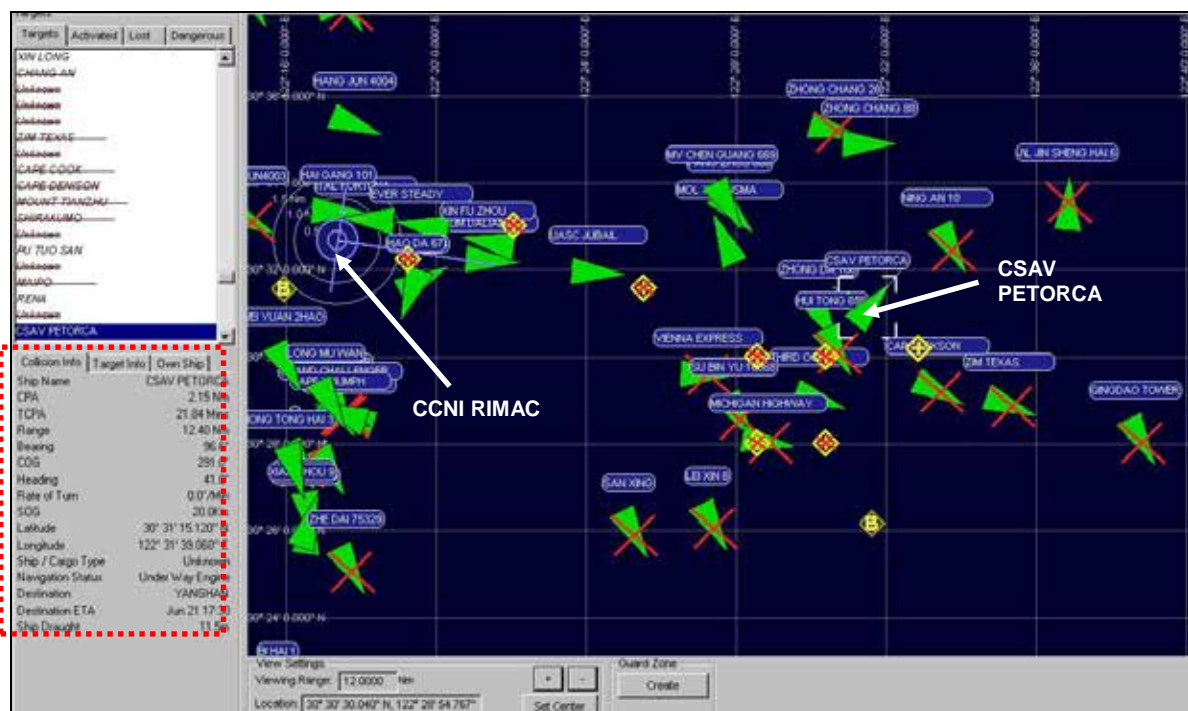
Figure 5: Volume of traffic in the area of the accident (AIS signals at 112959)¹⁹

Figure 5 below is indicative of the significant traffic density in the area of the accident at **1130**.¹⁸

According to the AIS²⁰ target information (see area marked red in **Fig. 5**), the distance between the two vessels subsequently involved in the collision was 12.4 nm at this point. CPA and TCPA have the non-critical values 2.15 nm and 21.84 minutes.

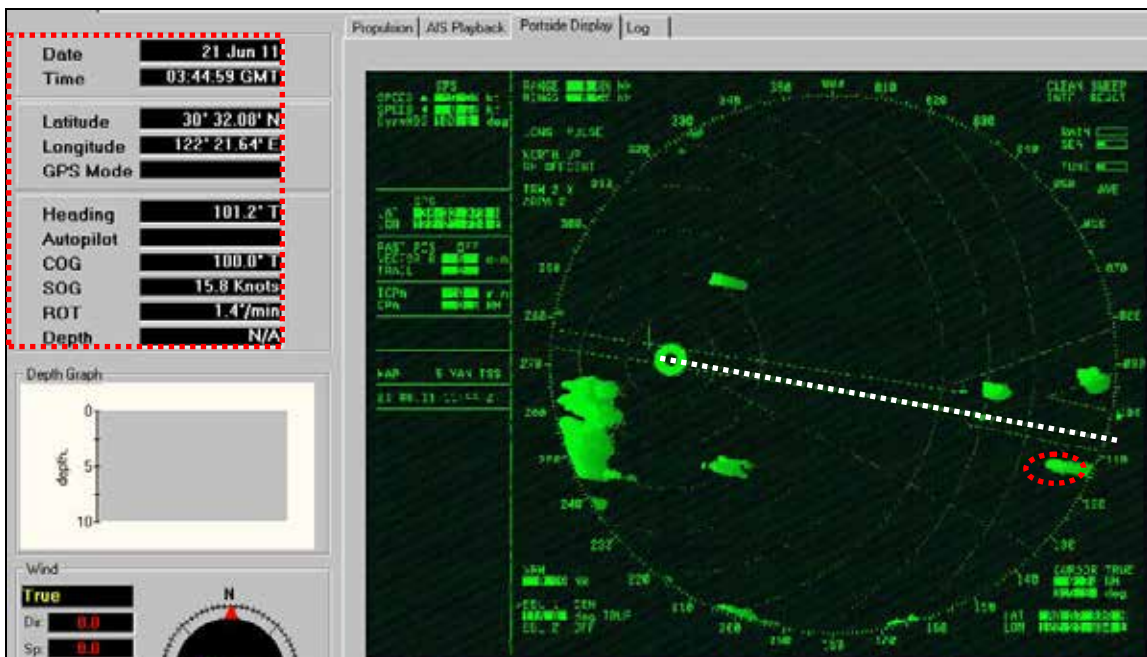
Figure 18: Starboard radar on the CCNI RIMAC at 114459 (S-VDR replay)³²

Figure 18 below is indicative of the traffic situation from the angle of the RIMAC's port radar unit at **1145**. At this point, the radar unit was operated at a range of 3 nm in the display mode north up, relative motion. The display was off-centre, meaning the actual sector that could be observed was about 5 nm ahead. Range markers ('RINGS') are displayed around the container ship's own position at intervals of 0.5 nm. Furthermore, a variable range marker surrounded the vessel's own position at a distance of 0.19 nm and a (manually variable) EBL²⁸ was set towards 118.8 degrees. The adjustments made by the ship's command to the monitor facilitated excellent observation of the traffic situation by radar.

Accordingly, the PETORCA's echo on the starboard side of the RIMAC's lubber line (heading line) at a distance of about 4.5 nm is clearly identifiable (see the PETORCA's echo marked red in **Fig. 18**). With the exception of the range, the above settings were not changed later.

The main GPS-based speed parameters of the RIMAC and the course steered (heading), as determined by the gyrocompass, are displayed by the S-VDR replay next to the radar image in the data window at the top left. According to that, the heading was 101 degrees, the COG²⁹ 100 degrees, and the SOG³⁰ 15.8 knots at the time in question.³¹

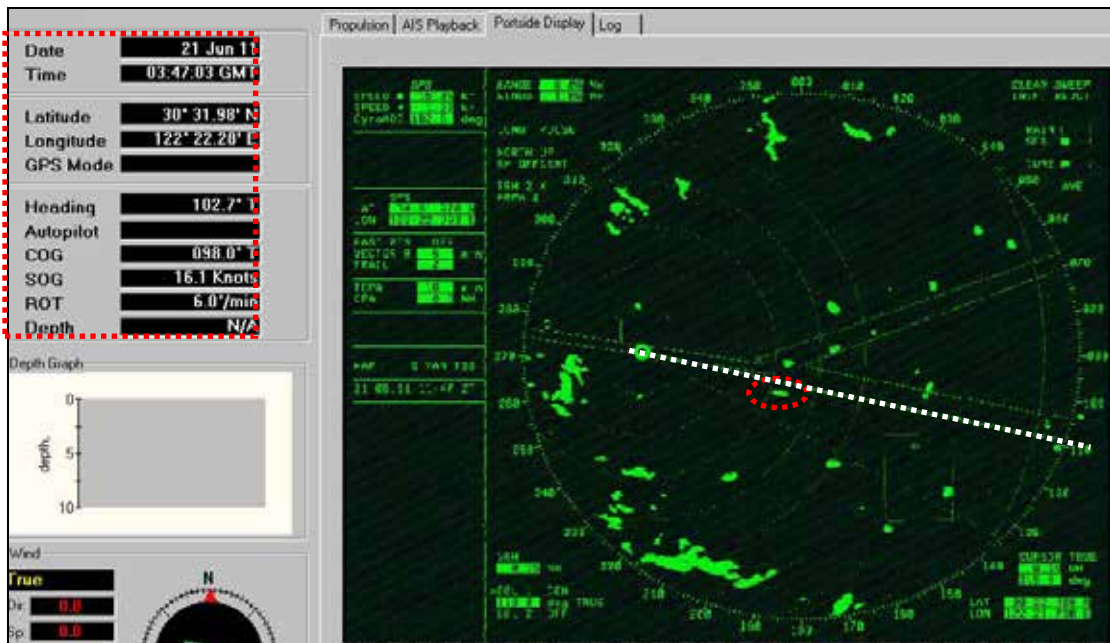
Figure 19: Starboard radar on the CCNI RIMAC at 114703 (S-VDR replay)

The range of the radar unit was increased to 6 nm a few seconds before **Figure 19** below. The distance between the range markers changed accordingly by 0.5 nm to 1.0 nm. In the area ahead, echoes now appear up to a distance of about 9.5 nm because of the (still) off-centred setting.

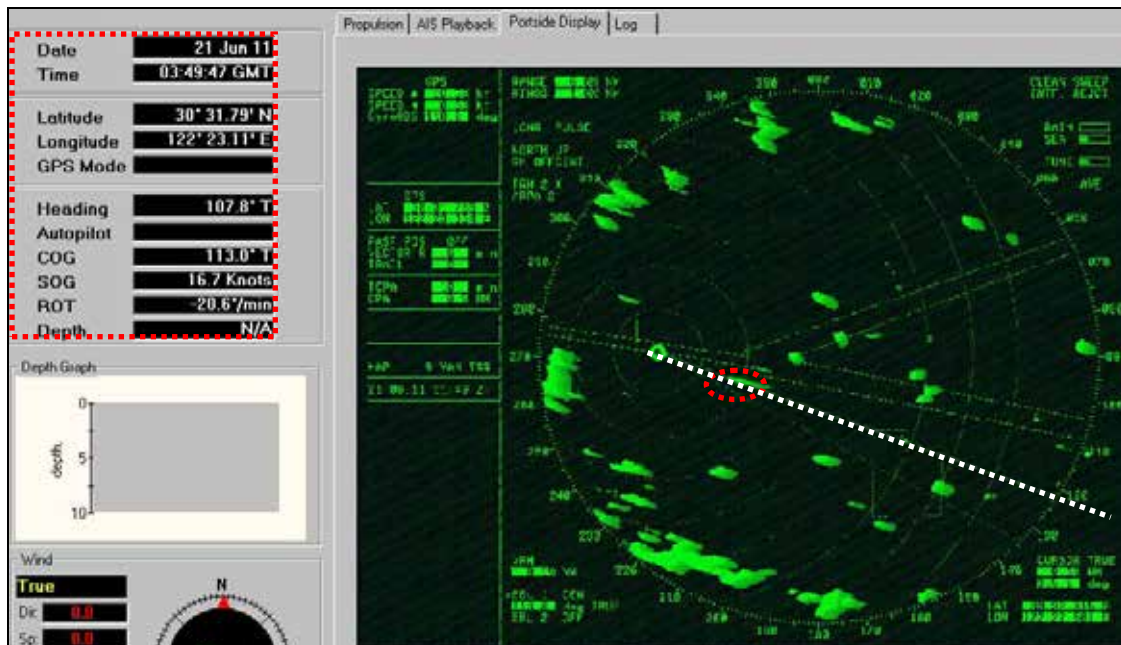
Figure 20: Starboard radar on the CCNI RIMAC at 114947 (S-VDR replay)

The RIMAC altered her course slightly to starboard during the next three minutes (see **Fig. 20** below). With regard to the PETORCA, alterations to the course of the voyage are still not visible – as far as possible on the radar image.

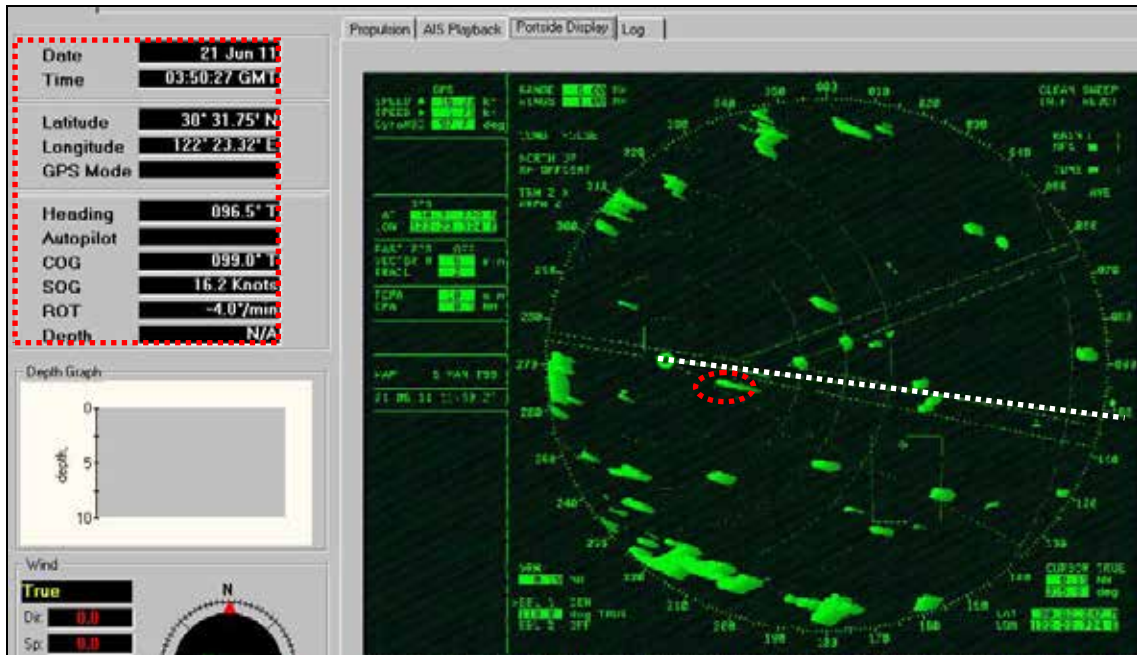
Figure 21: Starboard radar on the CCNI RIMAC at 115027 (S-VDR replay)

The VDR replay display at **115027** (see **Fig. 21** below) shows that the RIMAC has now turned back to port within the range of her original course. The distance to the PETORCA, whose speed parameters are – as far as visible – still the same, is 1.7 nm at this point.

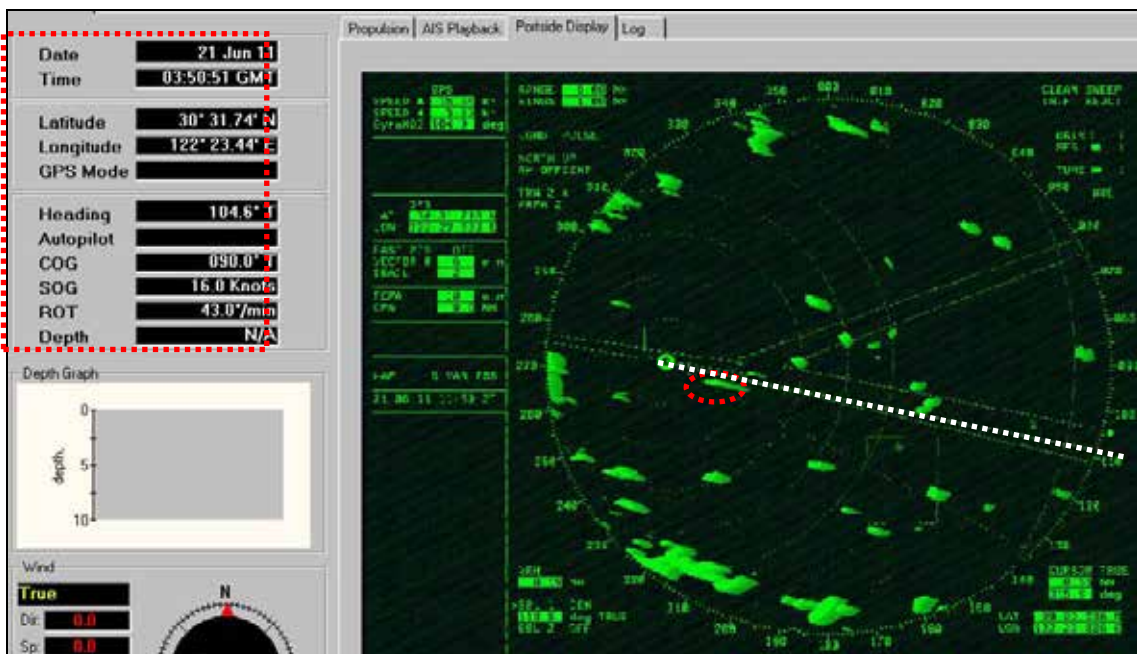
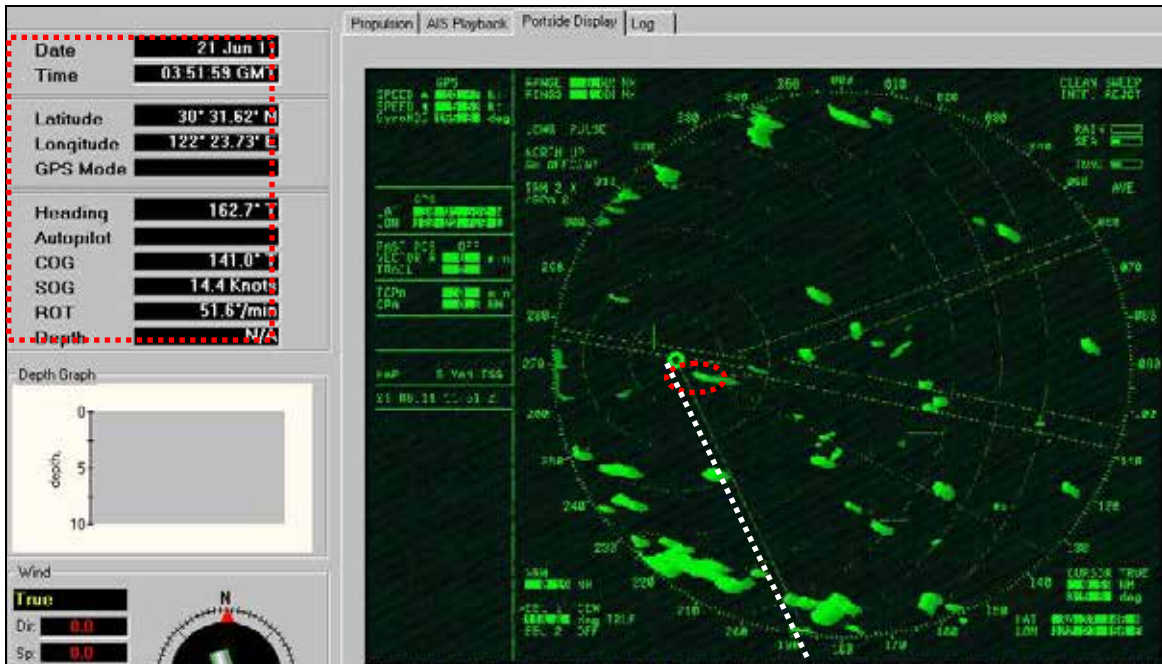
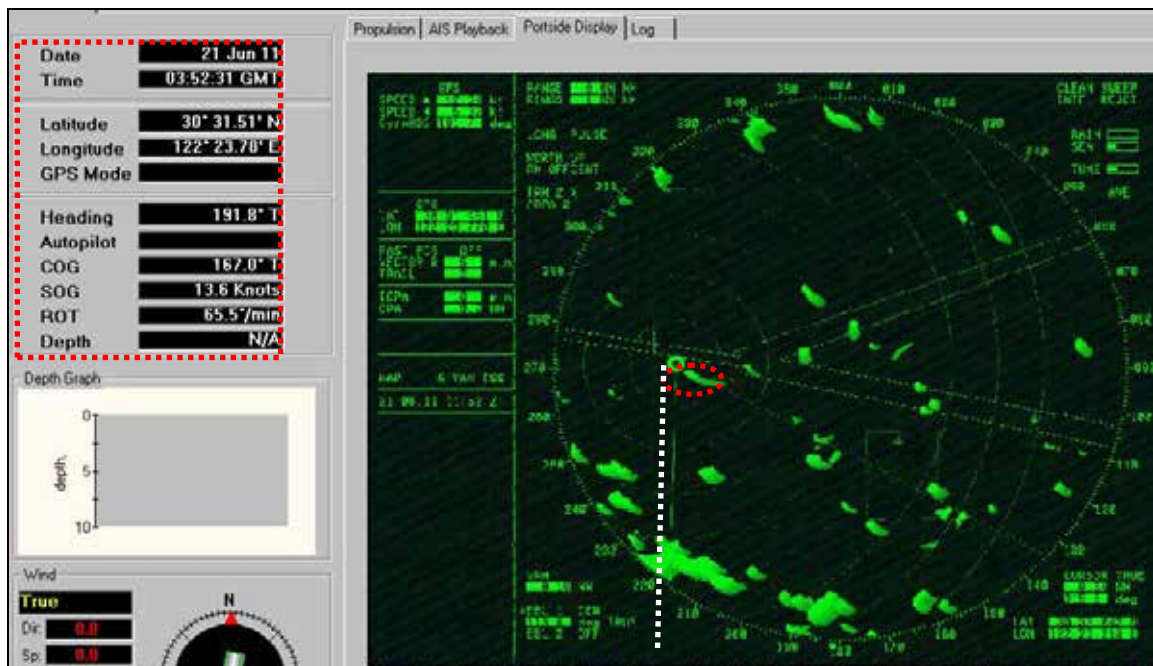
As can be clearly seen from **Figures 22 ff.**, the RIMAC started a continuous and rigorous course alteration to starboard at immediately after **115027**. The distance between the two vessels was about 1.3 nm.

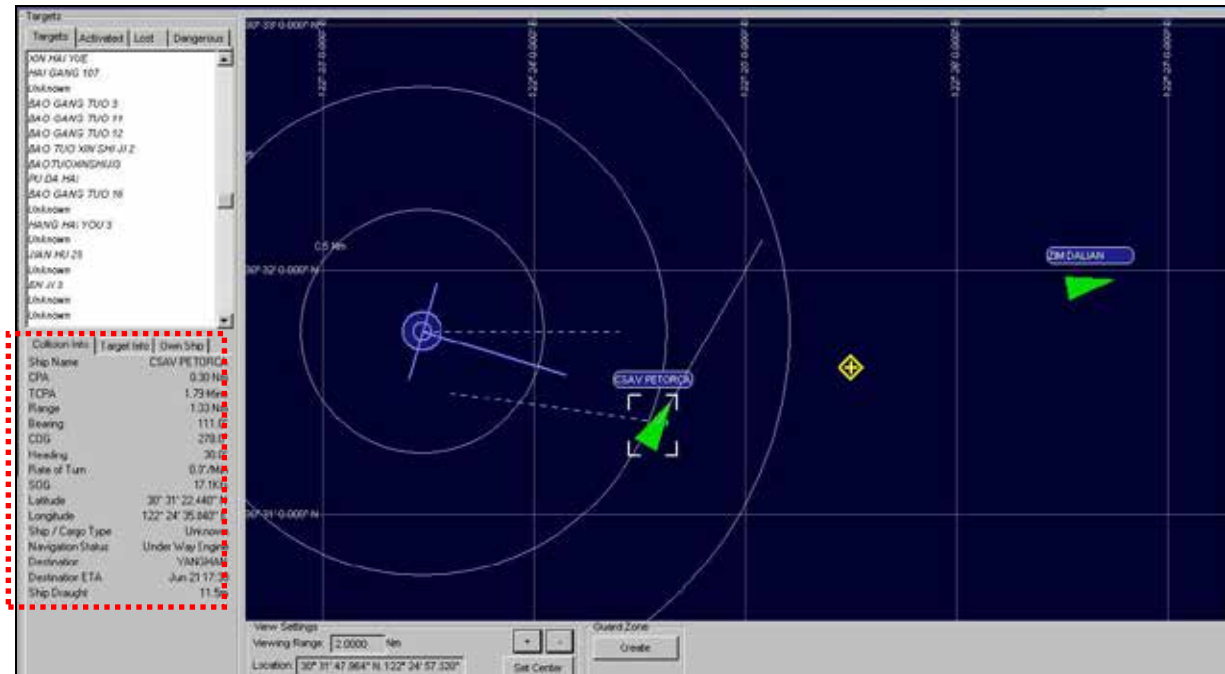
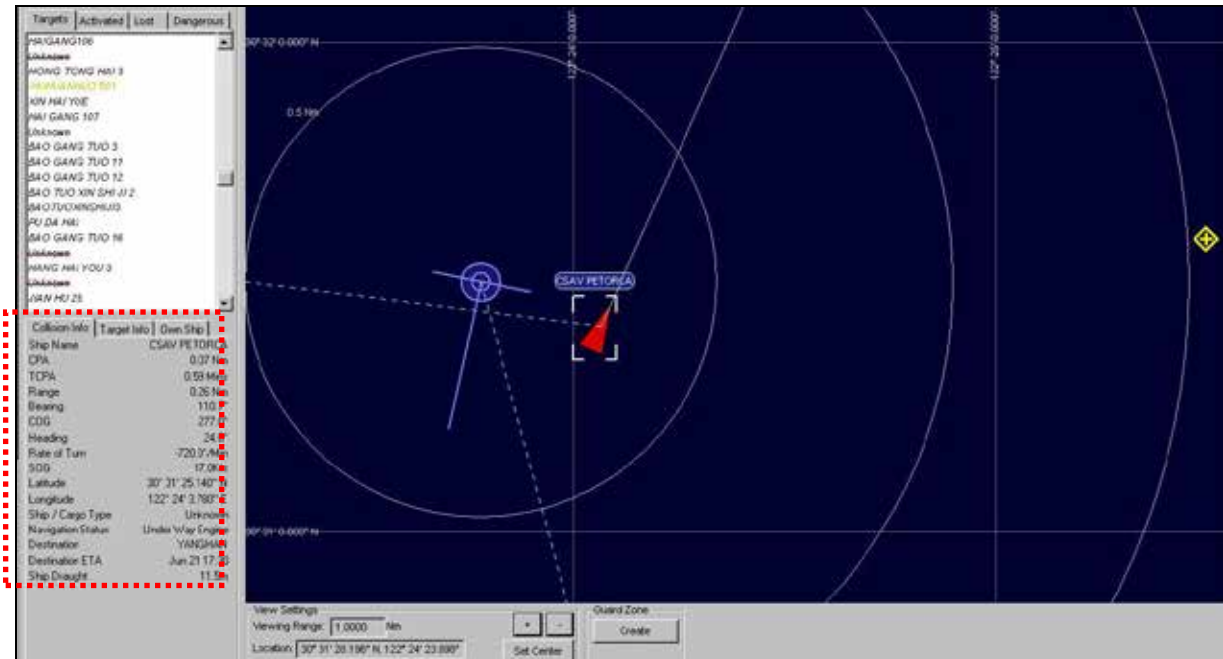
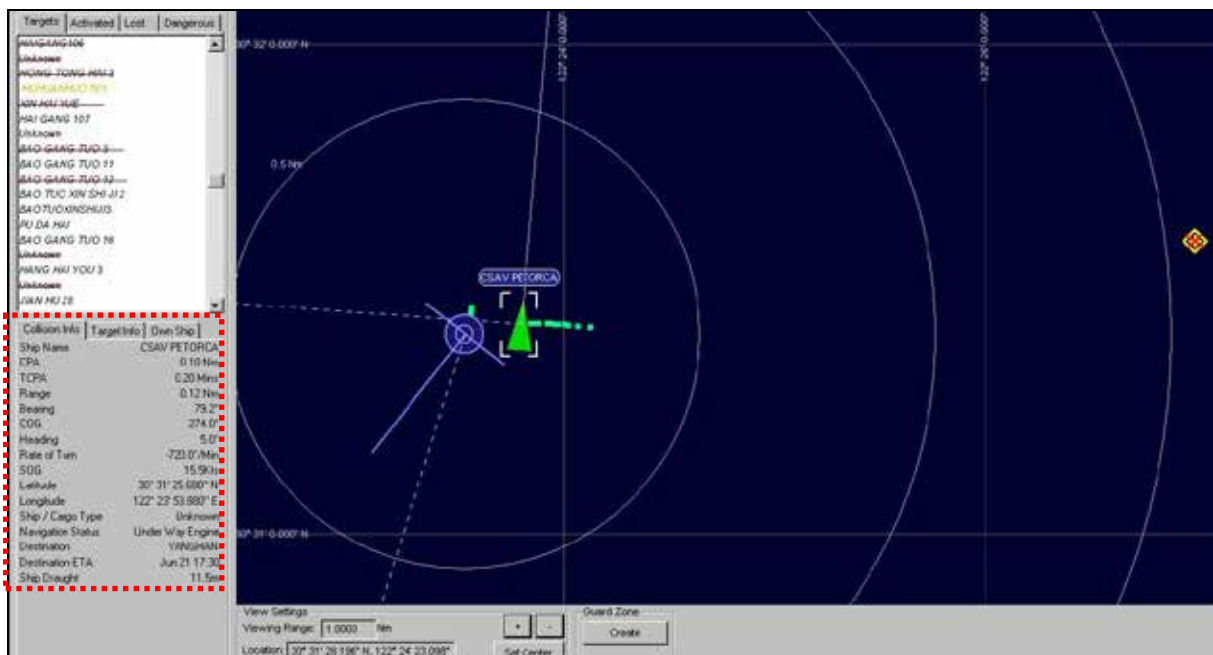
Figures 30 ff. below vividly demonstrate the consequences of the manoeuvre supposedly agreed on as a result of the radio contact between the two ships, which

finished at about **115027**. While the heading (solid heading line) and gradually³⁷ also the COG of the RIMAC continuously and rigorously change to starboard, only a slight course alteration to port can be seen in respect of the PETORCA's COG.

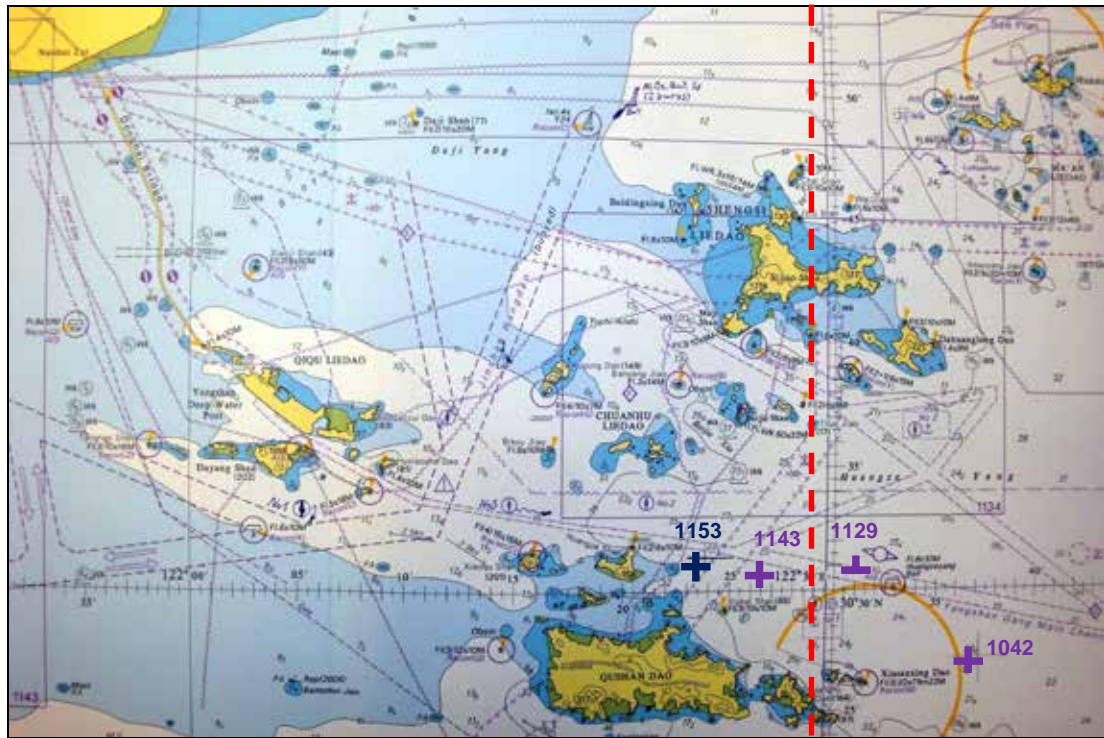
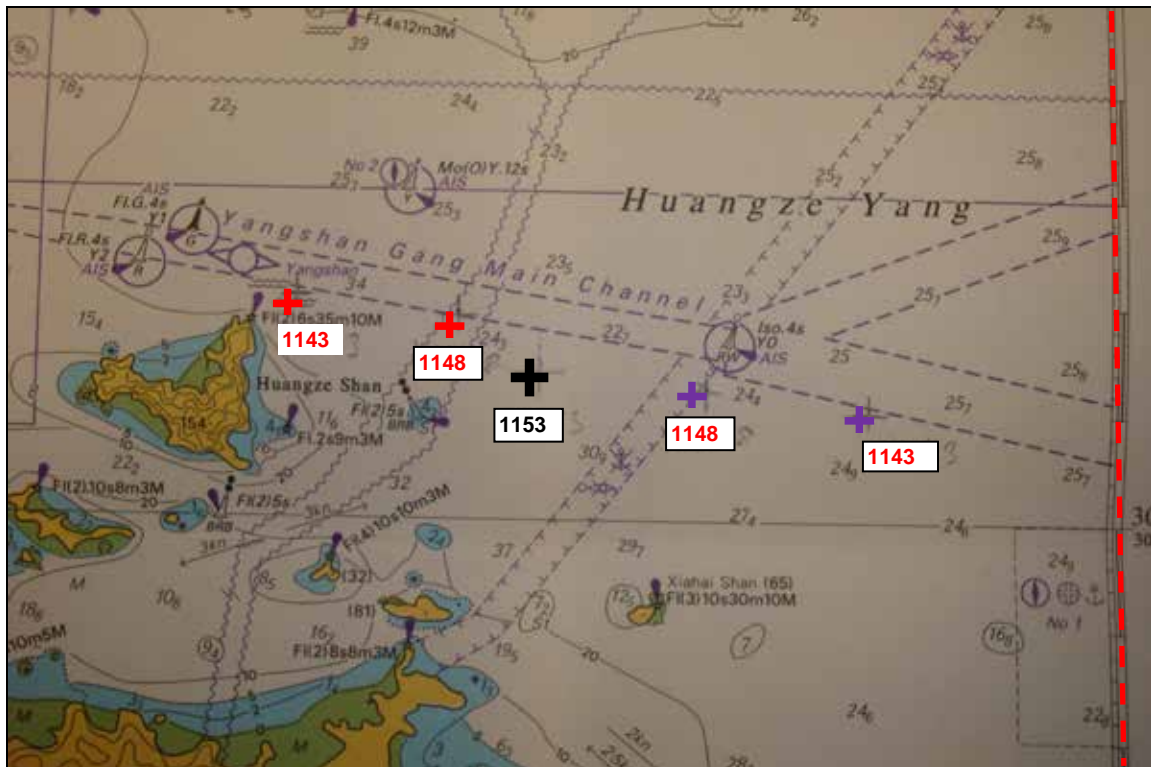
The British paper chart BA 1199 (NINGBO GANG TO CHANGJIANG KOU) at a scale of 1:300000 followed by the (partially overlapping) chart BA 1124 (NORTHERN APPROACHES TO NINGBO GANG INCLUDING YANGSHAN DEEP WATER PORT) at a scale of 1:130000 are available for the eastern approach to the port of Yangshan (see excerpts at **Figs. 34 and 35** below).

Neither of these nautical charts have the scale recommended for an approach to a port (1:30000 to 1:75000).⁴¹ The transition to the at least somewhat better resolution of Chart BA 1124 is located in the middle of the Yangshan Gang Main Channel (see red marking in **Fig. 34 f.**), meaning the scale of the only chart available for use on the eastern part of the fairway was 1:300000.⁴²
