**Bundesstelle für Seeunfalluntersuchung**  
**Federal Bureau of Maritime Casualty Investigation**  
Federal Higher Authority subordinated to the Ministry of Transport  
and Digital Infrastructure

Investigation Report 255/12

**Very Serious Marine Casualty**

**Fire and explosion on board the  
MSC FLAMINIA on 14 July 2012  
in the Atlantic and the ensuing  
events**

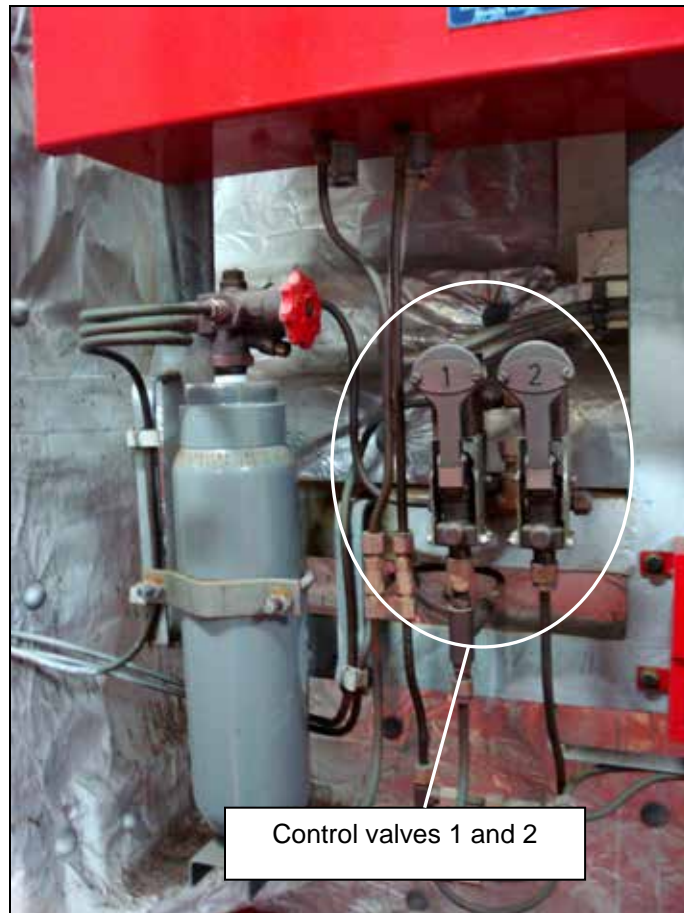
Figure 11: MSC ALESSIA – control valves 1 and 2 in the normal position (closed)

The fact that both valves seemed to have been activated manually, was initially interpreted by the investigators to that effect that it was an operating error of the crew. It was assumed, that the actuation of the pilot valves led to the activation of the electrical connections connected with them which in return triggered the alarm and shut down the ventilators. In contrast the vessel's operator advised the BSU in its statement supplied in December 2013 of the fact that an inspection of the releasing station in June 2013, carried out by the vessel's operator and Noske-Kaeser, revealed that an incorrect installation of pipes was the cause for the malfunction of the releasing station. Representatives of Noske-Kaeser confirmed this on inquiry of the BSU. Additionally it was made clear that in all likelihood the error already existed since the installation of the system. However, the error should have been detected with a proper acceptance of work. The error should also have been detected during regular inspections of the system.

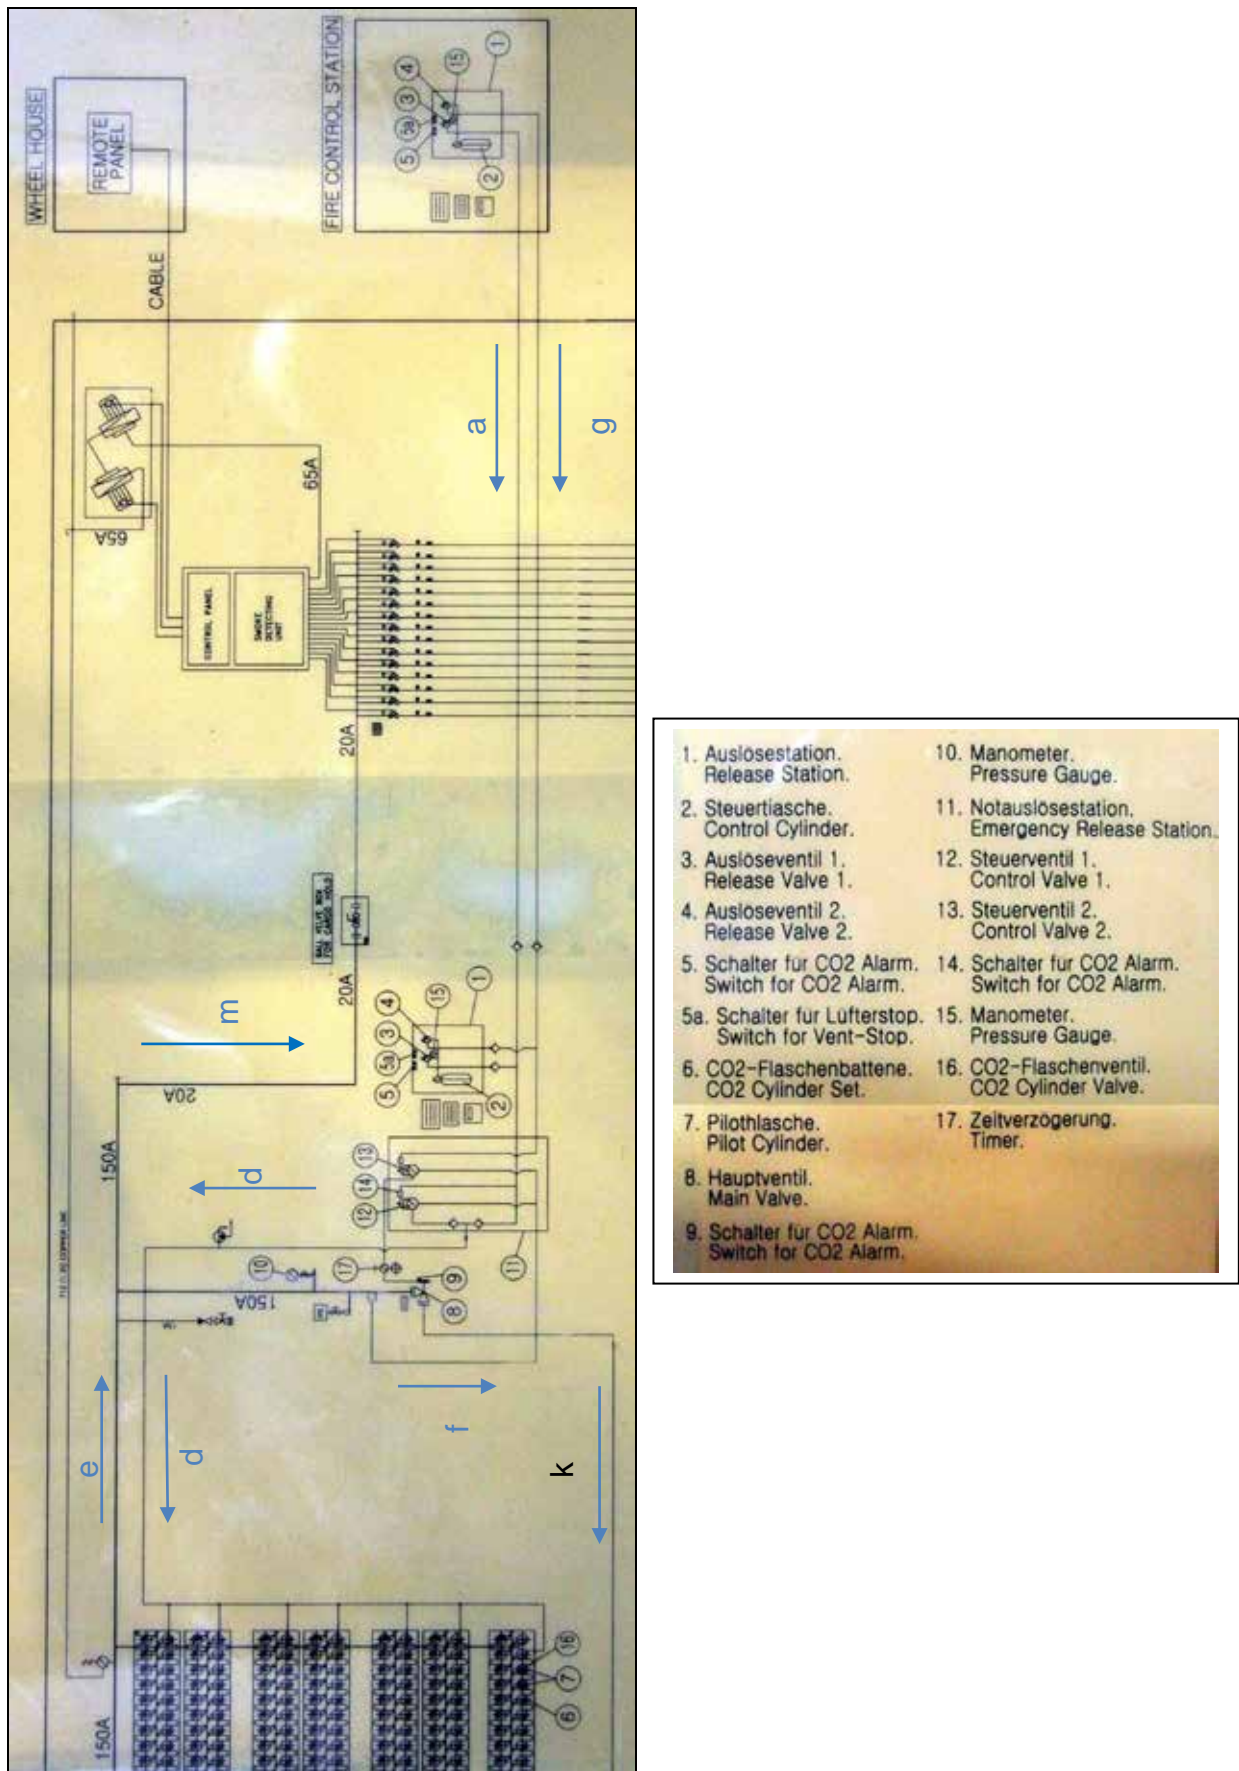
Figure 12: Detail of the CO<sub>2</sub> fire extinguishing system plan and the parts of the CO<sub>2</sub> system

In order to explain the erroneous release of the control valves 1 and 2, the normal CO<sub>2</sub> release process for the engine room is hereafter described. This is necessary in this respect since the incorrect assembly of the station, which is actually only indirectly affected when releasing the CO<sub>2</sub> for the cargo holds, was now directly involved.

After the filling of the timer cylinder, which requires at least 30 seconds, the pressure is transmitted through [i]. The main valve (8) then opens automatically. The CO<sub>2</sub> gas provided for extinguishing can then flood the engine room via [k].

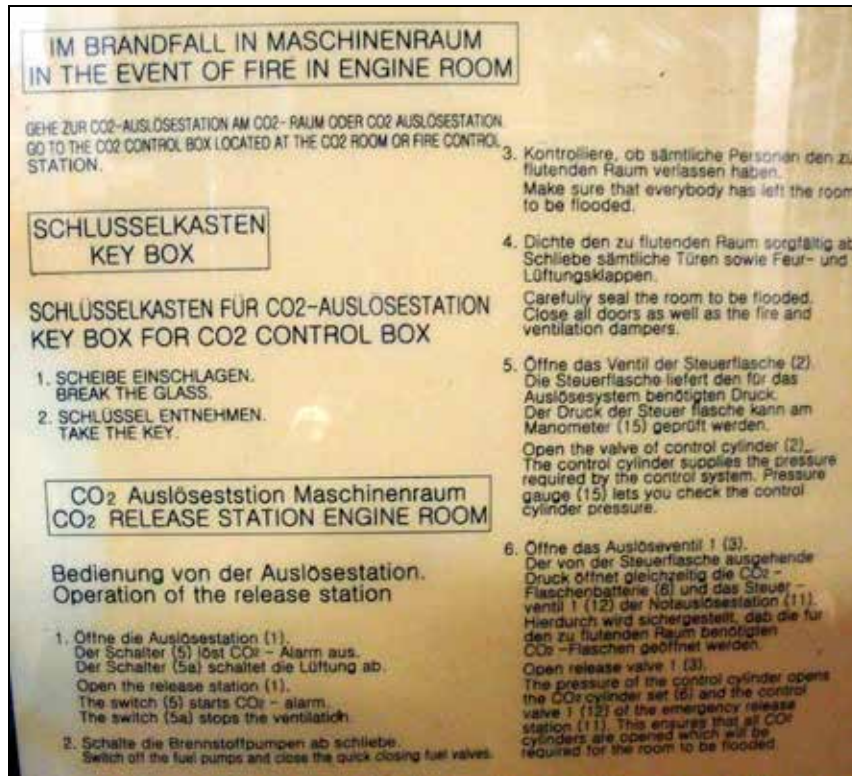
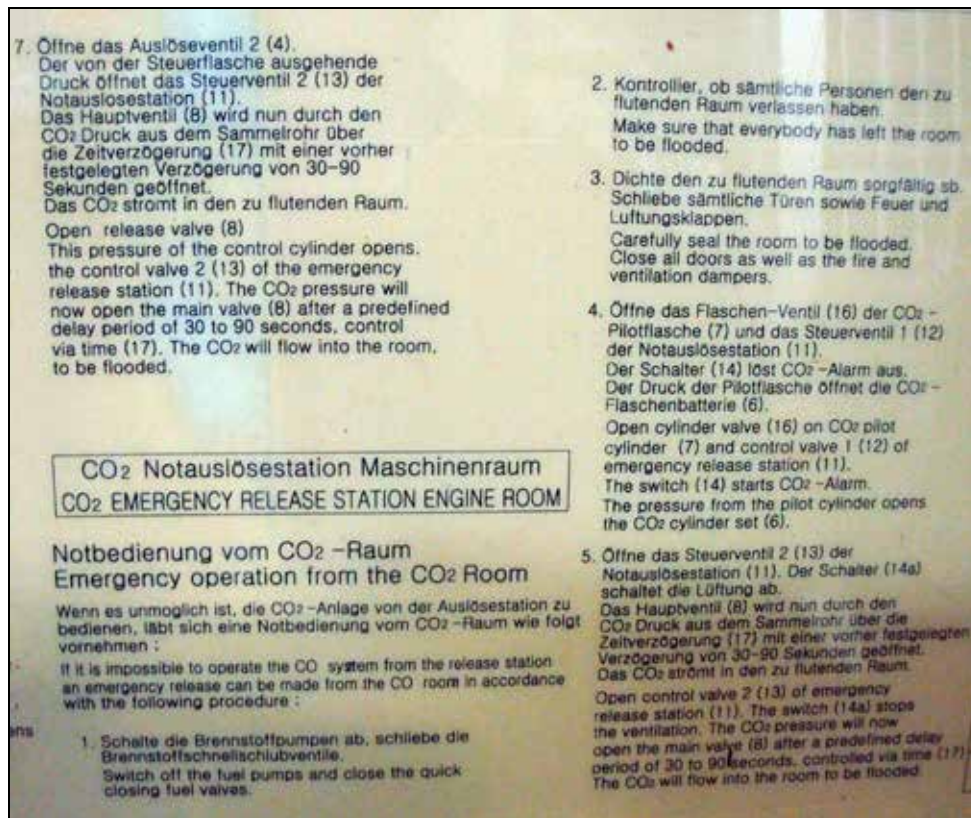
Figure 15: Description for releasing CO<sub>2</sub> for the engine room

Figure 16: Description for releasing CO<sub>2</sub> for the engine room and emergency release (continued)

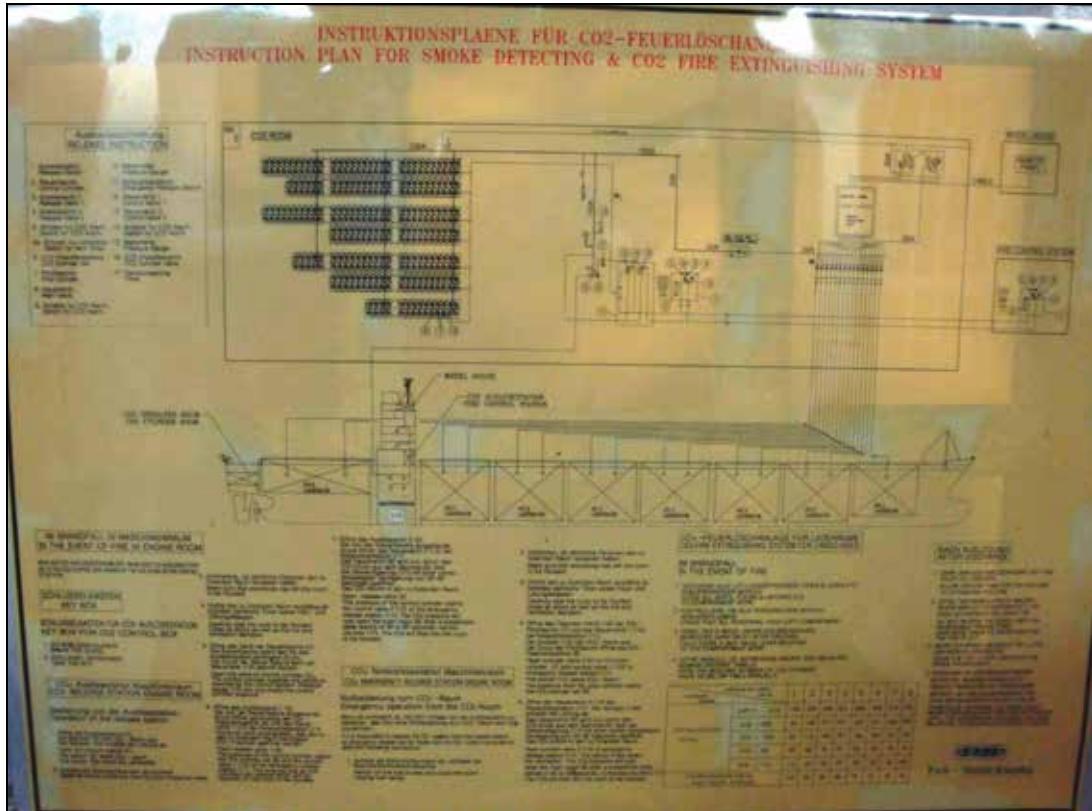
Figure 17: Schema and functioning of the CO<sub>2</sub> fire-extinguishing system

The procedure for discharging CO<sub>2</sub> into the cargo holds was also described in German and English on two other boards. These were located on the release station (alarm secured box with ball valve – Figures 18, 19 and 20) and on the sample extraction smoke detection system's switch cabinet (see Figure 8). The description on the schema was the same as the description on the switch cabinet and indicates the following procedure:

Working through the steps in this sequence would have been unsuccessful because they did not include opening the ball valve, meaning no gas would have flowed between the cylinders and three-way valve. However, the description on the ball valve box (Figure 18) was correct, but incomplete in that it referred to the other plan for the next steps, i.e. opening the CO<sub>2</sub> cylinders.

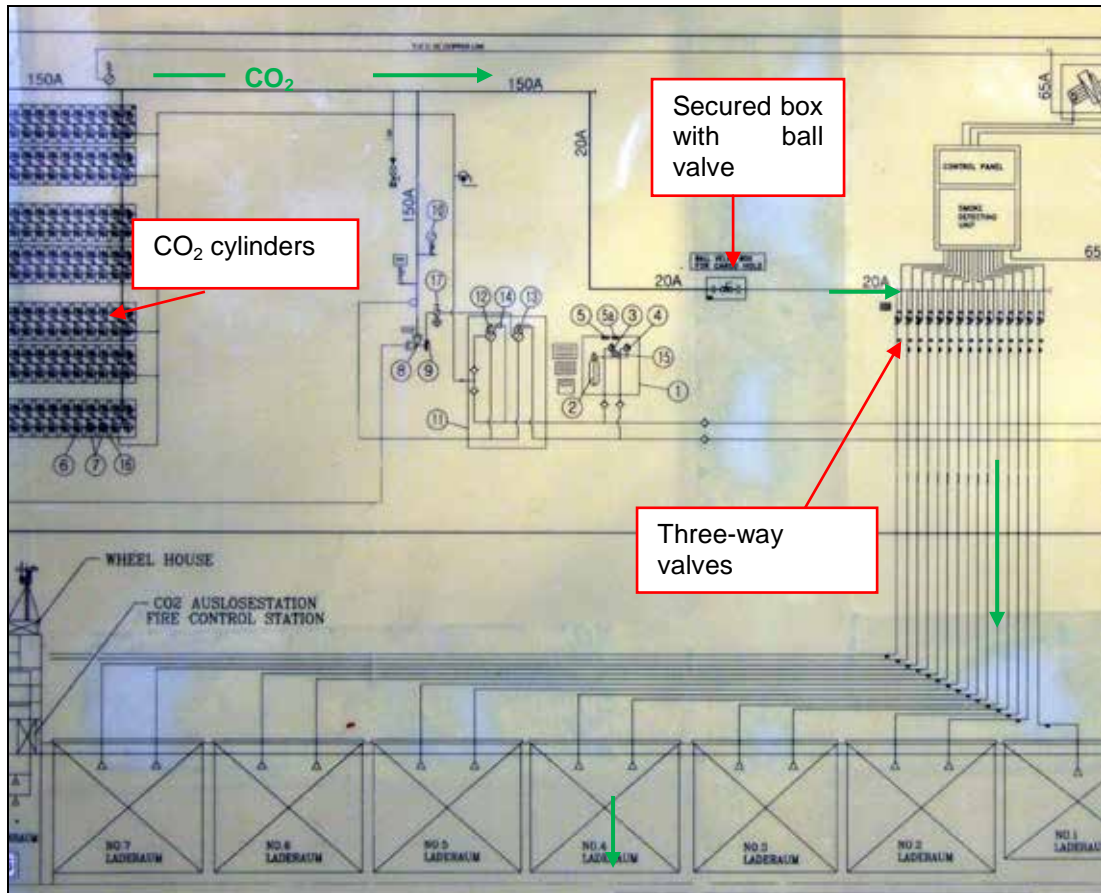
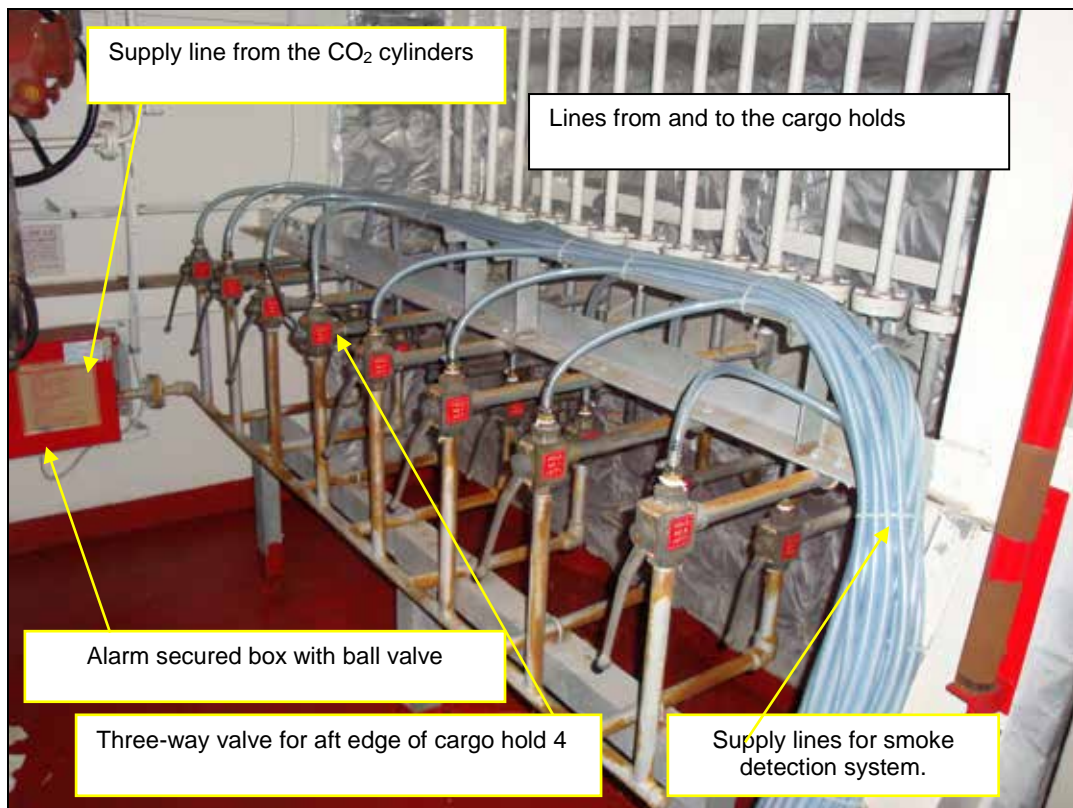
It should also be noted that the instructions in the CO<sub>2</sub> room described the procedure for the three-way valve as follows: "Fully down 3-way valve lever relating to the compartment fire." In fact, the lever on the MSC FLAMINIA had to be pulled upward. This also corresponded with the label on the valve itself (Figure 21).

Figure 19: Excerpt from the schema – CO<sub>2</sub> for the cargo holds

Figure 20: Part of the CO<sub>2</sub> release station for the cargo holds

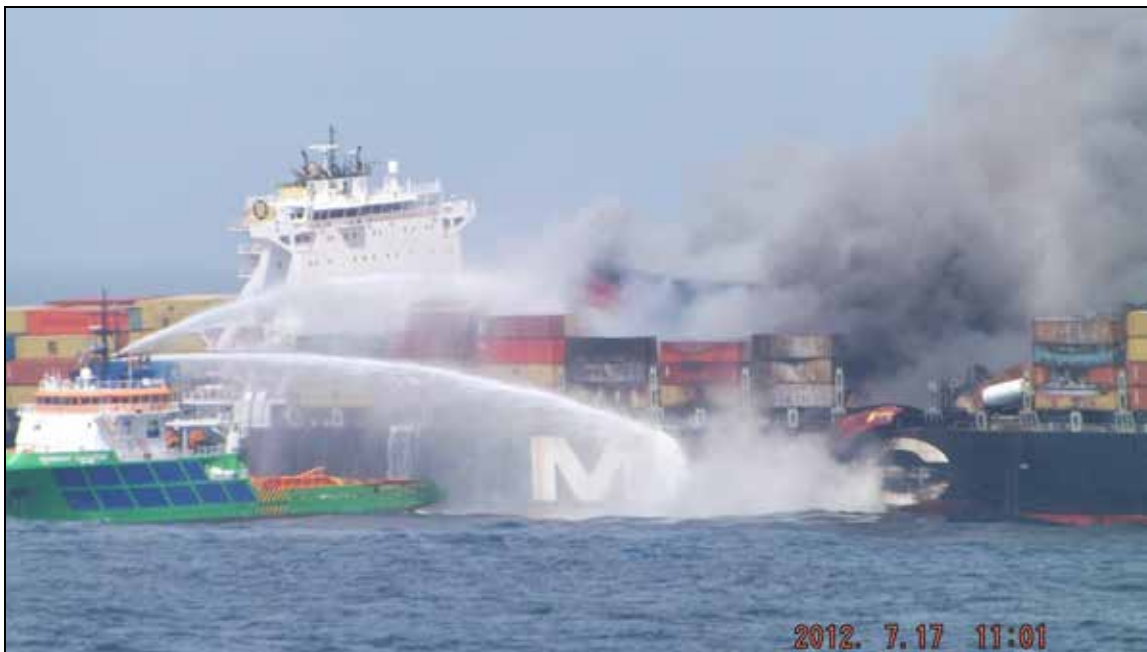
Figure 24: FAIRMOUNT EXPEDITION at the MSC FLAMINIA

After the FAIRMOUNT EXPEDITION reached the MSC FLAMINIA on 17 July 2012, she immediately began extinguishing and cooling. The photographs (Figures 24 and 25) taken from on board the HANJIN OTTAWA show the condition of the ship about 72 hours after the explosion.

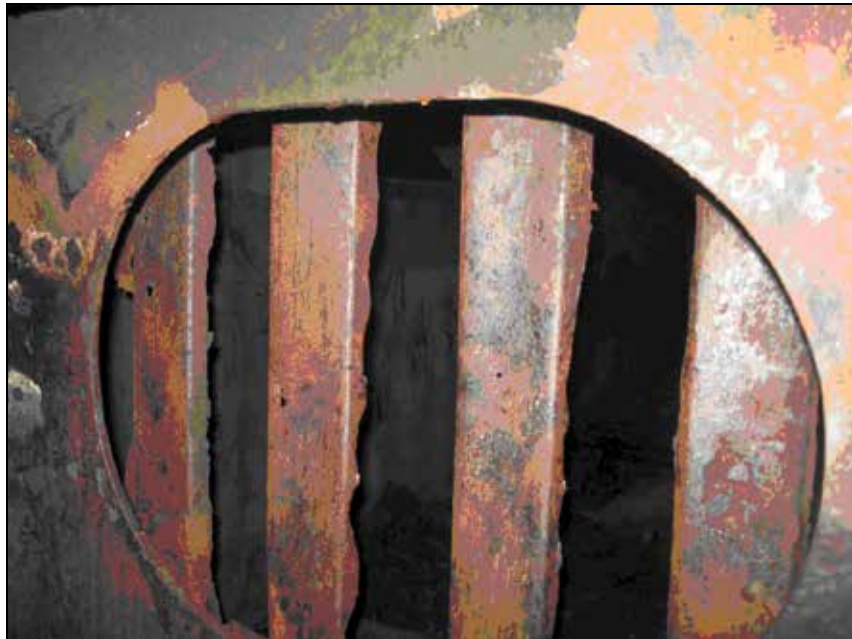
- moved forward on and below deck to detect and extinguish single pockets of fire. This involved the use of advanced fire-fighting equipment like a high pressure extinguishing and cutting system. Amongst other things, these were used to cut openings into containers to improve the ventilation and individual extinguishing of containers (Figures 26 and 27). In turn, this facilitated the creation of blocking positions.

Figure 26: Ventilation opening in a container in cargo hold 3

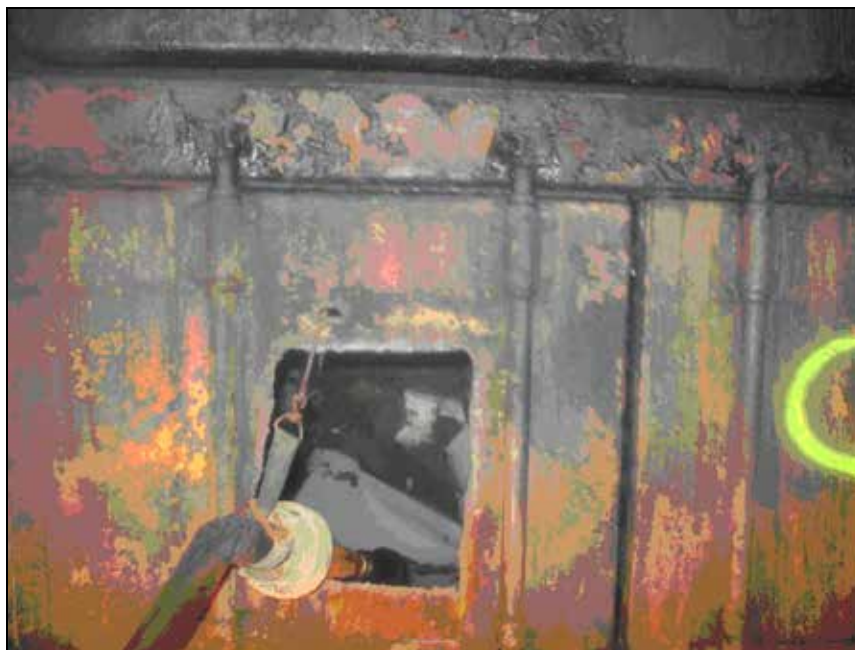
Fire-fighting continued while she was made fast in Wilhelmshaven because glowing fires repeatedly reignited in the containers laden with paper and cellulose in cargo hold 7, in particular.

Figure 27: Cut open container in cargo hold 7 with suspended nozzle

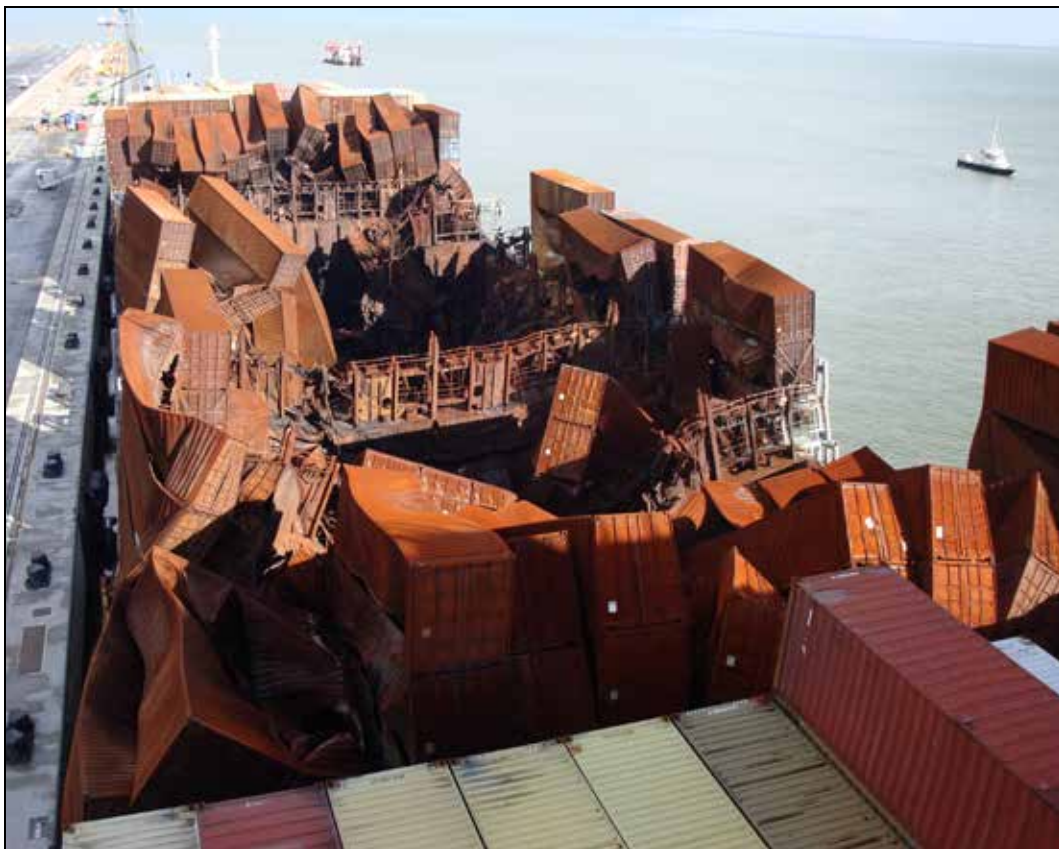
Figure 28: View forward from the MSC FLAMINIA's observation deck

Figures 28 to 31 show the condition of the ship at the time of the first survey by the BSU and the fire experts it had appointed after she arrived at Wilhelmshaven.

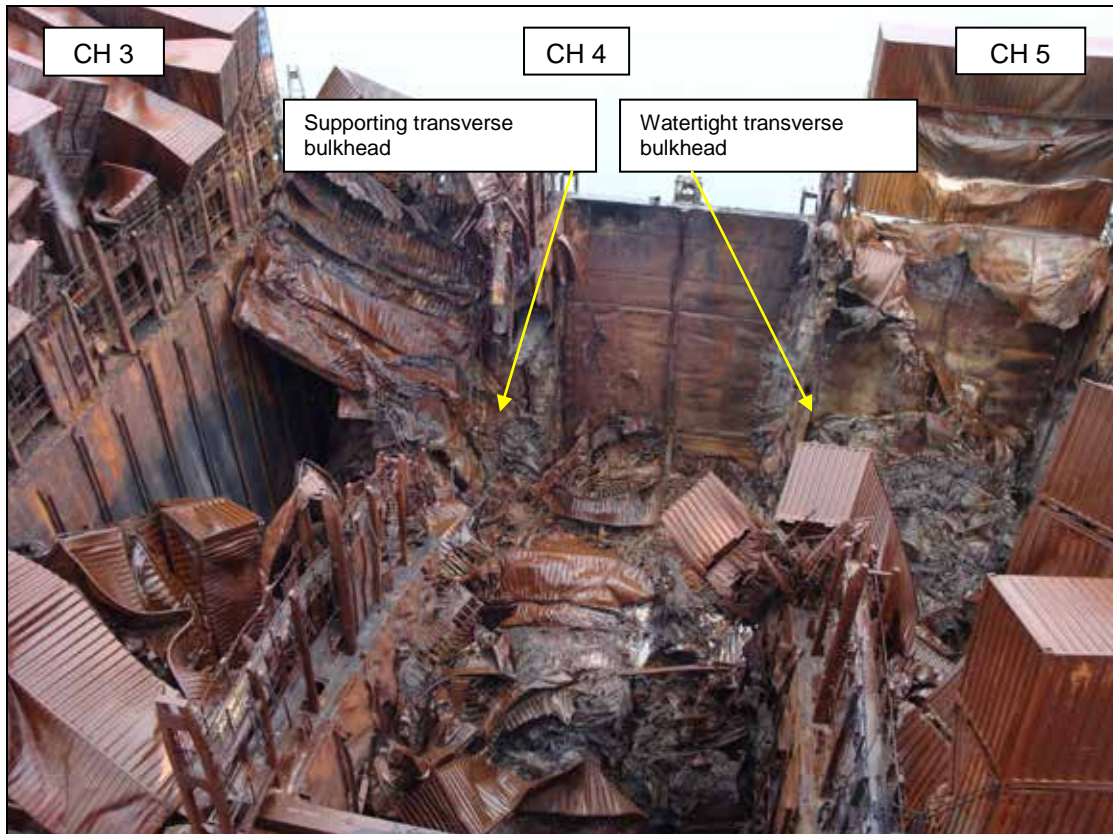
Establishing the cause of the fire at its original source was impossible due to its long duration, the considerable heat that developed in the process, and the ensuing destruction of all the containers in cargo hold 4. Furthermore, large parts of the hatch covers and the containers located on them fell into the hatch, thus concealing any evidence that possibly existed. The potential for ascertaining the cause of the fire at the scene was additionally worsened by the long stay at sea, 59 days from when the fire broke out, and the fire-fighting during that period.

Figure 29: Cargo hold 4, view from the port side

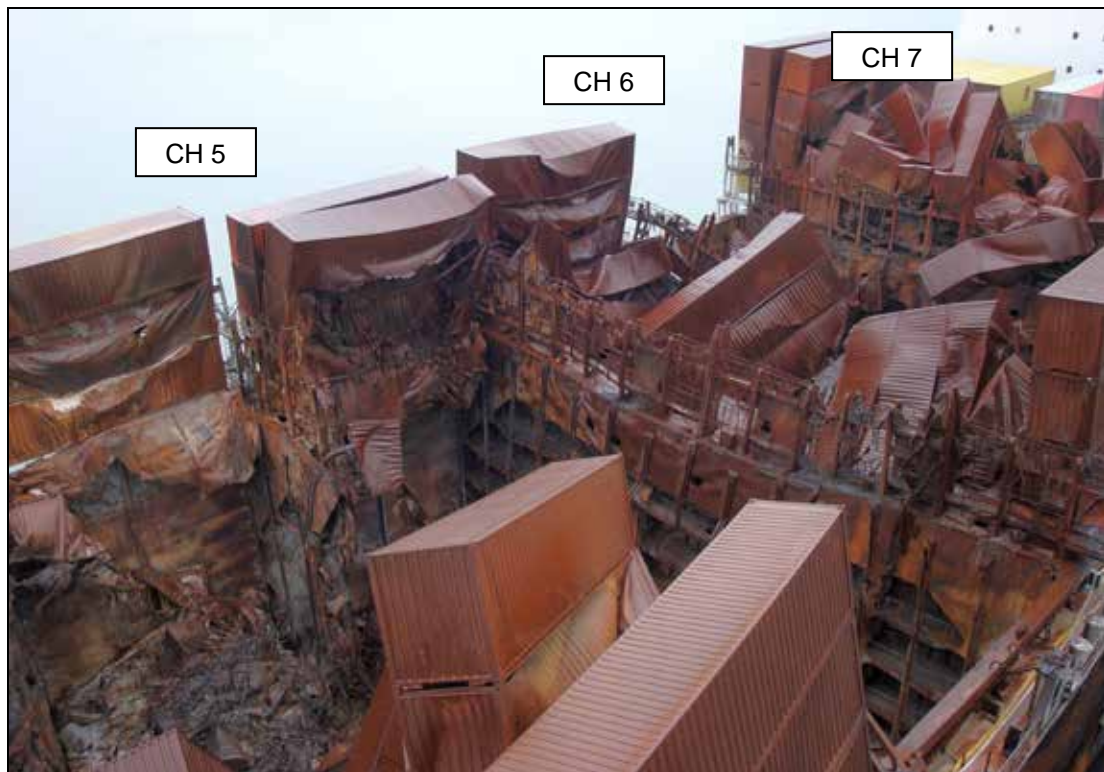
Also due to the high temperatures generated, the watertight transverse bulkhead between cargo holds 4 and 5 was destroyed. The supporting transverse bulkheads between bays 26/30, 34/38, and 42/46 were destroyed or very heavily damaged.

Figure 30: View of cargo holds 5, 6 and 7 from the port side

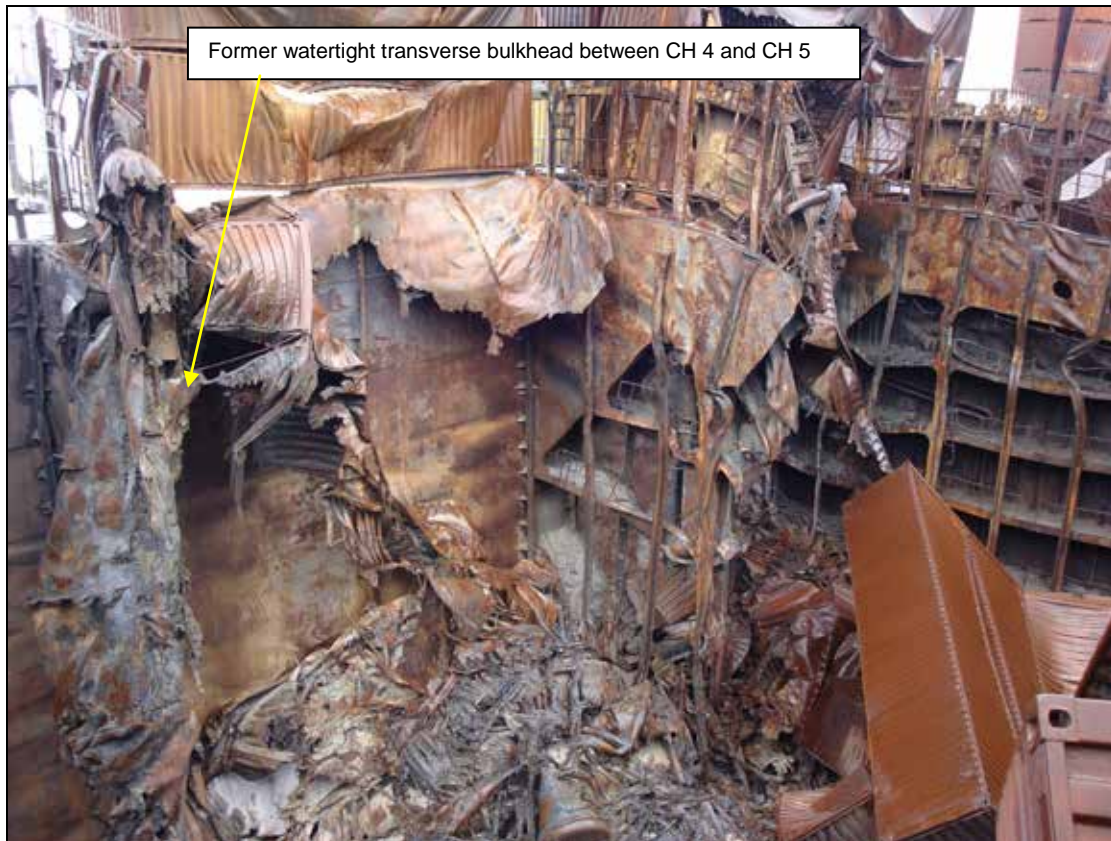
Figure 31: View through cargo hold 5 up to transverse bulkhead to cargo hold 6

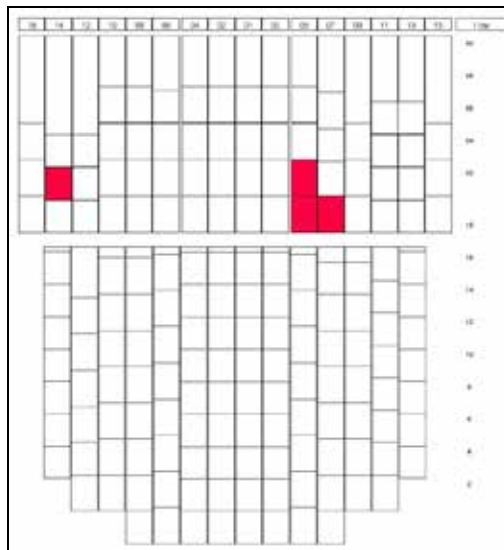
**Isopropylamine** was stowed in a tank container on deck (Figure 36)."

Figure 36: Stowage of highly combustible substances in bay 25; left: a tank container with isopropylamine; right: three containers with hair spray (bay 26)

"The GESTIS<sup>47</sup> substance database<sup>48</sup> indicates that the density ratio of isopropylamine gas to dry air at the same temperature and pressure is 2.04. Accordingly, isopropylamine gases possibly leaking from the tank container or vapours produced by escaping liquid isopropylamine are heavier than air and may accumulate in the cargo hatch below.

**Hair spray** was in small pressurised gas cylinders stowed in dry van containers on deck (see Figure 36). Presumably, these were commercially available hair spray products. Even if some of them were damaged, the amount of flammable gas released can be assessed as very low. An accumulation of these gases in the cargo hatch is very unlikely (similar to the considerations for isopropylamine). An explosion inside a dry van container on deck was not observed.

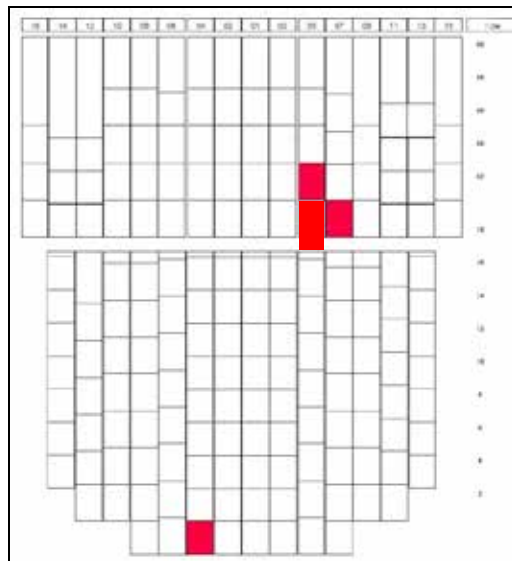
Figure 37: Stowage of highly combustible substances in bay 27; below deck: one container with car care products

**Car care products** were stowed in gaseous form in pressurised gas cylinders or liquid form in tanks in a dry van container right at the bottom of bay 27 (see Figure 37). Since the pressurised gas cylinders evidently represented smaller outer packaging (spray cans), the gas concentration of a flammable gas to leak would certainly only have been marginal if some of the packaging was damaged. However, in this case there is the possibility of a detonation inside the container, resulting in the possible development of a smouldering or smaller fire. Here, the other (liquid) products in this container have flashpoints of 37.8°C or 60°C and could have ignited relatively easily, meaning the spread of fire would be possible. However, it seems less likely that these liquid products caused the fire because the discussed flashpoints are relatively high. The properties of this mixed cargo and the slot position of this container permits this scenario to be one possible cause of the fire.

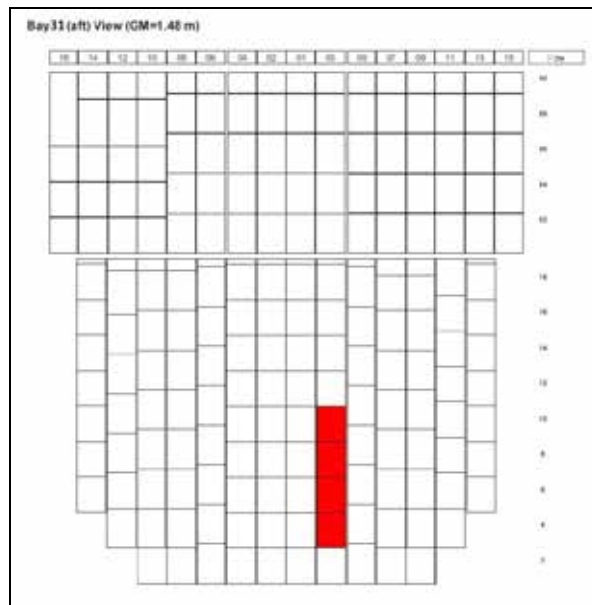
**Dimethylaminoethanol** was stowed in tank containers below deck (see Figure 38).

Figure 38: Stowage of highly combustible substances in bay 31; below deck: four containers with dimethylaminoethanol

At 39°C, the flashpoint of dimethylaminoethanol is already relatively high. On the other hand, the statements of the crew [...] indicate that it was *"hot and dry with water temperatures of about 24°C"* in the port of departure, Charleston. Consequently, it is quite possible that temperatures of up to 40°C would have prevailed in the cargo hatch – a temperature close to or even above the flashpoint of dimethylaminoethanol. Moreover, while being heard the crew indicated that bunker tanks were located in the area of the hatch relevant to the accident. These were kept at a constant temperature of or automatically heated up to (but specifically not beyond) 45°C. Therefore, an ignition of fumes arising from leaking cargo (dimethylaminoethanol), which resulted in the development of a detonation or smouldering fire, seems possible."<sup>49</sup>
