Bundesstelle für Seeunfalluntersuchung
Federal Bureau of Maritime Casualty Investigation
Federal Higher Authority subordinated to the Ministry of Transport
and Digital Infrastructure

Investigation Report 289/12

Serious Marine Casualty

**Ground contact by the
oil tanker KATJA
in the River Jade
on 14 August 2012**

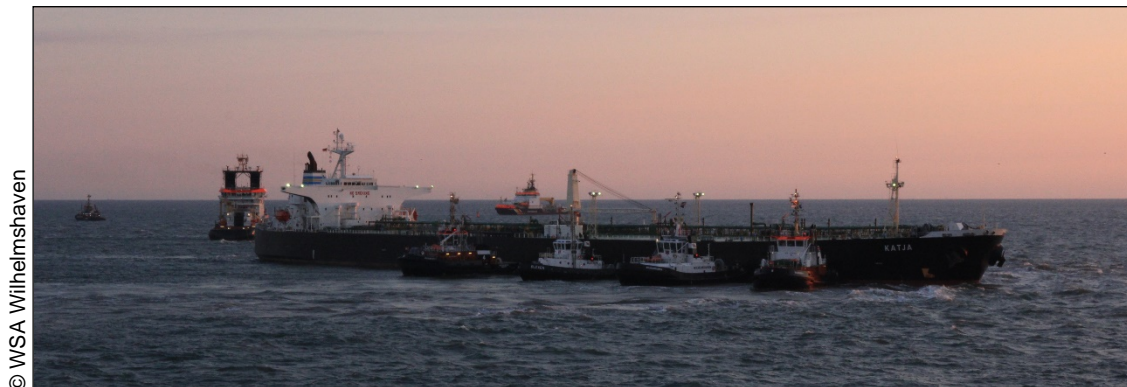
Tug BUGSIER 3 arrived at the scene at 0600. The situation there was still stable. In particular, no cargo was escaping. A total of seven support tugs, as well as the emergency tug NORDIC, the MELLUM, and the NEUWERK were at the distressed vessel to prevent the KATJA from possibly drifting into the Wadden Sea. The KATJA was grounded at about 1.5 m (13.45 m draught, 12 m immersion). A towing attempt at 0615 with simultaneous tugging by four tugs (see Figure 9) and the onset of the tide finally resulted in the KATJA refloating.

Figure 9: The KATJA refloats

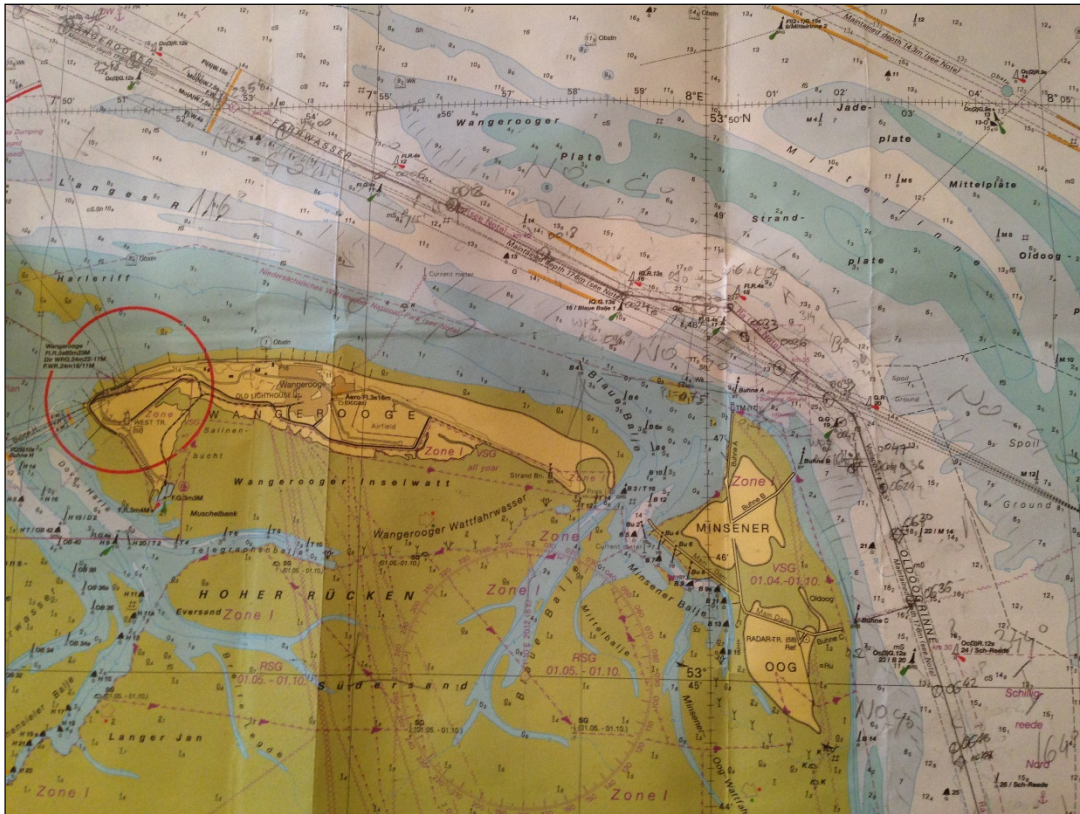
The voyage plan was prepared by the second officer and approved by the chief officer. The voyage from the deepwater anchorage to Wilhelmshaven (44.2 nm) was planned in consideration of the water depths inside the dedicated corridors, as provided by the official nautical paper charts.

Figure 14: Excerpt from Paper Chart INT 1456 from aboard the KATJA

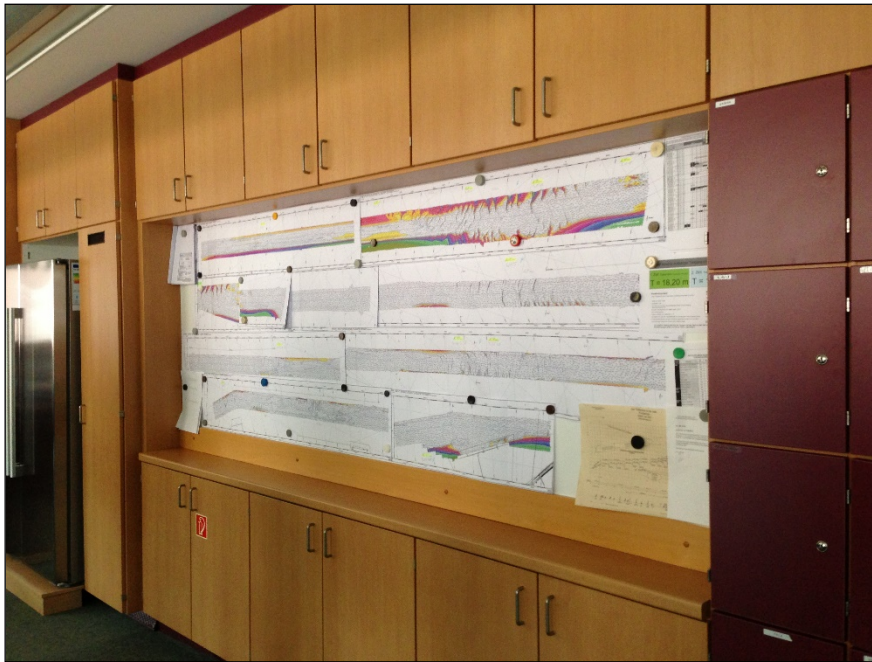
At VTS Wilhelmshaven, the latest sounding charts are displayed directly adjacent to the workstations (see Figure 15).

Figure 15: Sounding charts displayed at the VTS

It remains unclear why distribution of the latest sounding chart to the KATJA's sea pilot ultimately failed. Adequate voyage preparation by the sea pilot was not possible without the chart.

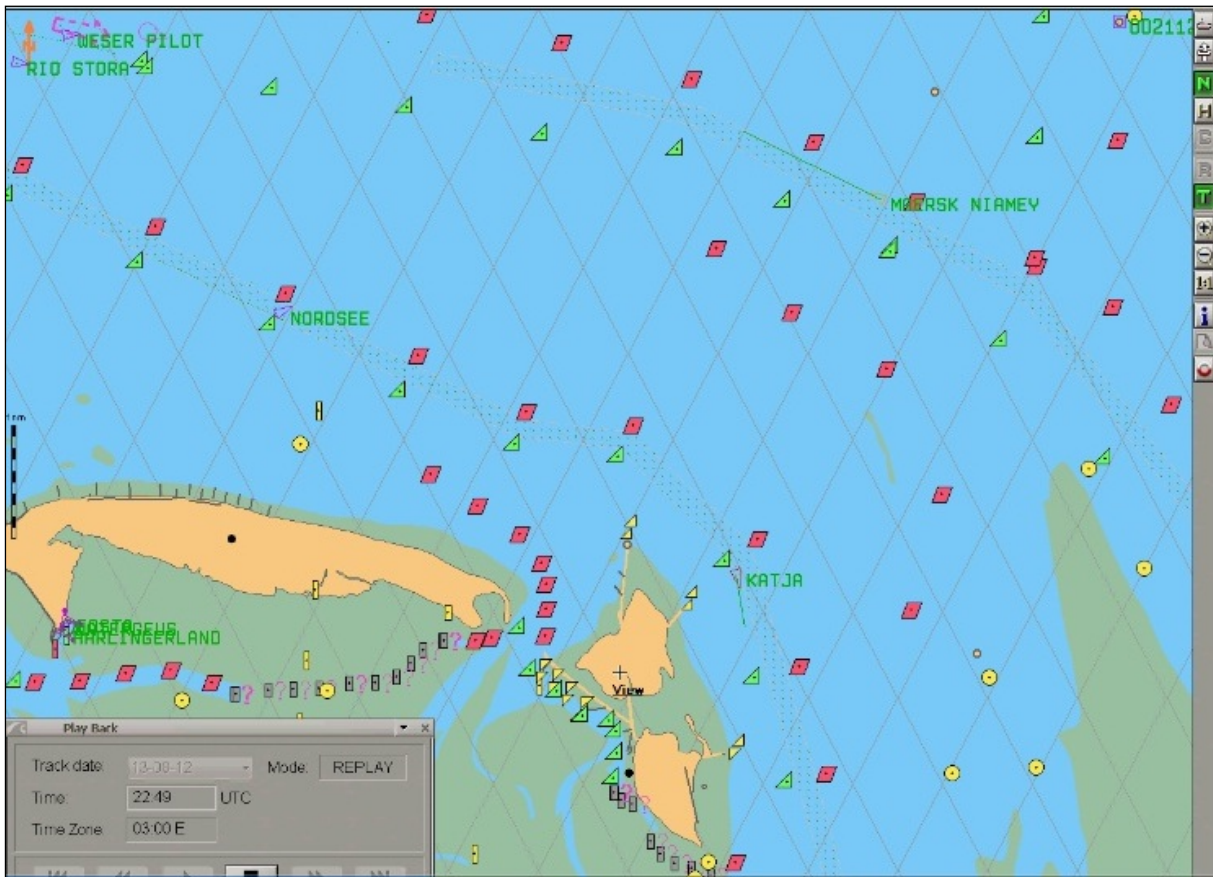
In addition to the recordings of the S-VDR from aboard the KATJA, AIS recordings from Jade Traffic were available for the investigation (see Figure 24). Due to the large amount of data available, the S-VDR data were used for preparing the course of the KATJA.

Figure 24: AIS plot from Jade Traffic; KATJA at the scene of the accident
