Investigation Report 342/13

Serious Marine Casualty

**Stability-related accident involving the MV ROSEBURG
in the Kieler Förde
on 5 November 2013**

20 October 2014

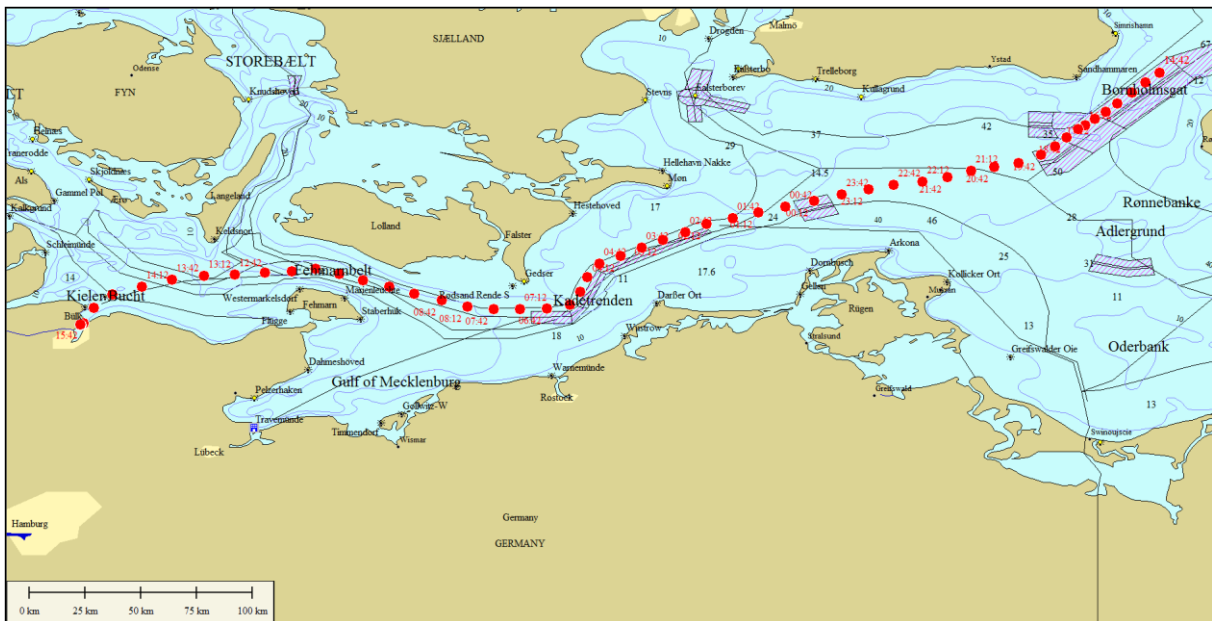
Figure 9: AIS data 1

The ROSEBURG is a cargo ship of less than 3,000 GT. Therefore, she is not required to operate a voyage data recorder (VDR) under Chapter V Regulation 20 SOLAS. Since there were no electronic recordings on board either, the BSU referred to the AIS recordings⁶ of the Federal Waterways and Shipping Administration. Figure 9 shows most of the course of the voyage taken by the ROSEBURG from Riga to Kiel. The positions, speed and course were correlated with the detailed weather report in section 3.2.4 and influenced the final assessment of the stability report in section 3.2.5 thus.

All the times shown in figures 9-14 are based on UTC.

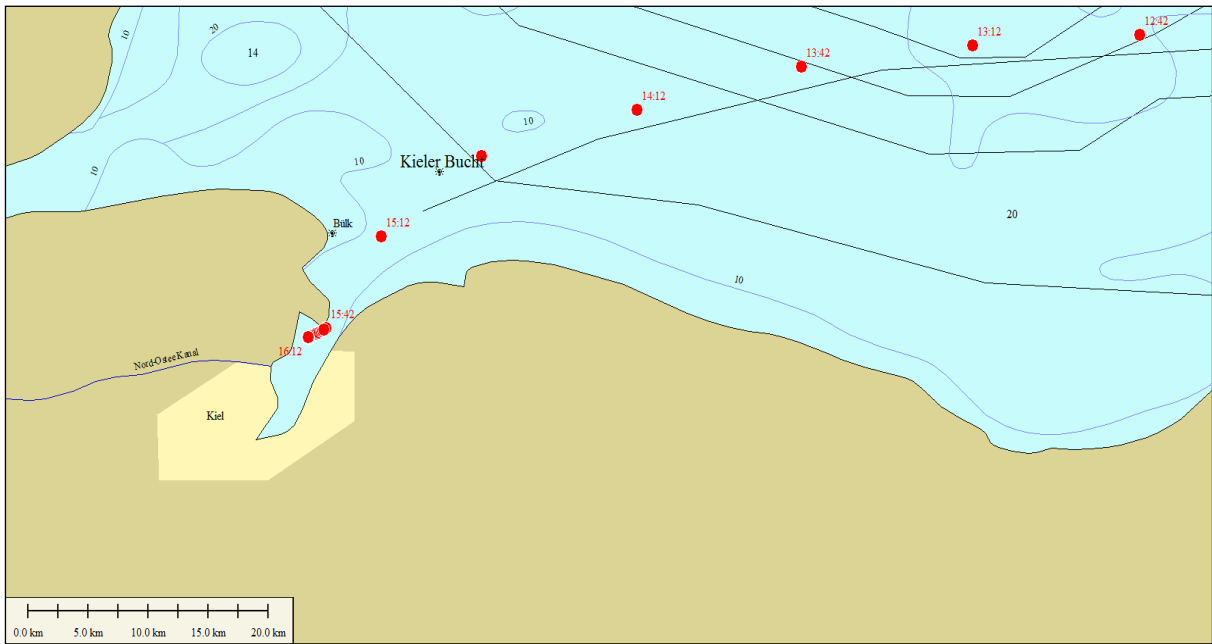
Figure 10: AIS data 2

Figure 10 shows the arrival at Kieler Förde . Figure 11 shows the anchor manoeuvre at the time of the accident, 1553 UTC (1653 LT).

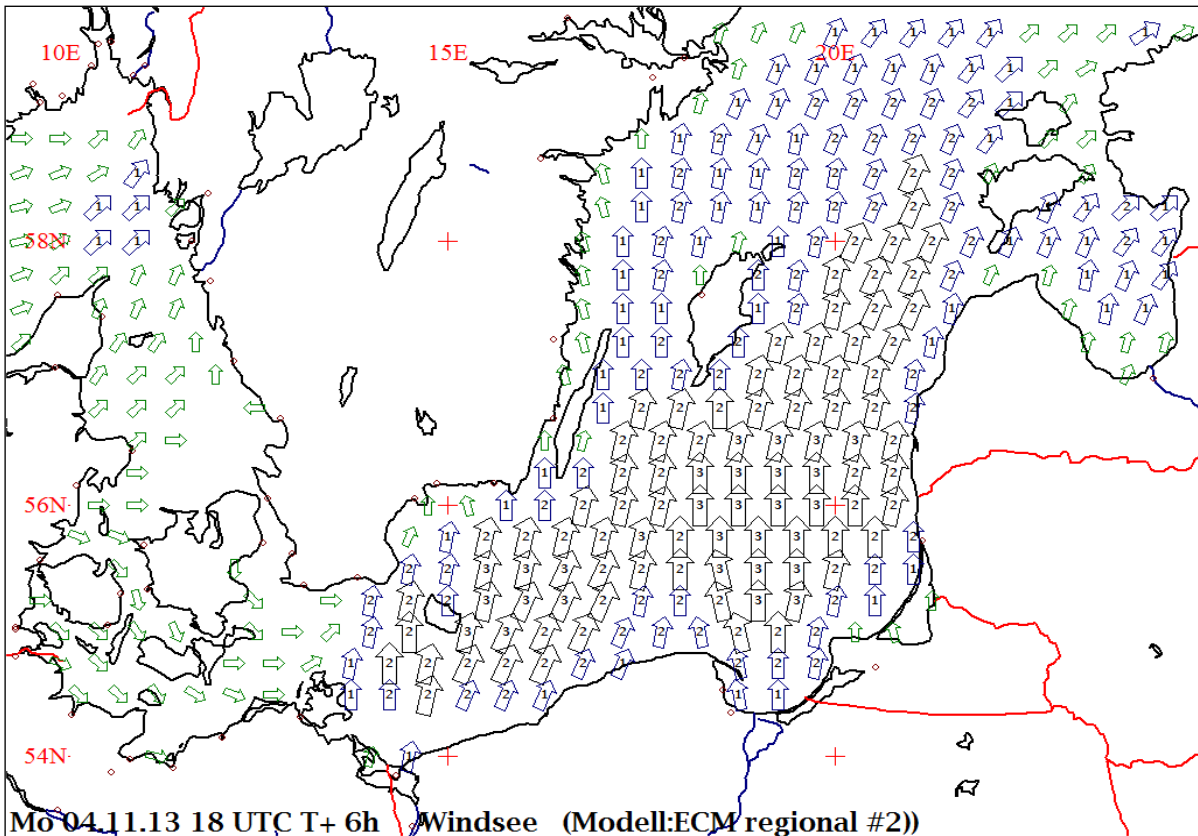
Figure 12: Wind sea forecast of the global ECMWF model for 4 November 2013 at 1800 UTC

Sea state generally stood at 2-3 m. It was mainly generated by wind, meaning the swell was insignificant. Current was negligible. (See Fig. 12.)

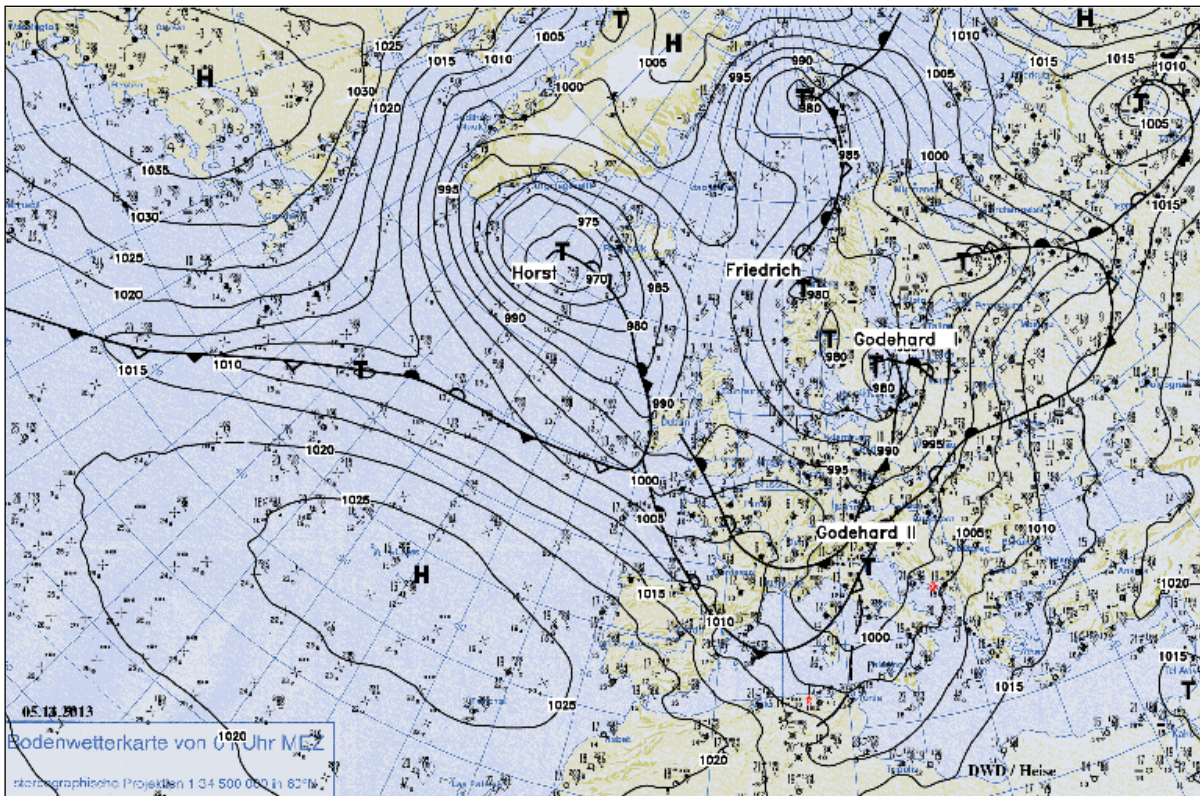
Figure 13: Weather chart

Figure 13 shows the GODEHARD 1 and the HORST low pressure systems with core pressures of 975 hPa and 970 hPa respectively. The first low pressure system mentioned tracks to southern Finland by the evening, while the HORST remains in the area south-west of Iceland. In the process, colder air flows into the region and briefly falls within the influence of an interim high wedge, causing the onset of slightly more moderate weather. At the same time, a fringe from the HORST stretches into the western part of the North Sea. A secondary depression forms around this in the Dover area and subsequently tracks across the North Sea.

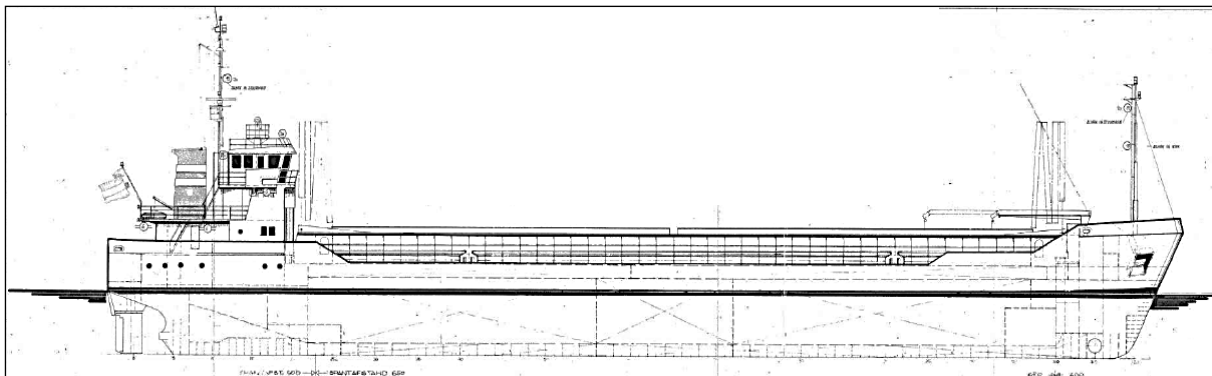
Figure 14: Side view of the MV ROSEBURG

Length (overall)	:78.00 m
Moulded beam	:12.50 m
Draught at summer load-line	: 4.953 m
Height of freeboard deck	: 6.600 m

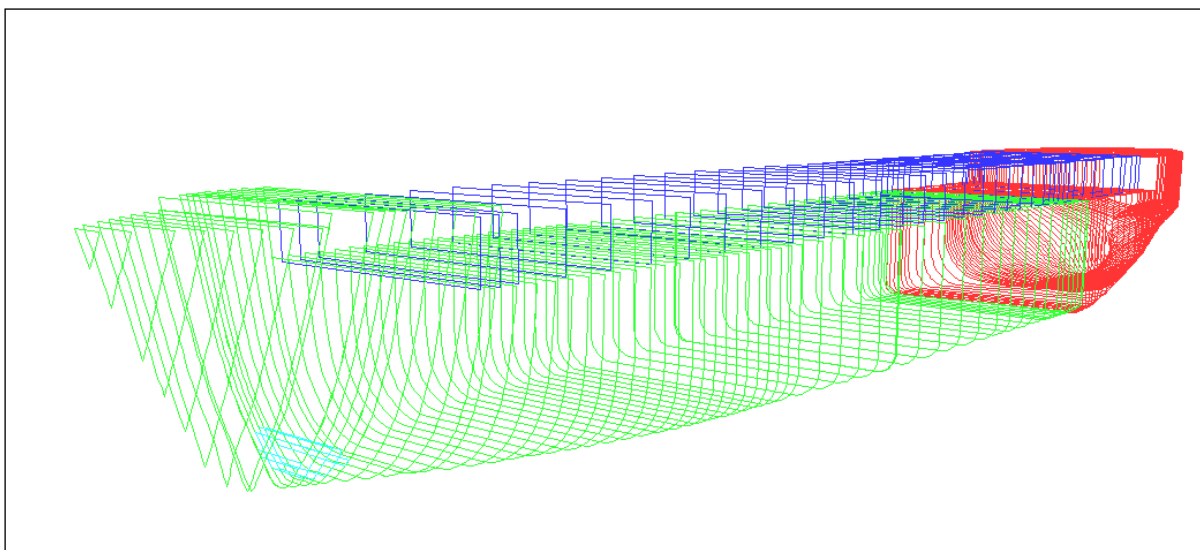
Figure 16: Computational model of the MV ROSEBURG

The computational model consists of the fore and aft section geometry up to a height of 8.8 m (height of hatch cover); the sheer strake does not contribute to buoyancy. The deckhouse is not taken into account because this only meets the water at a heeling angle of more than 45°, meaning it is not relevant to the investigation.
