**Bundesstelle für Seeunfalluntersuchung**  
**Federal Bureau of Maritime Casualty Investigation**  
Federal Higher Authority subordinated to the Ministry of Transport  
and Digital Infrastructure

Investigation Report 86/13

**Very Serious Marine Casualty**

**Fatal accident  
of the entrance to the port of  
Figueira da Foz, Portugal  
on the training craft  
SY MERI TUULI  
on 10 April 2013**

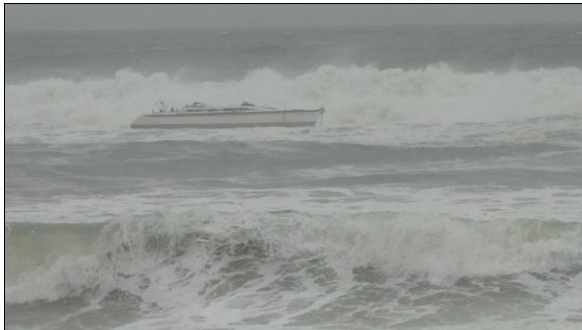
Fig. 5: Drifting MERI TUULI

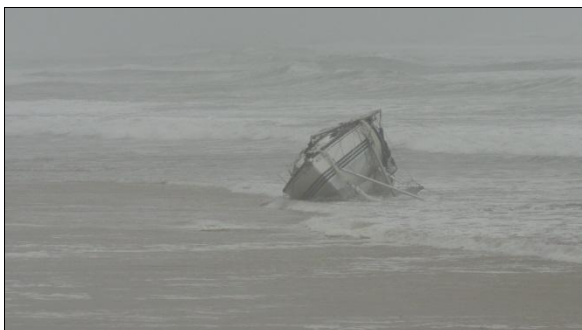
Fig. 7: MERI TUULI grounded

The MERI TUULI only exhibited minor damage above the waterline during the survey at Teerhofinsel in Bad Schwartau on 30 July 2013. The loss of the mast and the entire standing rigging, as well as the destroyed railing only caused minor damage to the shell. Similarly, no significant damage was evident on the underwater hull, except for the steering gear. The keel-hull connection was intact. The wheel was buckled and the emergency tiller's arm had broken off. The interior of the yacht had already been cleared up and cleaned. There was practically no equipment left. The electronic system was destroyed by water ingress, even though the companionway with washboards and sliding hatch were reportedly closed in the surf zone on the day of the accident. However, the hatch reportedly opened a little before the starboard side grounded on the beach and the upper washboard fell out, meaning water could enter. The rigging was reportedly replaced about a year ago and as new.

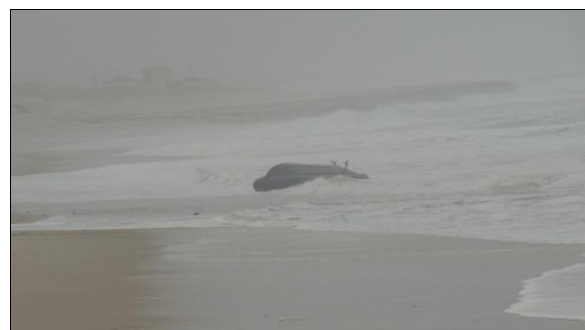
Fig. 8: PAPA NOS grounded

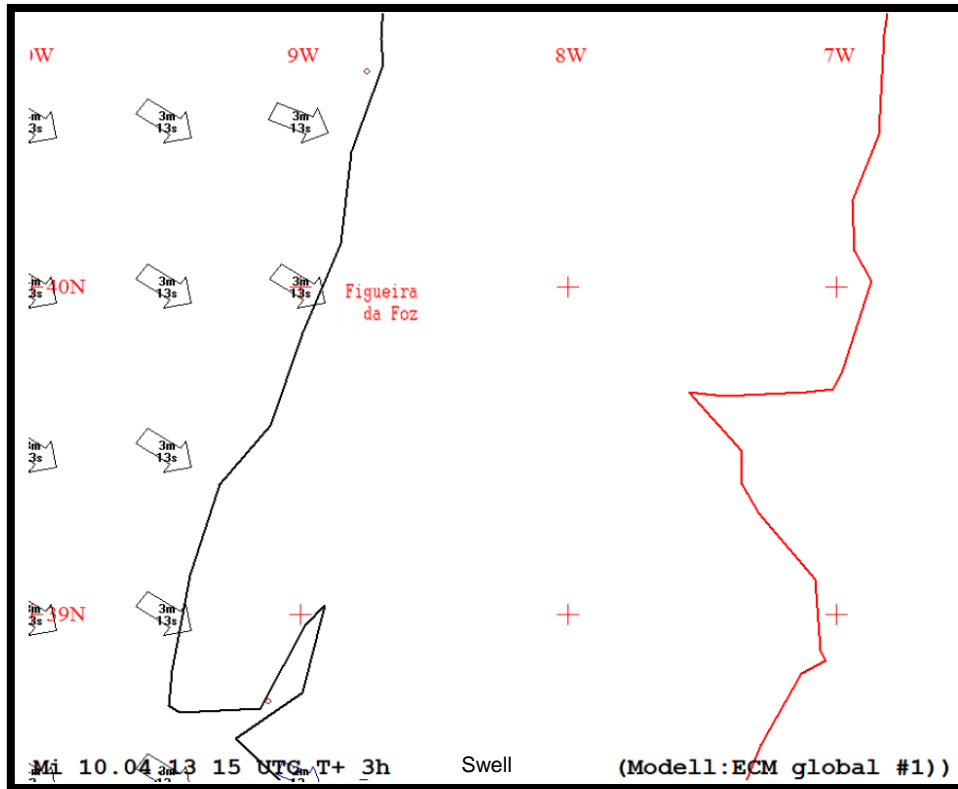
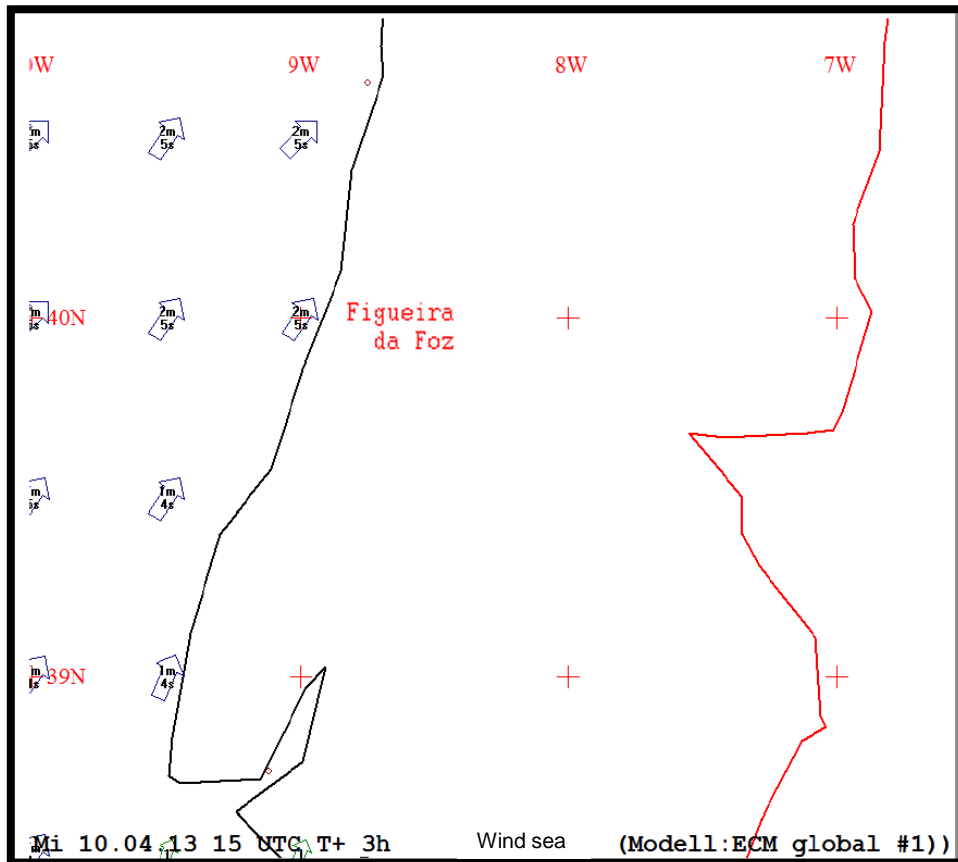
The swell exhibited values of 3.3 m from west-north-west. At 1.5 m, the wind sea caused by the south-westerly wind of 6 Bft was significantly lower. A chaotic wave pattern was caused by the overlay of wind sea and swell. The swell was not severe in the deep Atlantic. However, the waves neared the sea floor (groundswell) when they converged with shallower water. In the case in question, a relatively high west-north-west swell converged with shallower water.

Fig. 15: Swell and wind sea

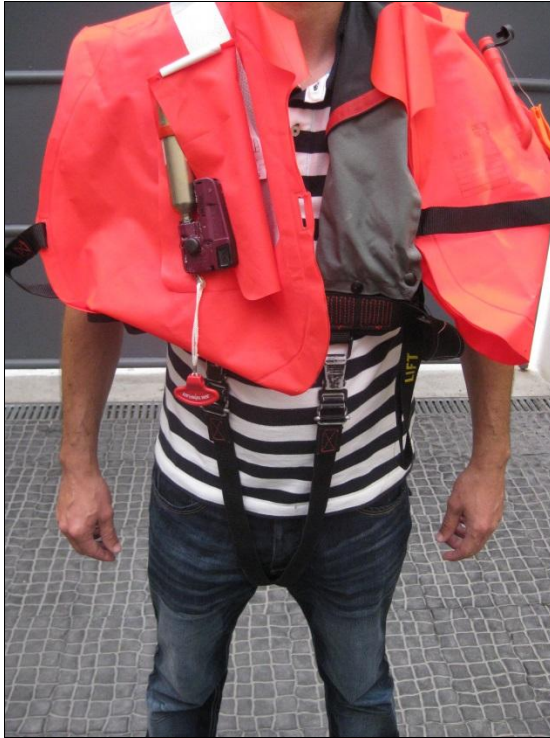
Fig. 21: 275 newton lifejacket

The inflatable lifejackets used on the MERI TUULI had a volume of buoyancy of 275 newton and were also equipped with spray hood and crotch strap.

During the rescue, the inflated lifejackets impeded the survivors from the MERI TUULI. 257N jackets with spray hood were found, some of which had been removed and were tattered. It is possible that 150N jackets would have been easier to handle. It was not possible to climb the craft's stern ladder when they were inflated. Moreover, in the cockpit the skipper helped to release twisting and constriction at the neck of a sailor caused by the pressure of the lifejacket. The crotch strap also proved obstructive for one crew member. The designers of the lifejacket attempted to combine the function of a fall arrest belt with that of an inflatable lifejacket. The effect of this was the removal of the lifejacket by some crew members during the rescue and tragic death of a crew member. For unknown reasons, the inflatable lifejacket of the fatally injured police officer did not inflate. In the case of the liferaft having not inflated, which drifted off, a mistake occurred in that attention was not paid to the fact that the release cord was no longer fixed to the craft because of the destroyed railing.

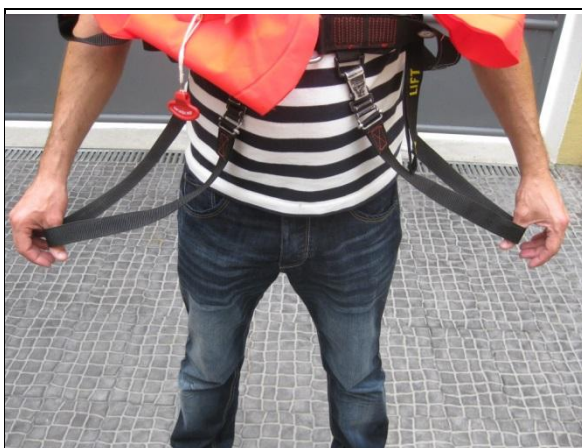
Fig. 23: Crotch strap

The abdominal belt has a D-ring to the left and right of the buckle. A lifeline to the craft with shock absorbers (fall arrest line) was not on board. This would soften the load during a fall to about 6 kN for the person and the energy induced by the fall is converted into a plastic deformation in the fall arrest line. It is unclear how the lifejackets were donned by the crew and how they were secured to the craft. One crew member suffered a shoulder fracture, the others who fell overboard bruises.

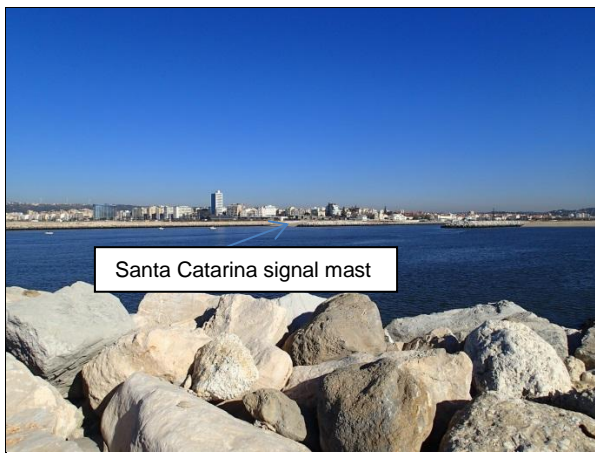
The decision to call at the port of Figueira da Foz was taken about 2 nm off the entrance. The crew was not aware of the information concerning the closure of the port, even though it was broadcast via NAVTEX and the receiver was on. It is likely that the message was lost among the many reports. The VHF calls made to obtain information on the port went unanswered. In some cases, the MERI TUULI called stations in Figueira da Foz incorrectly due to wrong information in the sailing directions on board. The TIME BANDIT, which was sailing with the MERI TUULI, called on VHF channel 14 shortly before the accident and was advised the port was closed to vessels of less than 35 m (probably by the pilot). Moreover, the Santa Catarina signal mast, which signalled the closure, was not visible from the sea with binoculars. It is located in the inner harbour entrance. Moreover, the BSU could not make it out even from the opposite southern jetty. Inasmuch, its value tends to be more tourism-related/historical.

Fig. 26: Outer southern jetty, focal distance = 25 mm

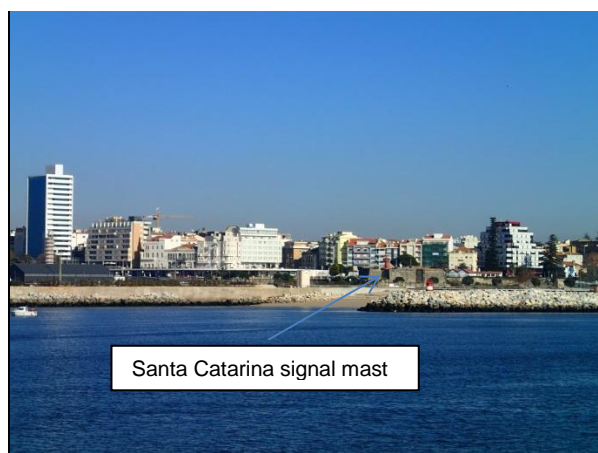
Fig. 27: Outer southern jetty, focal distance = 100 mm
