Investigation Report 94/13

**Serious Marine Casualty**

**Grounding  
of the MV NORFOLK EXPRESS  
on 18 April 2013  
on the River Weser**

10 April 2014

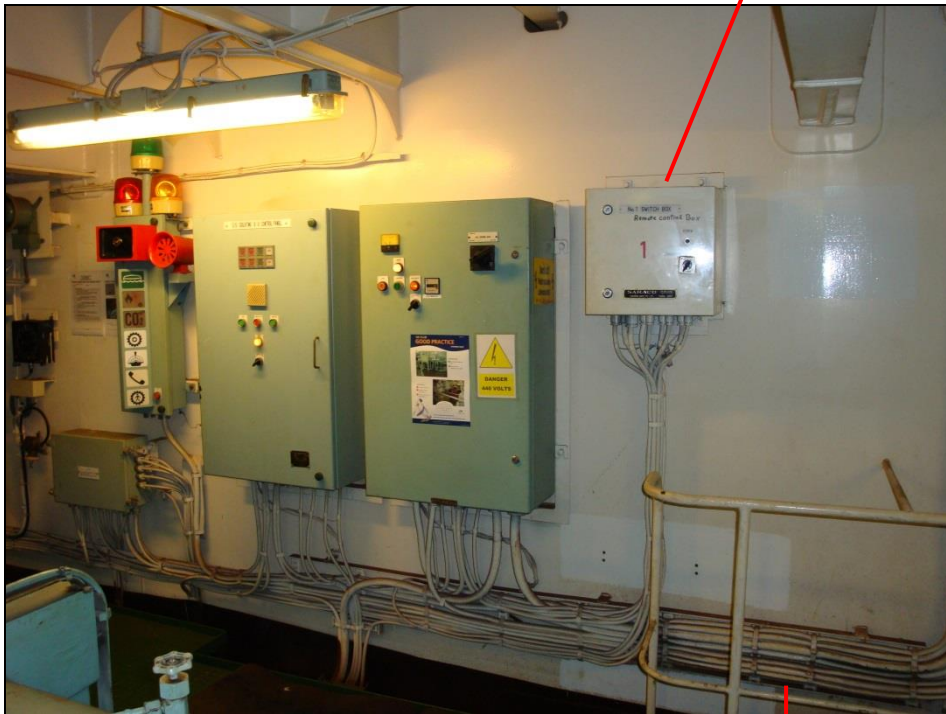
Figure 11: Switch cabinets for the steering gear

Both steering gear telemotors were sent for a complete overhaul. All the hydraulic valves were cleaned and the system's oil was replaced. The electric control units were examined carefully. It took four days to determine that a defective rectifier was the cause of the malfunction on the starboard telemotor control unit.

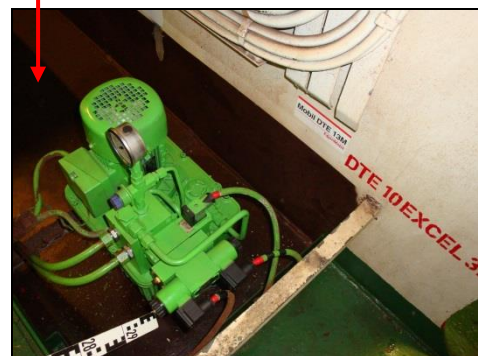
Figure 12: The hydraulic motor for the steering control is located on the floor below the switch cabinets
