Bundesstelle für Seeunfalluntersuchung
Federal Bureau of Maritime Casualty Investigation
Federal Higher Authority subordinated to the Ministry of Transport
and Digital Infrastructure

Investigation Report 07/14

Serious Marine Casualty

**Collision between the
installation vessel PACIFIC ORCA and the
fishing vessel JURIE VAN DEN BERG
north of TSS Terschelling-
German Bight on 17 January 2014**

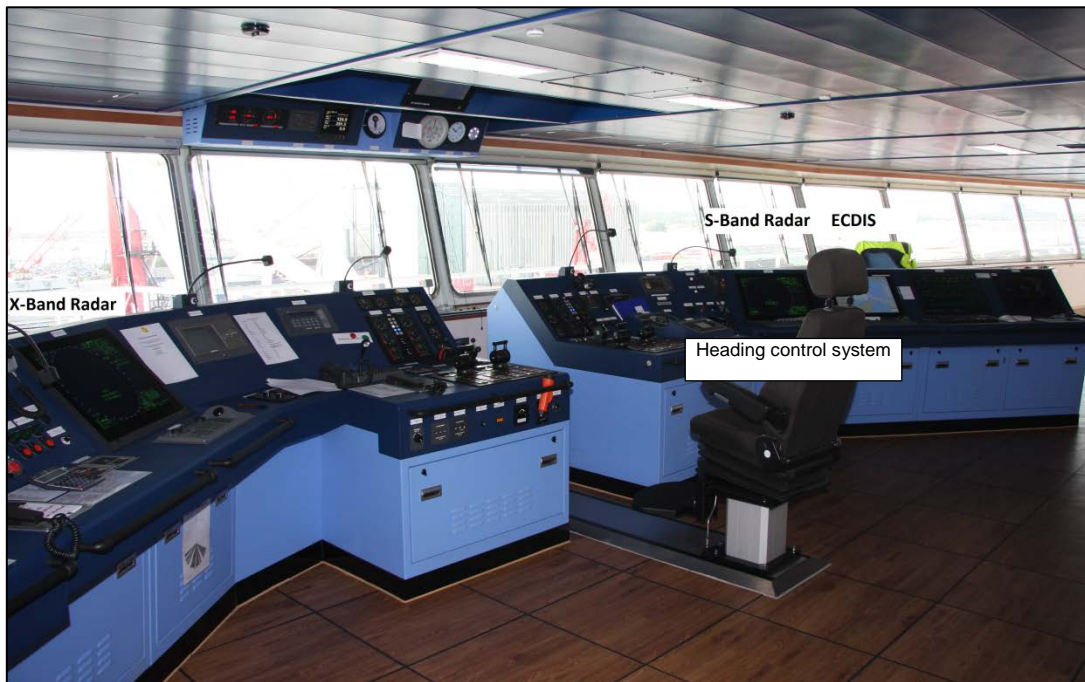
Figure 10: Main steering position

Figure 16 shows the photo of a drawing of the shadow sectors of the X-band radar system. The display is attached below the radar system (see Figure 10).

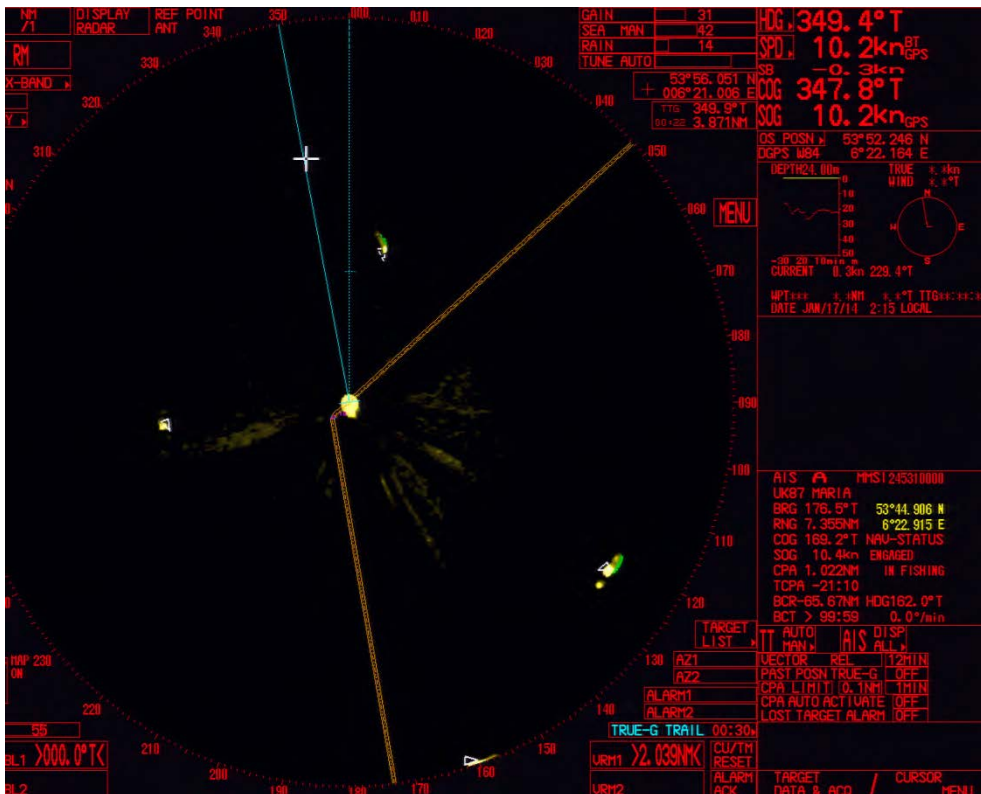
Figure 12: Radar image at 021530

As things progressed, the JURIE VAN DEN BERG was visible on the radar images clearly and continuously as a radar echo and AIS symbol. When the PACIFIC ORCA started her navigational course alteration at 021530 (Figure 12), the distance to the JURIE VAN DEN BERG was 2.4 nm and the relative bearing 024° to starboard. By only 021615 (Figure 13), the JURIE VAN DEN BERG was almost right ahead at a range of 2.2 nm. The course alteration was completed at 021800 (Figure 14). The distance to the JURIE VAN DEN BERG was now 1.6 nm with a relative bearing of 037° to port.

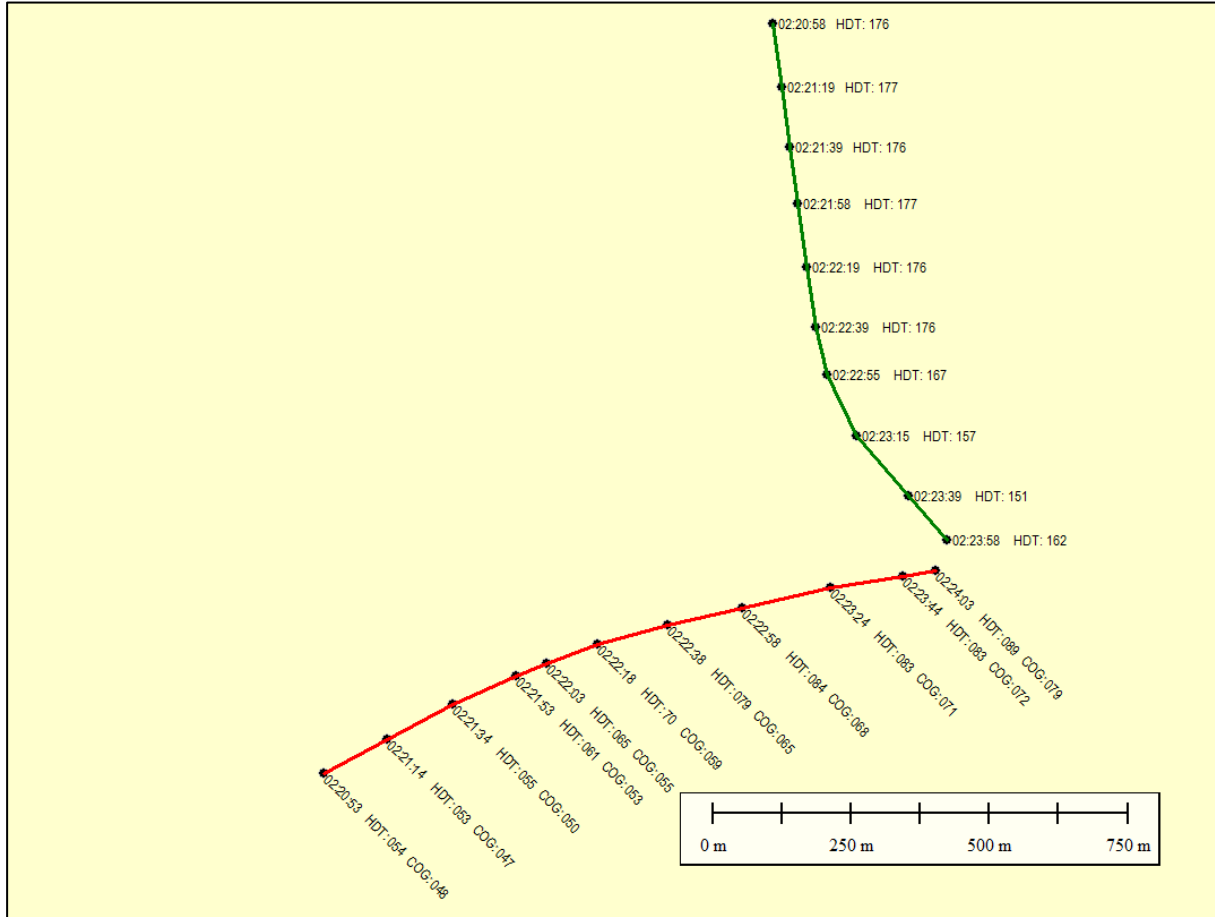
Figure 20: AIS display

The range stood at 1.0 nm when the lookout on the PACIFIC ORCA identified the JURIE VAN DEN BERG at 022003. The distance between the vessels decreased to 0.62 nm up until 022126 on a steady bearing. An alteration of course to starboard from 054° to 084° (TH) was then carried out on the PACIFIC ORCA. This course alteration was completed about one minute before the collision. The PACIFIC ORCA only began to turn to starboard again immediately before the collision.

Figure 20, it is evident that a course alteration to port is initiated on the JURIE VAN DEN BERG between 022239 and 022255. Here, the distance to the track of the PACIFIC ORCA stood at 9-11 ship lengths. The investigators assume that a port manoeuvre was initiated on the JURIE VAN DEN BERG because they had not observed the course alteration of the PACIFIC ORCA, initially went for a starboard-to-starboard pass and thus wanted to give the PACIFIC ORCA more room. The whistle signals of the PACIFIC ORCA may have led to the error being noticed. After realising this error, a starboard course alteration was initiated. The distance was too low to avoid the collision, however. The vessel only turned significantly a few seconds before the collision. As a result, the two vessels collided almost at right angles (see Figure 26). A change in speed is not visible on the JURIE VAN DEN BERG.

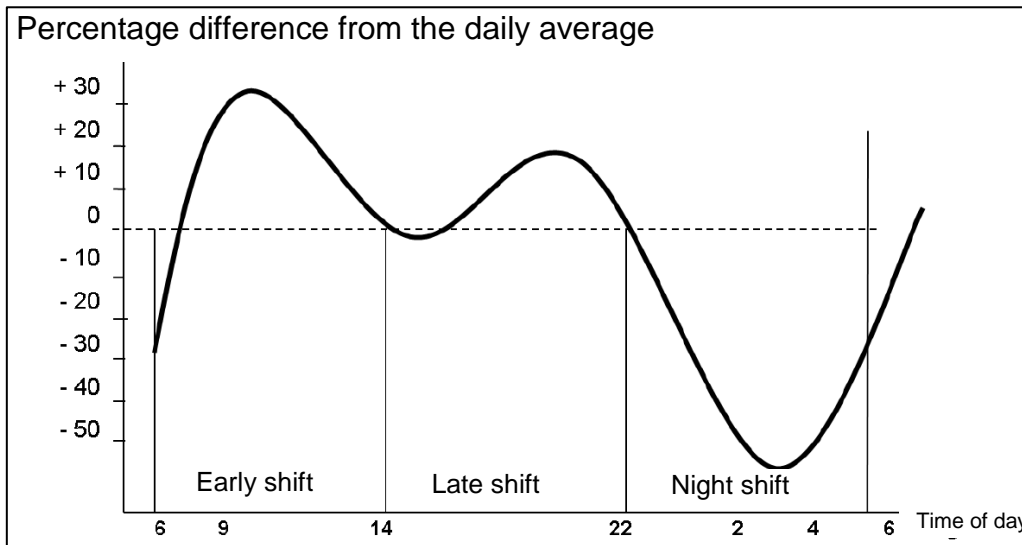
Figure 21: Performance curve of a person¹³

The accident occurred at 0224 in the morning. Due to the so-called circadian rhythm (physiological clock), practically all the functions of a person change systematically in the course of a day and night. Circadian rhythms influence the sleeping and waking state, the body temperature and hormonal changes, thus also the performance of a person. Performance reaches its absolute low at about three in the morning.

The impairment of the performance of a person causes a slowing of physical and mental reflexes and/or the ability to judge. With regard to error frequency, fluctuations can be identified according to the time of day. Accordingly, error frequency does not depend only on the motivation of a person. Figure 22 shows how error frequency increases at night, in particular.

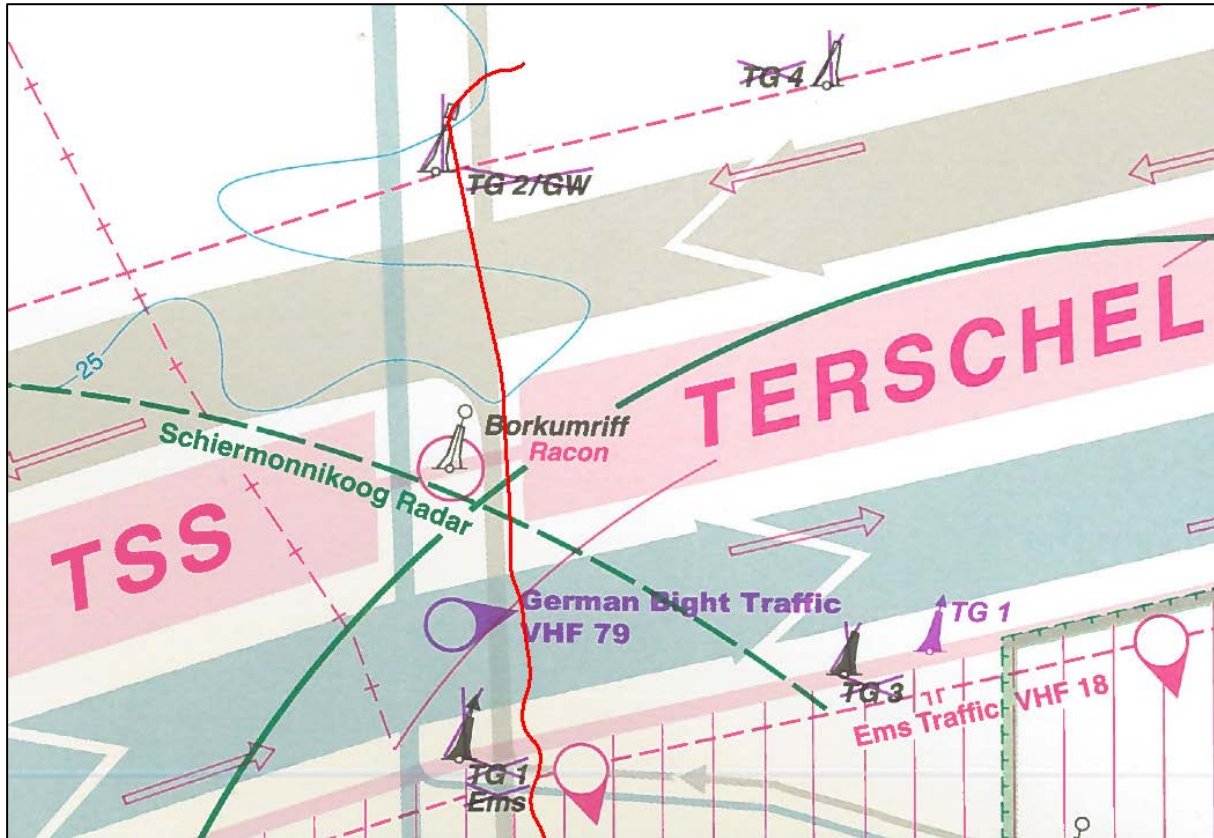
Figure 24: Excerpt from Nautical Chart 2910 (BSH)

Referring to the comments of BSH Nautical Chart 2910 (Mariner's Routing Guide German Bight), the opinion states that in this area of high traffic density a large number of vessels cross the Terschelling-German Bight traffic separation scheme and, similar to the PACIFIC ORCA, many vessels alter their course in the direction of the wind farm after crossing. The investigators believe that due consideration should also be given to the actual traffic situation, however. Traffic density was low at the time of the course alteration. The manoeuvres of neither vessel were restricted by other vessels. Nautical Chart 2910 (see excerpt in Figure 24) gives no indication that a large number of vessels sail in an easterly direction towards the wind farms after crossing the traffic separation scheme. As the track (marked in red in Figure 24)

shows, the PACIFIC ORCA's clear tendency after passing the BORKUMRIFF buoy was westward, meaning a course alteration eastward after crossing the traffic separation scheme seemed rather unlikely.
