**Bundesstelle für Seeunfalluntersuchung**  
**Federal Bureau of Maritime Casualty Investigation**  
Federal Higher Authority subordinated to the Ministry of Transport  
and Digital Infrastructure

Investigation Report 128/14

**Serious Marine Casualty**

**Allision between the MSC BENEDETTA and  
pier in Zeebrugge on 16 May 2014**

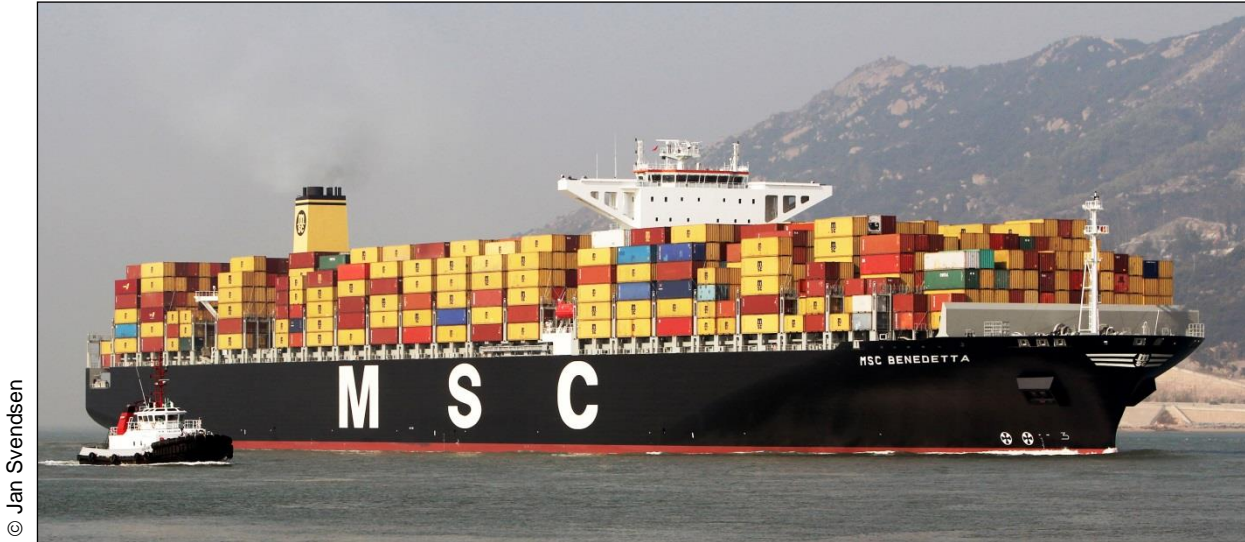
Figure 1: Photo of ship

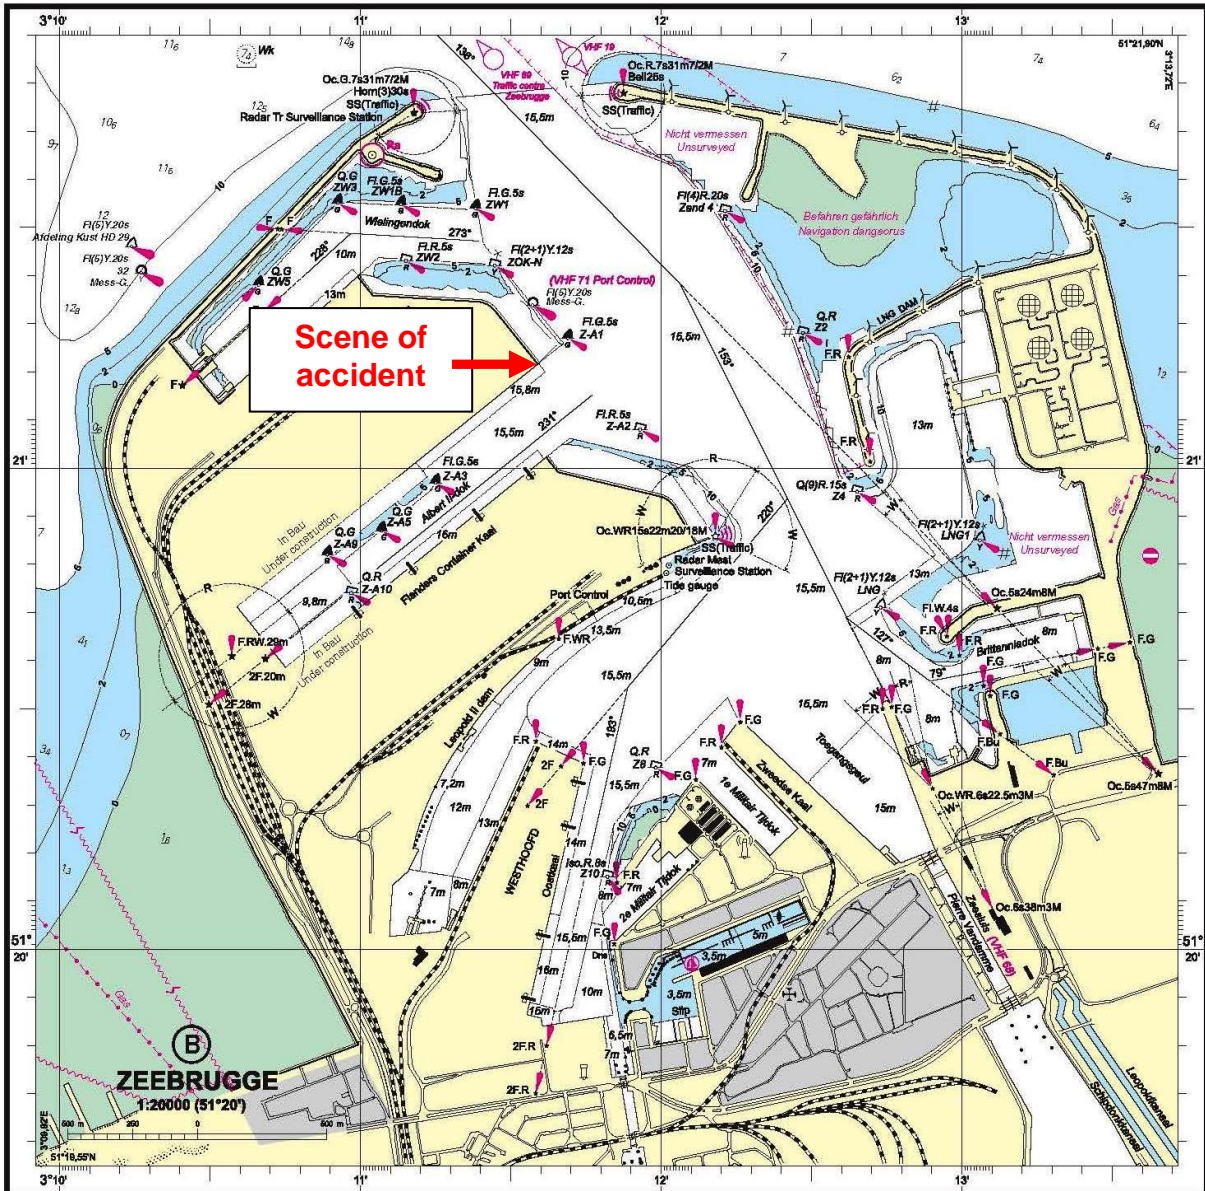
Type of marine casualty or incident:	Serious marine casualty, allision
Date, time:	16/05/2014, 0504
Location:	Port of Zeebrugge, Albert II Dock, Flanders Container Terminal
Ship operation and voyage segment:	Arrival/berthing
Place on board:	Starboard side level with the superstructure
Consequences (for people, ship, cargo, environment, other):	Tear in the shell plating level with the water line; no injuries or environmental pollution

Figure 2: Nautical chart showing the scene of the accident

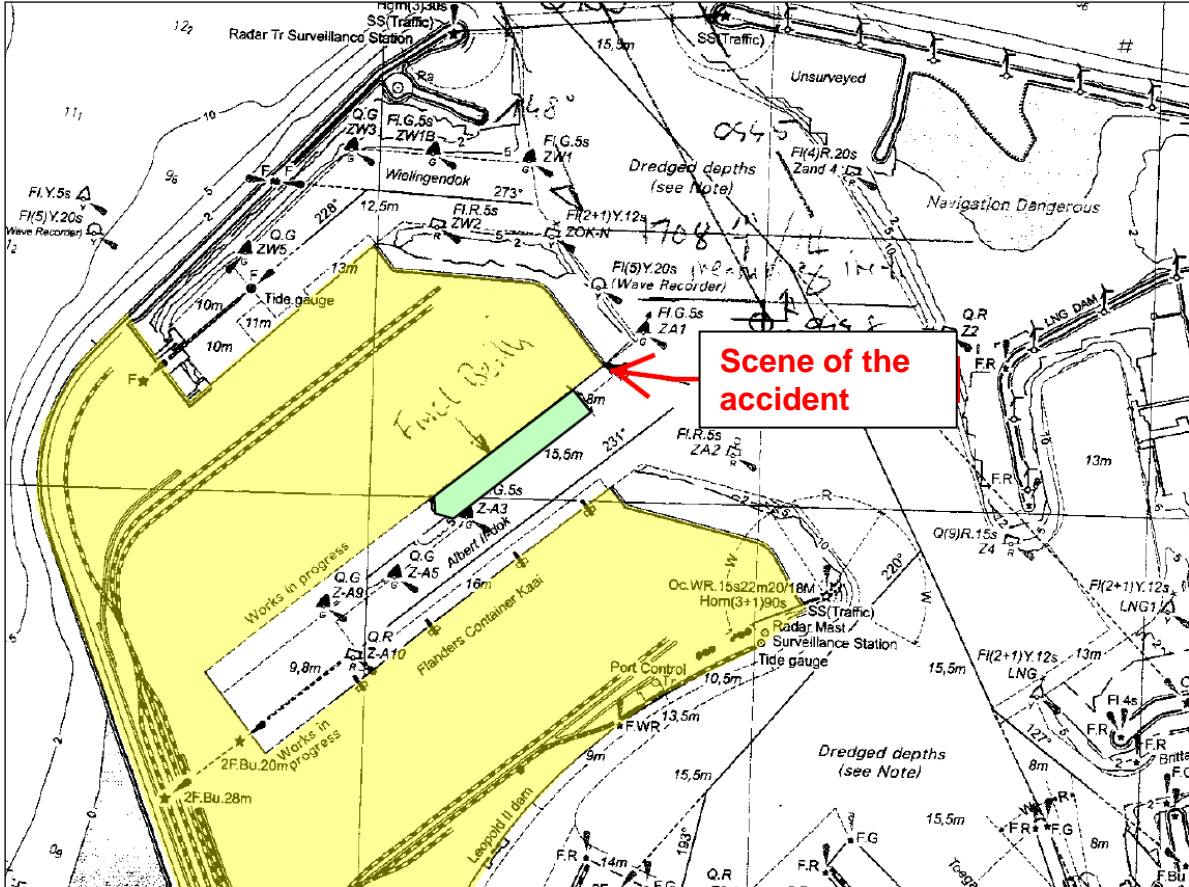
Figure 5: Original nautical chart showing the scene of the accident

Contact with the pier resulted in severe damage to the outside of the fourth and fifth ballast water tanks. Since the tear formed level with the waterline, these tanks took on a substantial amount of water rapidly.

The north-east corner of the mole sustained minor damage.

Extensive repairs were necessary.
