Bundesstelle für Seeunfalluntersuchung
Federal Bureau of Maritime Casualty Investigation
Federal Higher Authority subordinated to the Ministry of Transport
and Digital Infrastructure

Investigation Report 140/14

Very Serious Marine Casualty

**Fatal accident in the
port of Goole, England,
on board the MV SUNTIS
on 26 May 2014**

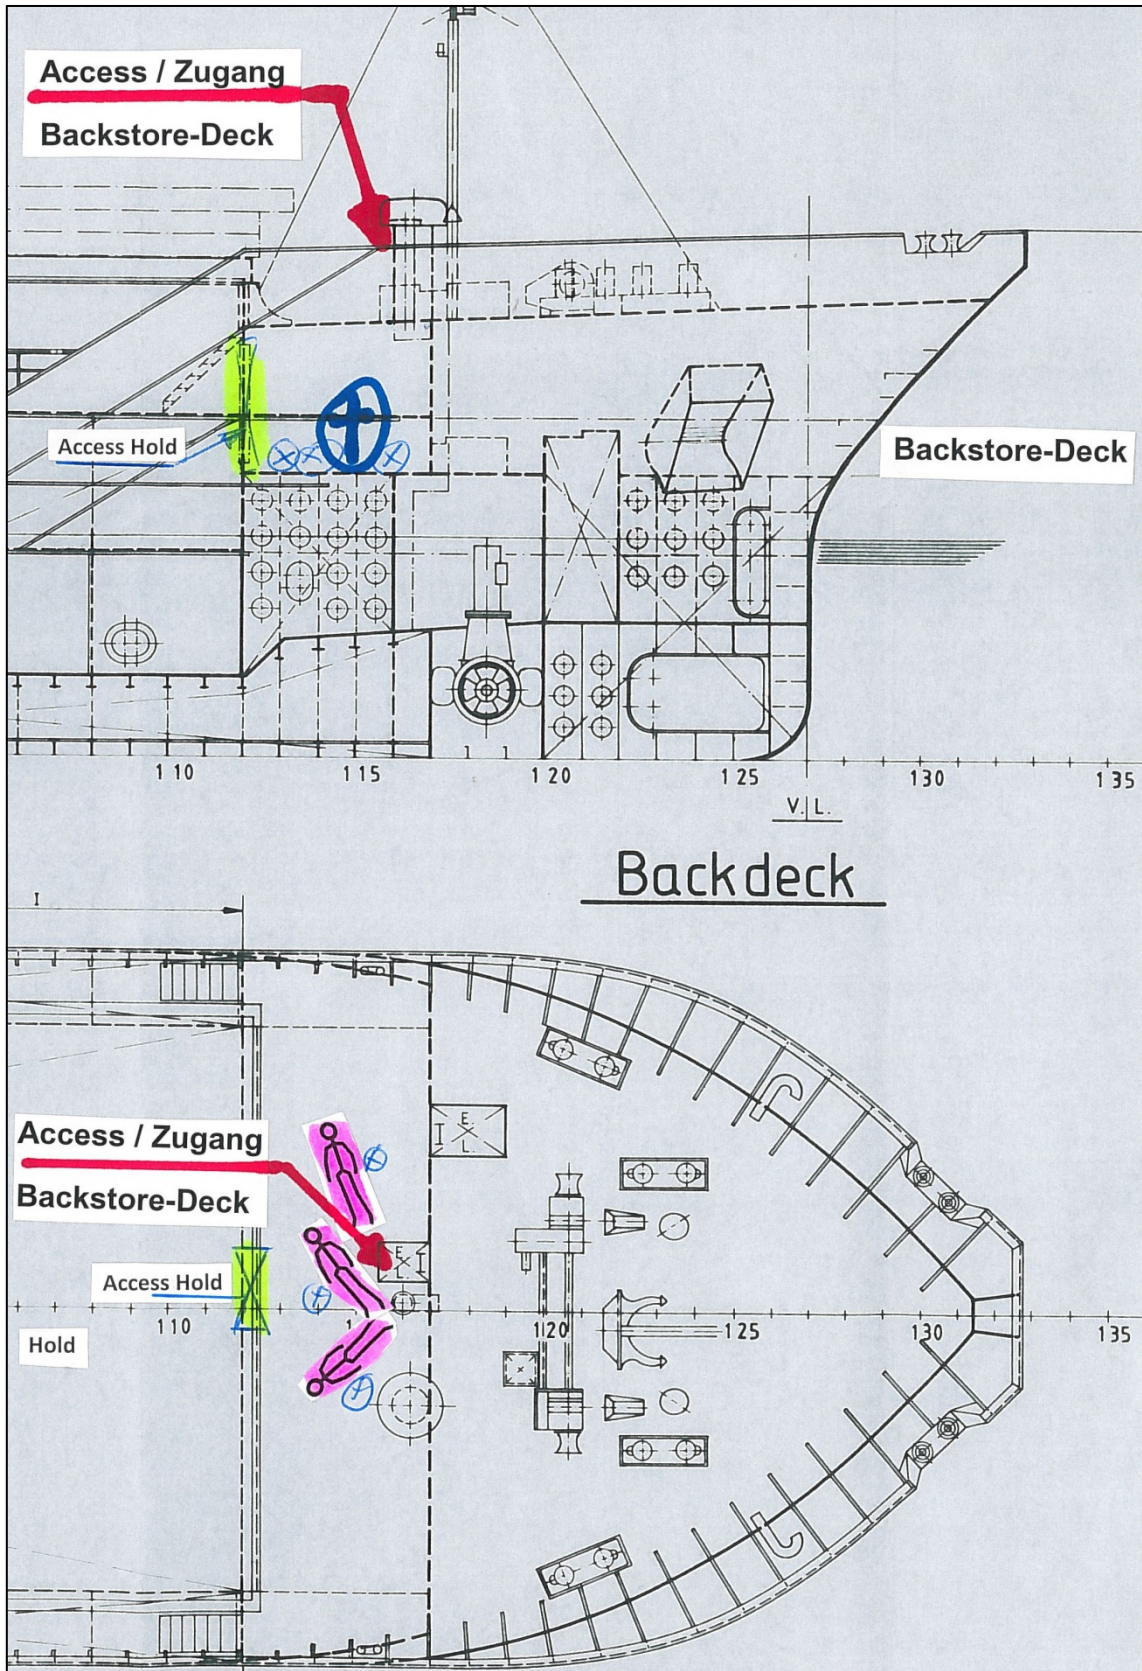
Figure 11: Position of the crew members

The position of the three collapsed crew members is shown on the below drawing:

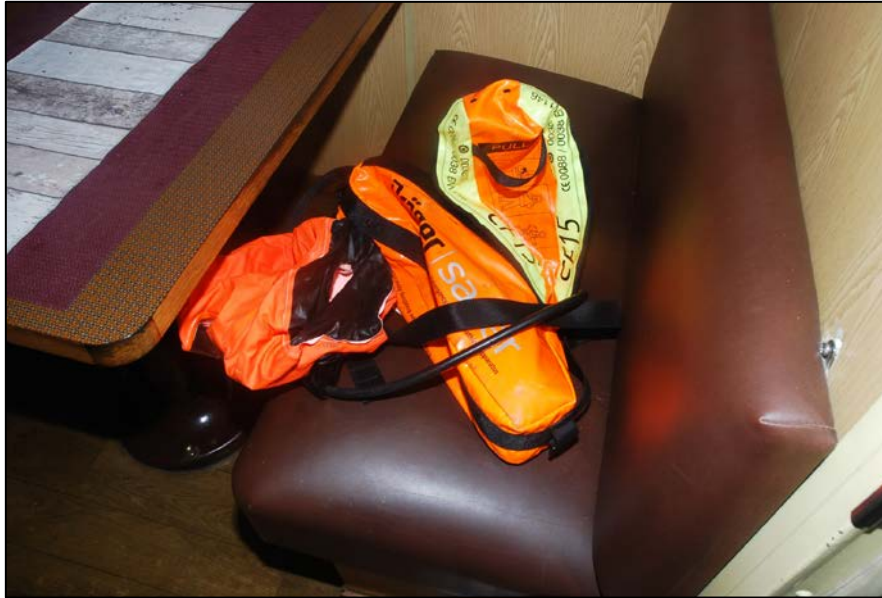
Figure 17: EEBD

An EEBD is a device supplied with air or oxygen, which is intended for a period of use of at least ten minutes. EEBDs should be used to escape from a compartment containing a hazardous atmosphere. They should never be donned to re-enter or work in a compartment containing a hazardous atmosphere.

On the SUNTIS, the EEBDs are stored in the cabin of each crew member.

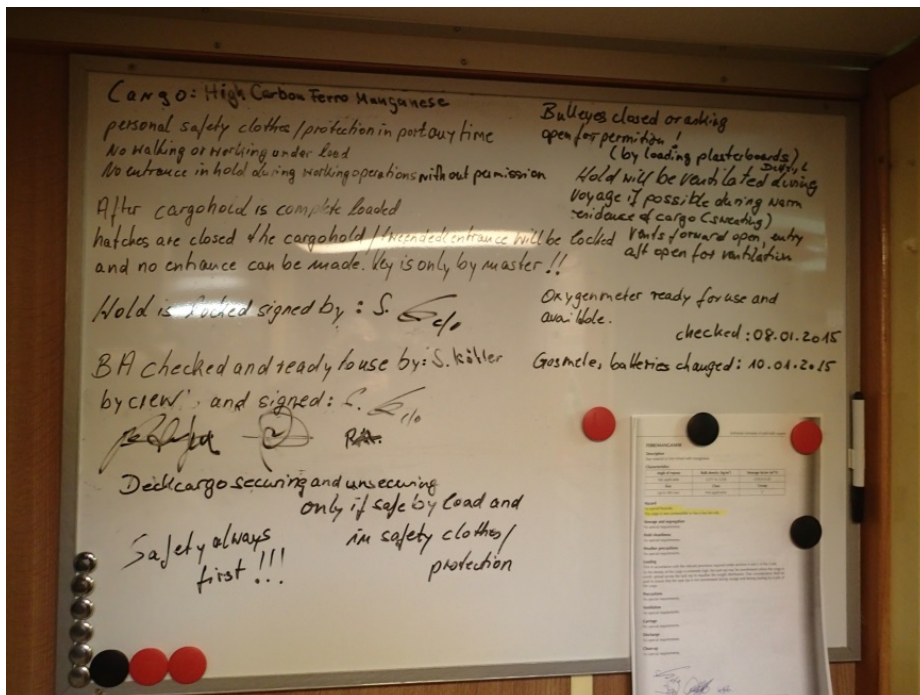
Figure 20: Notice board

- 2.) A lock at the aft access door and at the forward hatch secures access to the cargo hold. The master keeps the key on the bridge.
