Bundesstelle für Seeunfalluntersuchung
Federal Bureau of Maritime Casualty Investigation
Federal Higher Authority subordinated to the Ministry of Transport
and Digital Infrastructure

Investigation Report 266/14

Serious Marine Casualty

**Foundering of PONTON 1
on 13 August 2014
north of Darßer Ort**

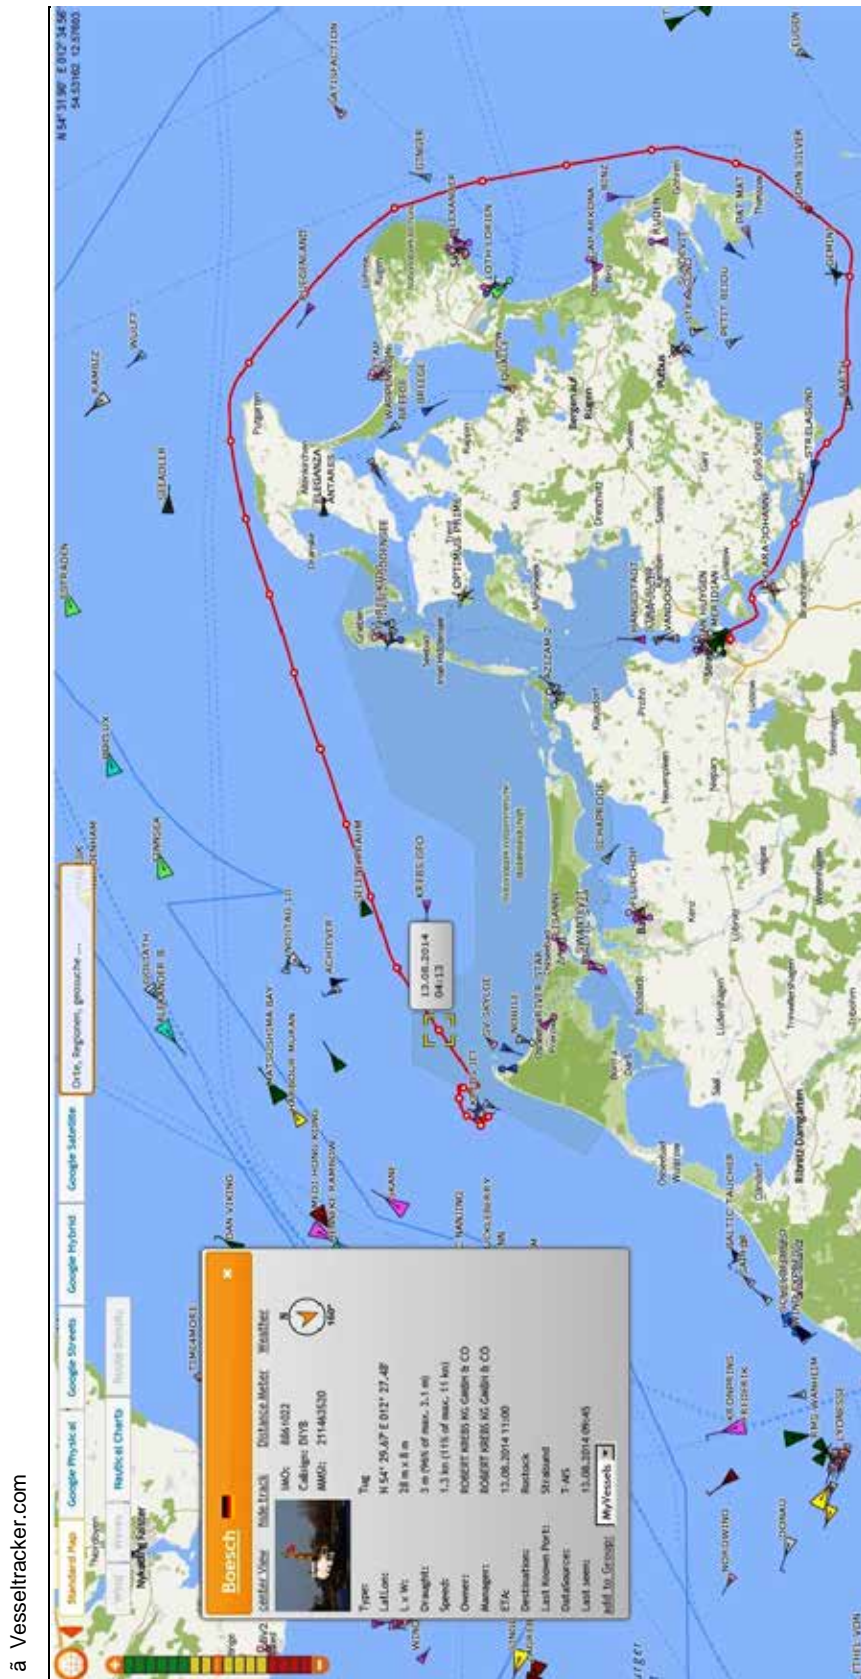
Figure 8: AIS track of the course of the voyage

The BÖSCH let go her anchor at 0755 to remain at the scene. Figure 8 shows the course of the entire voyage of the pushed convoy from leaving the Volkswerft shipyard until the PONTON 1 foundered. It can be concluded after a detailed analysis of the position data that no shallows were passed.

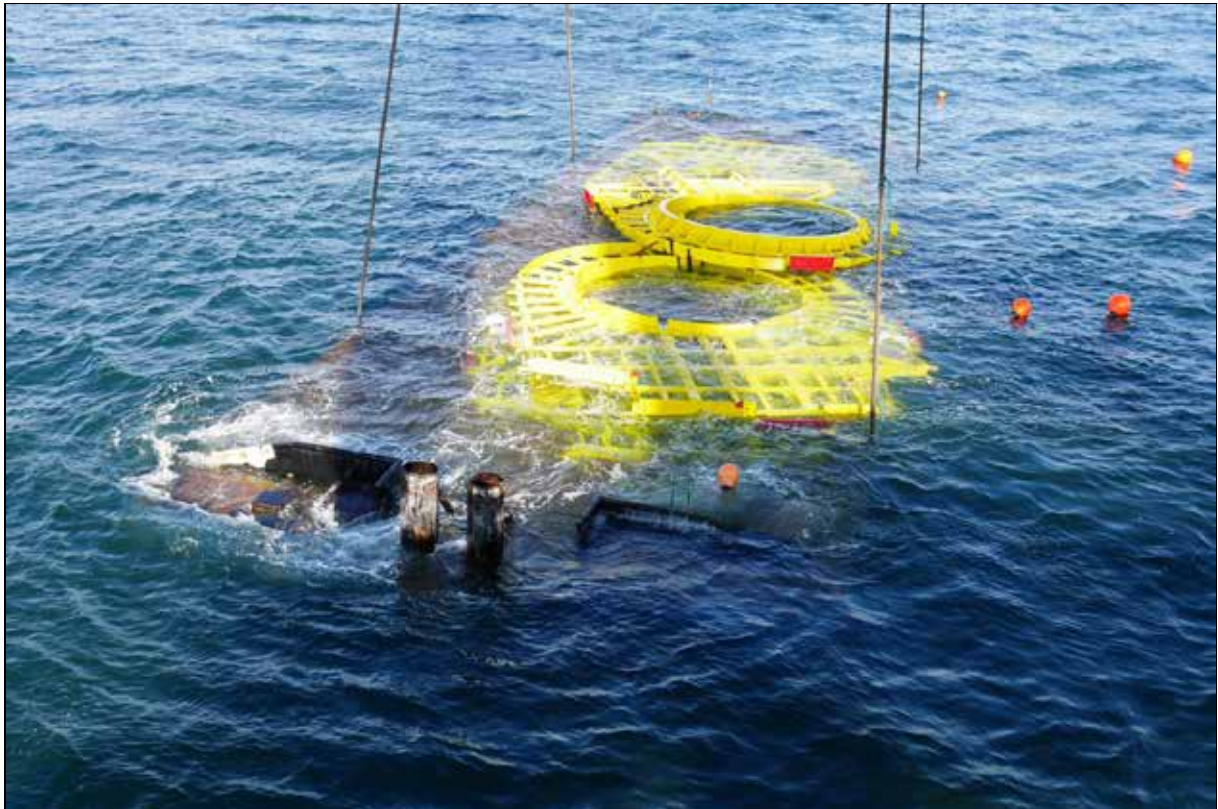
Figure 9: PONTON 1 being salvaged

All sides had already confirmed their intention to salvage PONTON 1 shortly after she foundered on 13 August 2014; however, the weather obstructed this for days. The floating crane SAMSON and the tug OBELIX arrived at the scene of the accident on 26 August 2014. Divers began to pull towing cables under the pontoon. The pontoon was turned under water and then brought to the surface in the afternoon.

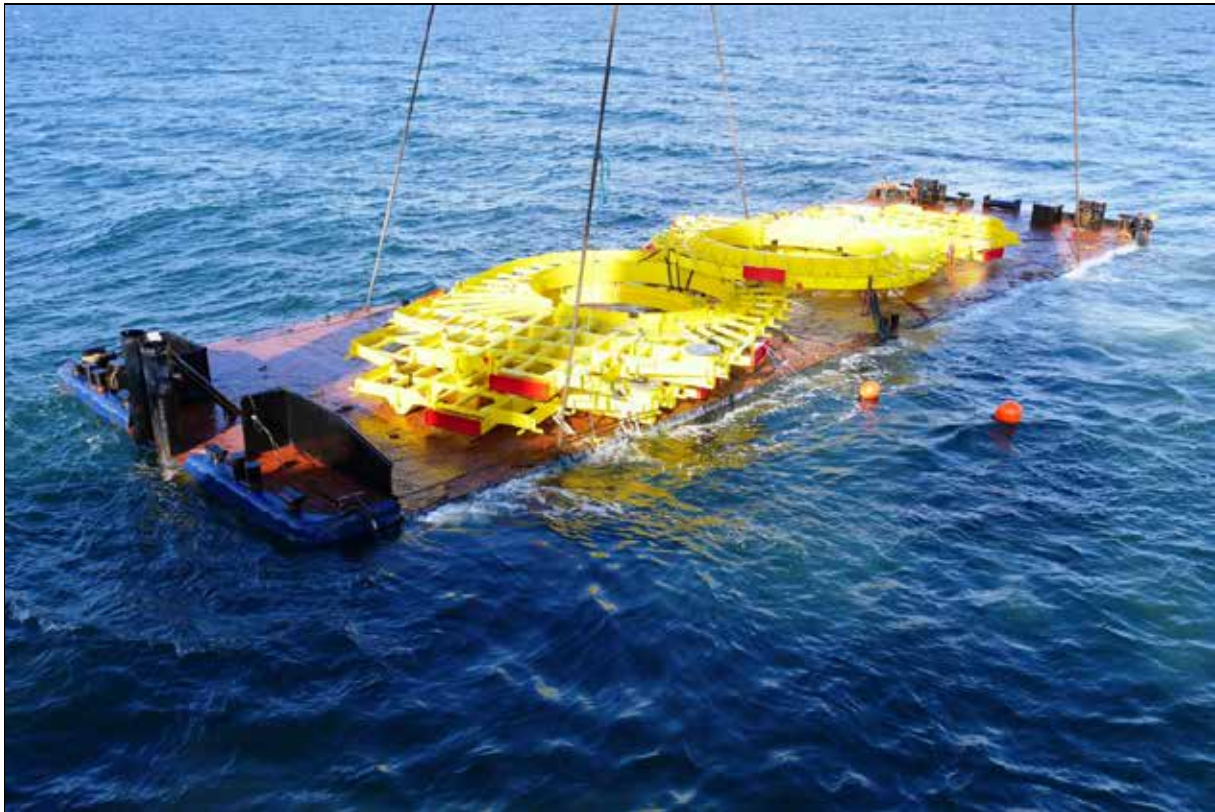
Figure 10: PONTON 1 salvaged

The push tow started to move in the evening and arrived at Rostock early in the morning of 27 August 2014.
