Bundesstelle für Seeunfalluntersuchung
Federal Bureau of Maritime Casualty Investigation
Federal Higher Authority subordinated to the Ministry of Transport
and Digital Infrastructure

Investigation Report 276/14

**Collision in the Kiel Firth
at Friedrichsort between the
MV FRANCISCA and MV RMS BREMEN
on 5 September 2014**

4 September 2015

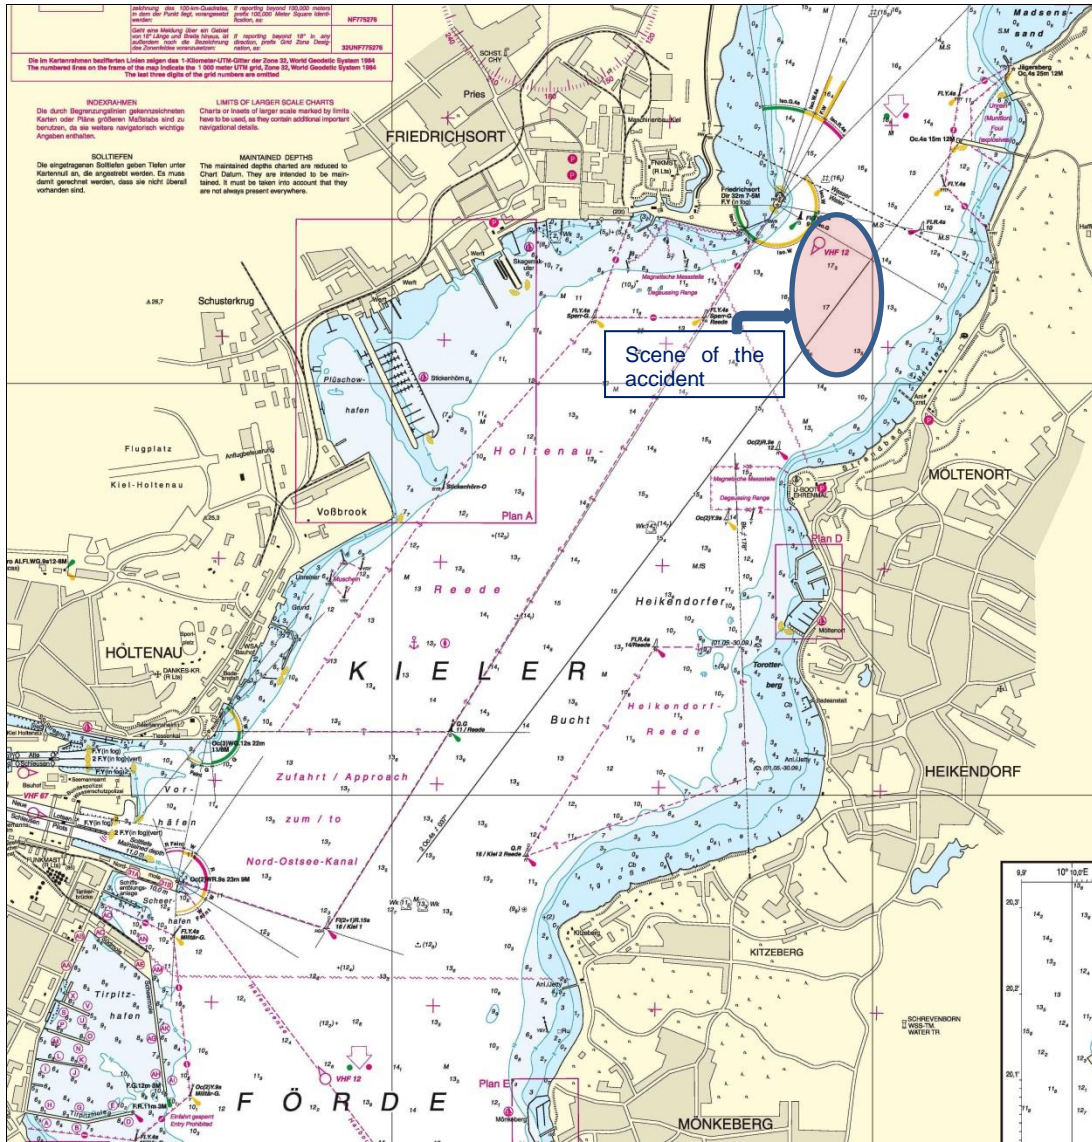
Figure 3: Nautical chart

The BSU was only able to narrow down the scene of the collision (see Fig. 3). According to the GPS data-based AIS recordings, the vessels passed each other at some distance. The recorded positions could not be verified by another coastal system. The vessel traffic service did not save recorded radar images in the Kiel Firth on a long-term basis, meaning they were already overwritten at the time of the investigation and could not be reproduced.

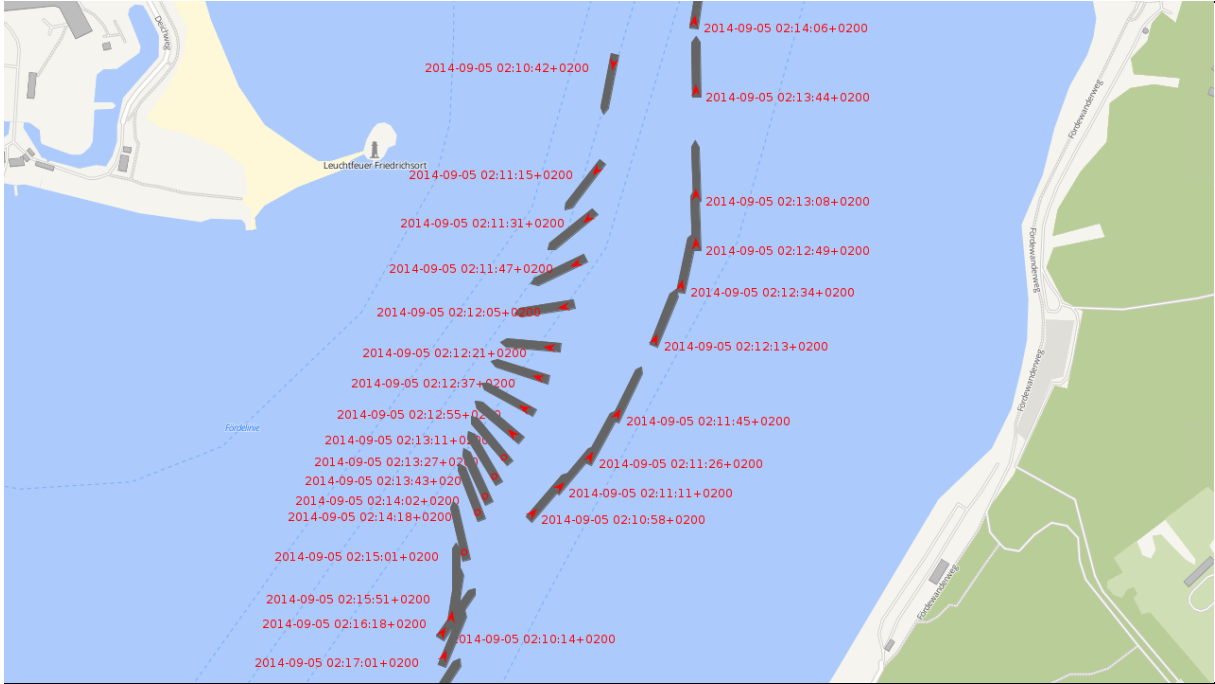
Figure 9: Chart from Vesseltracker made using OpenStreetMap

The scene of the collision does not correlate with the time. At 0211, the time of the collision, the southerly proceeding FRANCISCA and the northerly proceeding RMS BREMEN were far apart and passed one another without touching according to the AIS recordings.

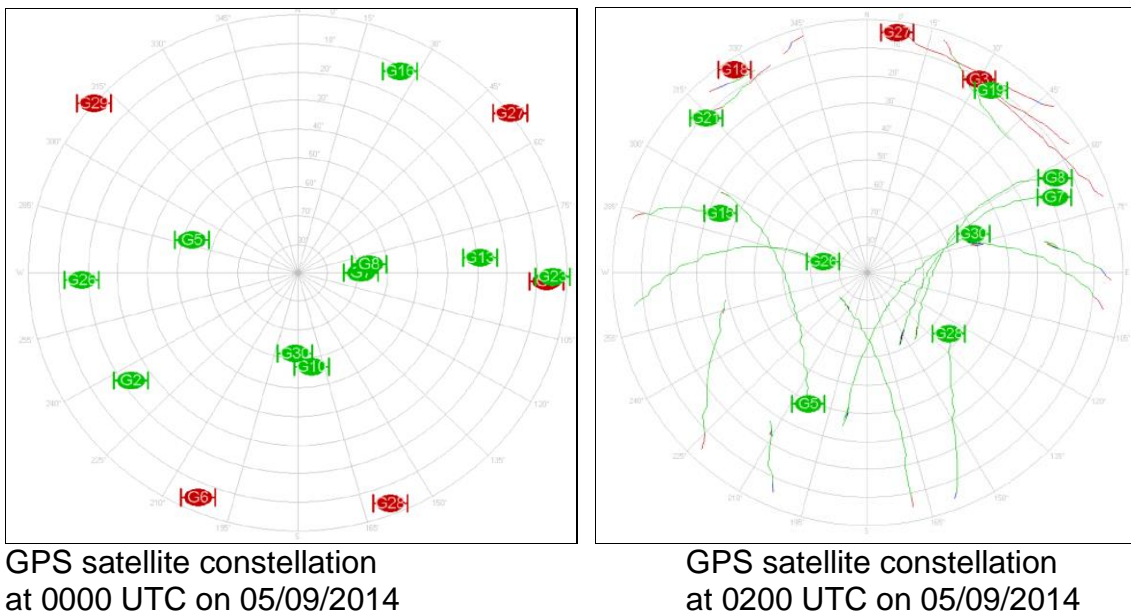
Figure 14: Satellite constellation

Simulated situation at the scene of the accident based on the GPS Observation Archive of the United States Coast Guard (USCG NavCen), GPS Satellite Almanac of 4/5 September 2014 (<http://www.navcen.uscg.gov>). The height of the satellites marked red is less than 10° above the horizon.

A slight deterioration of the available satellite constellation at about 0200 UTC in the vicinity of the scene of the accident is apparent in the simulation. It is not sufficient to explain deviations of more than 20 m, however. Two GPS receivers type tested for maritime shipping did not exhibit any failures or anomalies.
