Investigation Report 364/14

Very Serious Marine Casualty

**Fatal accident due to a rescue
boat on the MTM WESTPORT falling from
height during a boat manoeuvre on the
Outer Elbe roadstead
on 21 November 2014**

20 November 2015

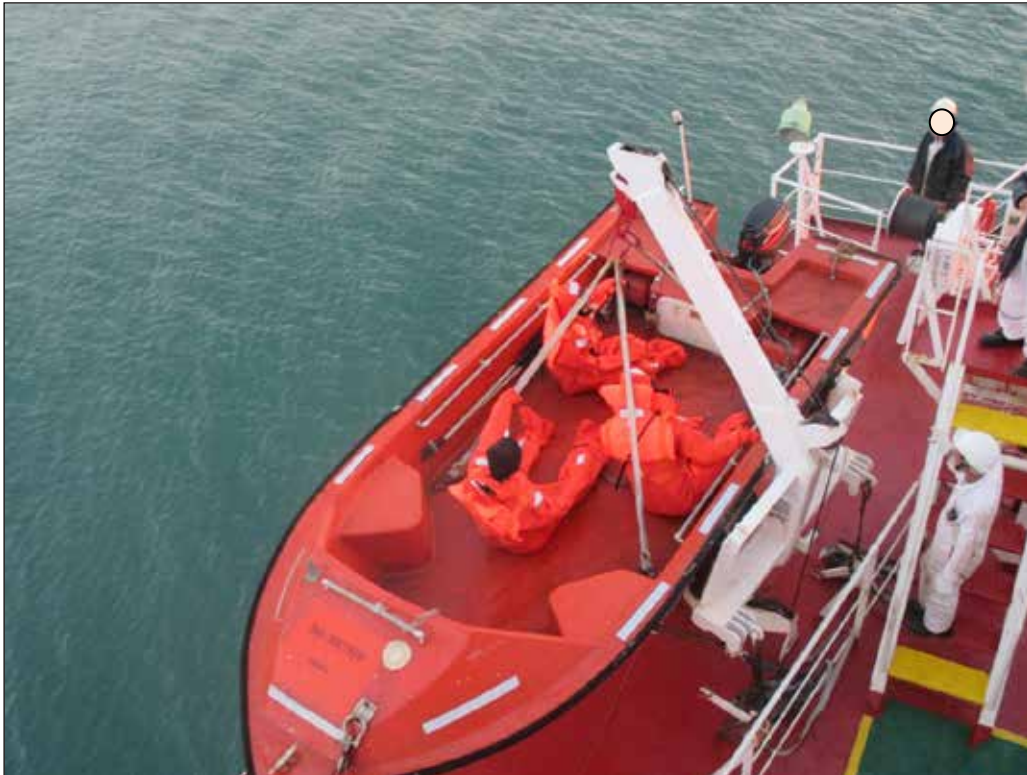
Figure 4: Start of manoeuvre; davit system still retracted

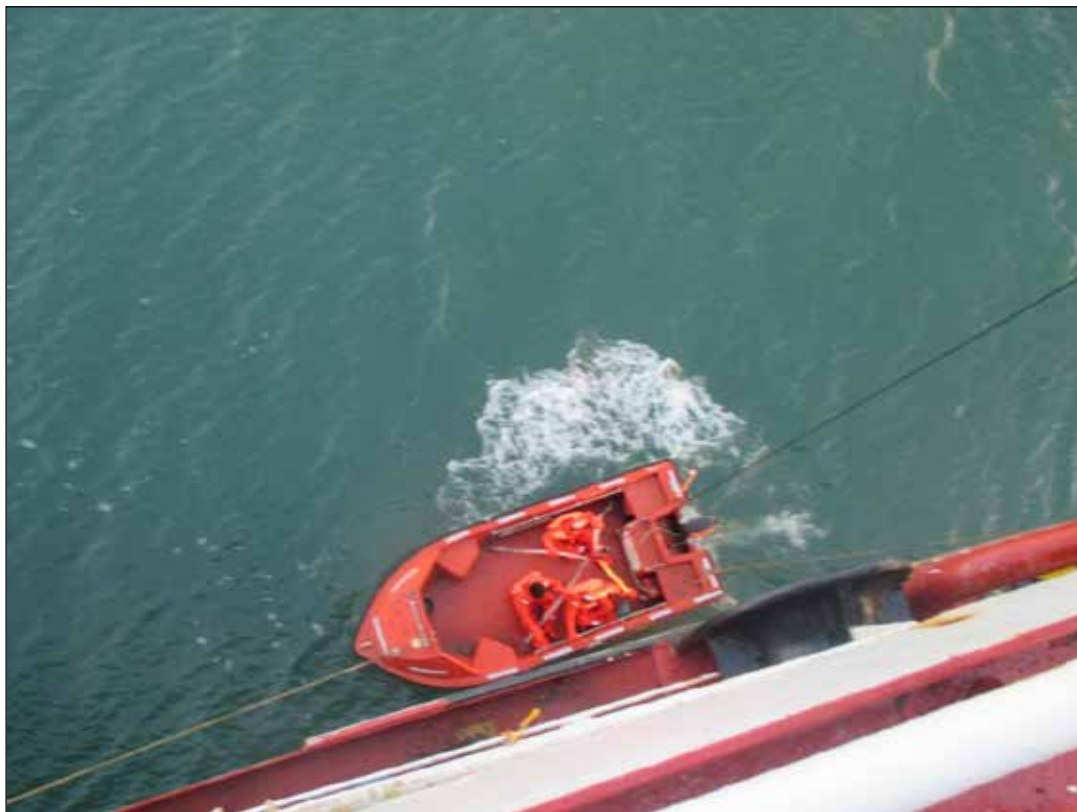
Figure 5: Boat lowered to the water

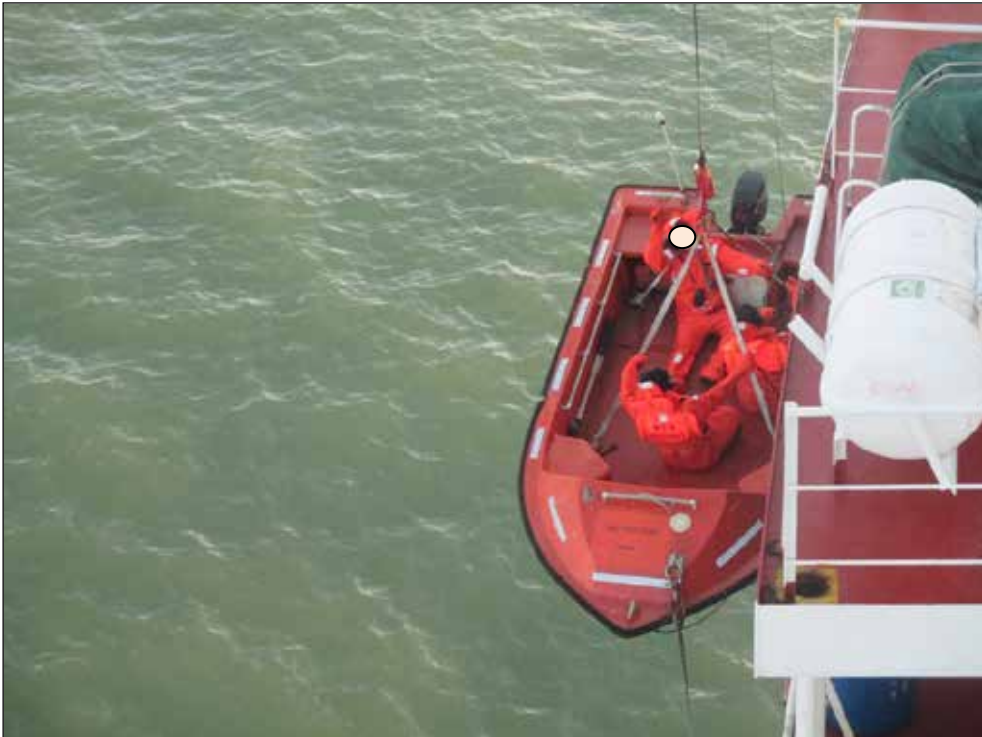
Figure 6: Boat is hoisted out of the water until the davit head is reached

Figure 6 constitutes the key photograph. This must have been taken shortly before the accident because the next photograph in the sequence shows the helicopter. Accordingly, the time of the accident can be set at about 0912.

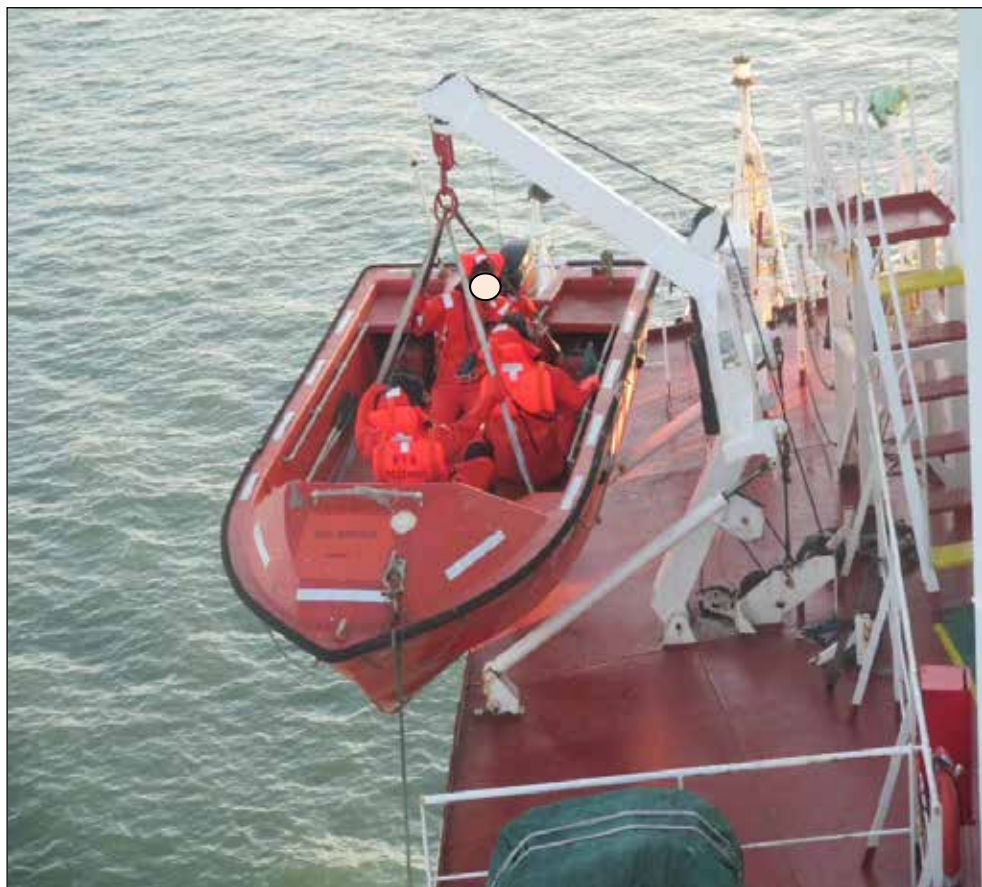
Figure 7: Davit system retracted with the boat

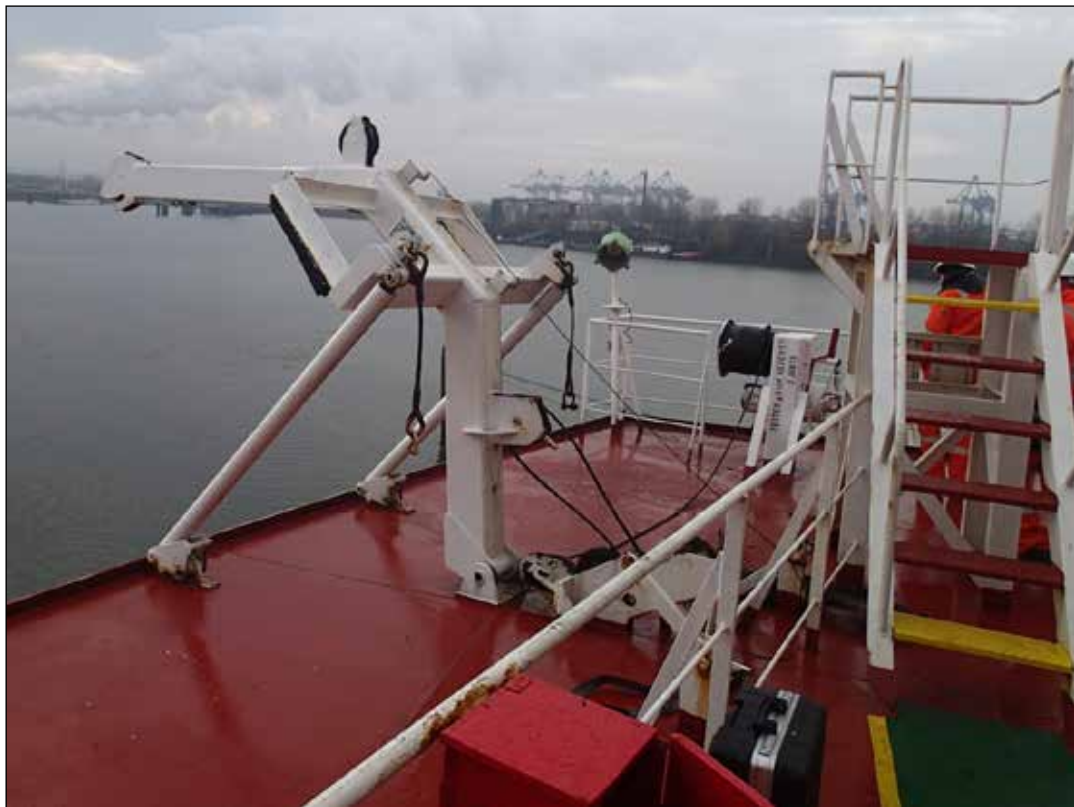
The davit system was found on board in a fully swung out position on the starboard side of the first superstructure deck. The davit system's wire rope was reeved through the guide pulleys only partially. WSP Husum had already seized the parted wire rope that was connected to the davit. The same applies to the parted cable and hook on the boat. The expert later took charge of these two items.

Figure 12: Extended davit system

Damage was not found on the steel structure of the davit system or base. The two spring-loaded cylinders operated as expected.

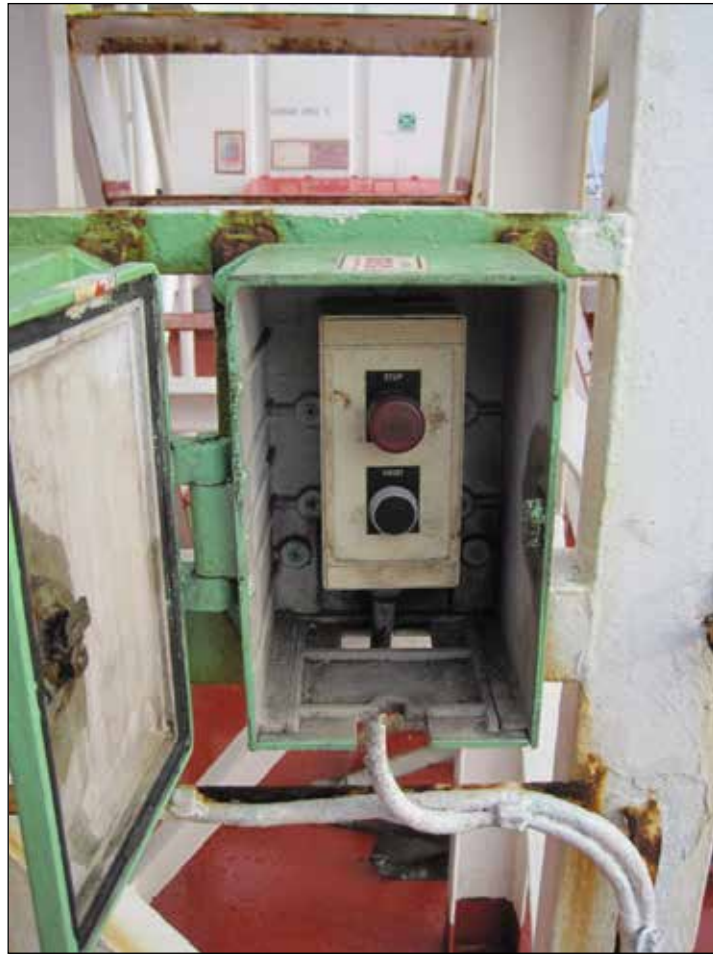
Figure 19: Electrical hoist/emergency shutdown pushbutton next to the davit system

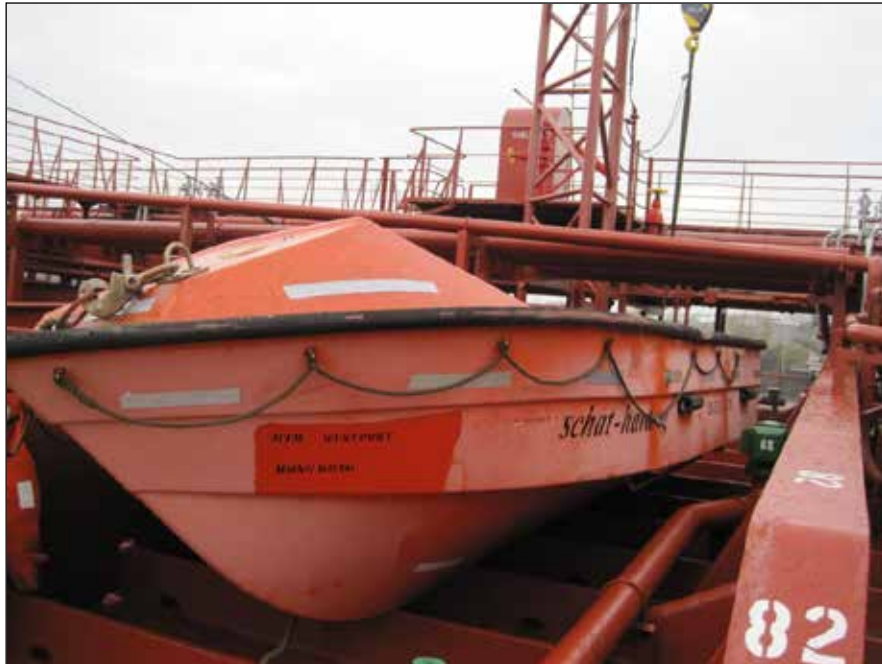
The rescue boat was inspected on the main deck below the pump station. Structural GRP-related damage was not found. The outboard engine was absent and only the retaining bolts were still in place. The rear light holder was torn off. The foundations of the single-point bridle suspension system (where the boat is suspended on the hook) did not exhibit any damage.

Figure 20: Rescue boat – view from fore

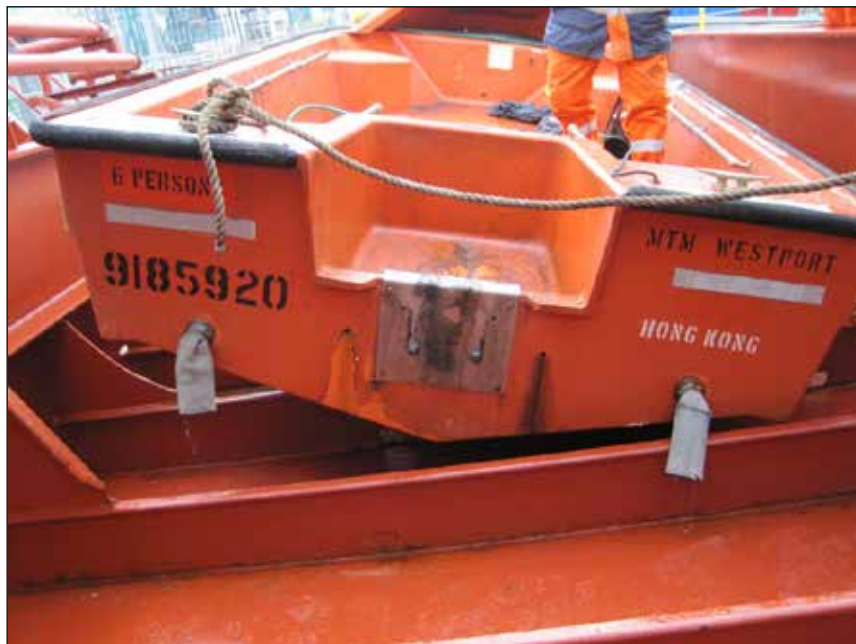
Figure 21: Rescue boat – view from aft with absent outboard engine

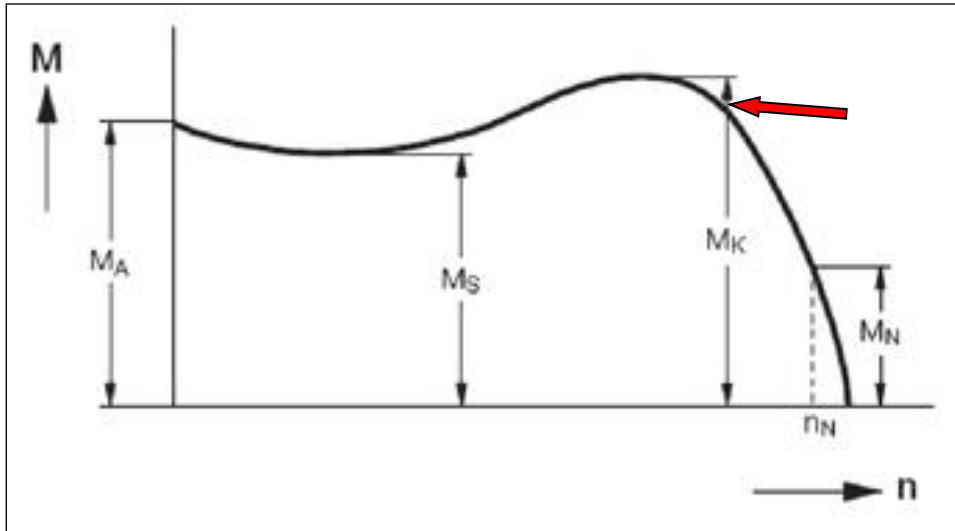
The winch has a rated tensile load of **about 27.98 kN** according to the manufacturer's winch analysis. According to the data sheet for a type 112M04, 5.5-6.5 kW, s2-10 min electric engine, the maximum torque (see Figure 32) could be **220%** higher than the rated value at 440 V/60 Hz operation. This situation arises when retracting to the limit.

Figure 32: Typical moment diagram for a 112M04, 5.5-6.5 kW series electric engine

Mk can reach a value of 220% of Mn.

The following force could have been produced in this operating condition:
 $27.98 \times 2.2 = \mathbf{61.6 \text{ kN}}$

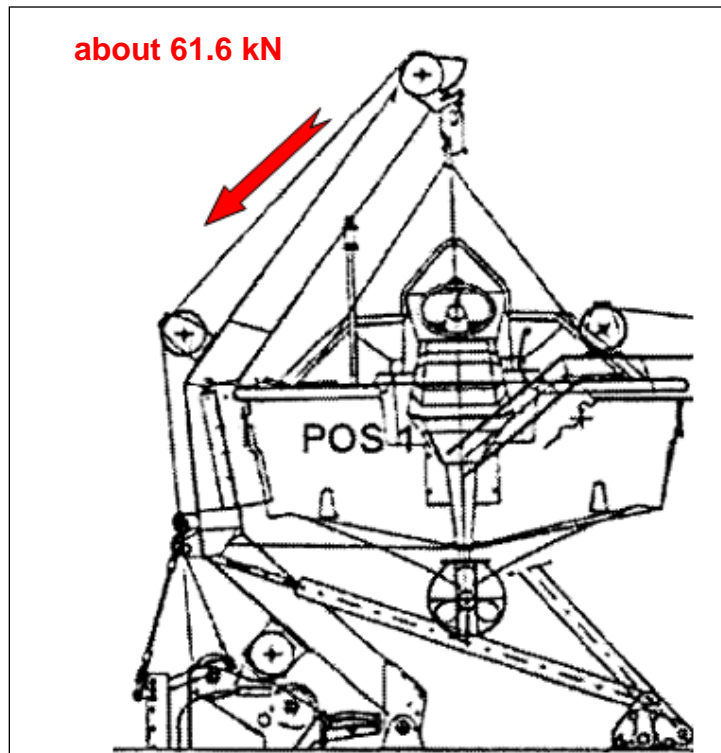
Figure 33: Drawing that shows how the forces act

This load factor is in the vicinity of the breaking load of the corroded point of failure on the davit system's parted cable. This scenario is also supported by the fact that the grease was forced out from the limit's supporting surface (see Figure 30). The injured P2's testimony that the winch was not running during the accident underpins this cable overload scenario.

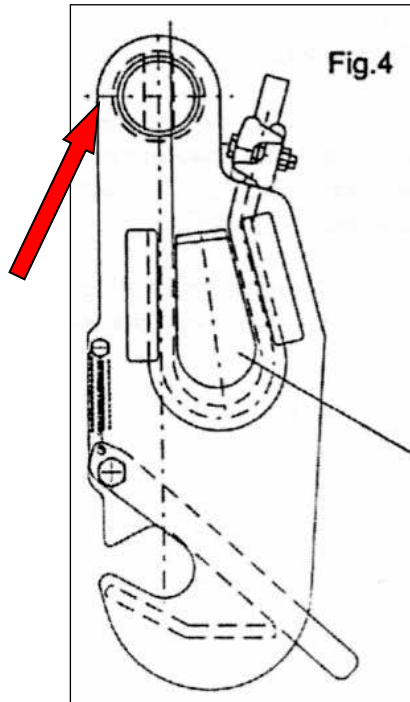
The type RH 1.5 off-load hook was not attached to the davit system's wire rope properly at the time of the accident. Based on this investigation, the BSU concludes that the crew of the ship reattached the hook improperly most recently when the wire rope was turned on 3 June 2013. Due to the cable being improperly attached in this manner, the hook does not hang vertically but is always slightly inclined, as the load-bearing cable is passed through the hook laterally (see Figures 23-25). Page E 7/16 of the INSTRUCTION MANUAL SA 1.5 Davit shows the correct assembly. A further consequence of this improper assembly is that the cable clamp integrated with the lateral cable exit rests against the cable sheave when the davit system is retracted. This means that the hook cannot slip inwards on the davit head, as provided for in the design. The measured angle at which the hook meets the davit head of about 36° is also determined in the theoretical reconstruction of the interaction between the davit head and hook and thus credible. The documented dents on the hook attachment points are indicative of considerable pressure.

Figure 34: Page E7/16 of the manual – drawing shows the correct assembly of the rope attachment in the hook
