# Summary Investigation Report 373/13

**Serious Marine Casualty**

Collision while mooring between the MV MERWEBORG and the ro-ro MV CAROLINE RUSS at Steubenhöft in Cuxhaven on 12 December 2013

1 December 2014

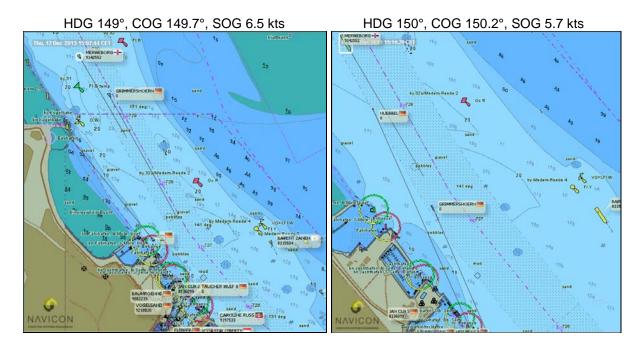
Heading (HDG), course over ground (COG), and speed over ground (SOG)

AIS (automatic identification system) analysis from the Joint Control Centre of the Waterway Police of the Coastal States in Cuxhaven. A time lag exists compared to the VDR analysis at the BSU and the BAW in Hamburg. The times displayed must be corrected by +65 seconds to make them consistent with the VDR data. The VDR times are correct. The BSU notified the control centre in Cuxhaven of the issue on 10 September 2014.

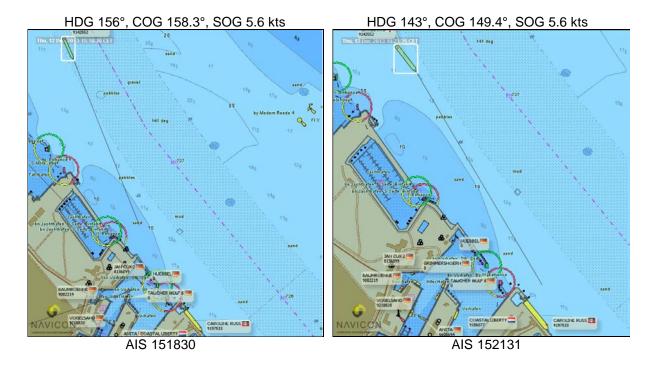
AIS 150740 AIS 151429

The MERWEBORG heads at an acute angle from the edge of the dredged channel directly for her berth at Steubenhöft. The COG is directed at the end of the pier.

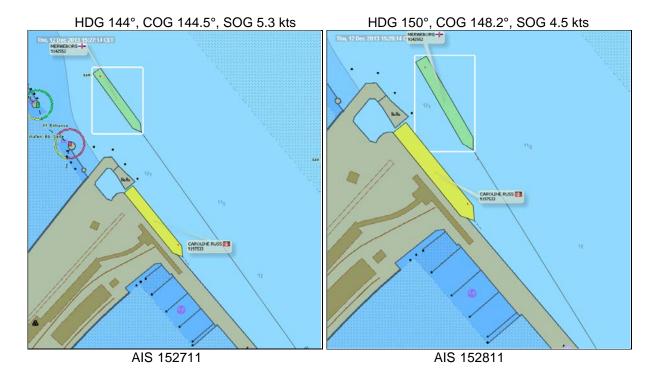
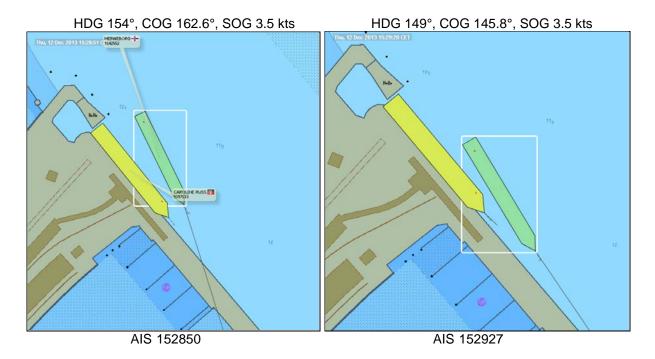
It is evident that the heading was briefly changed to about 5° to port between 1522 and 1526, while at 5.6 kts the SOG remained almost stable. The speed was not reduced until after that. At 1528, when the MERWEBORG reached the CAROLINE RUSS up to amidships, the transverse distance from the forecastle only stood at 40 m at a speed of 4.5 kts.

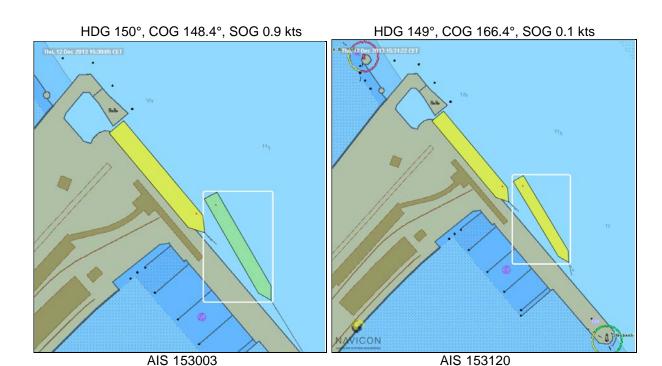
The speed during the berthing manoeuvre was too high and the passing distance too low. That it would culminate in a collision was inevitable. Hydrodynamic interactions were to be expected in the area of the CAROLINE RUSS. With its reverse berths for recreational craft, Steubenhöft is on stilts at the pier, i.e. not separated by a wall from the Elbe current.

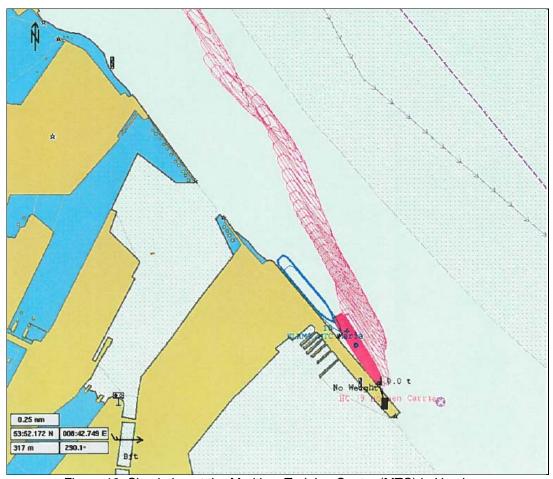
Figure 10: Simulation at the Maritime Training Center (MTC) in Hamburg

On 28 May 2014, several berthing manoeuvres involving Elbe pilots at Steubenhöft under similar conditions to those of the MERWEBORG were simulated at Maritime Training Center in Hamburg. The ebb current was set at 4 kts in accordance with the information then available. The BSH's sailing directions for the North Sea indicate that the tidal streams along the quay facilities set across and at times into the entrances at up to 5 kts. The manoeuvre is shown in the form of a time lapse in Fig. 10. For reasons of simulation, a current setting away from the pier had to be taken into account while berthing at Steubenhöft. It is striking that during this manoeuvre, at 1-2 kts SOG, the vessel sailed much slower, closer and more parallel to the pier than during the accident. The current model at the Steubenhöft berth was reportedly not true to reality. In particular, manoeuvres had to be continuously corrected when berthing. Hydrodynamic interactions were reportedly not sufficiently accounted for in the model. Nevertheless, a different approach of pilots is clear: they did not take the direct track from the fairway to the berth. The direct approach at smaller distances and a speed of 5.5 kts resulted in a collision in the simulator, too (see Fig. 11).
