Bundesstelle für Seeunfalluntersuchung
Federal Bureau of Maritime Casualty Investigation
Federal Higher Authority subordinated to the Ministry of Transport
and Digital Infrastructure

Investigation Report 99/13

Serious Marine Casualty

**Fire on the con-ro carrier
ATLANTIC CARTIER on 1 May 2013 in the Port
of Hamburg**

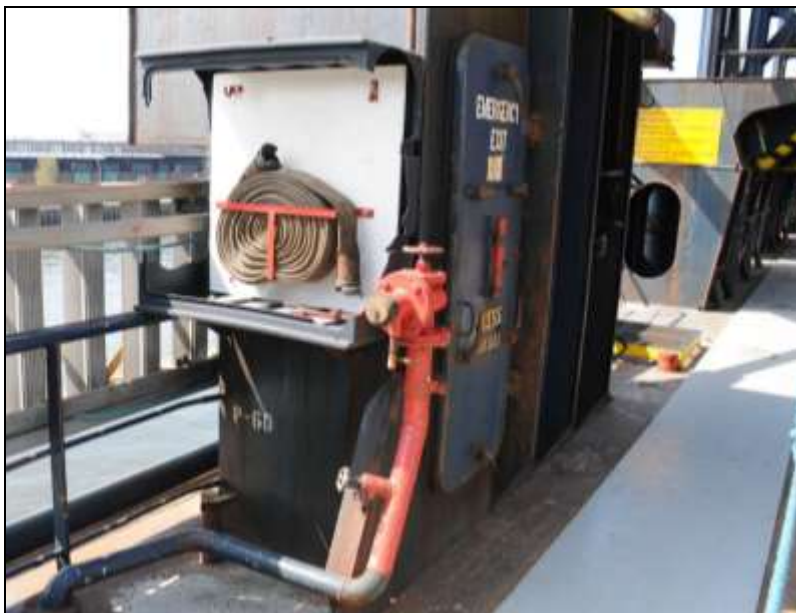
Figure 3: Emergency exit for ro-ro decks 3, 2 and 1 on the main deck

In preparation for further action, inter alia, a turntable ladder was used to establish direct access between the pier and main deck of the ship, seaborne water supply from a fireboat was set up, and potential access routes for fighting the fire on deck 3 B were explored. Here, special attention was given to the emergency exits on the main deck, each of which are not in the immediate vicinity of the presumed seat of the fire but give access to all ro-ro decks below deck via vertical ladders (see **Figure 3** above).

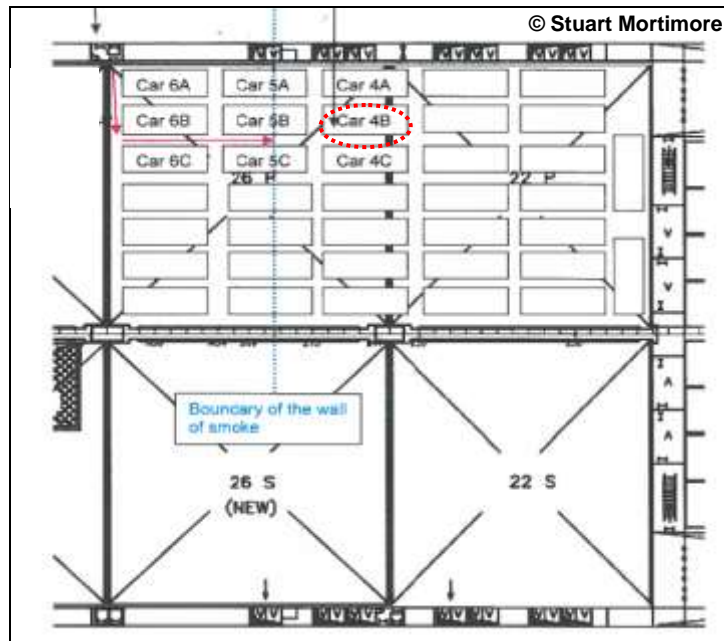
Figure 4: Witness Y's route on deck 3 B⁸

The route shown in **Figure 4** above and the marked boundary of the wall of smoke and fire source (car 4 B) correspond with the account of witness Y. The witness reportedly selected the route between the second and third row of vehicles, as it was claimed that its width was greater than between rows 1 and 2.

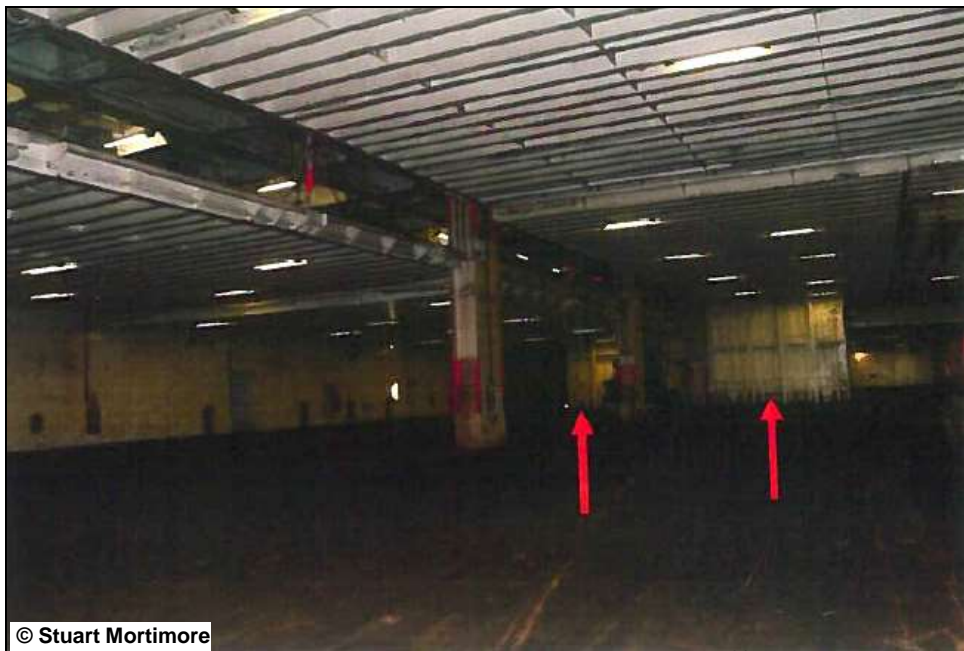
On **Figure 15** below, it can be seen that the two sliding doors (see also the blue marking above in **Figures 12** and **13**) located in the area of frame N 11 (boundary between bay 35 and bay 37 of the main deck), i.e. within the section of the ship inserted subsequently, are half-open. They are two hydraulically operated steel doors

The two sliding doors were supposedly closed during the ATLANTICS CARTIER's passage from Gothenburg to Hamburg. Accordingly, the starboard sliding door must have been opened at some point after she made fast in Hamburg and prior to the outbreak of fire, as establishing watertight integrity was one of the subsequent activities in connection with making ready for the CO₂ extinguishing action.

Figure 15: Sliding doors in cargo hold 3²⁴

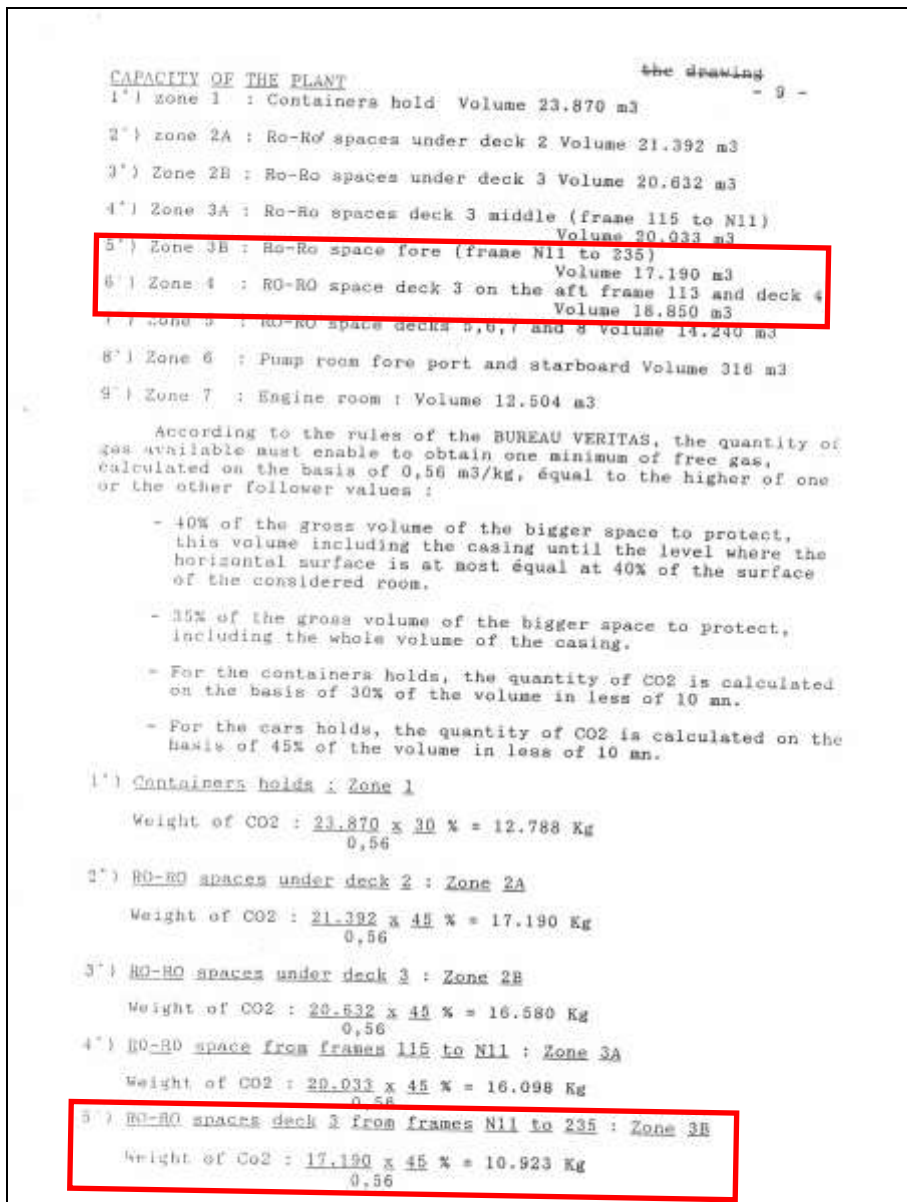
While reviewing the technical documents for the CO₂ installation, it was noted at various points that they contain incorrect or partially difficult to understand information with regard to certain volumes and computations, inter alia (see the areas

highlighted in red in **Figures 26 f.** below, for example). For example, according to the information given at the top of page 9 of the technical description created after the ship was lengthened, the volume of zone 4 is 18,850 m³. However, as regards the important computation of the CO₂ quantity needed to flood this zone, page 10 of the description specifies a volume of 13,850 m³. Another error is at the bottom of page 9 in the important computation of the CO₂ quantity necessary for zone 3 B. The result of this calculation (17,190 x 45% ÷ 0.56) is actually 13,813.39 kg, and not the 10,923 kg specified.

Figure 26: Extract from the technical description of the CO₂ installation after the ship was converted (page 9)

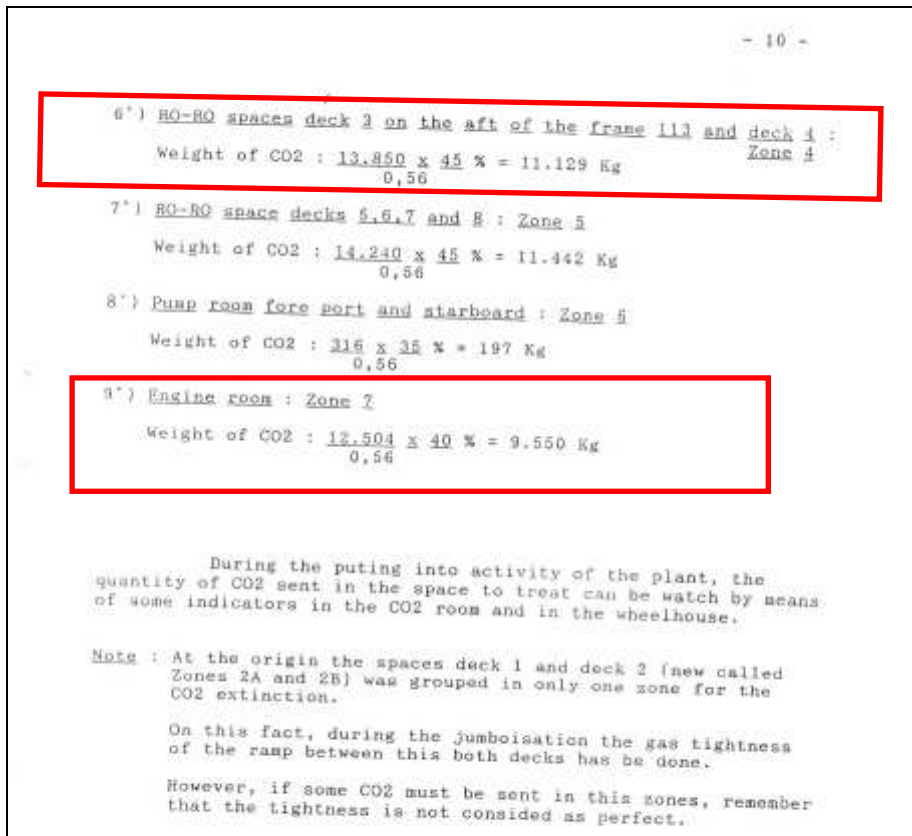
Figure 27: Extract from the technical description of the CO₂ installation after the ship was converted (page 10)

The calculation of the CO₂ quantity for the engine room on page 10 of the above technical description is also incorrect, as the result of this calculation (12,504 x 40% ÷ 0,56) is actually 8,931.4 kg and not 9,550 kg. In reality, the calculation for the engine room at the bottom of page 3 of the original technical description of the system manufacturer arrives at the latter result when based on a (alternate?) volume of 15,281 m³ and a 35% flooding requirement (see **Figure 29**).

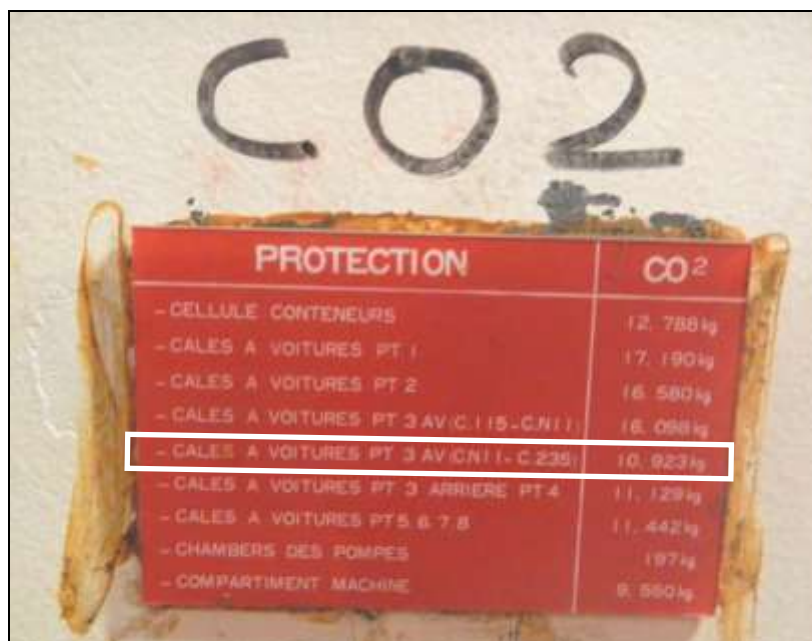
The CO₂ quantity 'calculated' in the technical description for zone 3 B (10,923 kg) is shown on an information panel in the CO₂ control room, which contains details – in French – of the CO₂ flood quantities necessary for the various zones (see **Figure 28** below).

Figure 28: Overview of the CO₂ flood quantities (CO₂ control room)

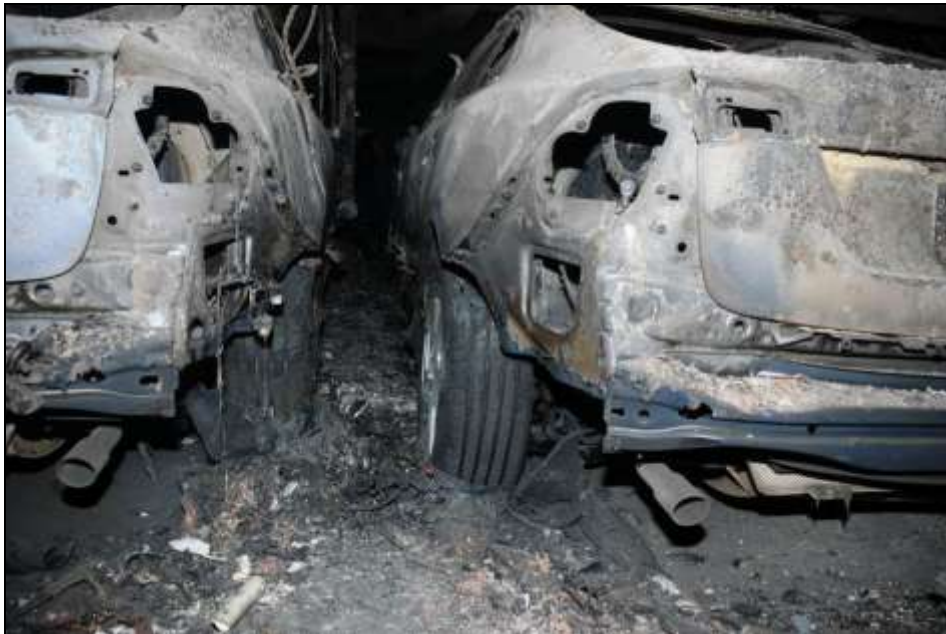
*When considering the severity of the damage, it is evident that no effective action was taken to fight or contain the fire in the affected deck over a period of hours. Consequently, the fire was able to spread unhindered. That the entire cargo on the affected deck was not destroyed is thanks only to the specifics of the cargo, i.e. the fire resistance of the cars loaded. It is apparent that leaking fuel did not cause an extensive spread of fire, either. Most of the tyres survived at least partially even on the burnt out vehicles (see **Figure 48** below).*

Figure 48: Spread of fire from above by heat radiation

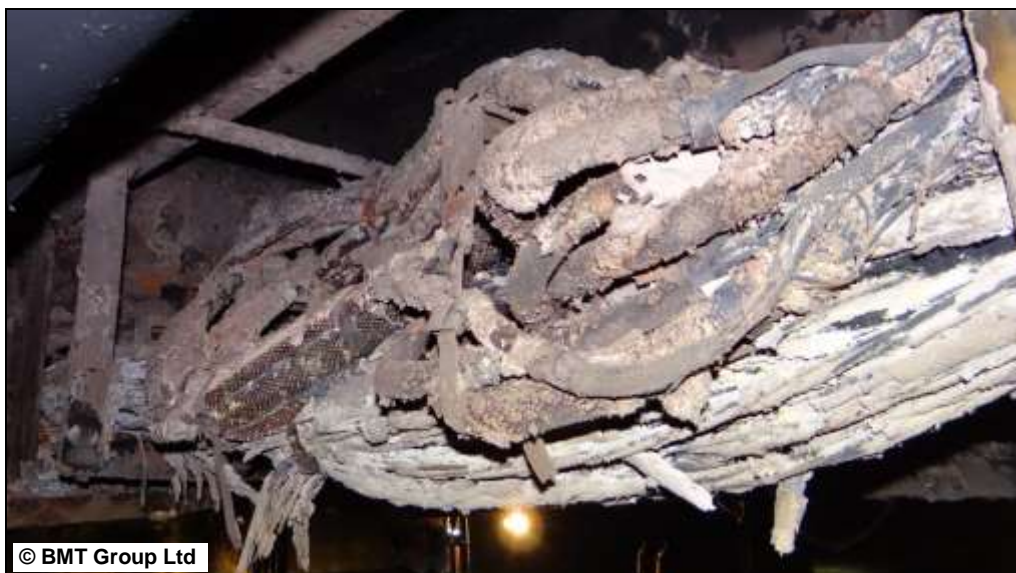
Figure 61: Cable splices on the ceiling of vehicle deck 3 B³⁴

*In the opinion of the cargo insurer's expert, all the electric wiring on board the ship was defective and fire prone to an unusually high degree. According to that, evidence of inadequate wiring was revealed by cable loops protruding from the protective sheath, traces of corrosion on cables, cable connections of inconsistent strength, existing damage to cables due to welding operations, damage due to abrasion caused by metal cables, forcibly bent cables inside the insulation, damage to the insulation due to overheating, and traces of several earlier fires on deck 3 B. Indicative of the cable routing was numerous cable splices originating for the most part from the lengthening of the ship (see **Figures 61 f.**).*

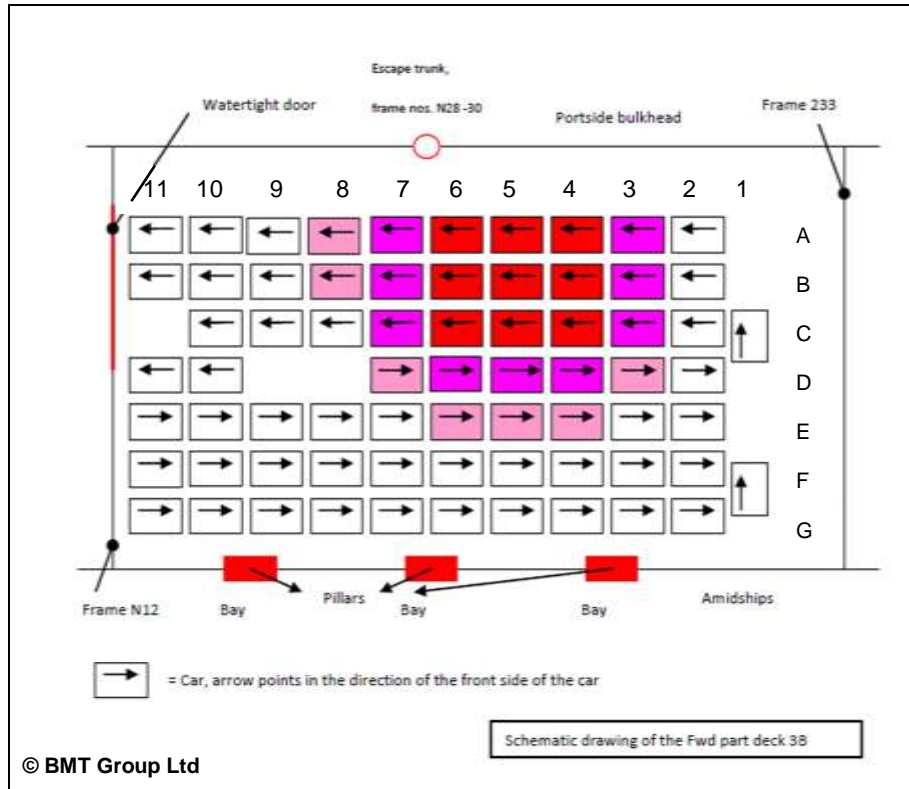
Figure 63: Schematic drawing showing the cars stowed on deck 3 B (port side)³⁶

There were about 200 cable splices in the area above vehicle 4 B alone at the time of the fire. **Figure 63** below is a schematic drawing showing the cars stowed in the forward part of deck 3 B. The nine vehicles affected by the fire most severely are highlighted in red.

Finally, to prove the existence of inadequate or damaged cable insulation, conspicuous signs of corrosion caused by the particularly aggressive saliferous air on seagoing vessels are referred to. This causes the formation of bright green copper chloride on metal conductors without proper insulation. The experts found chemical reactions of this nature on wiring above the positions 4 and 5 B (see **Figure 63** above and **Figure 74**).

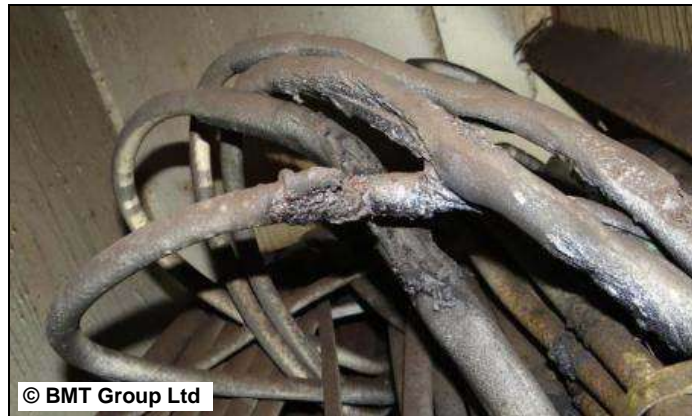
Figure 66: Example of charred cable insulation (1)³⁹

Such inconsistencies in diameter cause electrical resistances capable of generating heat until the metal conductors are red hot. Traces of such overheated cables and scorch marks can be found at various points on deck 3 B (see **Figures 66 to 68** below).

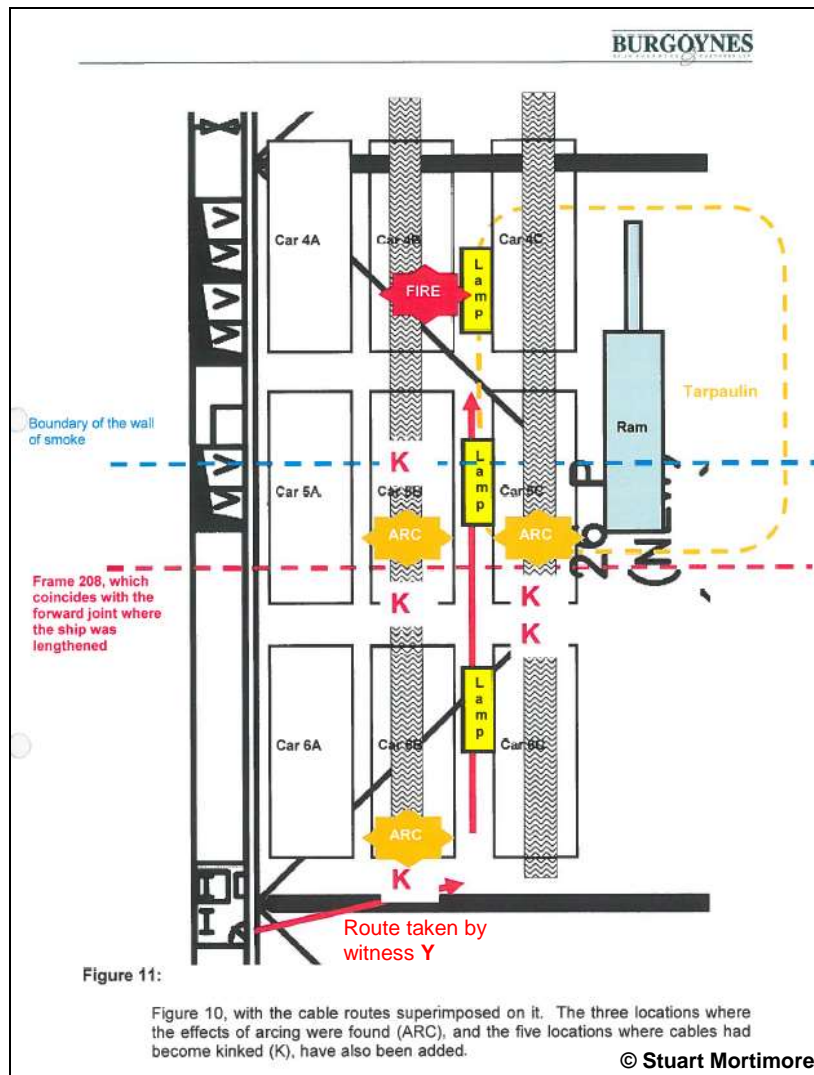
Figure 78: Schematic drawing of selected conditions in the vicinity the seat of the fire⁵¹

*The expert agrees with the respective experts of the cargo insurer and the BSU that the fire spread from the area of the fourth row of vehicles in the forward part of vehicle deck 3 B on the port side. The expert prepared the schematic drawing below to illustrate the specific circumstances and location of the focal points of the investigation in the vicinity of the nine cars most severely affected by the fire (see **Figure 78**).*

The area outlined in yellow at the top right of **Figure 78** above indicates a hydraulic ram in the vicinity of the fourth and fifth vehicle rows, which is needed for raising and lowering the segments of vehicle deck 3 B. To protect the vehicles stowed in the immediate vicinity of this hydraulic ram from oil spills escaping from the ram system, tarpaulins are hung above the vehicles stowed in the areas in question (see **Figures 92 f.** below). These tarpaulins are coated with an exchangeable absorbent textile layer.

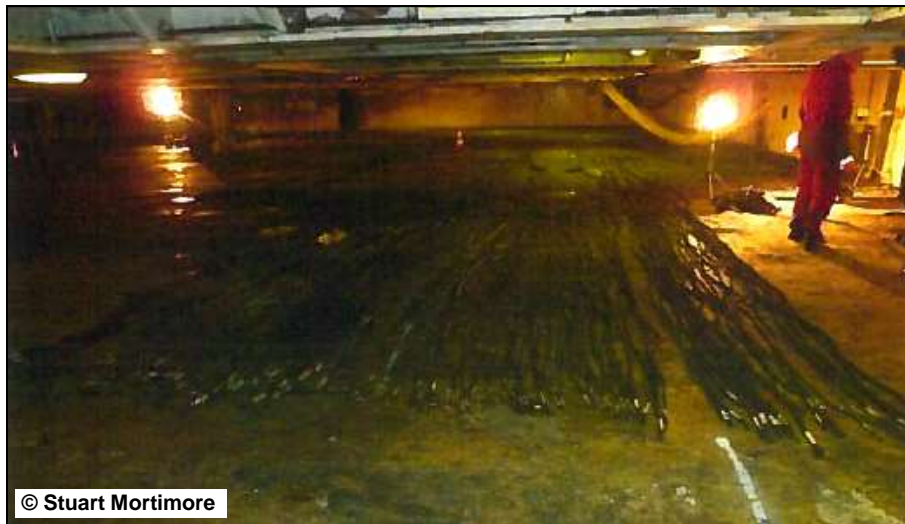
Figure 79: Example of dismantled cable harnesses⁵²

In the course of the second local investigation after deck 3 B was fully cleared, the entire electric wiring in the forward section, i.e. the section of deck 3 B primarily affected by the fire, including the transition to the aft section of this deck was thoroughly inspected and the parts damaged by the fire then dismantled (see **Figure 79** below).

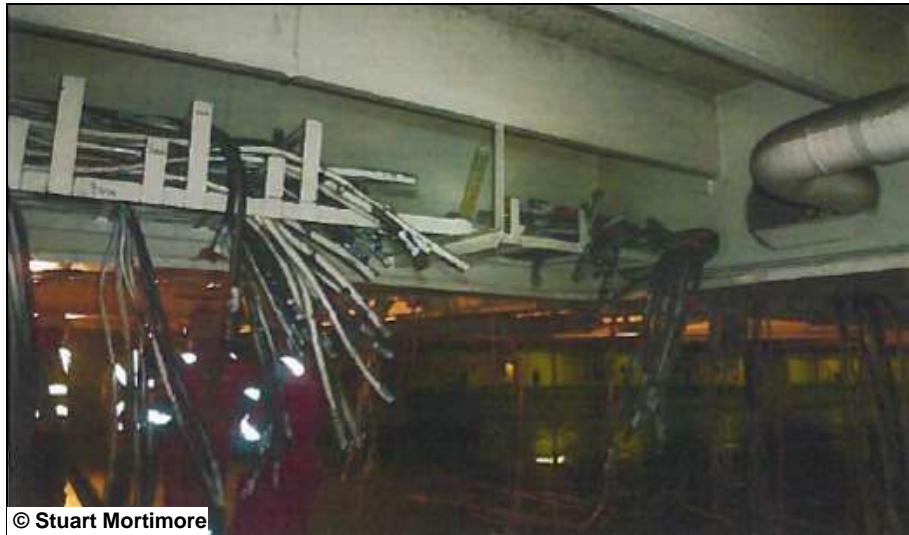
Figure 81: Rear cable splice⁵⁴

*In contrast, the rear cable splice (in the vicinity of frame 207) was located outside the forward section of the vehicle deck, which was affected primarily by the fire and isolated from the rest of deck 3 by the sliding door. Consequently, this cable splice was not destroyed and could be examined in greater detail (see **Figures 81 f. below**).*

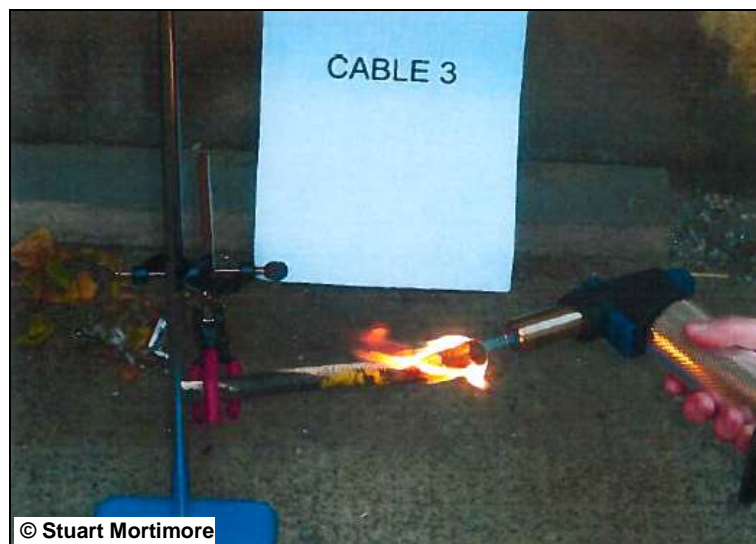
Figure 84: Test setup – ignition and fire performance of a cable sample⁵⁶

*An investigation of the plastic material used for the insulation and sheathing, which was performed in a laboratory, revealed that they both contain fire-retardant additives. The ignition or fire performance of three single cables of different sizes or with different sheaths was tested in a laboratory using a lighter and a blowlamp, among other things (see **Figure 84**). It was not possible to set the various cables on fire with a lighter. While it was possible to ignite two of the three types of cable tested using a blowlamp, the fire extinguished within two or 25 seconds of the heat source being removed. It was also found here that the plastic insulation did not start to drip during the burning phase. Propagation of the fire on the insulation, similar to an ignition fuse, was not evident either.*

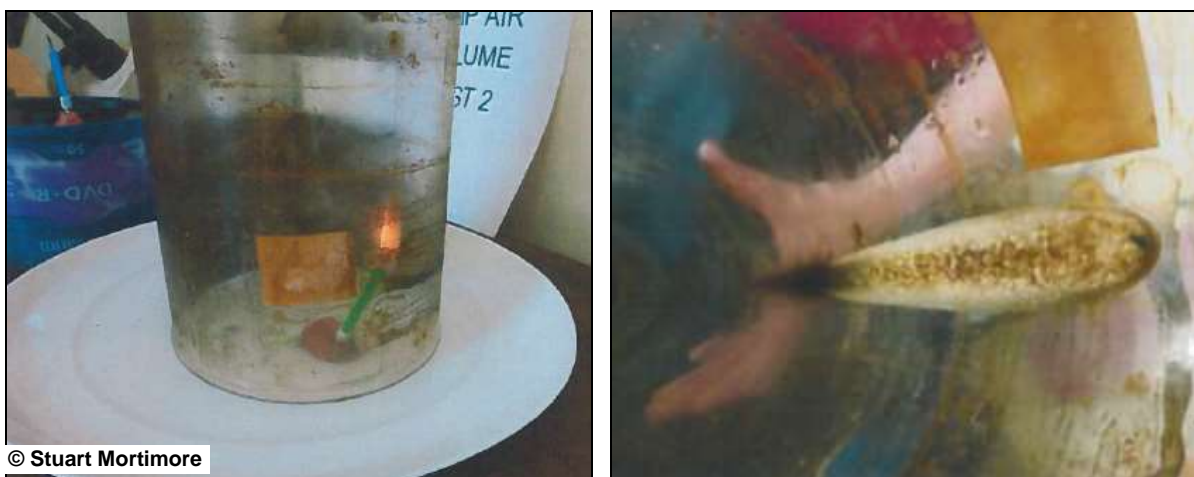
Figure 89: Test to establish the internal flammability of the ceiling lighting⁶¹

The plastic lamp cover holds only an extremely low amount of oxygen because of the airtight seal on the lamp cover. Accordingly, the candle positioned inside the lamp body during the test extinguished after the oxygen was consumed. Even if the candle was leaned against the plastic cover while it was burning, this resulted merely in scorch marks in the area of contact and a reduction in the plastic wall thickness of less than 25%.

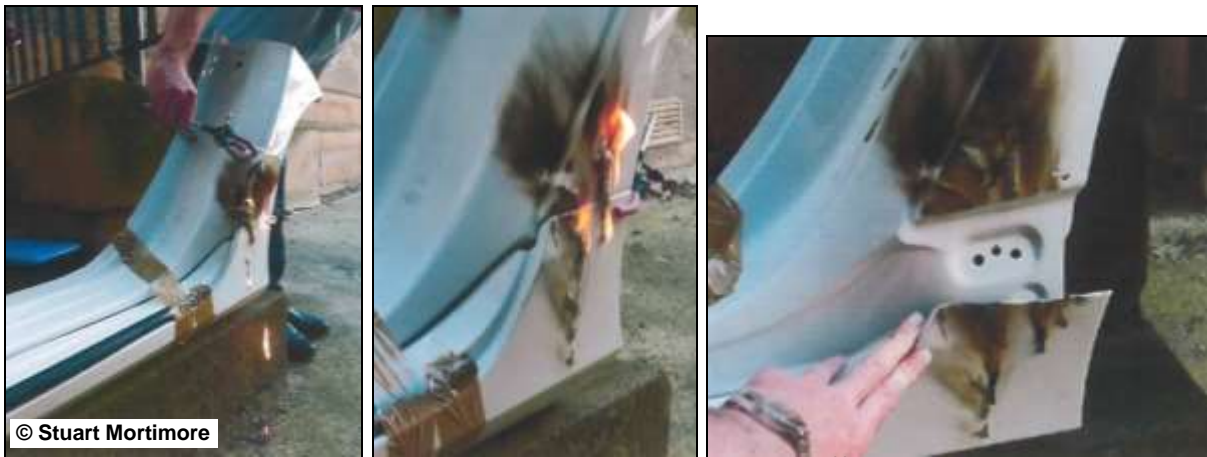
Figure 90: Ignition of the door sill (1)⁶²

In other tests a small amount of plastic that had been ignited with a blowlamp, which was supposed to simulate a drop falling from the burning ceiling light cover, was applied to the door sill. The burning drop, which slowly ran down the door sill, caused its plastic part to ignite. The fire died some time after the plastic drop had run off of the door sill (see **Figure 90**).

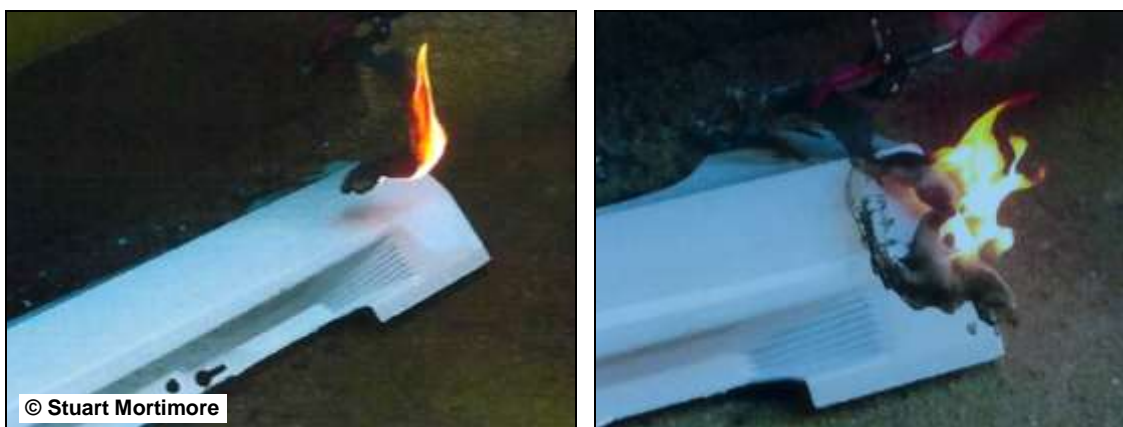
Figure 91: Ignition of the door sill (2)⁶³

Finally, the door sill was laid flat on the floor and the plastic drop applied to it permanently. The plastic under the drop had burnt through after about four minutes and it became apparent that the fire had now taken hold of the door sill so comprehensively that it would no longer extinguish alone (see **Figure 91**).

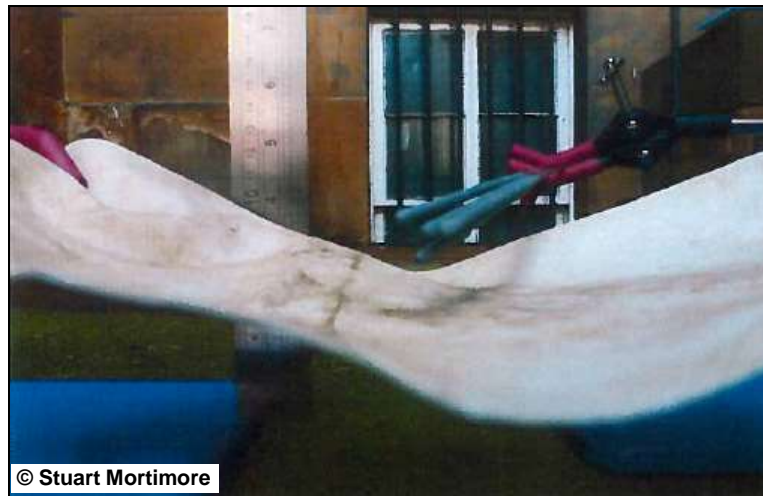
Figure 94: Test setup to establish the flammability of a tarpaulin⁶⁷

In the course of the tests, sparklers were ignited a small distance above the tarpaulin to simulate a sparkover. It was not possible to ignite the tarpaulin in this manner.

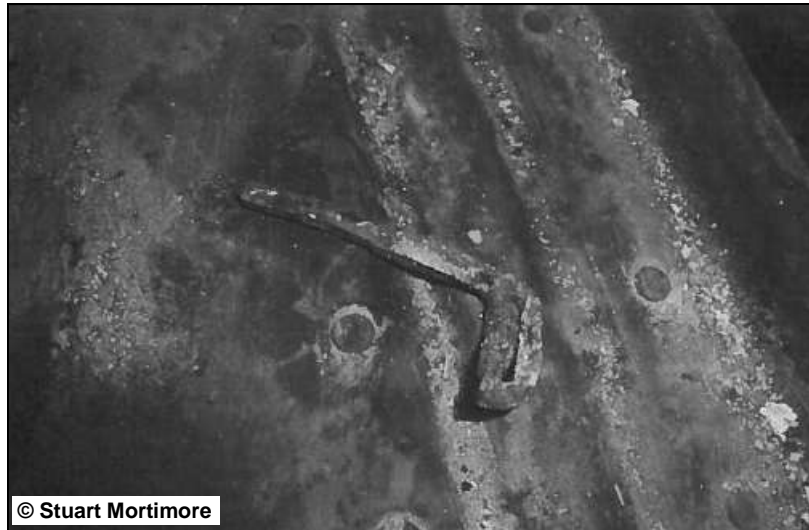
Figure 96: Remains of a vehicle ignition key⁶⁹

*With the exception of one car, an ignition key was found in each vehicle (see **Figure 96**).*

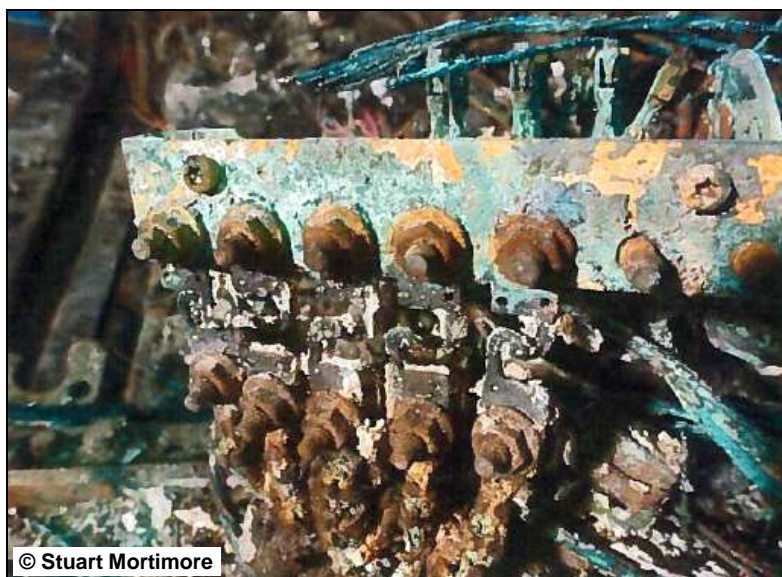
Figure 104: Close-up of the fuse box in the engine compartment of vehicle 5 A⁷⁷

In the course of the detailed inspection of the vehicle fuse boxes, during which partly intact but largely destroyed fuses were found, it was not possible to determine whether the fuse elements, which melt at temperatures upwards of about 200°C, were destroyed by the effects of electricity or as a result of the fire on the vehicle deck.

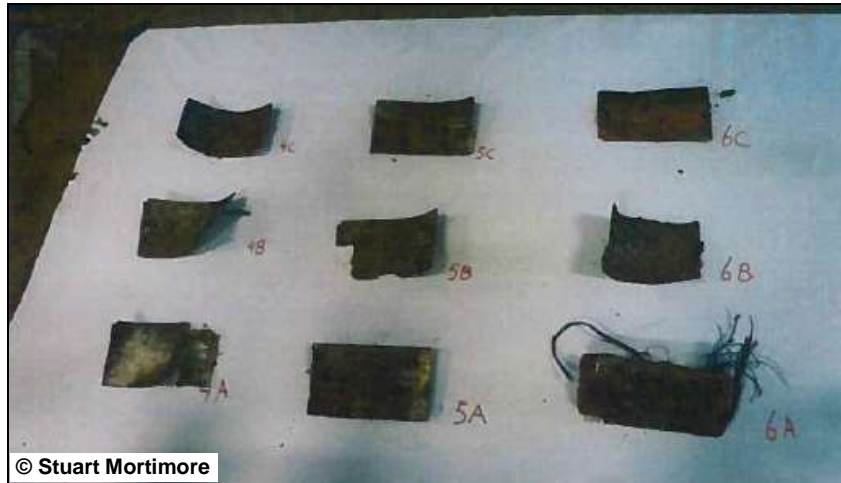
Figure 105: Disassembled main boards from the automotive electronics⁷⁸

The main boards on the central electronic modules from all the vehicles were also disassembled and examined. All the boards were severely damaged (see **Figure 103**). Nevertheless, the expert appointed by the owner believes that the destruction pattern of the boards belonging to vehicles 4 B, 4 C, and 5 C is consistent with the effects of arcing activities between the layers of the boards. (see **Figure 106**).

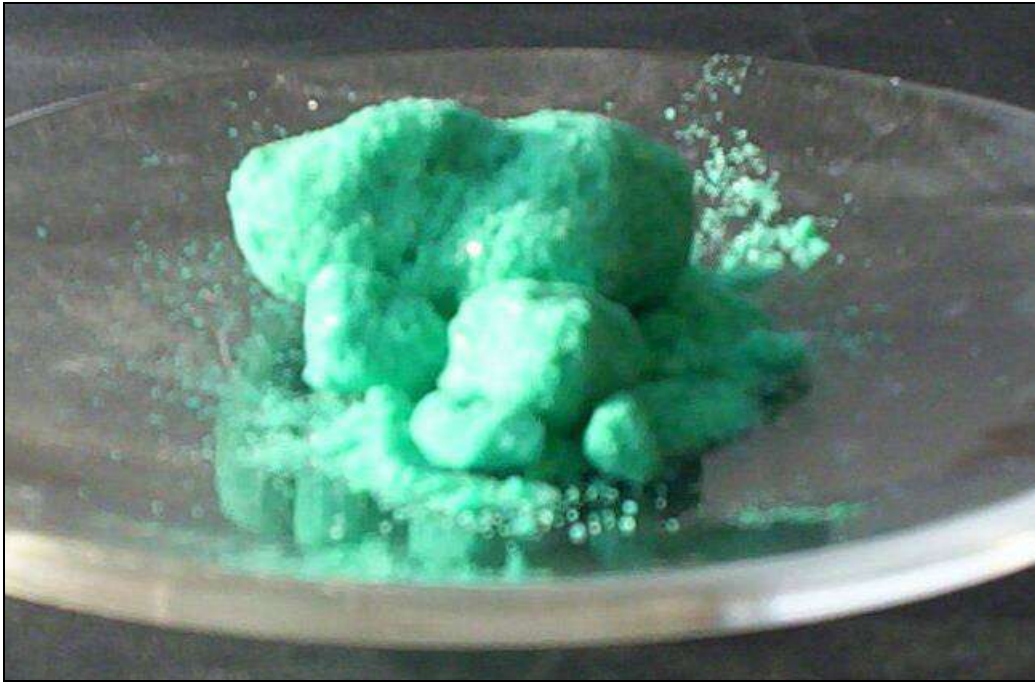
In the view of the expert appointed by the BSU, the traces of green corrosion at certain areas of the wiring cannot be interpreted as evidence of earlier damage on the cable routing. The expert was unable to find extensive traces of green corrosion in or outside the vicinity of the fire during the surveys on 3 and 6 May 2013. Moreover, salt from the air does not react with copper in that form. The expert concurs with the expert appointed by the owner that the green covering originates from the fire event.

Burning PVC (primary constituent of the cable insulation) produces gaseous hydrogen chloride, which in combination with water or humidity forms hydrochloric acid. Inter alia, copper chloride forms on the copper cores exposed by fire, which turns into basic copper(II) chloride during subsequent oxidation. The compound is highly hygroscopic. The bound crystallisation water produces green salt crystals.

*The salt (NaCl) and copper compound shown in **Figure 112** below is merely the product of simple electrolysis in the laboratory.*

Figure 112: Copper(II) chloride dihydrate $\text{CuCl}_2 \cdot 2 \text{H}_2\text{O}$

The crystallisation water dissolves at temperatures upwards of 100°C and Cu Cl_2 forms again. Such traces are usual for cable routing after exposure to fire and consequential destruction of the insulation.
