Bundesstelle für Seeunfalluntersuchung
Federal Bureau of Maritime Casualty Investigation
Federal Higher Authority subordinated to the Ministry of Transport
and Digital Infrastructure

Investigation Report 16/15

Serious Marine Casualty

Collision between the MV RED7 ALLIANCE and a lock gate at Brunsbüttel on 17 January 2015

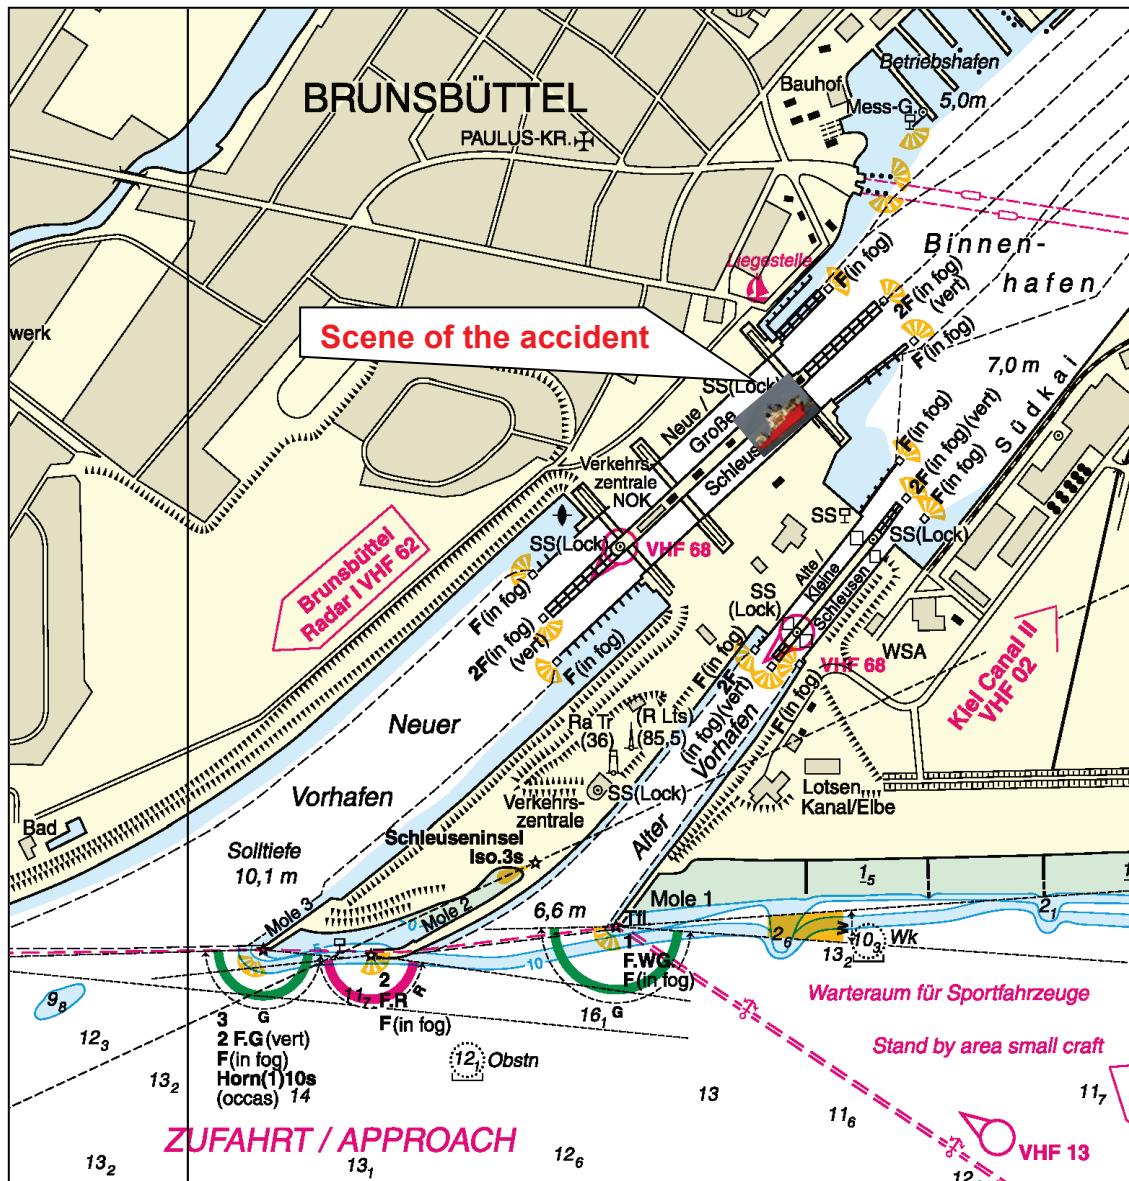
Figure 3: Scene of the accident

At 0942, the RED7 ALLIANCE rammed and became wedged with the lock gate. All the propulsion units were switched off immediately and a damage assessment initiated. There was significant damage to the bow and lock gate but neither physical injury nor environmental pollution.

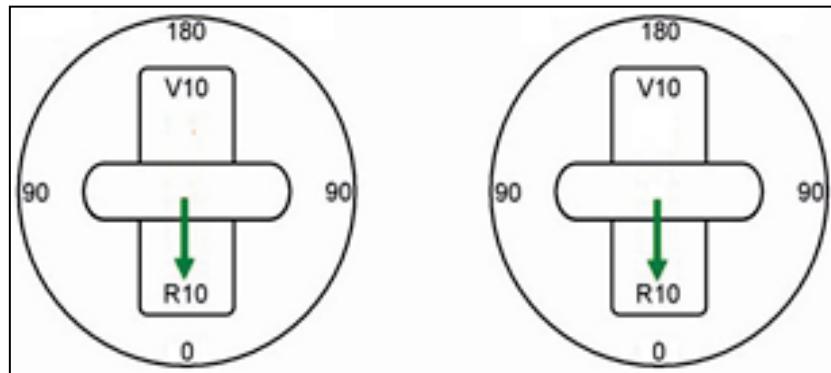
Figure 11: Position of the control levers when moving astern – option 1

(1) Both rudder propellers are operated in autopilot mode

The control lever of each rudder propeller is rotated to 'Full astern' (R 10) only about the horizontal axis – the thrust of the two rudder propellers is approximately 70% of the rated value.

The master initiated the sternward manoeuvre on the recommendation of the pilot. In the process, **he must have assumed** that he operated the control levers on both control consoles in manual mode (as per the second option shown in figure 12), and switched **both** control levers by 180°. He thus failed to switch the starboard propulsion, so far working in automatic pilot mode to manual mode.
