**Bundesstelle für Seeunfalluntersuchung**  
**Federal Bureau of Maritime Casualty Investigation**  
Federal Higher Authority subordinated to the Ministry of Transport  
and Digital Infrastructure

**Investigation Report 180/15**

**Very Serious Marine Casualty**

**Master of the  
MV HANJIN MIAMI  
missing in the Indian Ocean  
on 16 May 2015**

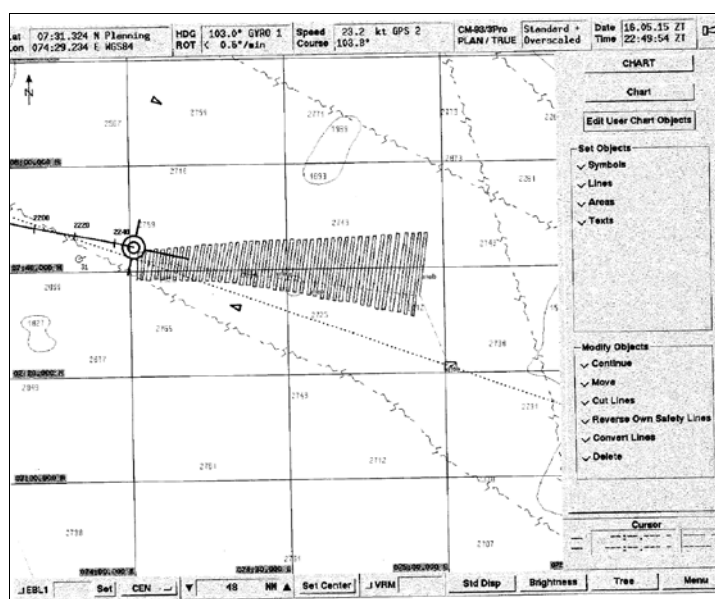
Figure 3: Search pattern; electronic nautical chart

Parallel lanes, each 3 nm from the reciprocal course, were then steered at a speed of 10 kts, as per an IAMSAR<sup>2</sup> search and rescue pattern. This was displayed on the radar system. The northerly displacement also had to be taken into account. The position at midday on 17 May was 07°44.9'N 074°41.8'E. With a day's run at an average speed of 17.17 kts, 412 nm were covered in the process.

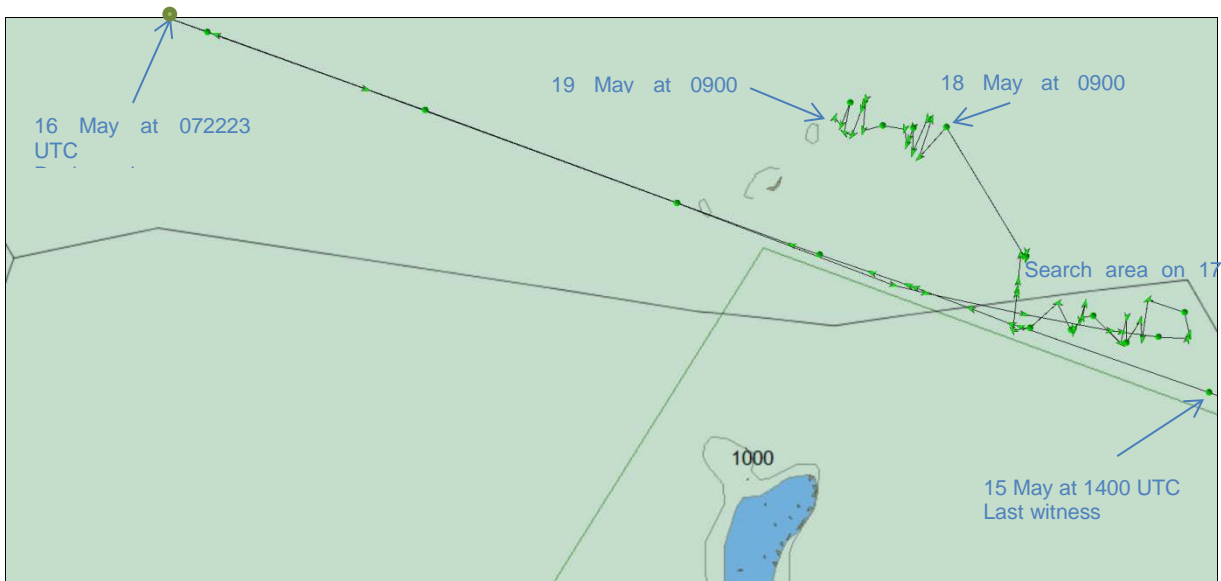
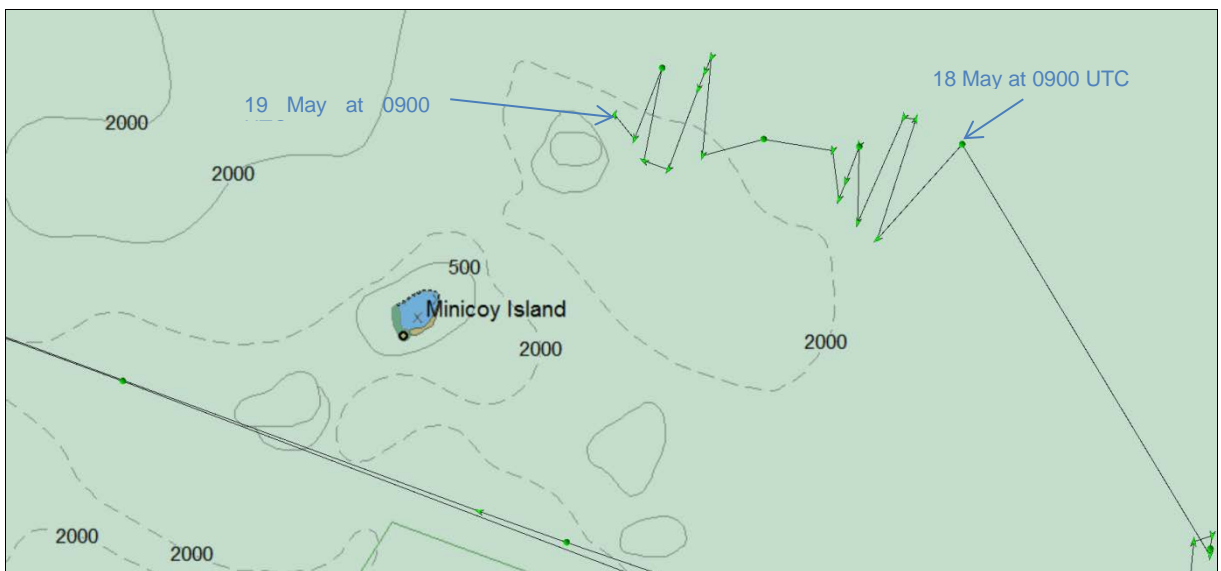
Figure 9: EMSA's IMDatE; tracks from 1400 on 15 May to 0900 on 19 May (UTC)

The European Maritime Safety Agency (EMSA) has a global monitoring system in place for ship movements. The HANJIN MIAMI was about 200 nm away from the coast of India. The BSU was able to obtain satellite data from the IMDatE<sup>3</sup> system subsequently. On the high seas data are accessible only at irregular and extended intervals. The directions and positions of the HANJIN MIAMI are evident based on the symbols. The area north of the island of Minicoy was navigated on 19 May, the last day of the search.

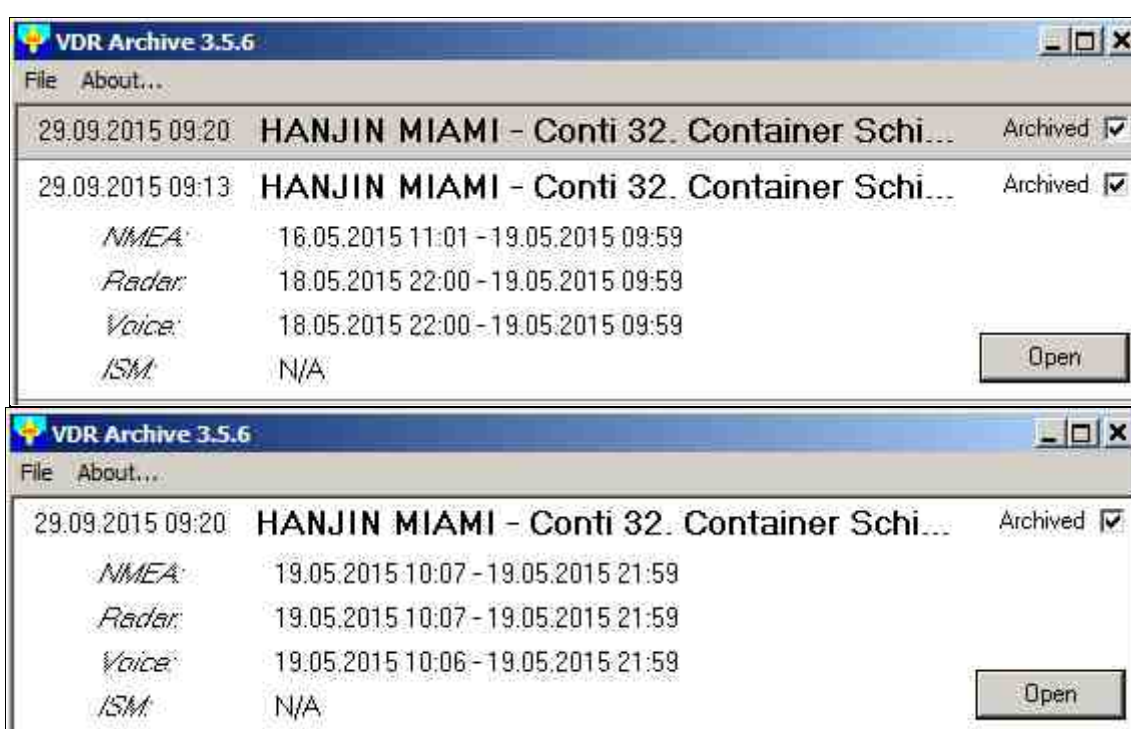
Figure 11: Backups from the HANJIN MIAMI's VDR (replay system)

A IS Steinsohn G4 VDR is installed on the HANJIN MIAMI. A technician from the manufacturer, Interschalt, read the data from the VDR in Suez. The service report indicates that one backup was made on 16 May and two on 19 May by pressing the emergency button. The oldest backup (in this case that of 16 May) is overwritten when the third backup is made. Consequently, using audio data to reconstruct the periods leading up to the master's disappearance was not an option. When a backup is made to the local hard disk the previous 12 hours are recorded. For the entire period of the three-day search, the data, which were backed up several times, should have been exported to an external storage medium. The backed up data were read at the BSU using the manufacturer's replay system and rendered the periods shown below by data type.

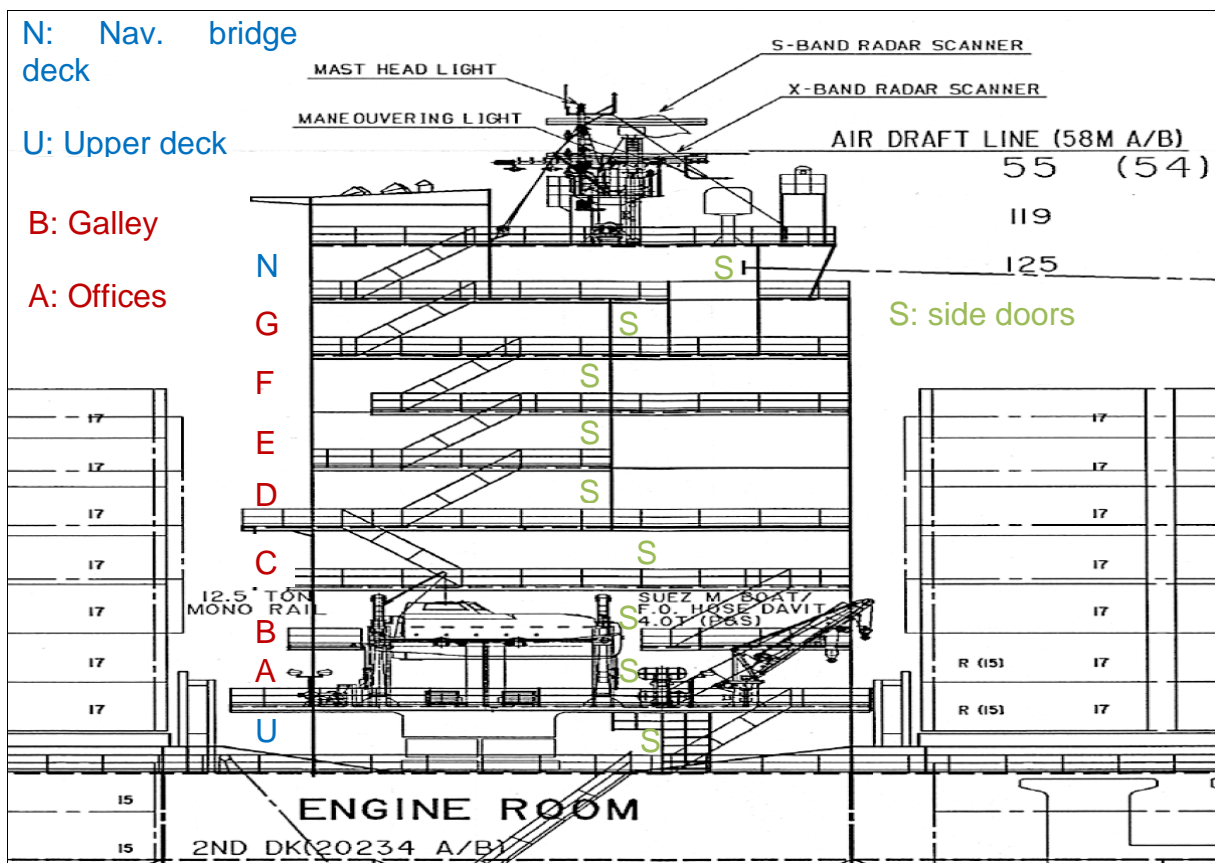
Figure 14: Superstructure

The BSU was sent photographs made on board the HANJIN MIAMI of the aft superstructure. They show the crew's self-built bar and the passageways in the area of the lifeboats, which lead directly to the outboard edges and are not protected by railing in places due to the design. Without the protection of the 1 m-high railing, the master could have fallen overboard there. It should be noted at this point that it was dark and the Moon was waning.

Taking the direct route to Suez, the HANJIN MIAMI was situated on the boundary with the presumed piracy area. Consequently, the superstructure was already blacked out, the exterior doors locked, and night-time rounds had been ordered. Going around would have taken the master from the galley through the service corridor on B deck outside to one of the lifeboat stations, where it would be possible to go to the outboard edge without the protection of railing. One reason would be the noises caused by safety lines and lashing on the lifeboats and davits, for example. He may have slipped and fallen overboard while inspecting something there in the dark. It is also conceivable that he had locked himself out of the superstructure because the outside door had been locked again from the inside in the meantime. Then he must have passed one of the lifeboat stations without a torch or radio so as to attract attention on the transverse passageway at the forward edge of the bridge.
