Bundesstelle für Seeunfalluntersuchung
Federal Bureau of Maritime Casualty Investigation
Federal Higher Authority subordinated to the Ministry of Transport
and Digital Infrastructure

Investigation Report 203/15

Very Serious Marine Casualty

Fatal accident
on board the FV ORTEGAL TRES
on 27 May 2015 off the Shetland Islands

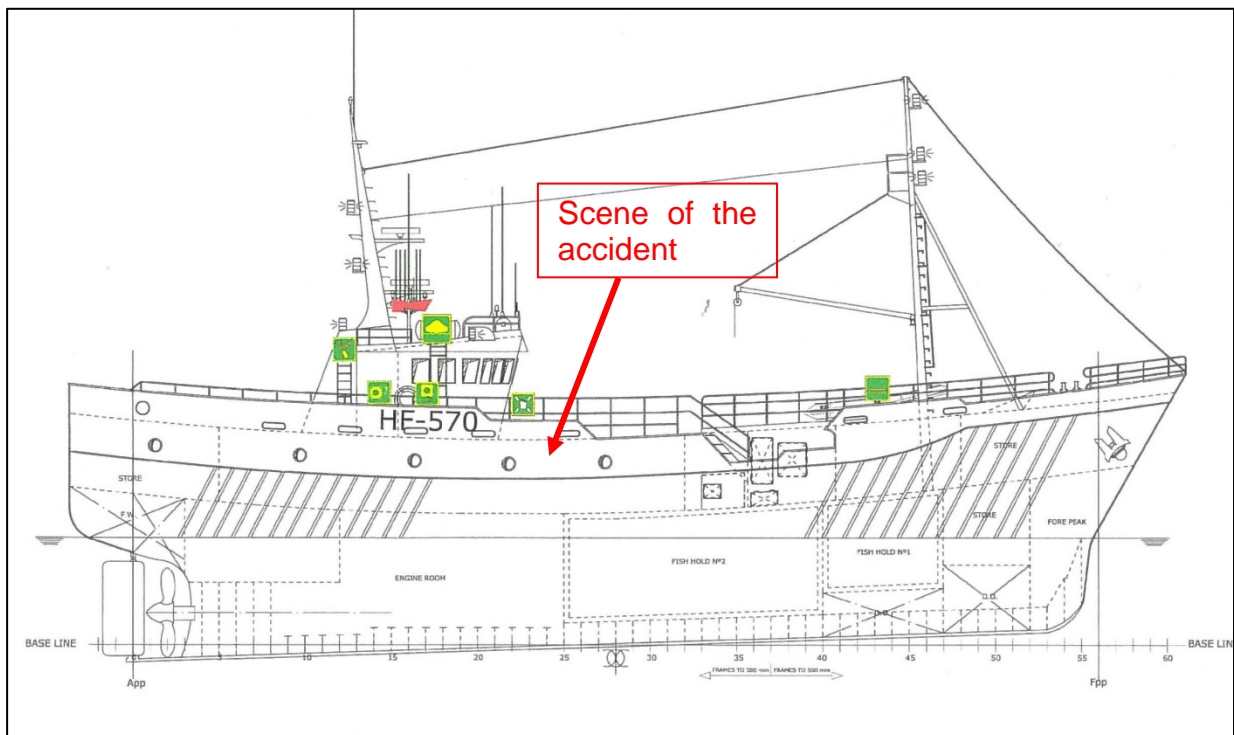
Figure 3: Extract from the general arrangement plan (side view)

On 27 May 2015, the fishing vessel ORTEGA TRES was on a fishing voyage west of the Shetland Islands with 17 crew members on board. The chief officer and chief engineer were on the bridge. The master was stood down in his cabin. Two crew members were on the port side opposite the casualty's cabin and three crew members on the lowest deck aft in the cabins. The casualty was last seen at supper at about 2030. He then stayed in the cabin on the starboard side (frames 26-32). Eight crew members were occupied with processing fish in the forward fish processing area (in front of frame 32) when smoke from the cabins was noticed billowing out of a ventilation fan at about 2130. The master was immediately awakened and the chief officer and chief engineer went up to the front of the cabin, from which heavy smoke was billowing, on the starboard side without respiratory protection. The cabin ventilation was switched off. One of the able-bodied seamen, who was on the port side in the cabin, went to assist and the door was open carefully. The able-bodied seaman threw a damp blanket onto the evident seat of the fire and subsequently pulled the crew member lying in the lower berth out of the cabin. The seat of the fire was extinguished using two fire extinguishers about five to ten minutes after the smoke was noticed. At the same time, the casualty was taken forward via the starboard passageway and the chief officer started attempts at resuscitation. The attempts were unsuccessful and discontinued after about five minutes.

During the evacuation of the casualty and the extinguishing work, the witnesses noticed a strong smell of burning rubber. The fire broke out in the cabin and was evidently caused by an electric household fan on which the casualty had probably dried his rainwear and rubber boots.
