Investigation Report 330/13

**Serious Marine Casualty**

**Collision between the MT CORAL IVORY and  
MV SIDERFLY on 28 October 2013 in the  
Kiel Canal**

15 March 2016

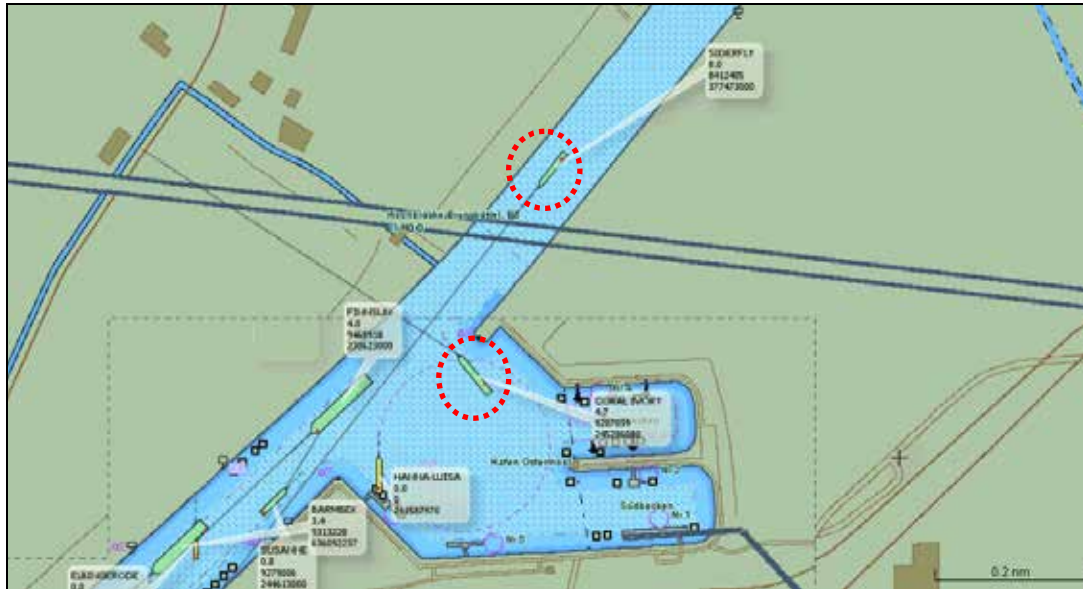
**Figure 14: AIS-based traffic situation at 0255**

The selected limitation of the CORAL IVORY to the northern part of the outer port during the turn into the canal becomes even clearer about 30 seconds later in **Figure 14** below. It is already evident that it will be virtually impossible for the CORAL IVORY, whose bow has reached the boundary of the mouth of the port exit to the Kiel Canal, to restrict herself to its southern half when filtering into the canal.

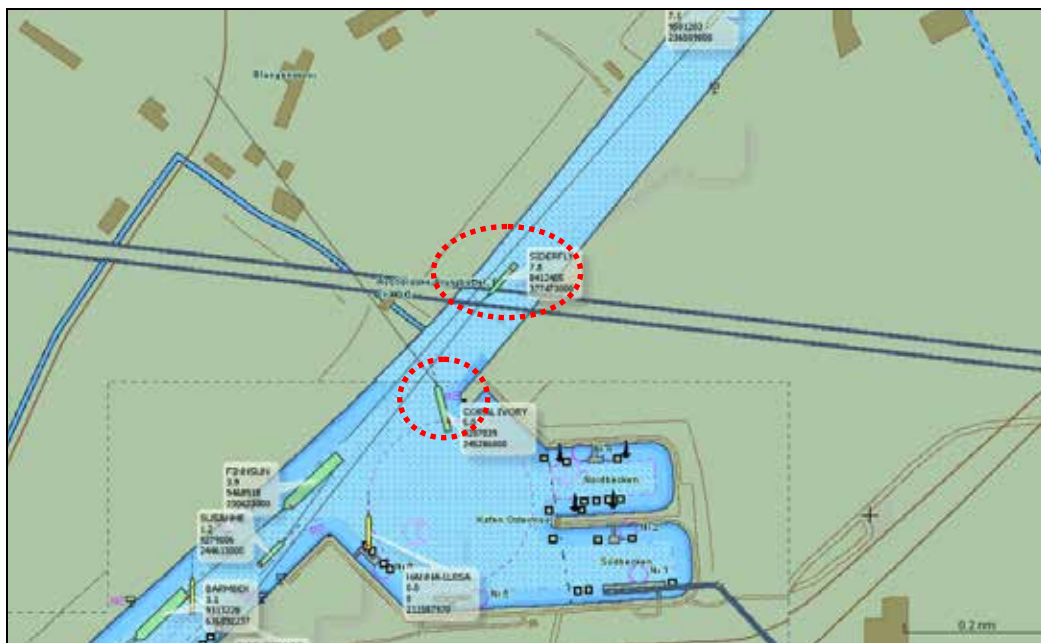
**Figure 15: AIS-based traffic situation at 025530**

The CORAL IVORY's bow has reached the middle of the canal in the AIS figure (**Figure 15**), which shows the traffic situation about 30 seconds later. The ship is still at a relatively obtuse angle to the course of the canal. The distance to the SIDERFLY, whose bow has now reached the viaduct, is about 0.2 nm. The immediate risk of collision is clearly visible.

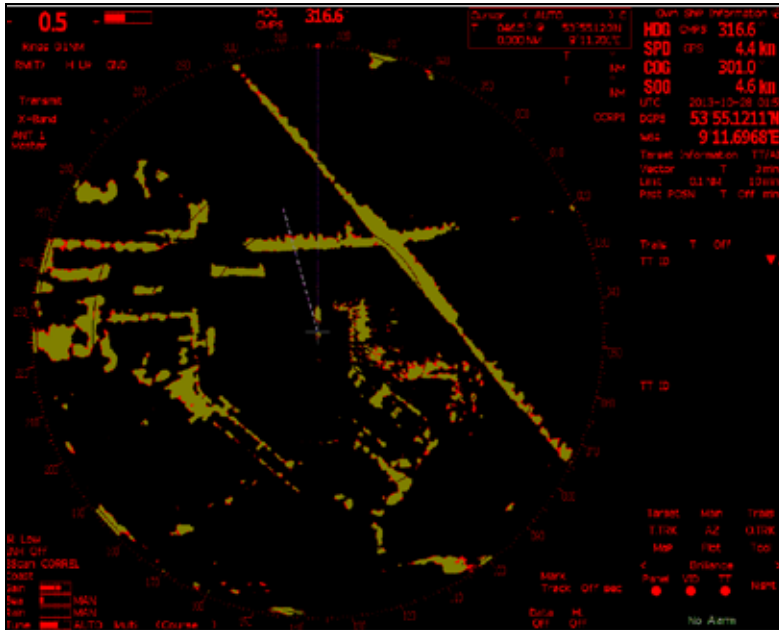
**Figure 23: CORAL IVORY – radar image at 025454**

The below radar image (**Figure 23**) relates to the time 025454. The AIS data reveal that the distance between the CORAL IVORY and the SIDERFLY is now only about 0.3 nm. In spite of that, the echo of the ship is still not visible on the radar image (which still covers the 0.5-nm range). Since the radar image continuously displays the land contours, the viaduct, and vessel echoes forward of the bow very clearly, the absence of the SIDERFLY's echo can only be explained by shadowing effects.

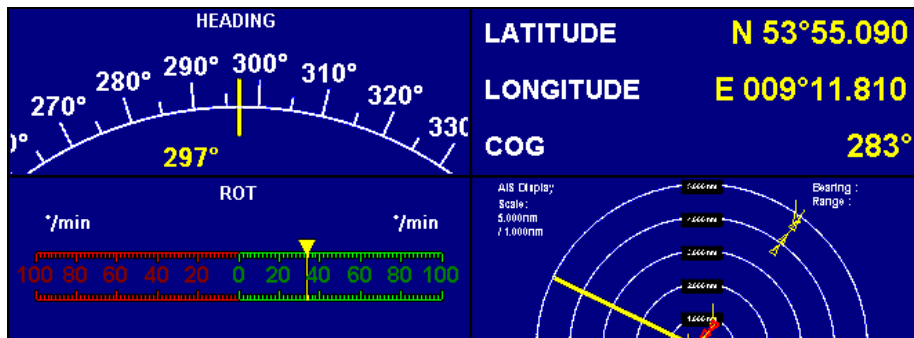
Figure 27: CORAL IVORY – ROT at 025410

They indicate that the CORAL IVORY turned to starboard (see **Figure 27**) at a rate of some 35°/min. at 025410. Starting at a starboard position, at this point an order was issued to set the helm to amidships temporarily, presumably to keep the ship sufficiently clear of the pier head. The ROT decreased very slowly in the ensuing 20 seconds. According to the recordings of the S-VDR, the SOG<sup>24</sup> was now 4.7 kts.

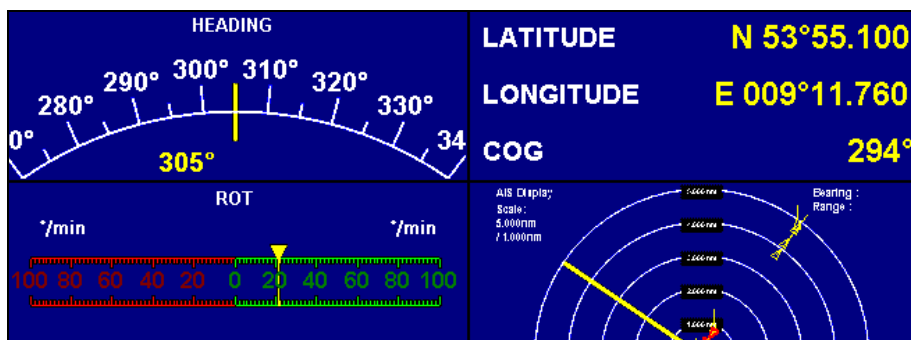
Figure 28: CORAL IVORY – ROT at 025430

When the ROT reached a value of 20°/min. at 025430, an order – clearly audible in the S-VDR's audio recordings – was issued to set the helm to hard to starboard.

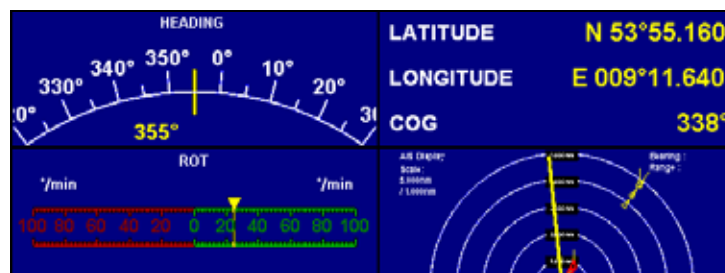
Figure 30: CORAL IVORY – ROT at 025545

The ROT then steadily dropped again from about 025515 onwards without a simultaneous discontinuation of the hard to starboard helm manoeuvre, however.

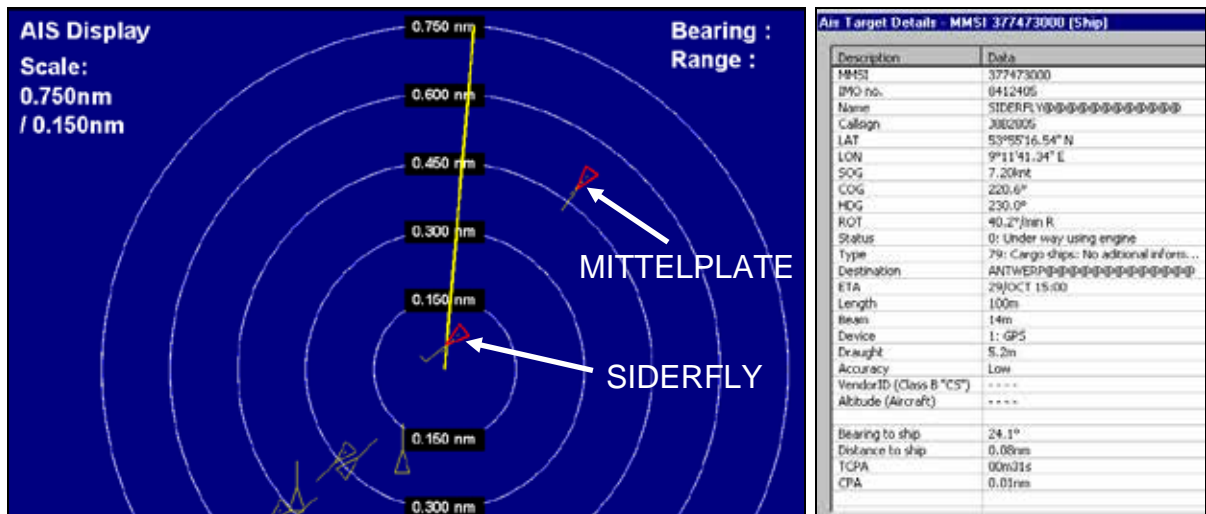
Figure 39: Traffic situation based on the CORAL IVORY's AIS at 025619 (immediately before the collision)

The AIS target details available from about 0255 (see upper right box in **Figures 35 ff.**) indicate that starting from 218° and exploiting the limited constraints of the canal to the absolute full, the SIDERFLY continuously changed her heading in the final 1.5 minutes leading up to the collision, reaching 223° by 20 seconds before the collision.<sup>26</sup> Presumably due to last-minute avoiding action, the SIDERFLY's heading was as much as 230° (see **Figure 39**) immediately before the collision.

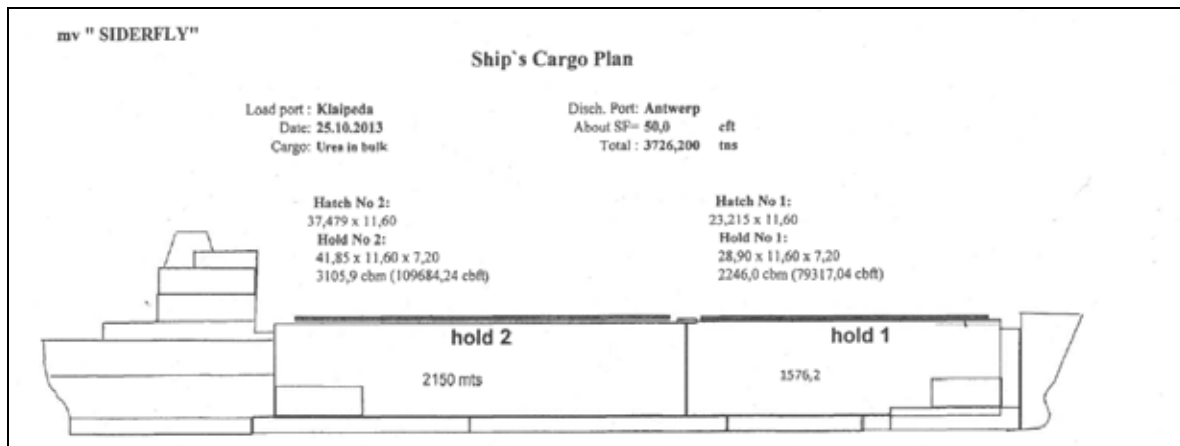
**Figure 47: Cargo plan of the *SIDERFLY***<sup>32</sup>

The maximum draught of the *SIDERFLY*, which has two holds, stands at 5.42 m. Her freeboard is 1.54 m at maximum draught. The draught of the ship stood at about 5.20 m when the collision occurred. According to the submitted cargo plan, the *SIDERFLY* was almost fully laden (see **Figure 47**). Ballast tanks 4, 8, and 12 were empty. The void space beneath ballast tank 8 was also empty.

The collision resulted in a 6 m x 4.5 m hole being torn in the forward section of the shell plating on the port side. This large hole led to the rapid flooding of ballast tanks 4, 8, and 12, as well as the aforementioned void space. Some 380 tonnes of water flooded the ballast tanks and the void space on the port side within a short period of time.
