Investigation Report 337/14

Very Serious Marine Casualty

**Fatal accident on board the
MV SILVER PEGASUS
in the port of Brake
on 20 September 2014**

13 July 2016

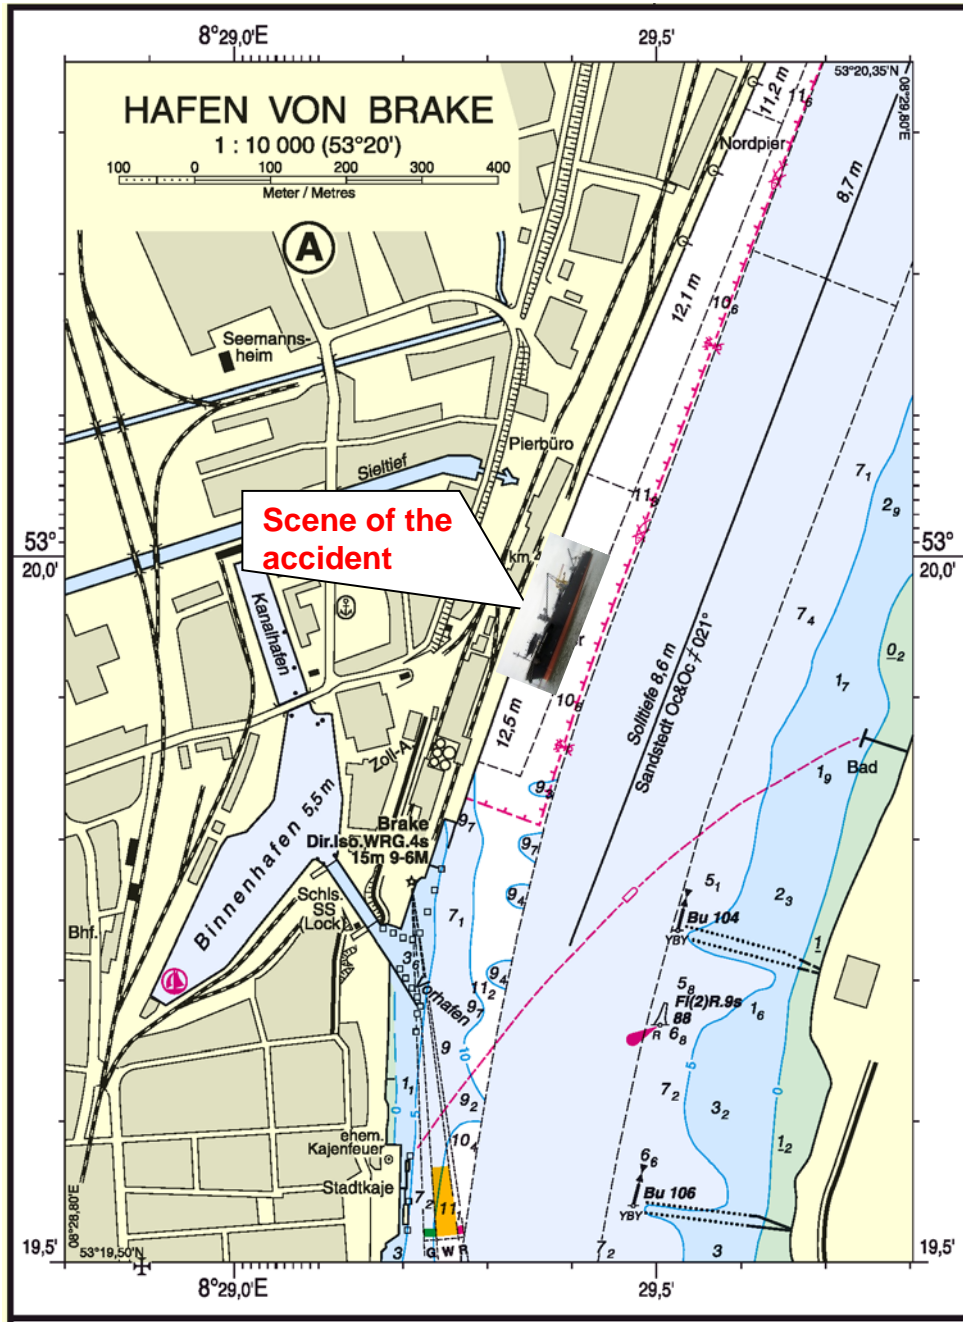
Figure 3: Scene of the accident

Type of marine casualty:	Very serious marine casualty/ fatal accident
Date, time:	20/09/2014, 0030
Location:	Brake, South Pier, Bollard 55
Latitude/Longitude:	φ °53 19.9'N λ 008°29.3'E
Ship operation and voyage segment:	In port
Place on board:	Aft edge of CH3
Consequences (for people, ship, cargo, environment, other):	Fatal injuries caused by falling into the empty cargo hold
