**Bundesstelle für Seeunfalluntersuchung**  
**Federal Bureau of Maritime Casualty Investigation**  
Federal Higher Authority subordinated to the Ministry of Transport  
and Digital Infrastructure

Investigation Report 34/15

**Very Serious Marine Casualty**

**Fatal accident**  
**on board the MV HANJIN DALLAS**  
**on 1 February 2015 off the east coast of**  
**the United States**

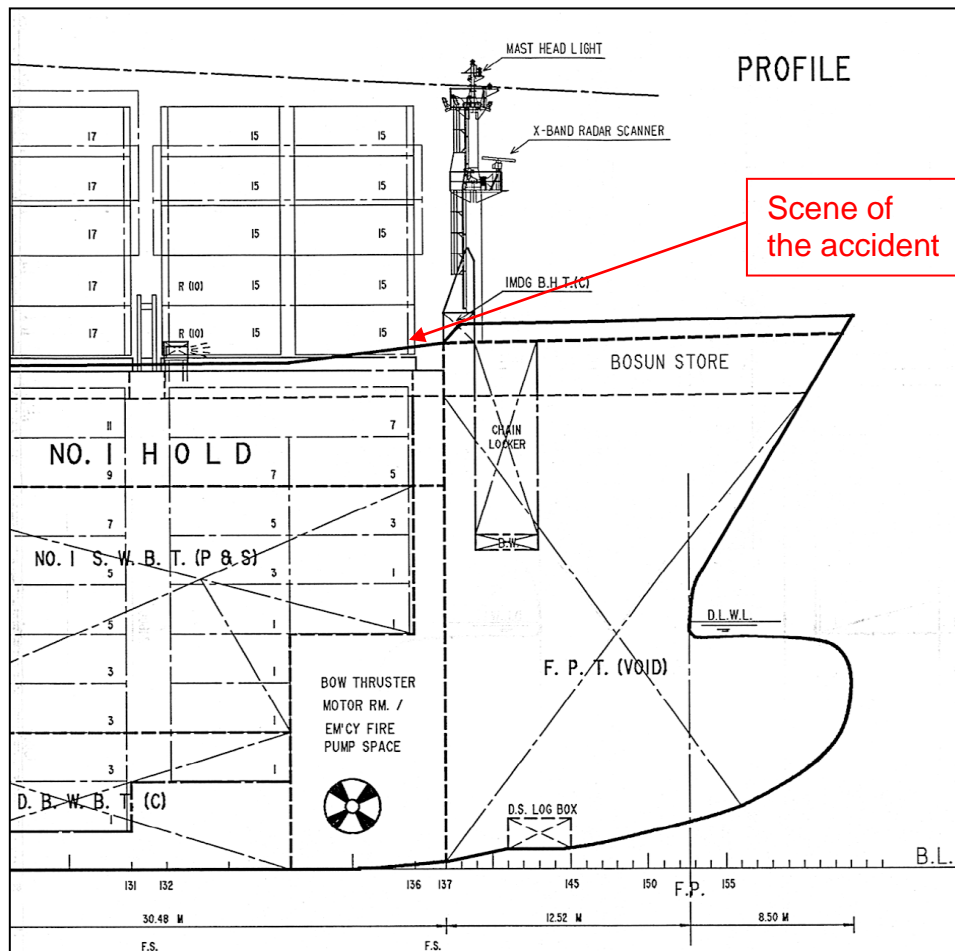
Figure 3: Extract from the general arrangement plan (side view)

The MV HANJIN DALLAS was en route from Singapore to New York. At about 1000 on 1 February 2015, the ship mechanic (SM) found the 50-year old bosun lifeless behind the container lashing bars on a hatch cover located on the starboard side of the forecastle.
