Bundesstelle für Seeunfalluntersuchung
Federal Bureau of Maritime Casualty Investigation
Federal Higher Authority subordinated to the Ministry of Transport
and Digital Infrastructure

Investigation Report 34/16

Serious Marine Casualty

Grounding of the CSCL INDIAN OCEAN in the River Elbe on 3 February 2016

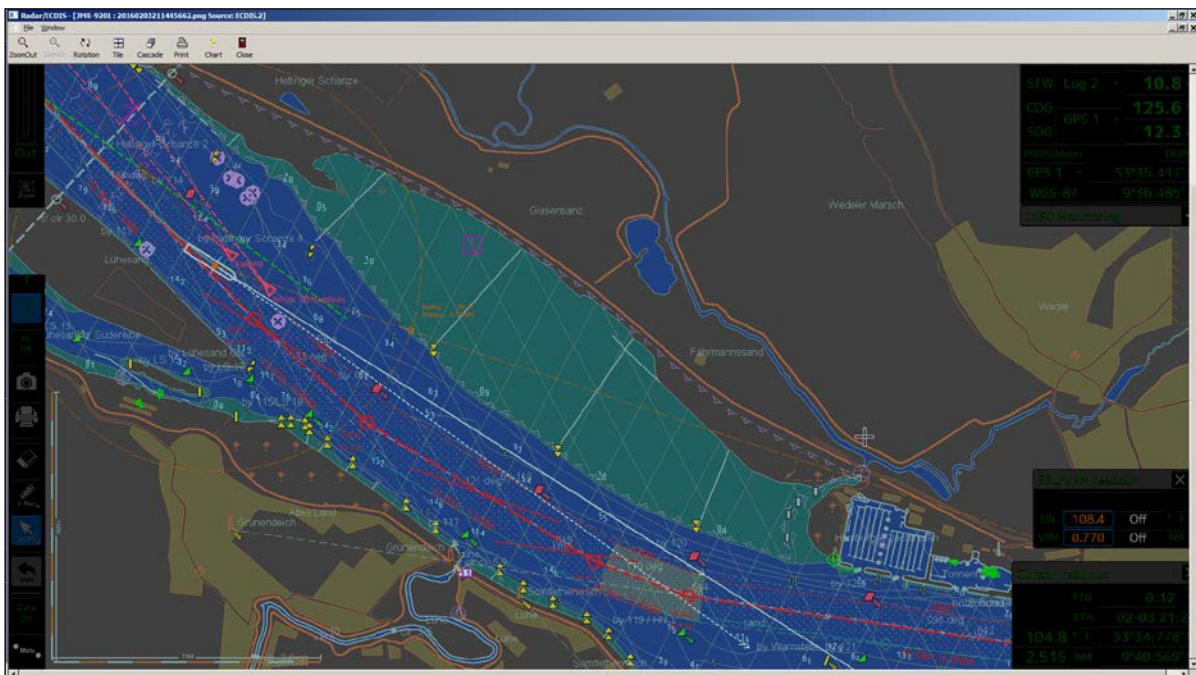
Figure 10: 221500 – helm responding again; oncoming traffic's closest point of approach

It can be heard at 2215 that the pilots are notified that the helm is responding again. Following that, the first pilot immediately advises HALF AHEAD and HARD TO STARBOARD. However, this manoeuvre had no significant effect. The speed has already dropped to $v = 12.5$ kts. The two oncoming vessels, MV EMPIRE and WSP boat BÜRGERMEISTER WEICHMANN, passed the CSCL INDIAN OCEAN on the port side at the same time.

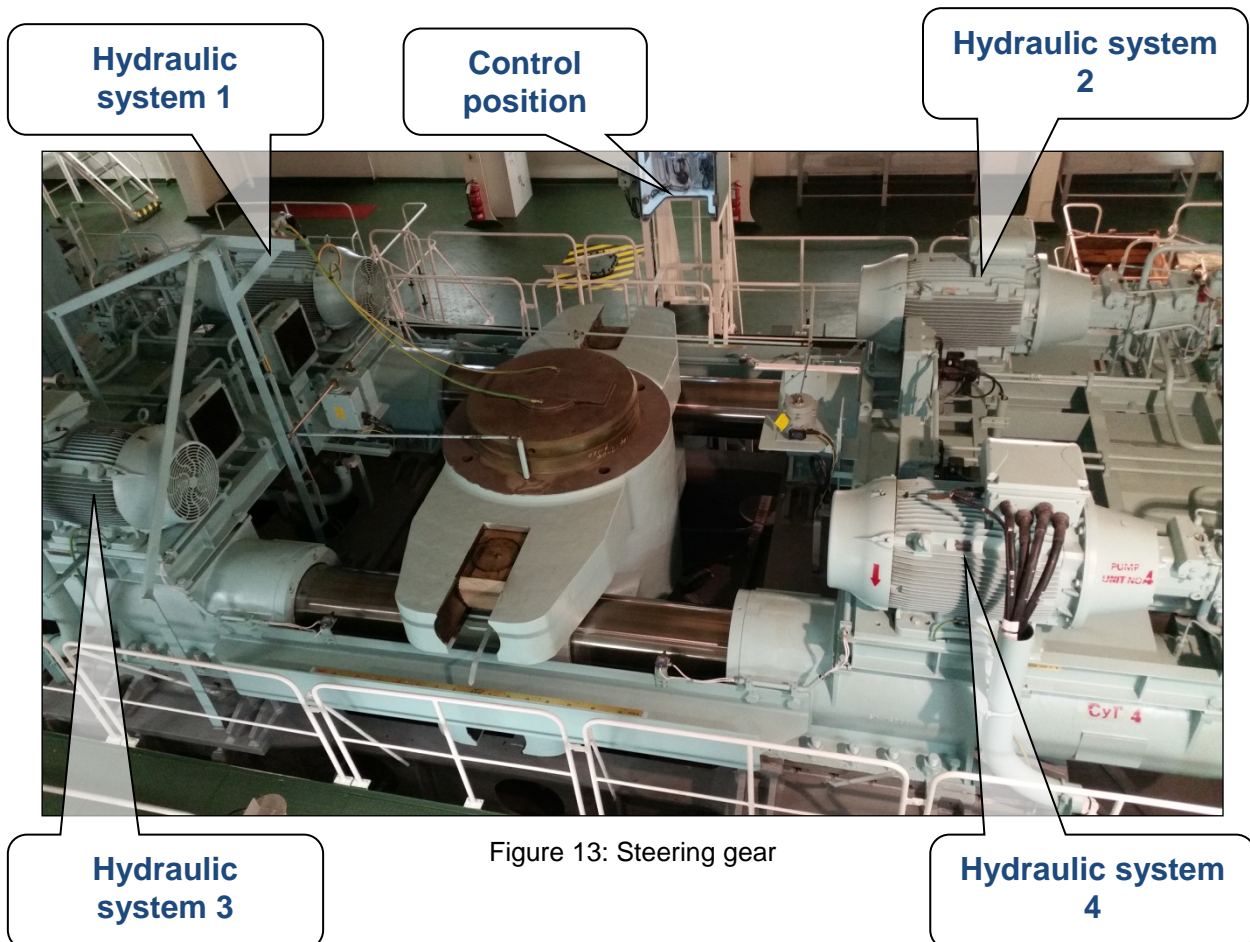
Figure 13: Steering gear

The steering gear was manufactured by HATLAPA and installed at the Hyundai shipyard. While the mechanical and electrohydraulic components were supplied by HATLAPA, the switch cabinets and their wiring came from the shipyard. The system consists of four hydraulic units. Each contains an electric motor, an axial high-pressure tandem pump, and a valve. Hydraulic units 1 and 3 are located on the port side, 2 and 4 on the starboard side. Hydraulic units 1 and 3 usually operate as a single propulsion unit and hydraulic units 2 and 4 as a second propulsion unit. One unit pulls while the other pushes. Each hydraulic unit can be switched from the bridge and the steering gear compartment.

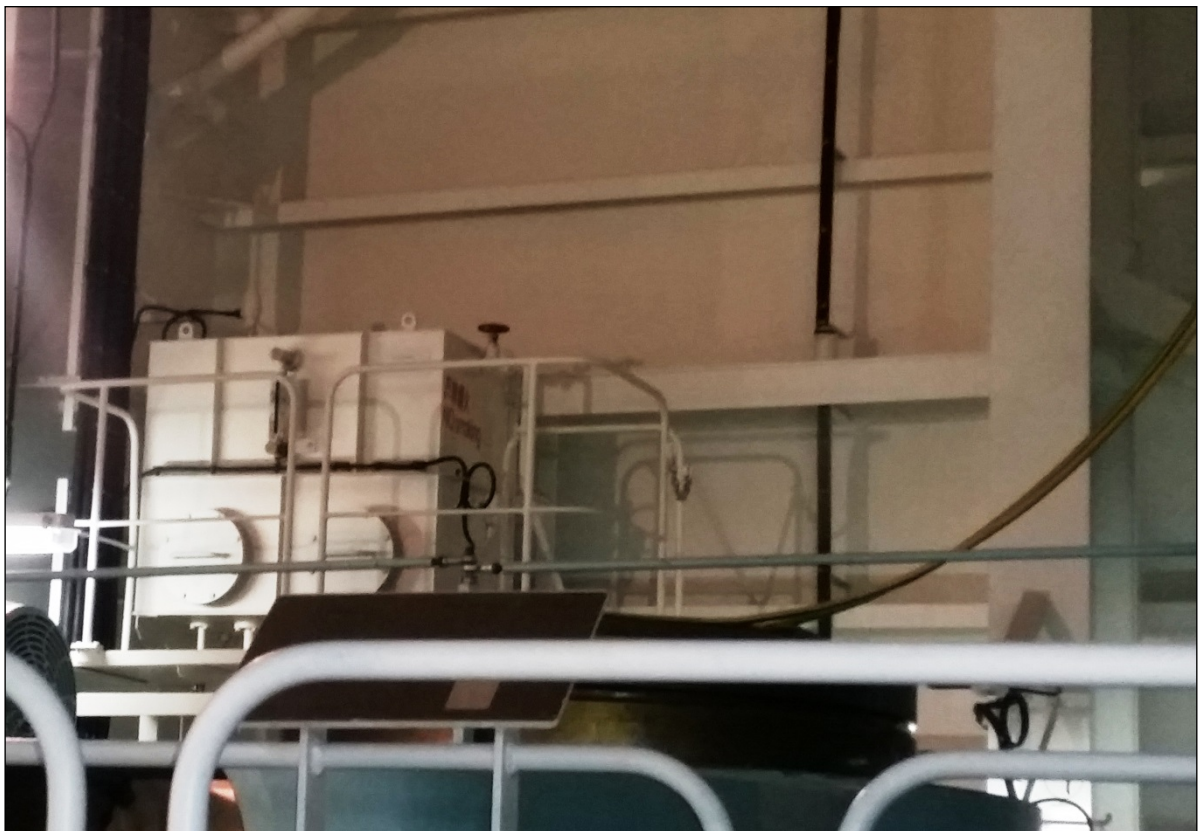
Figure 18: Hydraulic fluid tank

No leakage was found in the hydraulic system during the survey of the steering gear and SAFEMATIC on 5 February 2016. The level of hydraulic fluid in the compensating tank was above the low-level alarm. The crew stated that there had been no loss of oil. Accordingly, no traces of cleaning that could indicate the removal of a leak were found anywhere in the steering gear compartment, either.

Since there was no evidence whatsoever of any leakage, it is reasonable to assume that there was no leakage in the hydraulic system. From this point, a float switch malfunction would be conceivable. The expert disassembled and tested this completely on behalf of the BSU on 11 February 2016. Figure 16 shows the clean contact panel of the float switch. No faults were found, however. The float switch operated as it should.
