Bundesstelle für Seeunfalluntersuchung
Federal Bureau of Maritime Casualty Investigation
Bundesoberbehörde im Geschäftsbereich des Bundesministeriums
für Verkehr und digitale Infrastruktur

Investigation Report 36/14

Serious Marine Casualty

**Collision between the WES JANINE and
STENBERG on the Northwest-Reede anchorage
off Brunsbüttel on 16 January 2014**

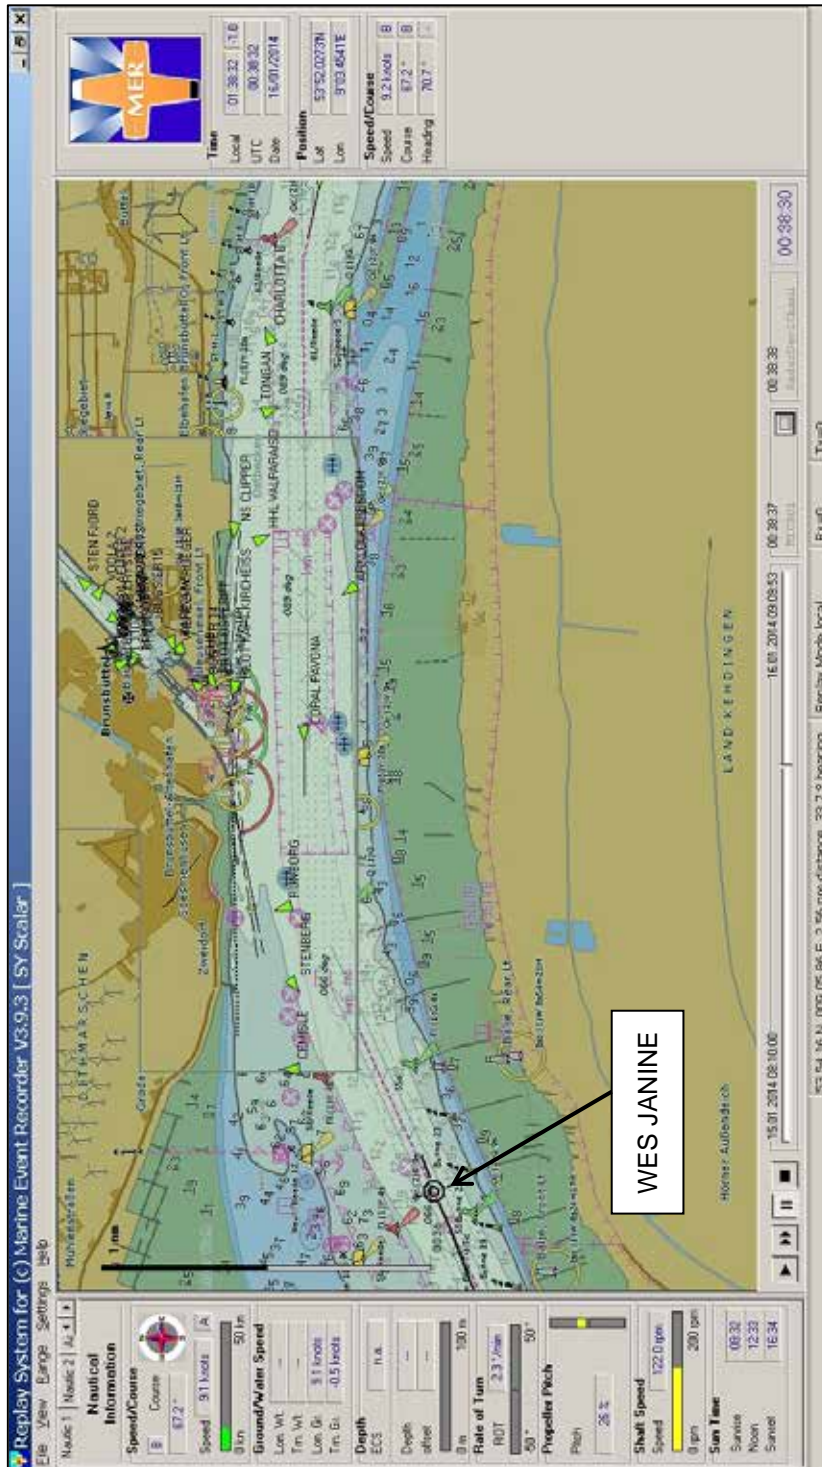
Figure 8: Overview of the ships' positions in the anchorage

When the WES JANINE approached the Nordwest-Reede anchorage, only the STENBERG and RIJNBORG were anchored there. The CEMISLE was also close to the boundary between the Neufeld-Reede Ost and Nordwest-Reede anchorages.

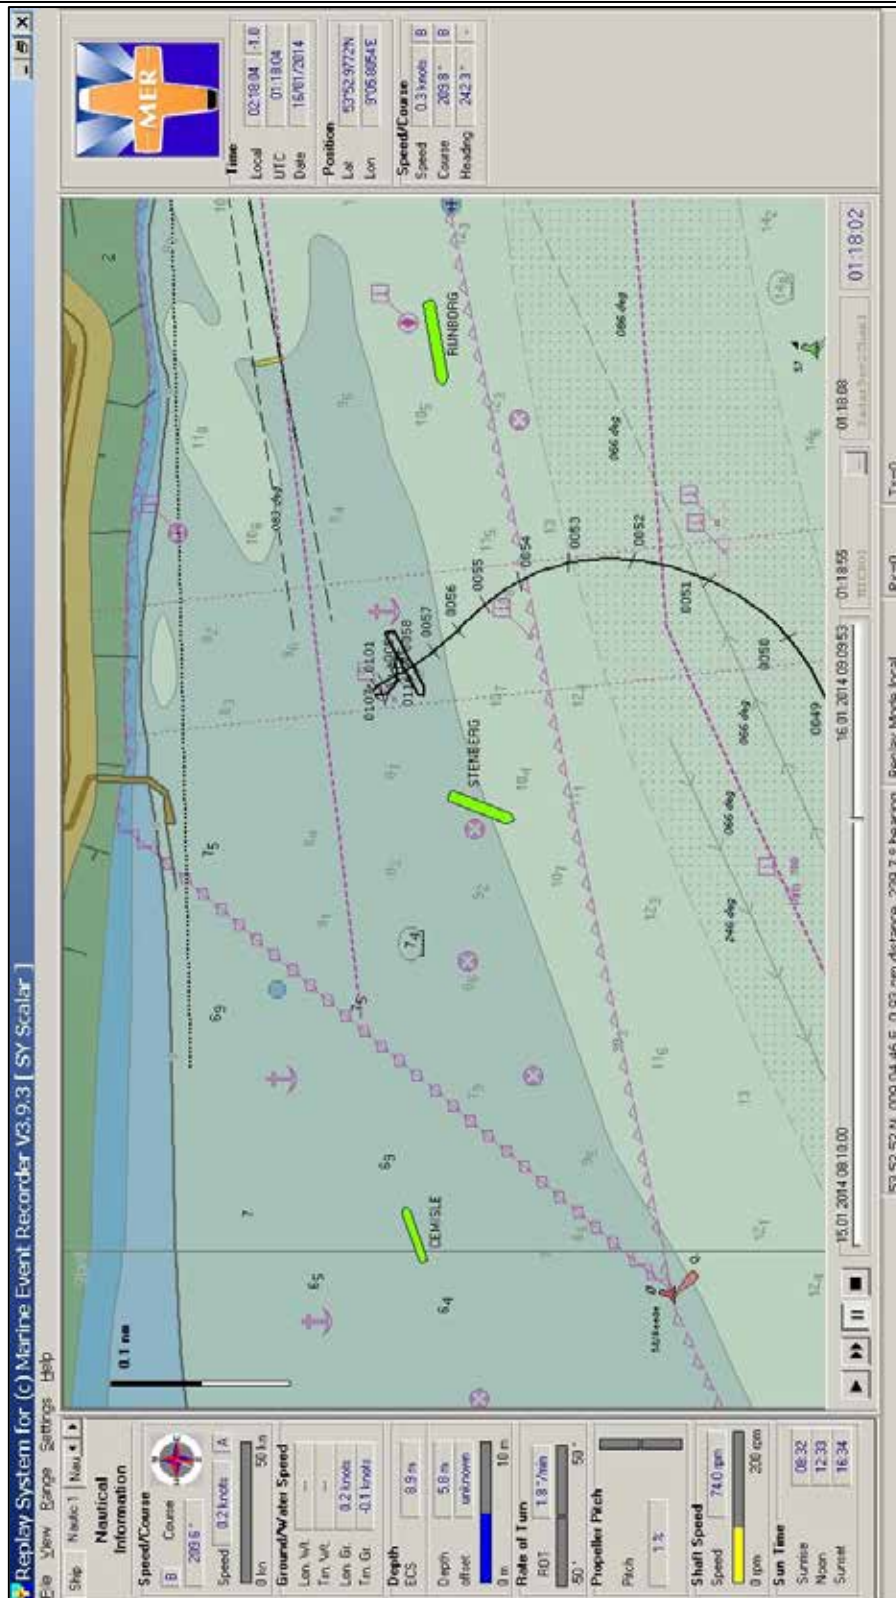
Figure 9: Situation in the anchorage at 0118

Due to their draughts (RIJNBORG = 7.7 m, STENBERG about 5.5 m), the ships anchored in the southern part of the Northwest-Reede anchorage because greater water depths are available there. The WES JANINE was to anchor there, too.

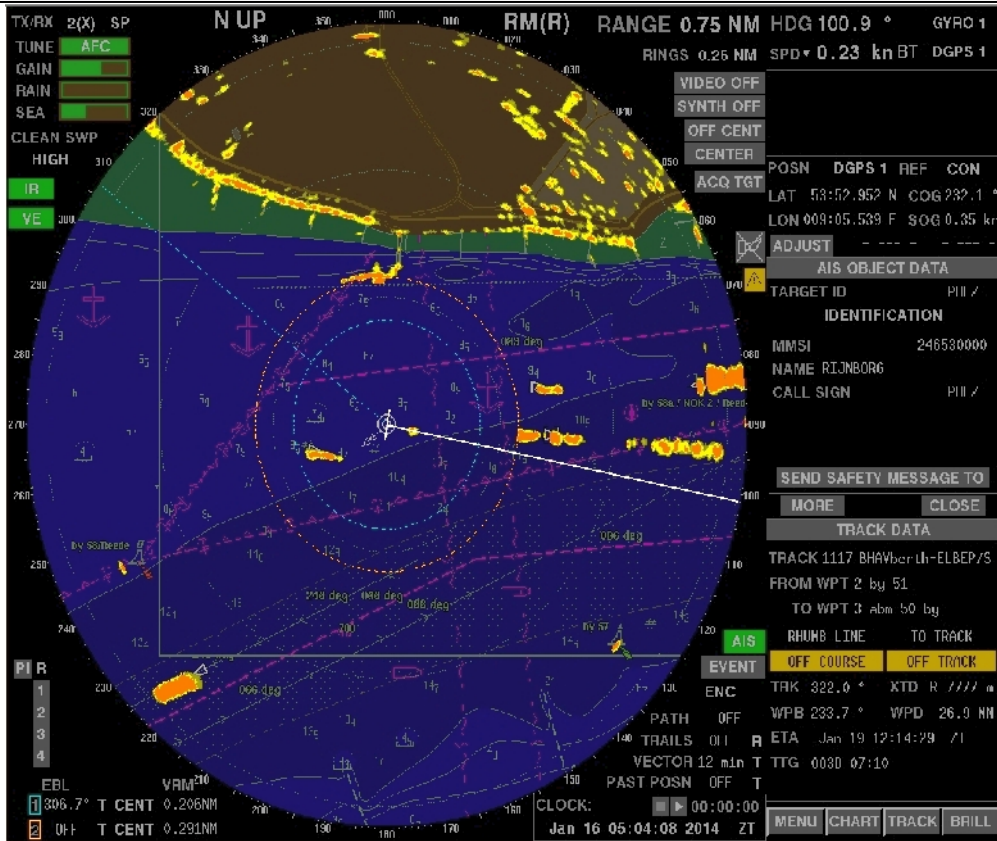
Figure 14: WES JANINE – image from radar 2 at 0504

At 0504, and even more distinctly at 0507, it was also clearly evident on radar unit 2 that a change had occurred (Figure 15) from the increasing distance of the STENBERG's radar echo to VRM 1, which was still at a distance of 0.206 nm. The two markers had parted from the radar echoes to such an extent that a drift in the direction of the STENBERG would have been clearly visible. However, the officer in charge of the navigational watch only responded at 0518.
