Investigation Report 370/14

Very Serious Marine Casualty

**Foundering of the grab dredger ZANDER
and drowning of two seamen
on 24 November 2014
in the North Sea north of Norderney**

1 July 2016

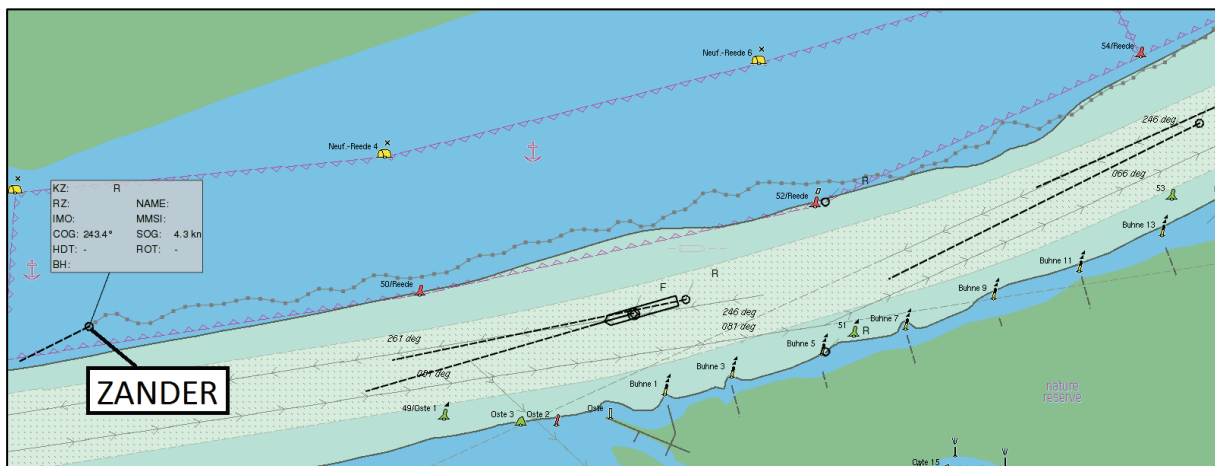
Figure 5: Course of the ZANDER's voyage on the Lower Elbe

VTSs Brunsbüttel and Cuxhaven used radar to record the voyage on the Lower Elbe and Outer Elbe. The ZANDER sailed along the outer edge of the fairway, including outside the fairway in places. Depending on the tidal stream, she sailed at speeds of between 3.5 kts and 8.8 kts (speed over ground). The recorded track (see Fig. 5) shows clearly that the ZANDER found it extremely difficult to maintain her course. She was not equipped with a track control system (autopilot).

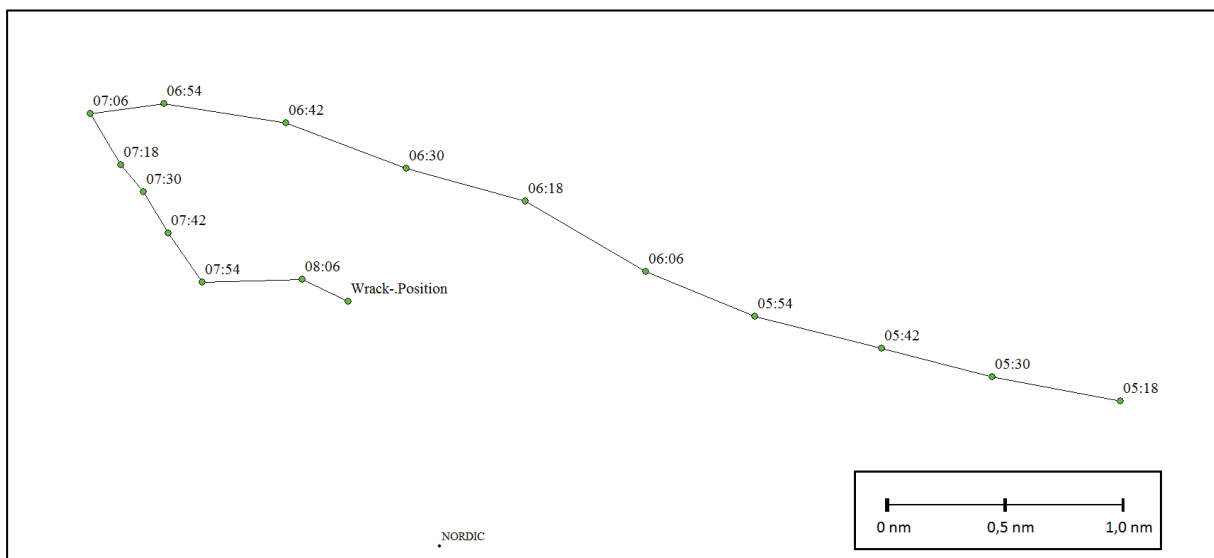
Figure 6: Radar analysis of the NORDIC's VDR

The ZANDER reached the North Sea at Cuxhaven at about 1630 and continued to follow the fairway. The ZANDER reached the Elbe Approach traffic separation scheme at about 2000, which she left in a south-westerly direction. The VTS responsible was unable to provide radar recordings for the next leg of the voyage on the German Bight. The ZANDER appeared on the radar of ETV NORDIC at 0518 on 24 November 2014. The NORDIC was laid up at her standby position north of Norderney in the inshore traffic zone. The radar images were recorded by the voyage data recorder (VDR). The analysis of the radar images (see Fig. 6) shows that the ZANDER steered a west-north-westerly course at a speed over ground of roughly 3 kts up until about 0700. After that, the speed reduced to less than 1 kt and the course changed to 145°. At an almost easterly course, which was maintained until she foundered, her speed then increased again from 0754 onwards.

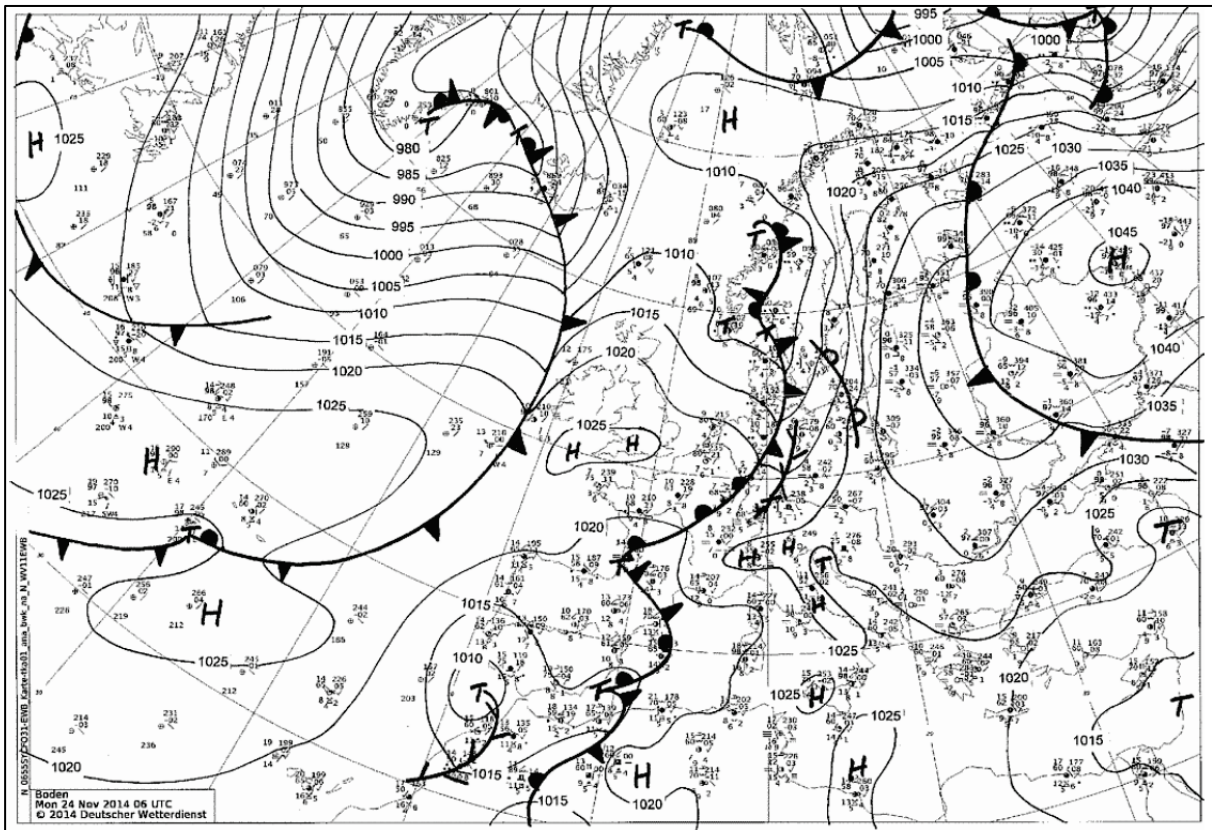
Figure 9: Weather map (ground pressure and frontal analysis) at 0600 UTC on 24 November 2014

The weather on 24 November 2014 was marked by differences in atmospheric pressure between the low-pressure system over southern Norway, which was only just tracking eastwards, and a high-pressure system over the southern part of Great Britain spreading eastwards. At the time of the accident at about 0800 (0700 UTC), the German Bight was on the reverse side of a cold front. This was embedded in a strong trough and had crossed the area on the previous night (see Fig. 9). Behind this cold front, cold maritime air flowed in with a strong north-westerly, later westerly flow. As the day progressed, the high-pressure system over the southern part of Great Britain spread eastwards, causing the wind to pick up steadily.

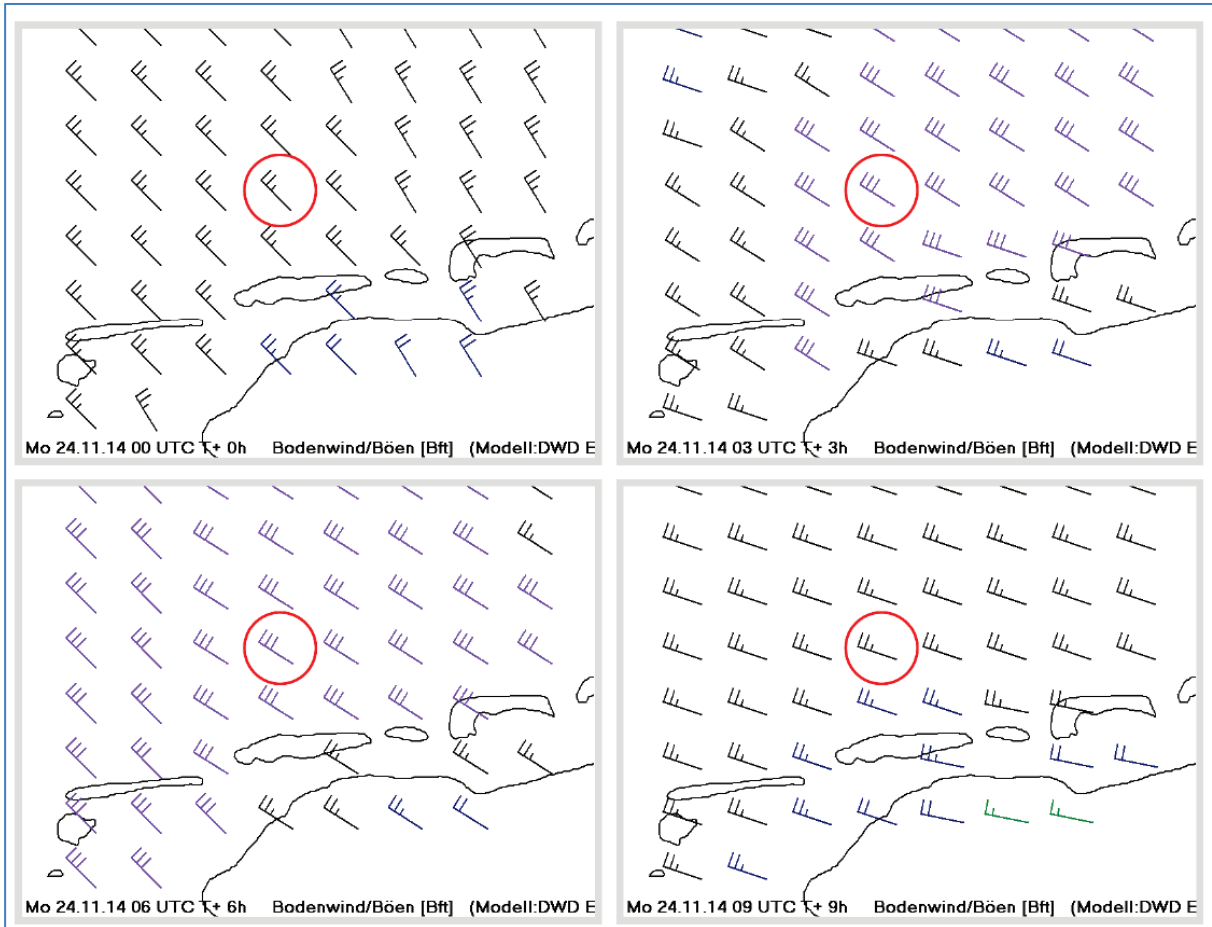
Figure 10: Wind development⁵

Mean wind (at a height of 10 m above the water surface): In the area of the accident, the hitherto southerly wind veered in a north-westerly direction between 2300 and midnight of the previous day. In the period between about 0400 and 0700, values of up to 25 kts (6 Bft) were reached on the open sea in isolated cases. A north-west wind prevailed off Norderney at 0800, reaching a mean average of 18-21 kts (5 Bft). In the following two hours, it veered back toward the west at the same force as before.

Gusts: At the time of the accident, the wind had reached speeds of 25-29 kts at a height of a few hundred metres. Due to the ensuing vertical shear, turbulence caused this upper wind to mix down to ground level at neutral stratification. These gusts of force 25-29 kts (6 Bft) were observed around and north of Norderney in the hours leading up to 0800.

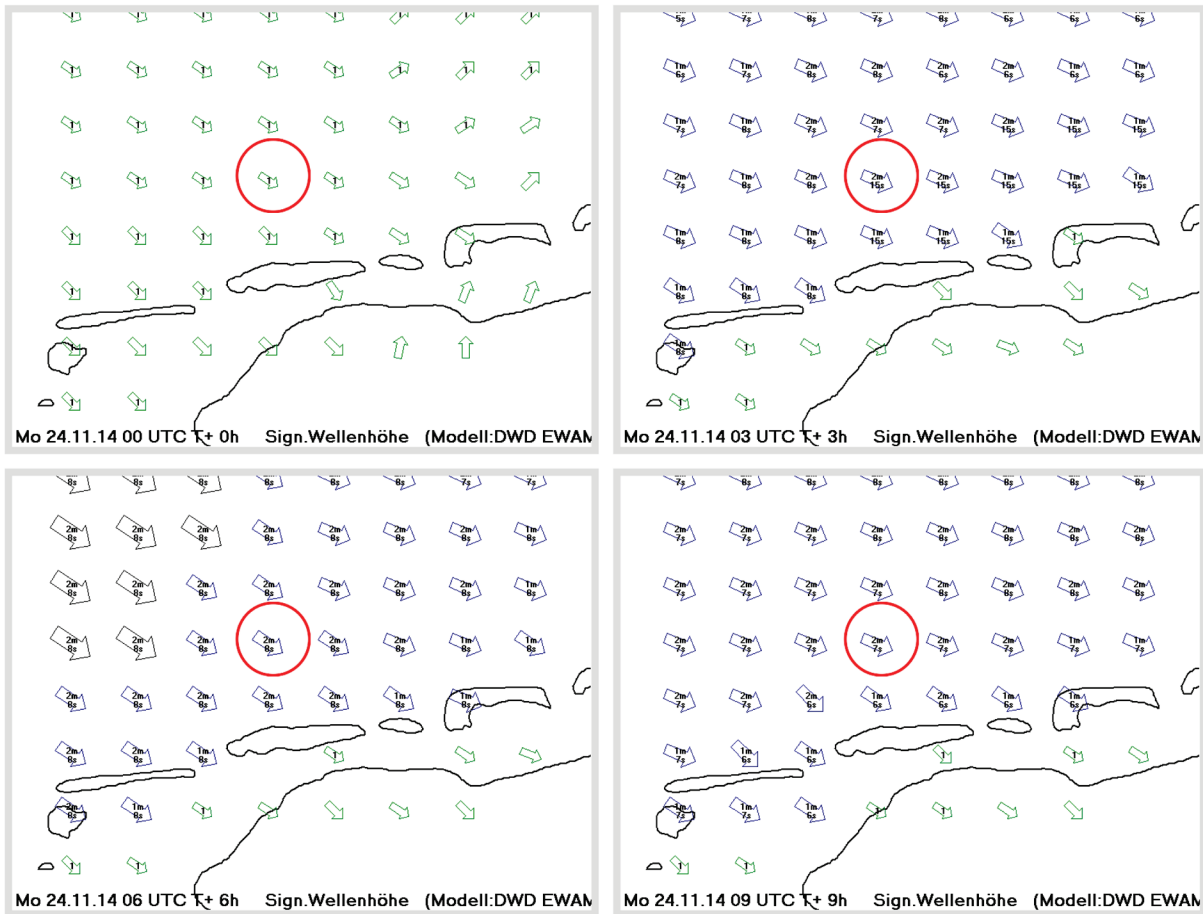
Figure 11: Height and direction of the significant wave height⁷

Significant sea state⁶: When the wind veered toward the north-west, a wind sea of 1.5-2 m was able to develop in the area of the accident between shortly before midnight and the time at which the accident occurred. On the previous day, the wind sea was less than half a metre in southerly winds.

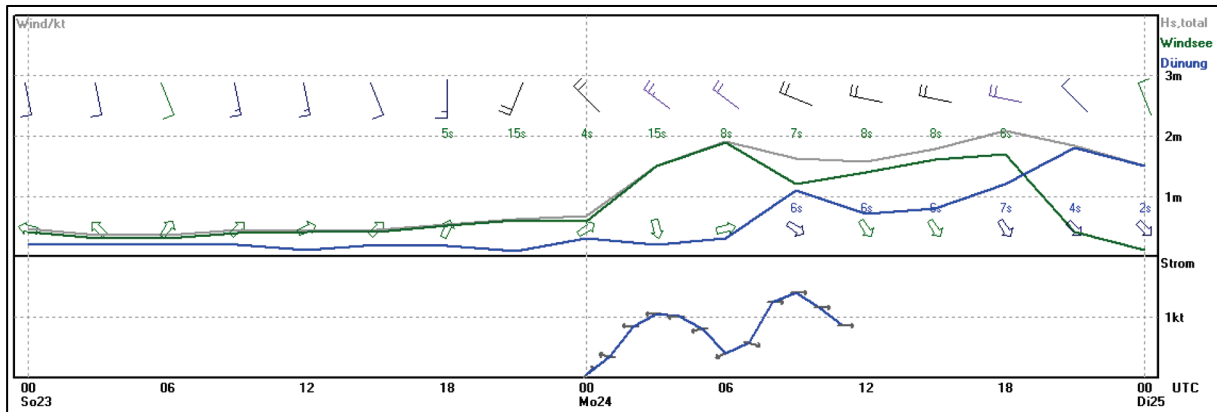
Figure 12: Development of wind, swell and current at the scene of the accident over time⁸

Weather and visibility: *The air close to ground level was saturated with moisture overnight up to a height of several kilometres (Fig. 12, grey lines). Consequently, it was heavily overcast and there was strong drizzle at times. From 0500 UTC onwards, drier cold air prevailed, which was essentially neutrally stratified toward the bottom. Accordingly, shallow convective clouds that covered only 2-3 eighths of the sky were visible at the time of the accident. Visibility was not restricted at this point in time.*

Current: *According to the BSH's circulation model, the current approached from the east (westerly current) at 0600 and was just short of a knot. In the following two hours up until the time of the accident, the current veered across the south (from north to south) toward the east (from west to east), while dropping to about half a knot. At the time of the accident at about 0800, the current approached the scene of the accident, as specified, at about half a knot from the north-west to the west and increased in the hour before 0900 to slightly more than a knot from the west.*
