Investigation Report 94/15

Serious Marine Casualty

Collision between the SAINT GEORGE and a lock gate at Brunsbüttel on 20 March 2015

21 March 2016

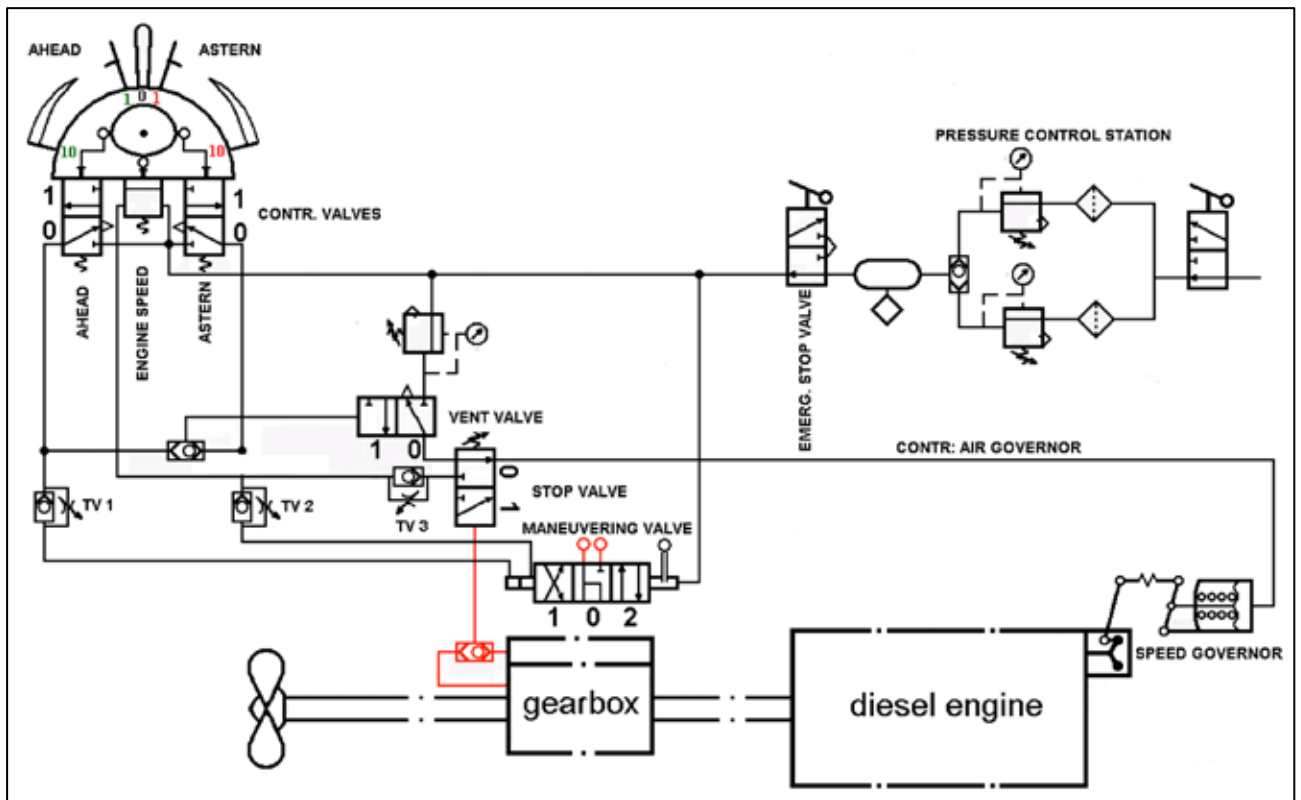
Figure 7: Remote control system circuit diagram

If TV (throttle valve) 1 or TV 2 (see Fig. 7) is obstructed (no flow), then the manoeuvring valve remains closed. Couplings are not closed and the engine continues to rotate at the idling speed. If this TV fails (full flow), then the manoeuvring valve closes almost simultaneously with the vent valve. There is a risk of speed suppression down to the engine stopping due to the insufficient increase in the engine speed prior to a coupling's shift operation.

If TV 3 is obstructed, then the control air line to the engine's speed governor is closed and the engine continues to rotate at the idling speed even if the coupling is closed. It is possible that there will be rapid variations in the number of revolutions of the engine if this valve fails. There is a risk of the engine being overloaded when it is under acceleration.

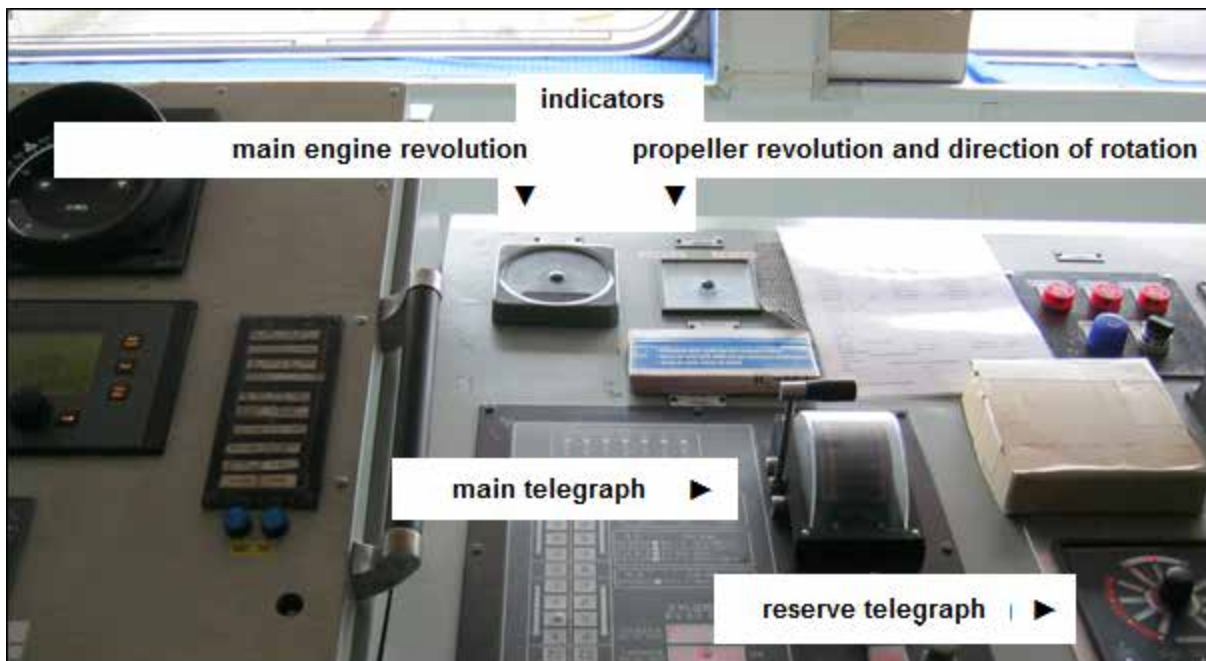
Figure 11: Engine order telegraphs on the bridge

A visual and performance test was carried out on the main and reserve engine order telegraphs after the accident. No defects or malfunctions could be found.

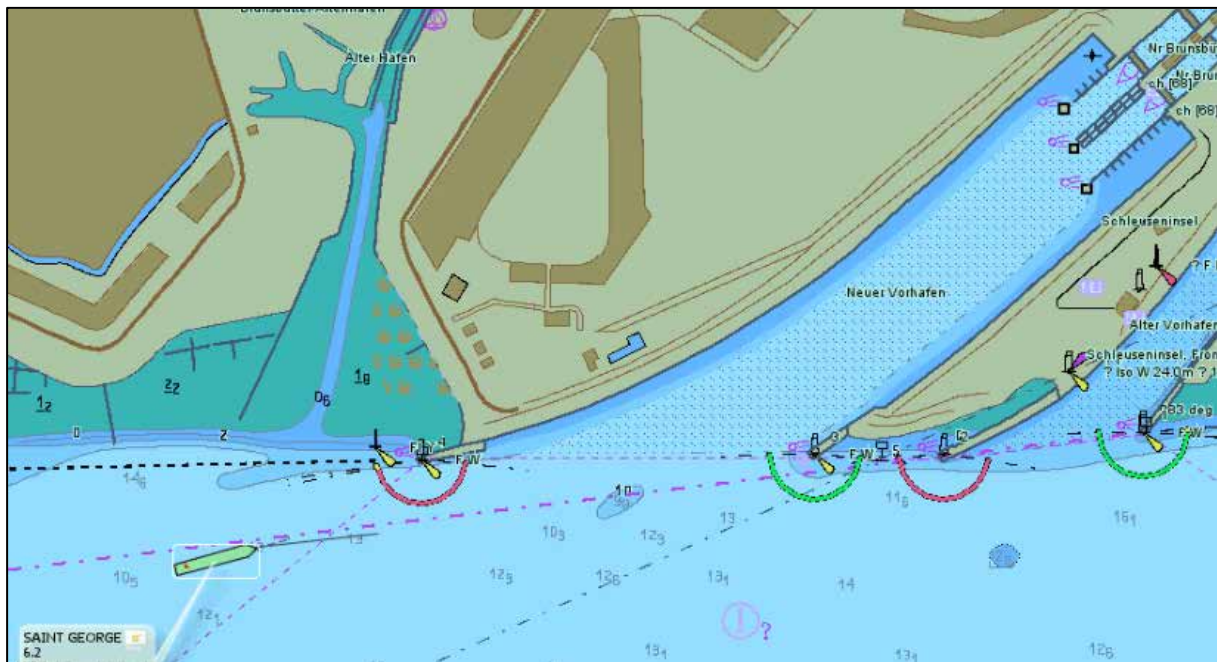
Figure 17: AIS display at 121417

The ship was running at dead slow ahead during the pilot transfer. This rate of speed was maintained initially. The SAINT GEORGE was first turned in on the main line. The engine was stopped at 1210 when the SOG stood at 7.9 kts. An order to set the engine to dead slow ahead again was issued at 1214 to gain the required ability to steer when entering the outer port and passing through the shear zone⁶. At this point (see Fig. 17), the SAINT GEORGE's SOG stood at 5.7 kts.

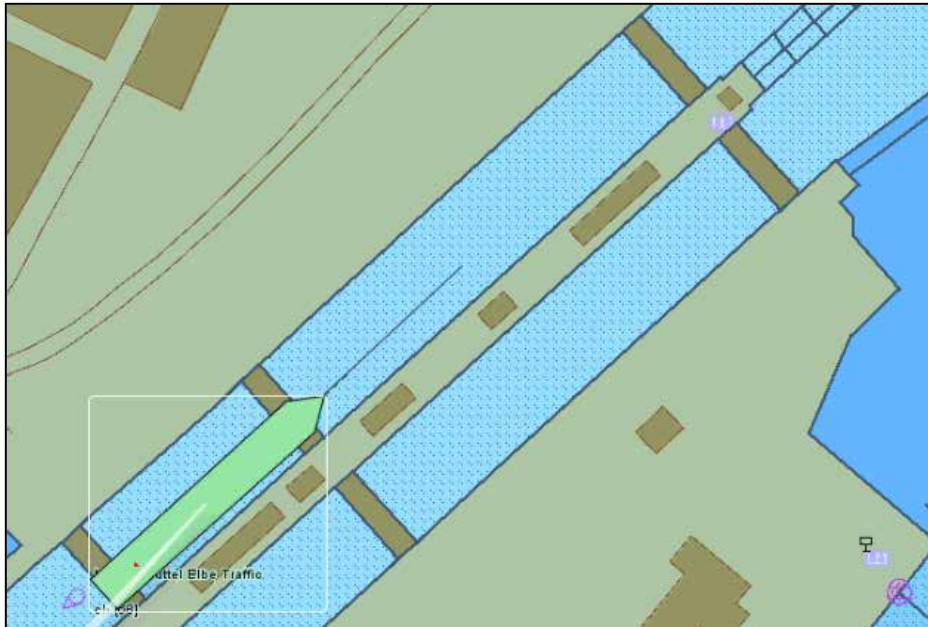
Figure 20: AIS display at 122446

At 122451, after the SAINT GEORGE had entered the lock completely (see Fig. 20), the pilot issued an order to set the engine to dead slow astern and bow thruster to full to starboard. The SOG was 2.7 kts at this point and the distance to the lock gate about 200 m. The SAINT GEORGE's manoeuvring characteristics indicate that she could be stopped safely before reaching the lock gate.

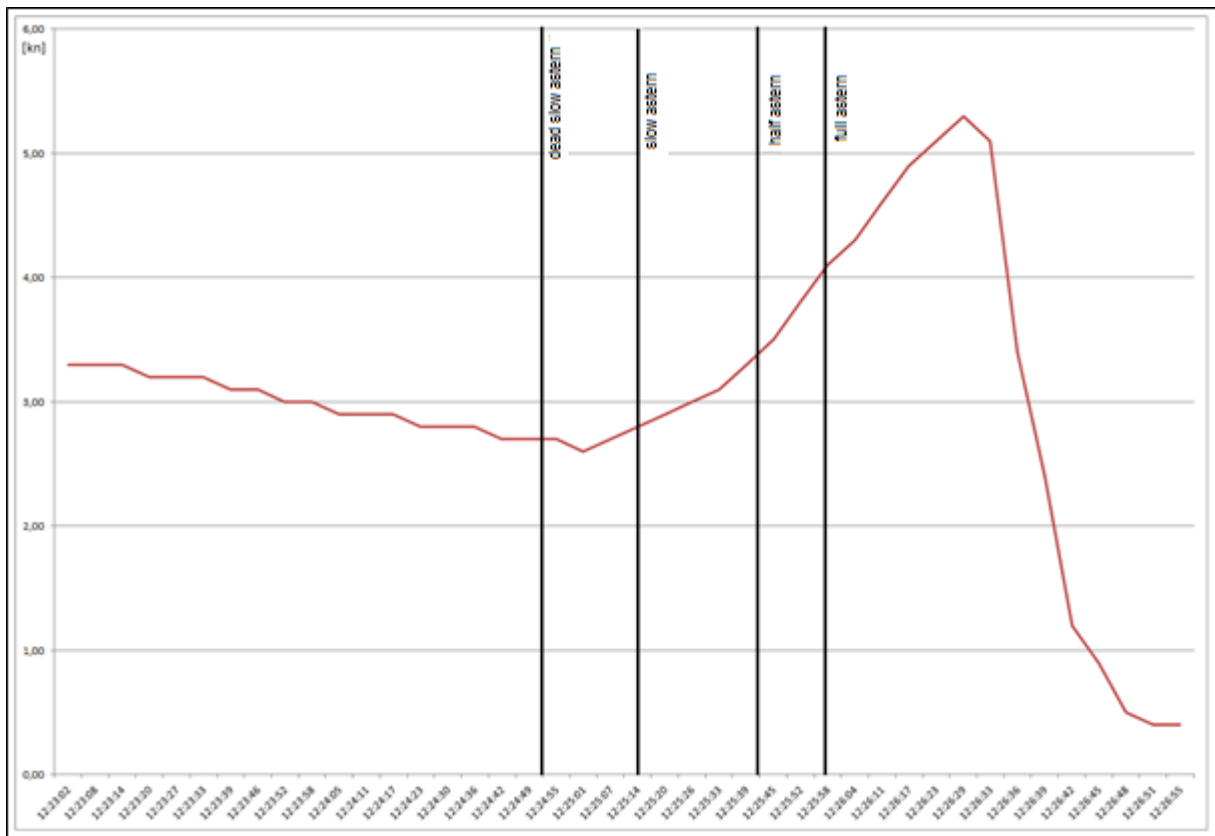
Figure 22: Diagram showing the speed curve

The diagram showing the SAINT GEORGE's speed curve during the entry manoeuvre illustrates how the speed was initially more or less constant after the dead slow astern command. The speed first rose moderately after the slow astern command and then sharply after the half astern command (see Fig. 22).
