Investigation Report 189/14

Serious Marine Casualty

**Collision between the sailing vessel NOBILE  
and worksite craft WERKER in the  
Flensburg Firth on 30 May 2014**

24 February 2017

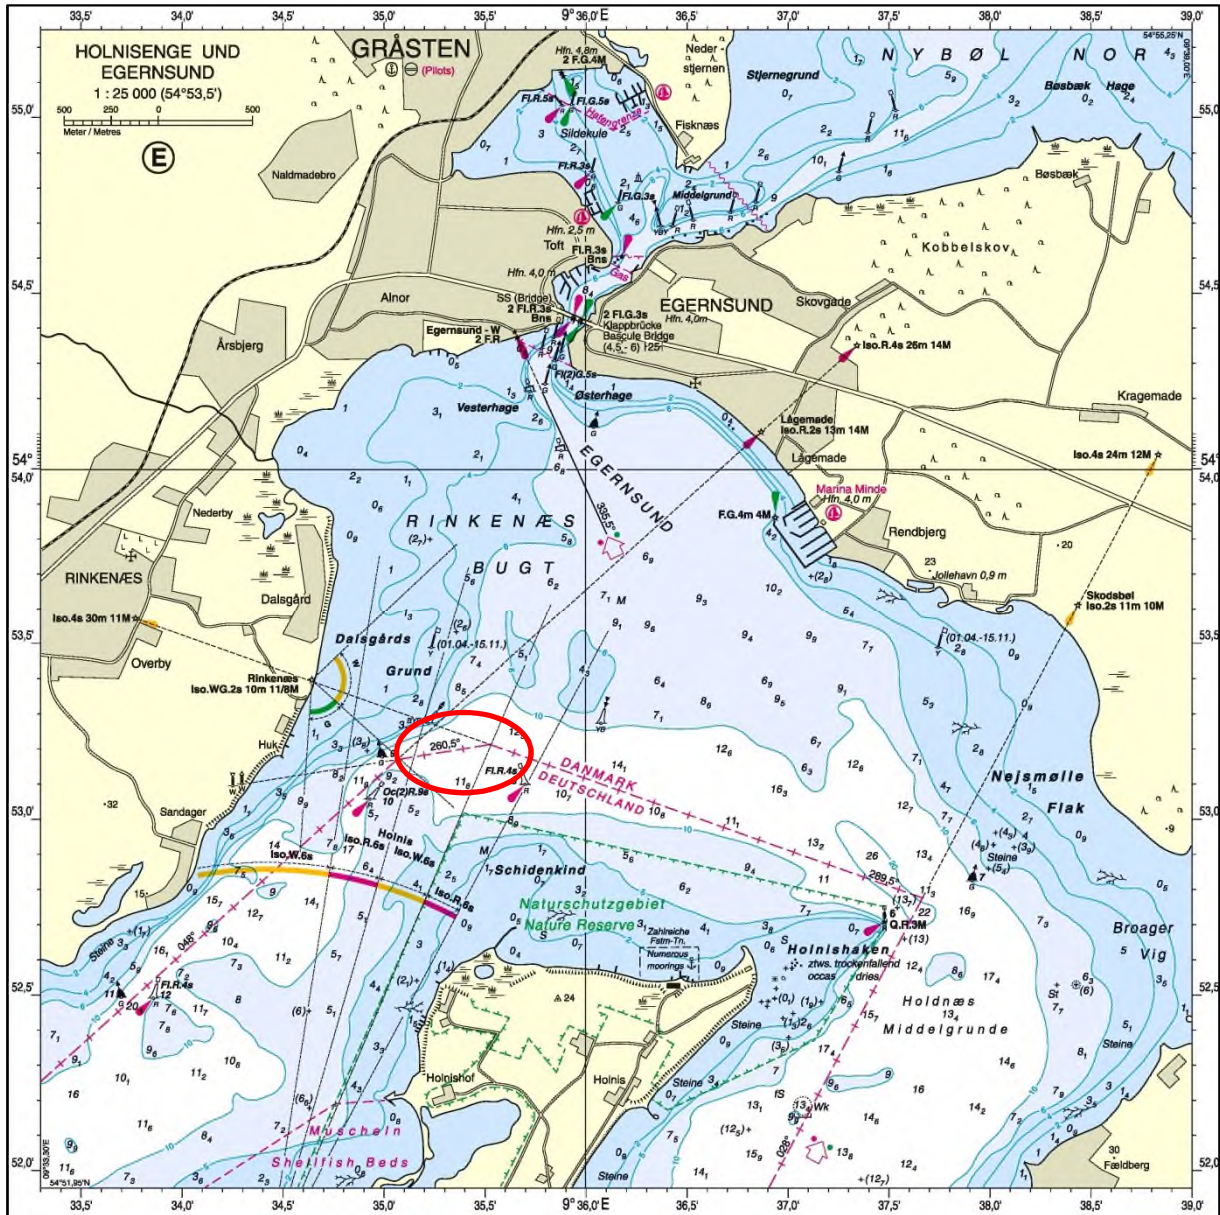
Figure 3: Nautical chart showing the scene of the accident<sup>4</sup>

In the area north of buoy 9 and the east cardinal mark on the edge of the Dalsgårds Grund, shallow waters are immediately adjacent to the buoys. The water in the area south of buoy 10 is about 5 m deep (see Figure 3).

The German-Danish border runs through almost the entire length of the Flensburg Firth, where in certain areas (between buoys 1 and 3, 7 and 9, 9 and 11, in particular) the border is located in or near the middle of the fairway. Moreover, the border is marked by the Skodsbøl, Rinkebøl and Lågemade leading lights, as well as the middle of the Holnis sector light (see Figures 3 and 4). All the leading lights and the sector light can also be used for navigation.

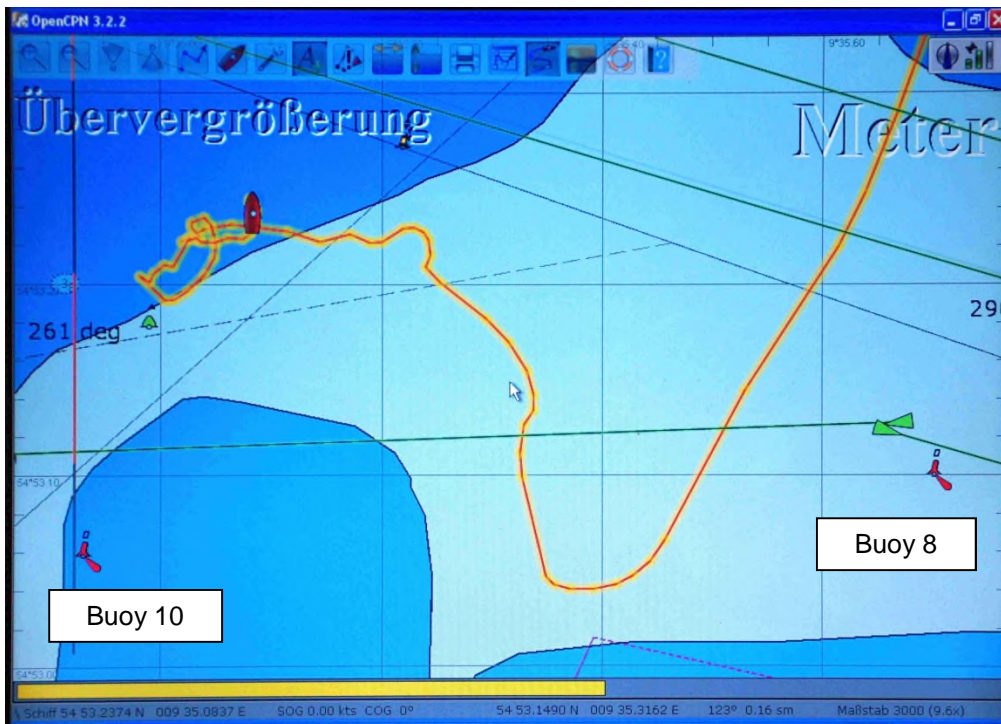
Figure 6: NOBILE's track, magnified view of the last leg

<sup>7</sup> The other AIS targets shown in green in Figures 5 and 6 are not related to the accident.

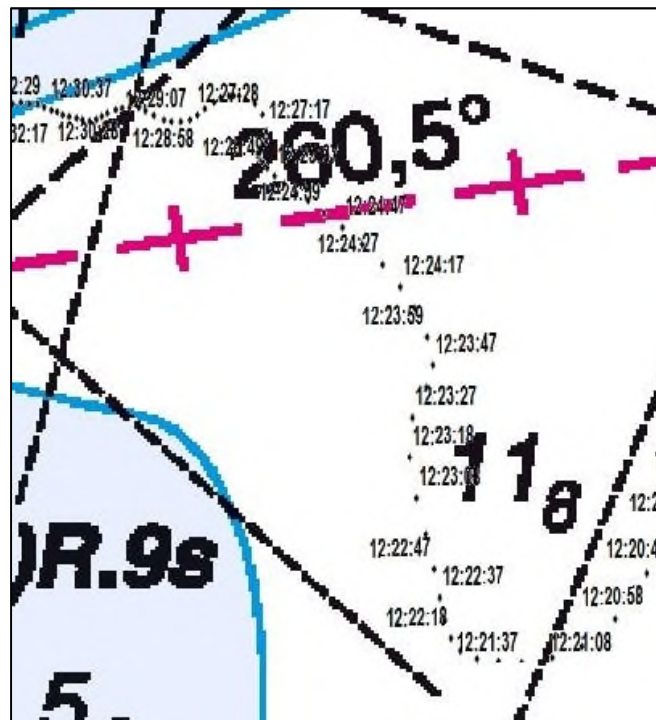
Figure 9: COG of the NOBILE, detail (times in UTC)

An analysis of Graph 1 reveals two possible times for the collision. One is the time at which there was a rapid loss of speed at 142327. However, this is opposed by the location and sequence of the following positions, as the NOBILE continuously moves further in a north-north-westerly direction (see Figure 9). The collision with the WERKER would have had to interrupt this movement because the two ships were locked together, and in all likelihood the NOBILE came to a standstill on the WERKER. Hence, the loss in speed is probably due to the ship luffing up at about 308° COG, which continued until 142459, meaning this point in time can be ruled out. The other is the time at which the NOBILE's position points start to converge and the COG veers abruptly to starboard (see Figures 6 and 9). This time is set at 142527. This abrupt veer could have two causes. One is the hard-starboard course alteration described by the crew of the NOBILE, which ended in the collision shortly afterwards. Two is the continuing full astern manoeuvre initiated by the WERKER, which drags the NOBILE (still locked together with the WERKER after colliding with her) aft, i.e. to starboard.

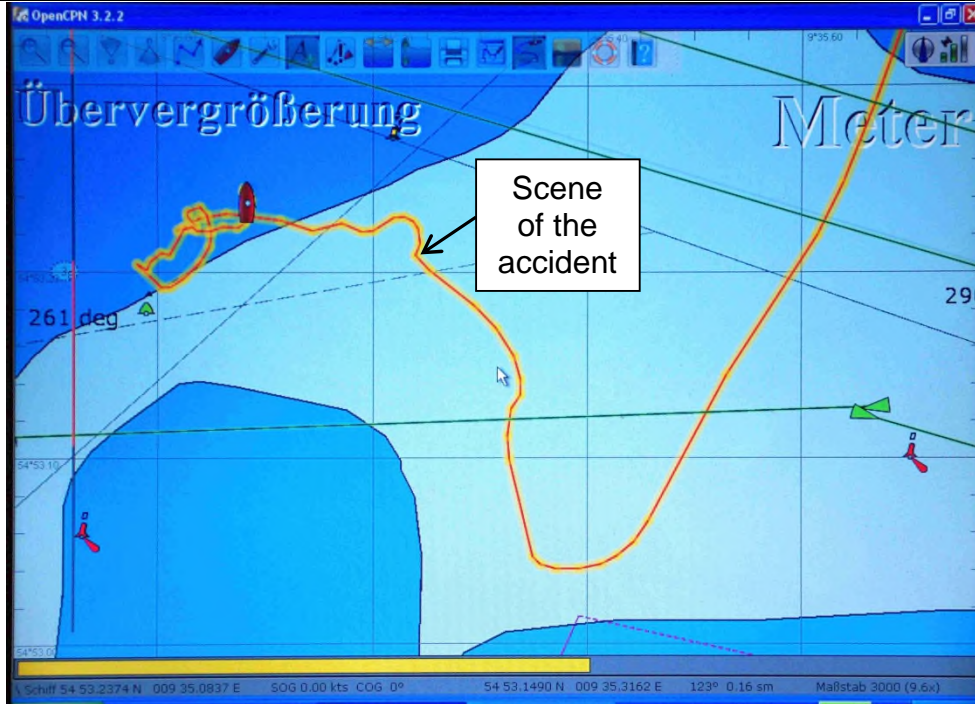
Figure 11: Track of the NOBILE with the scene of the accident

On that basis, the scene of the collision is defined as a location north of the directional line formed by the leading marks of Sandlager and border marking<sup>14</sup> (see Figures 11 and 12). Given the short intervals, the location at 142527 is determined as the scene of the collision. This equates to the following position: 54° 53.2'N 009°35.26'E, which is located in Danish waters.
