Investigation Report 225/15

Serious Marine Casualty

**Collision between the ferry FRISIA V
and a quay facility in Norddeich
on 16 June 2015**

7 March 2017

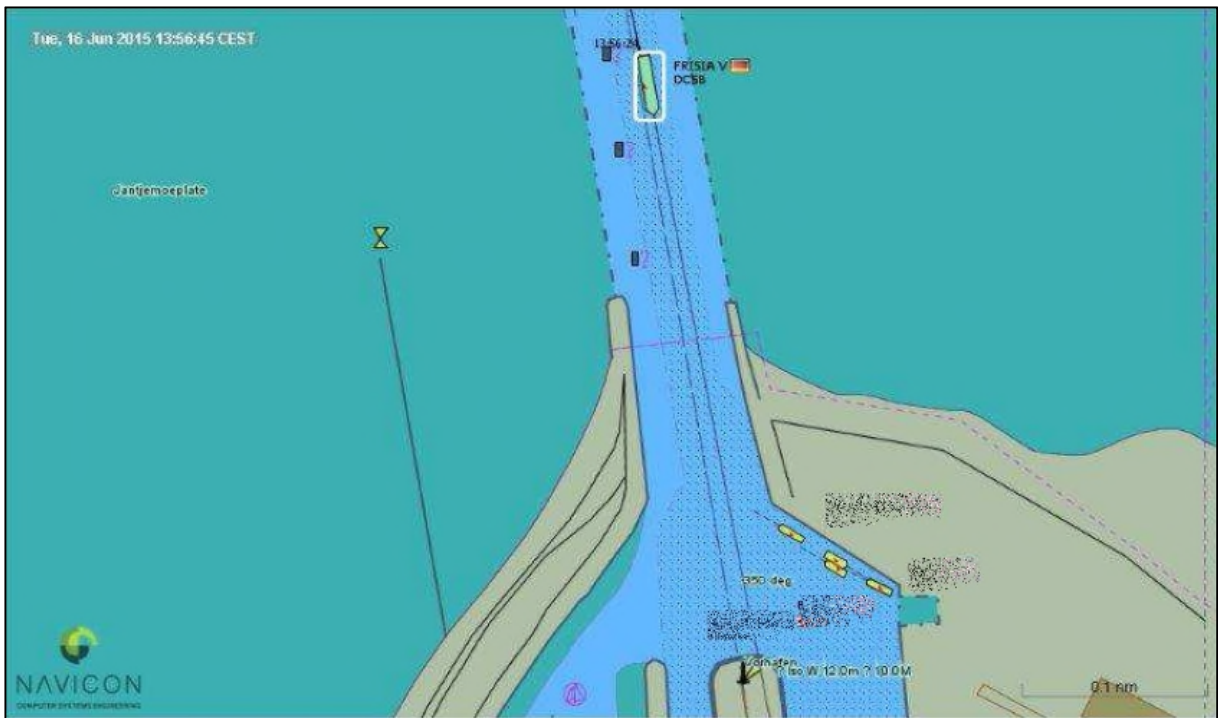
Figure 3: Position at 135645, 7.7 kts SOG⁵

The ship's course was still kept by the autopilot at 1356.

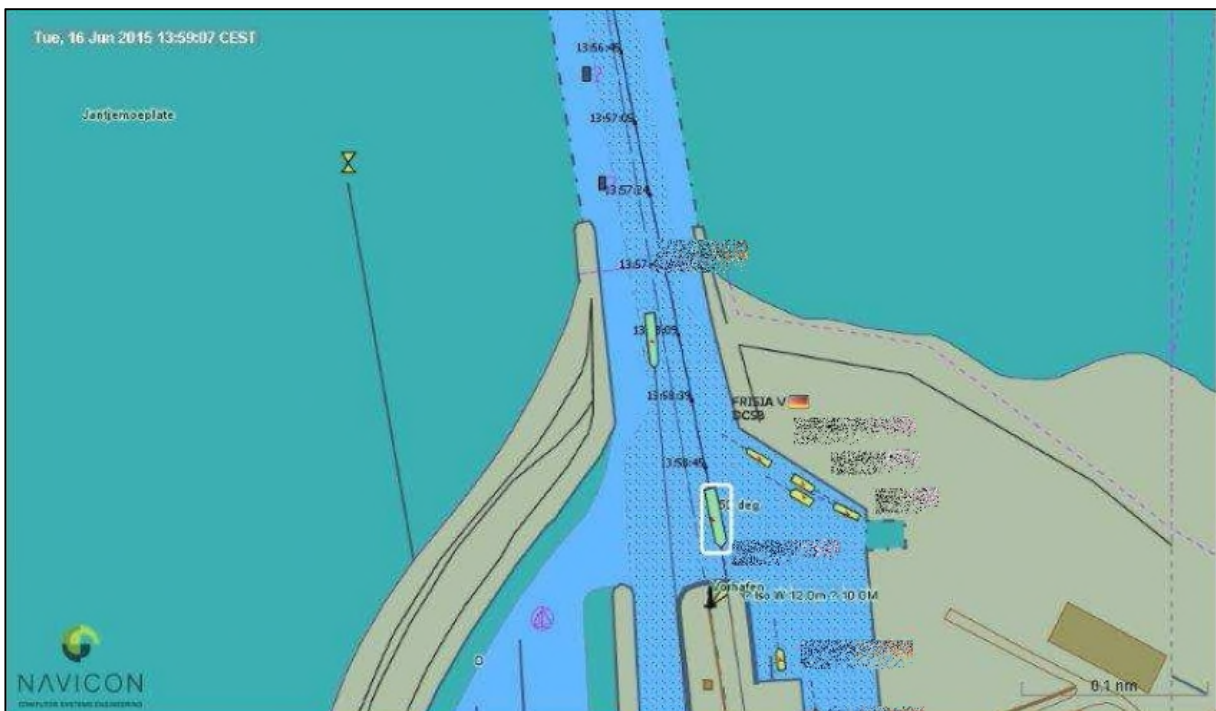
Figure 6: Position at 135907, 5.5 kts SOG

Shortly after leaving the narrow section between the breakwaters (Figure 5), the captain attempted to switch the steering gear to manual on the port control console, so as to then manoeuvre resp. turn the ship using the Schottel propellers. This was unsuccessful, meaning the autopilot continued to head for the quay. The force of the impact was reduced by the full astern manoeuvre with the help of the middle engine. The speed was about 5 kts on impact.

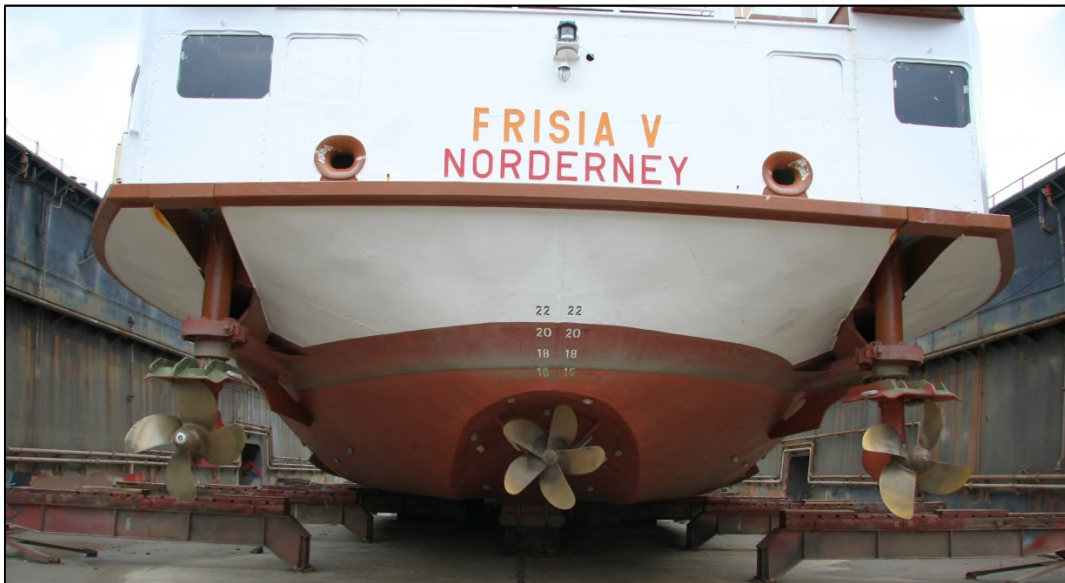
Figure 8: View of the FRISIA V's stern

The ferry had three independent propulsion units. Two main engines were each coupled with a Schottel propeller. Another main engine acted as a middle engine on a conventional propeller. The ferry was also equipped with a Veth-Jet lateral thruster.

Due to its design, this was only fully effective from low speeds. The Schottel propellers lent the ship good manoeuvrability.

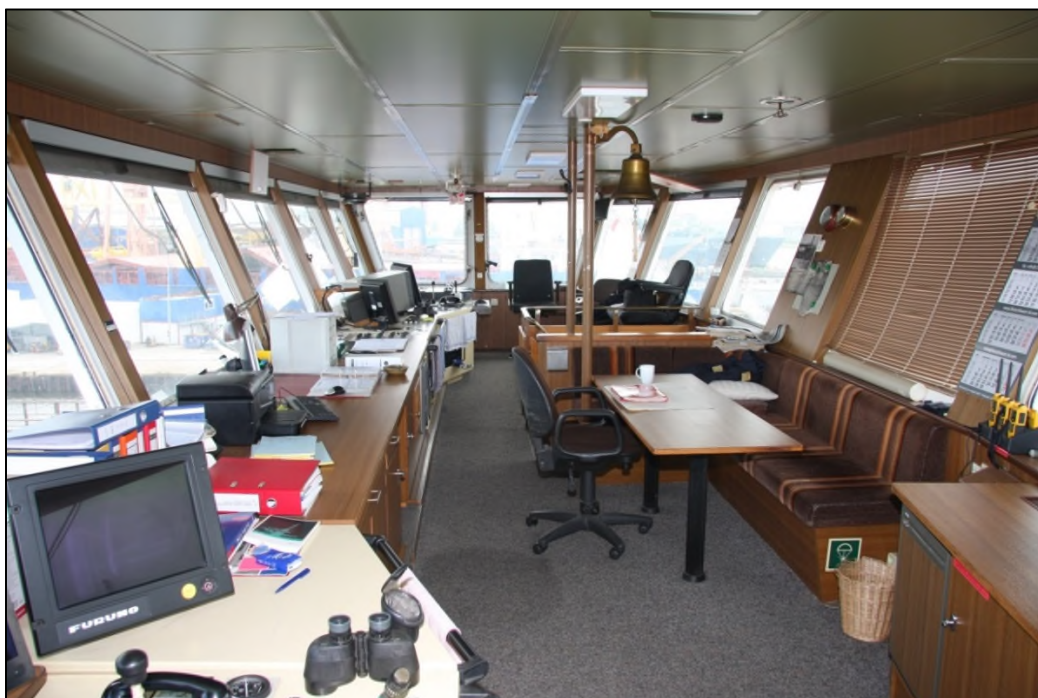
Figure 9: Overall view of the FRISIA V's bridge

Two control consoles were installed on the bridge of the ferry. They were located on the outer sides of the bridge console and offered good visibility of the respective side of the ferry and fore section. The autopilot's operating panel was installed in the console on the starboard side.
