Bundesstelle für Seeunfalluntersuchung
Federal Bureau of Maritime Casualty Investigation
Federal Higher Authority subordinated to the Ministry of Transport
and Digital Infrastructure

Investigation Report 262/14

Very Serious Marine Casualty

**Foundering of the fishing vessel ANDREA
and death of a crew member
in the Baltic Sea off Lippe
on 16 August 2014**

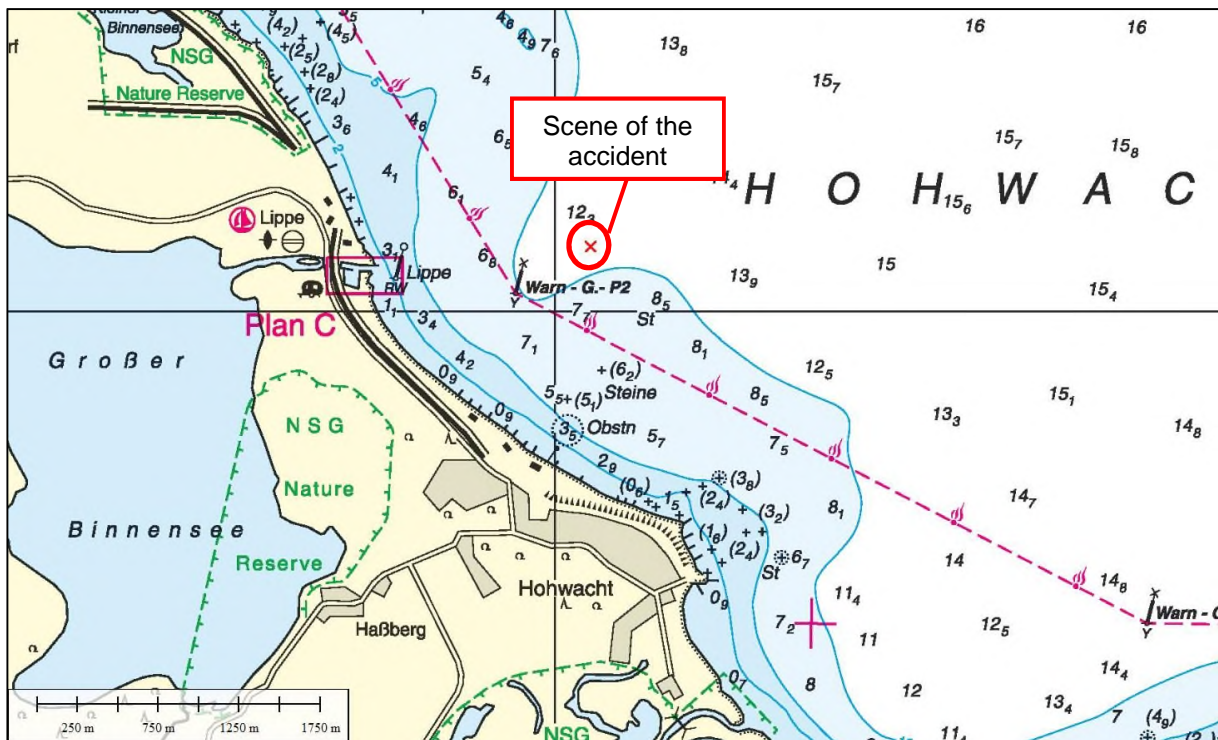
Figure 2: Navigational chart showing the scene of the accident and the port of Lippe

Type of marine casualty:	Very serious marine casualty, foundering of vessel and loss of a crew member
Date, time:	16 August 2014, 0630
Location:	Baltic Sea off the port of Lippe
Latitude/Longitude:	ϕ 54°20.230'N λ 010°40.232'E
Ship operation and voyage segment:	High seas
Consequences:	Fishing vessel foundered, one crew member drowned, second crew member initially treated in hospital for hypothermia

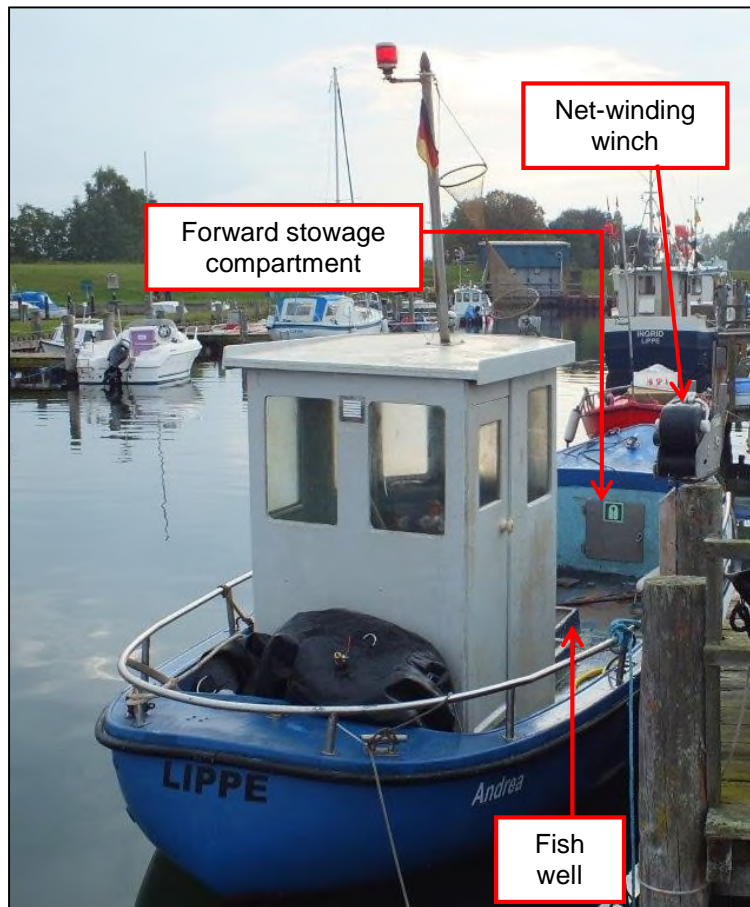
Figure 4: View of the ANDREA from aft

A hydraulic winch for hauling in the nets is installed in the forward area on the starboard side of the deck. This can be controlled directly at the winch. It is used for hauling in net containing the catch, in particular.

- no mount for a ring lifebuoy on the wheelhouse or anywhere else;
- extremely heavy wear in the forward area of the deck, meaning it had hardly any non-slip coating;

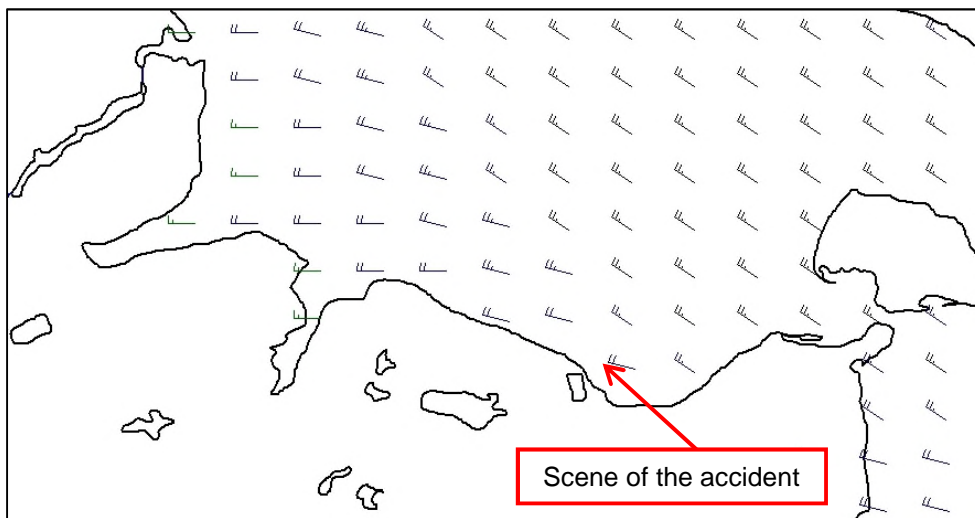
Figure 10: Wind speed and direction at 0500 CEST

Wind: Quite varied wind conditions were registered in the area of Hohwacht Bay at the time of the accident. While a generally light westerly to south-westerly breeze of 5-6 kts was measured in the coastal areas ashore, the exposed stations at Kiel Lighthouse and Fehmarn registered westerly to north-westerly wind of 12-19 kts (4-5 Bft). Calculating a north-westerly to westerly wind of 4-5 Bft over Hohwacht Bay, the model showed a good degree of consistency with the measurements. It is reasonable to assume that there were isolated gusts of 25 kts (6 Bft) over Hohwacht Bay. This statement can be derived from wind measurements at ground level and measurements of the vertical wind profile.

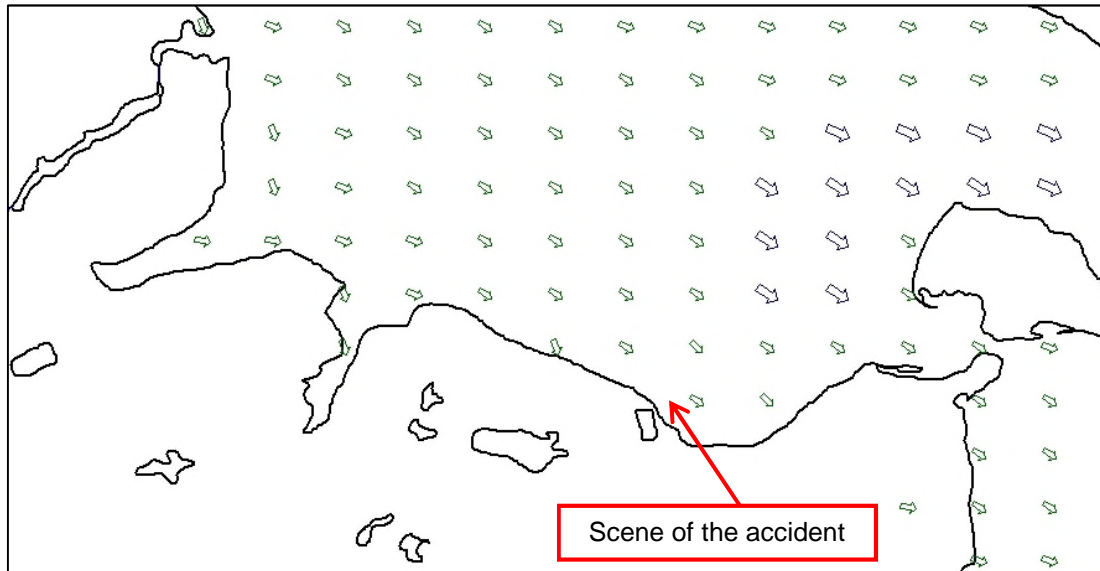
Figure 12: Significant wave height¹³ and direction¹⁴ at 0500 CEST

Significant sea state: *The significant wave height calculated generally stood at 0.5 m (and at 1 m in the direction of Fehmarn). At the same time, the waves were approaching from the north-west.*

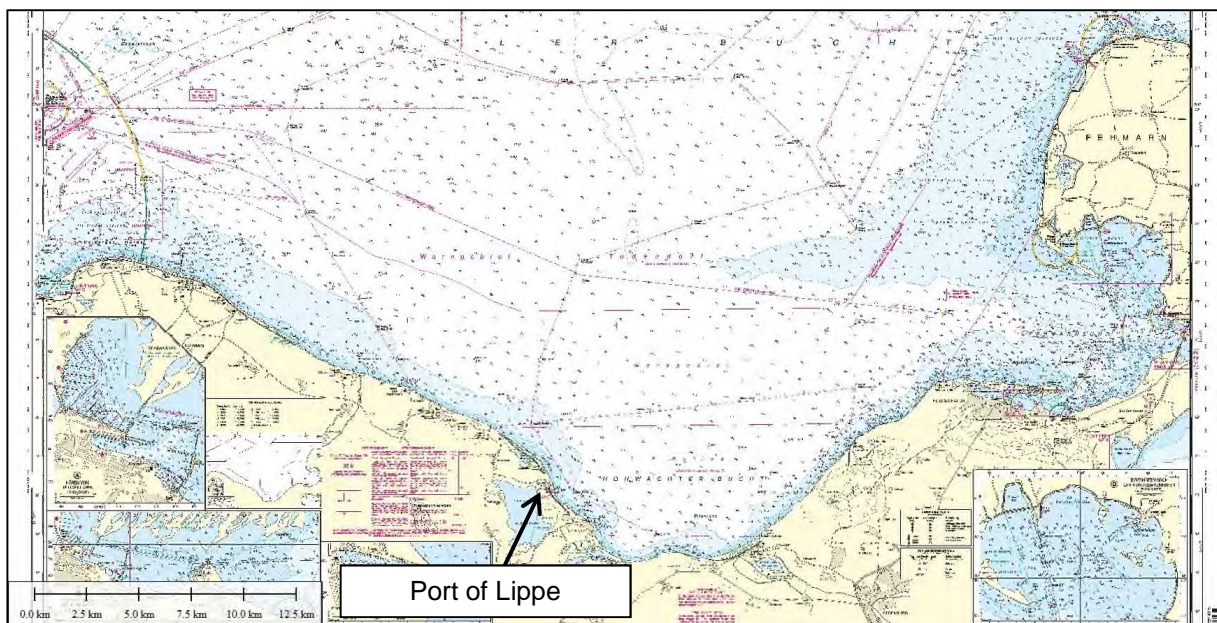
Figure 14: Overview of the sea area in the vicinity of the accident

During the next few hours, the wind turned to a more westerly direction and possibly dropped somewhat in the near-coastal area. The swell maintained its direction, which in all likelihood led to an unsettled wave pattern because the wind sea now approached from the west. At any event, the weather situation prompted the fishermen to hurry, resulting in the catch and nets being stowed in the net barrels together. The investigators assume that each net barrel weighed about 80 kg on the return voyage. In principle, this did not affect the stability of the fishing vessel.
