**Bundesstelle für Seeunfalluntersuchung**  
**Federal Bureau of Maritime Casualty Investigation**  
Federal Higher Authority subordinated to the Ministry of Transport  
and Digital Infrastructure

## **Investigation Report 268/15**

**Very Serious Marine Casualty**

**Fatal accident on board  
the CMV DUBLIN EXPRESS  
on 14 July 2015 en route from  
Caucedo to Rotterdam**

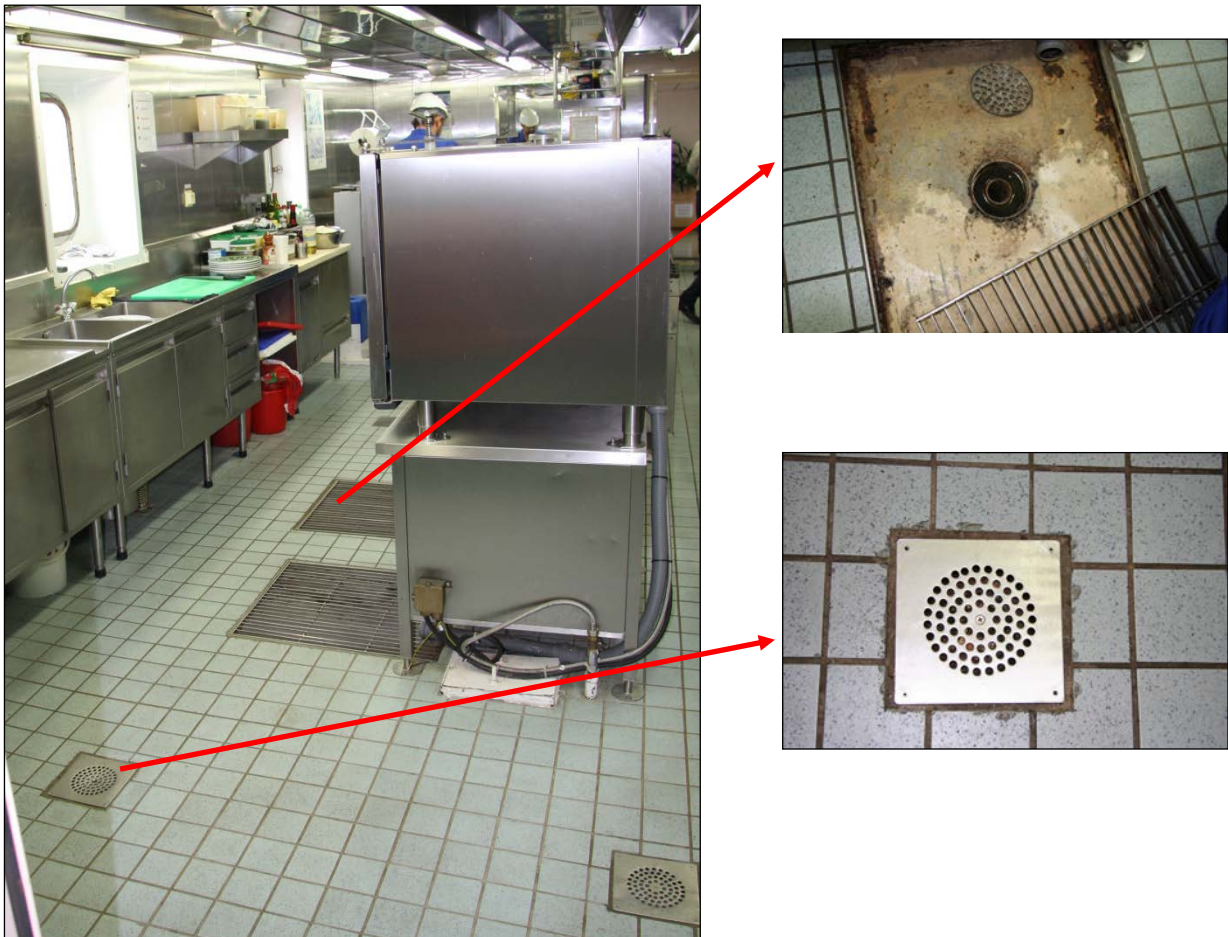
**Figure 3: Drains in the galley**

Eight channels flow into the discharge pipe. These include a double sink, dishwasher, two large and three small drain outlets (see **Figure 3** by way of example).

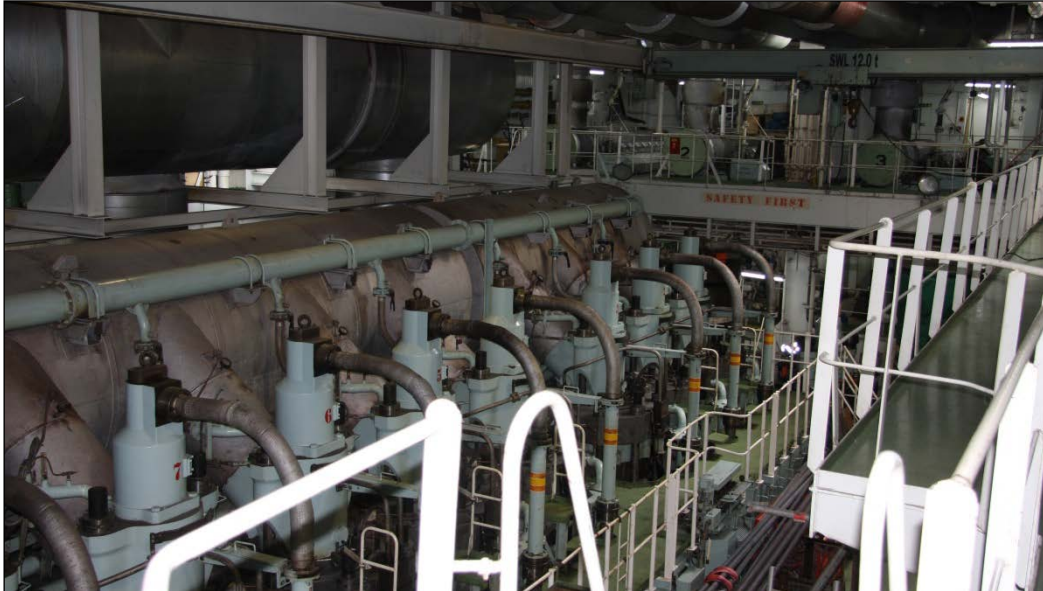
Figure 4: Upper section of the engine room in the ship's longitudinal direction<sup>5</sup>

The following figures illustrate the position at the scene of the accident and the routing of the discharge pipe (marked red)<sup>4</sup> within the engine room from various perspectives.

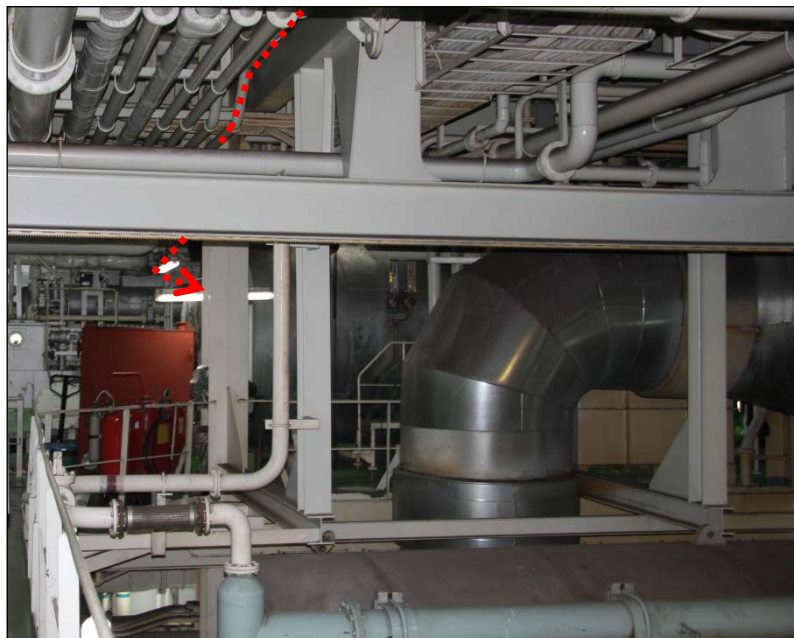
Figure 5: Upper section of the engine room in the ship's transverse direction<sup>6</sup>

**Figure 6** shows an overall view of the immediate scene of the accident, which is visible only in the background of **Figure 5**. The ladder the casualty fell from stood in the vicinity of the vertical steel beam visible in the front of the figure (see also Figure 7 below: close-up A) at the time of the accident.

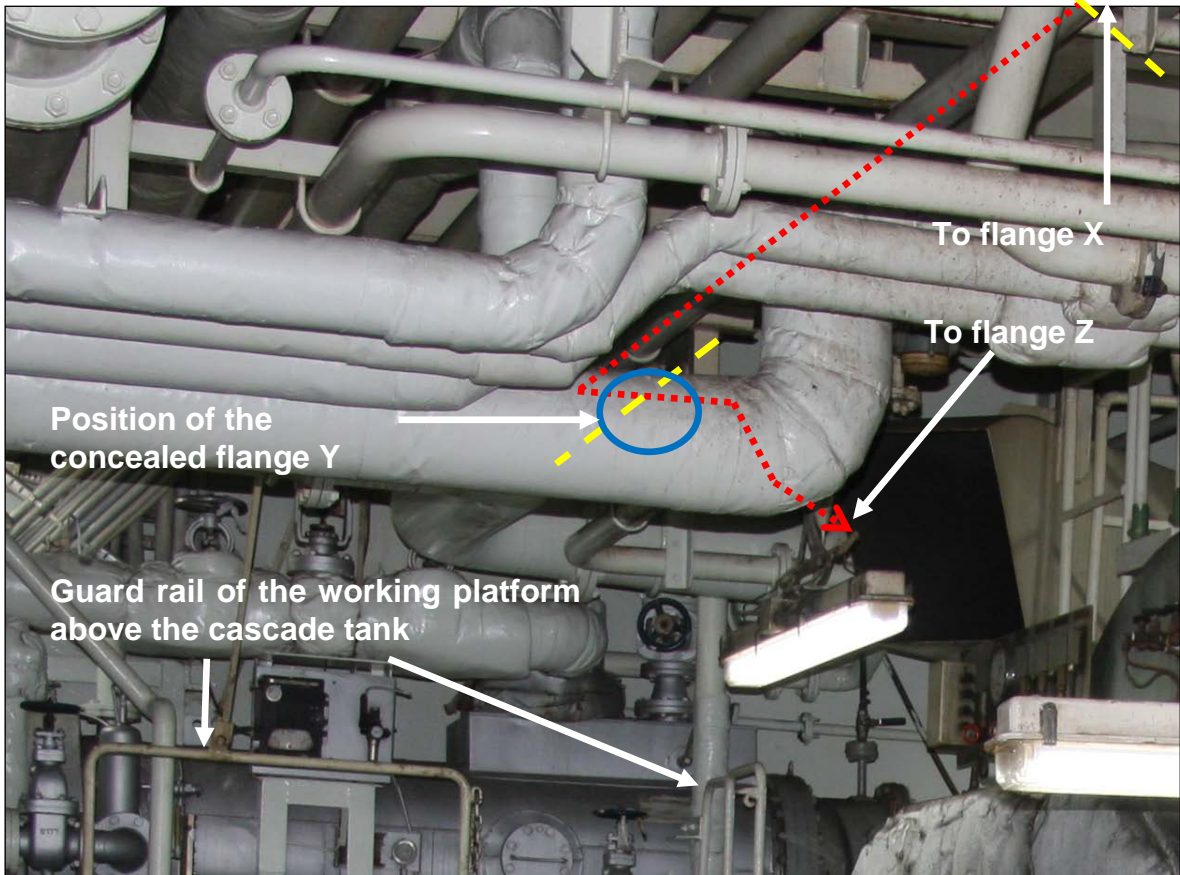
Figure 8: Routing of the discharge pipe – close-up B (transition of ship's transverse and longitudinal direction)

**Figures 8 ff.** below (close-ups B, C, D and E) show the remaining routing of the discharge pipe toward the starboard side of the engine room. The change in direction of the discharge pipe's routing and the guard rail of the working platform immediately adjacent to the pipe bend are visible in **Figure 8**.

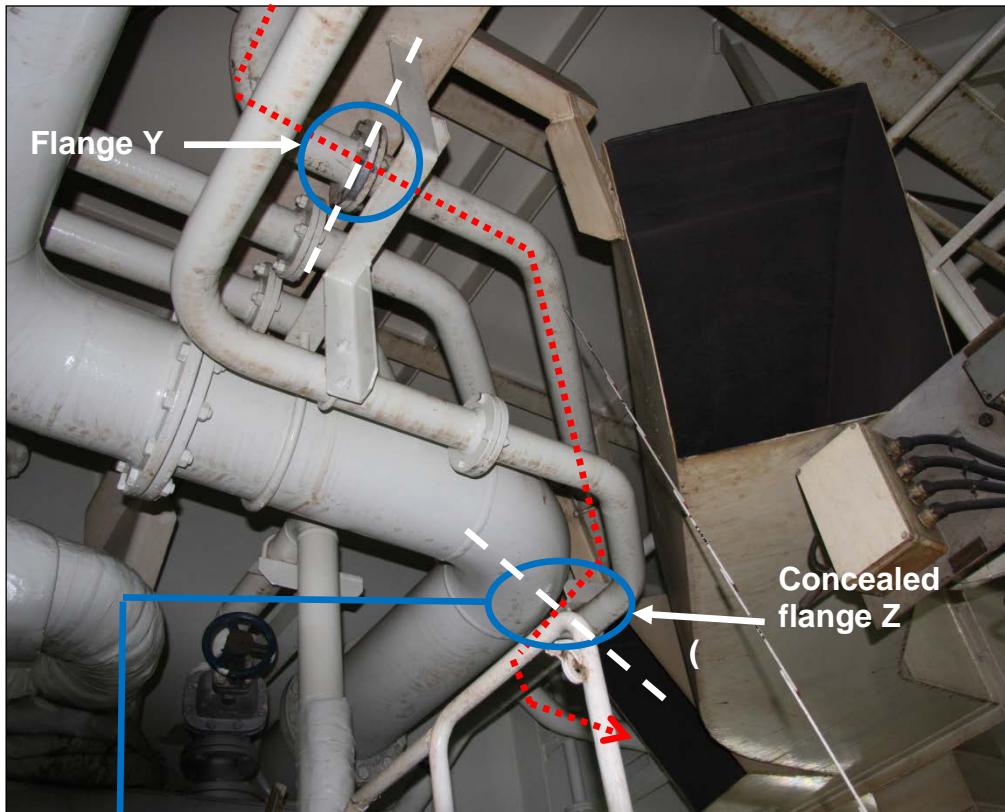
Figure 10: Routing of the discharge pipe (close-up D)

The bend in the discharge pipe in the vicinity of the longitudinal bulkhead on the starboard side of the engine room and the flange connections Y and Z located there (each circled blue) are visible from different angles in **Figures 10 and 11**.

It was initially thought that the discharge pipe was blocked in this area. Consequently, on the morning of the day of the accident the pipe joints at flanges Y and Z were first loosened and the curved pipe section marked with white lines in Figure 10 then removed. This pipe section was then cleaned and the remainder of the piping flushed with seawater. The ensuing check of the drain in the galley revealed that the blockage still existed. For that reason, the three seamen tasked with the works decided to remove another pipe section. This was the straight section of several metres in length between the vertical steel beam shown in **Figure 6** and the 90-degree bend (see yellow boundary marker in **Figure 8**). In addition to the previously unscrewed flange connection Y, flange connection X (see **Figure 7**) also had to be loosened to achieve this. It was only possible to reach this flange by ladder.<sup>9</sup> The long pipe section was not completely removed after the flange connection was loosened, but rather left in the ceiling mount because it was so heavy.
