Bundesstelle für Seeunfalluntersuchung
Federal Bureau of Maritime Casualty Investigation
Federal Higher Authority subordinated to the Ministry of Transport
and Digital Infrastructure

Investigation Report 43/16

Very Serious Marine Casualty

**Fatal line accident on board
the CMV MAERSK KURE
in the port of Bremerhaven
on 6 February 2016**

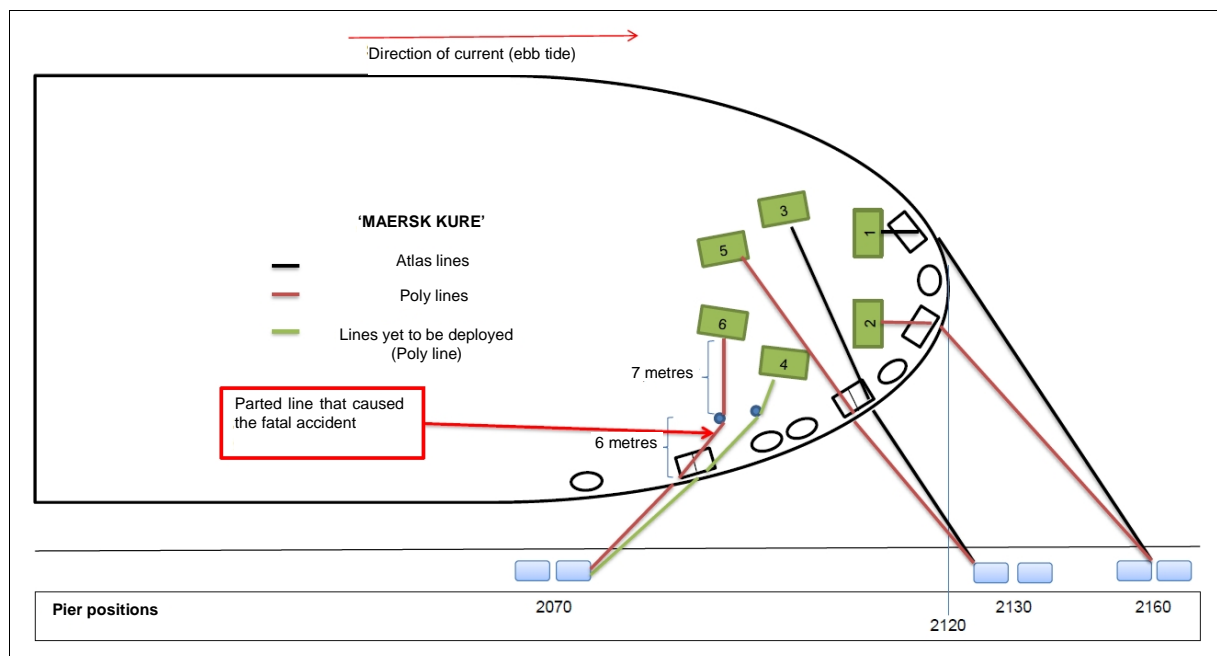
Figure 4: Schematic drawing of the line guidance on the forecastle

The bosun, a seaman, and the apprentice had just lowered the towline to the tug and proceeded to the starboard side to pass the second spring ashore. The second seaman had already attached the heaving line to the eye of the second spring there and begun to pay out the line through a fairlead on the starboard side. To this end, he had to stand right next to the deployed spring line. Accordingly, nobody was at the winch control positions at the time of the accident.
