**Bundesstelle für Seeunfalluntersuchung**  
**Federal Bureau of Maritime Casualty Investigation**  
Federal Higher Authority subordinated to the Ministry of Transport  
and Digital Infrastructure

## **Investigation Report 44/16**

**Very Serious Marine Casualty**

**Foundering of the fishing vessel CONDOR  
on 6 February 2016 about 3.5 nm east of the  
Baltic Sea Island of Fehmarn**

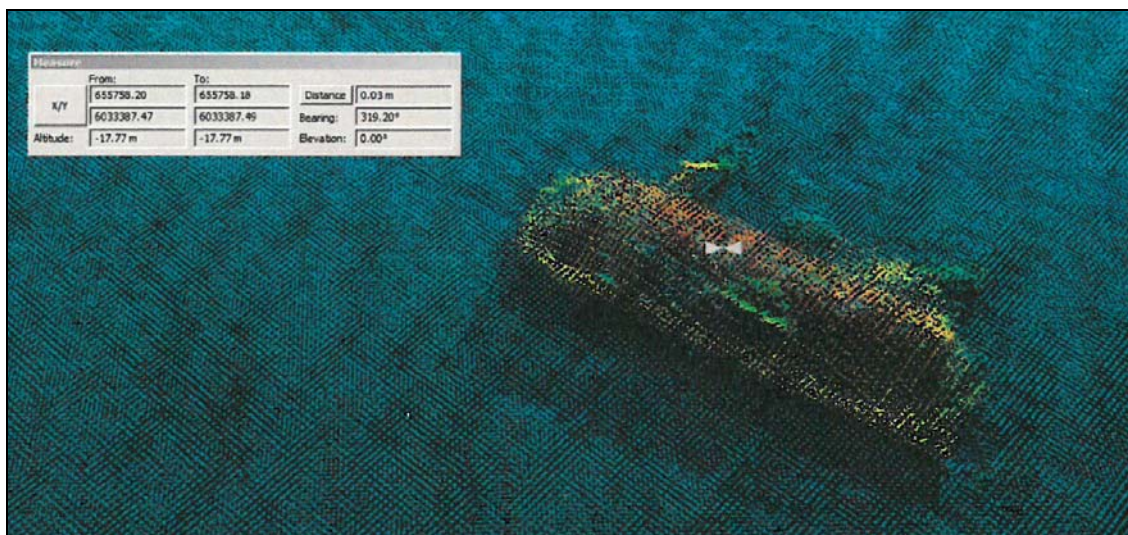
**Figure 3: Sonar image of the wreck of the FV CONDOR<sup>9</sup>**

The BSH's survey, wreck search and research vessel DENEK was dispatched to the presumed scene of the accident as a consequence of this and located the wreck of the FV CONDOR at a depth of about 18 m on the sandy seabed of the Baltic Sea at midday on 9 February 2016 (see **Fig. 3** below).

An initial analysis of these recordings and the reports prepared by the divers allowed no conclusions as to the specific cause of the foundering of the fishing vessel, which – as far as was evident – lay on the seabed on her starboard side largely undamaged. Consequently, it was necessary to salvage the fishing vessel to reliably clarify the cause of the accident.

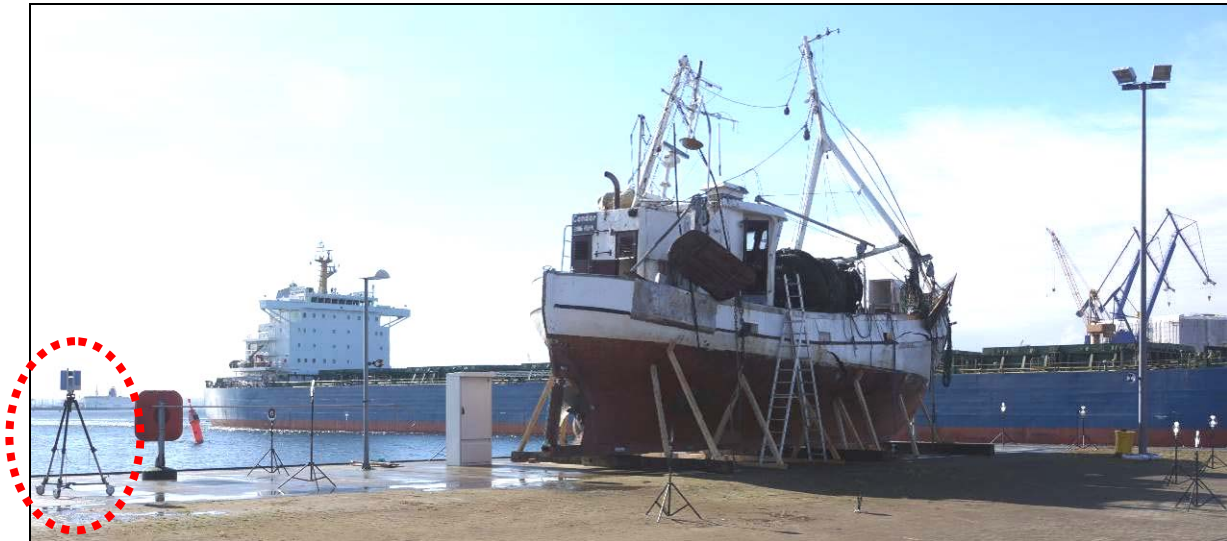
**Figure 10: 3D laser scan of the FV CONDOR by LKA Hamburg on 15 March 2016**

The BSU commissioned two external experts with investigating the hydrostatic and/or technical aspects requiring clarification in this matter. In addition, the Hamburg State Office of Criminal Investigation (LKA Hamburg) provided the BSU with administrative support by carrying out a 3D laser scan of the fishing vessel in the interest of a detailed survey (see **Fig. 10**).

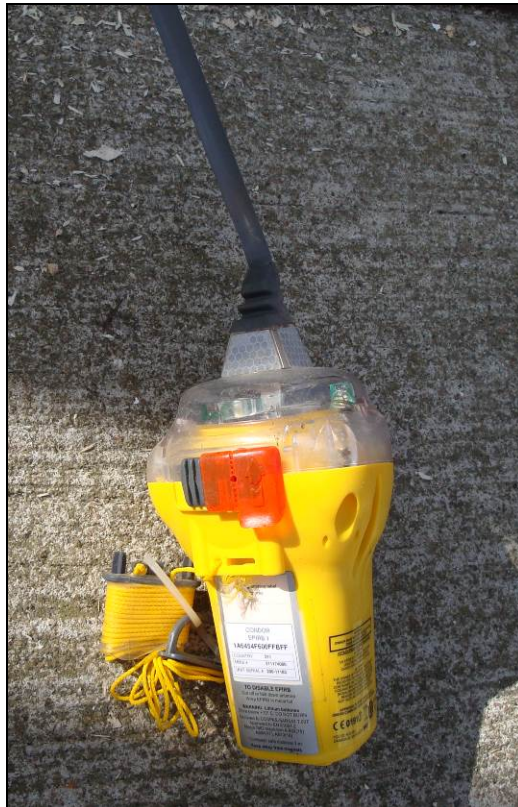
Figure 14: FV CONDOR's EPIRB<sup>12</sup>

Other focal points of the BSU's investigation were aimed at clarifying why the liferaft on board the fishing vessel did not float up to the surface after the vessel foundered and why the emergency position-indicating radio beacon (EPIRB) installed on the fishing vessel, which was designed to transmit an automatic distress signal after the vessel foundered, also failed.

Both the liferaft and the EPIRB satisfied internationally binding specifications and had undergone routine servicing by authorised service partners of the respective manufacturer in due form at the instigation of the fishing vessel's skipper prior to the accident.

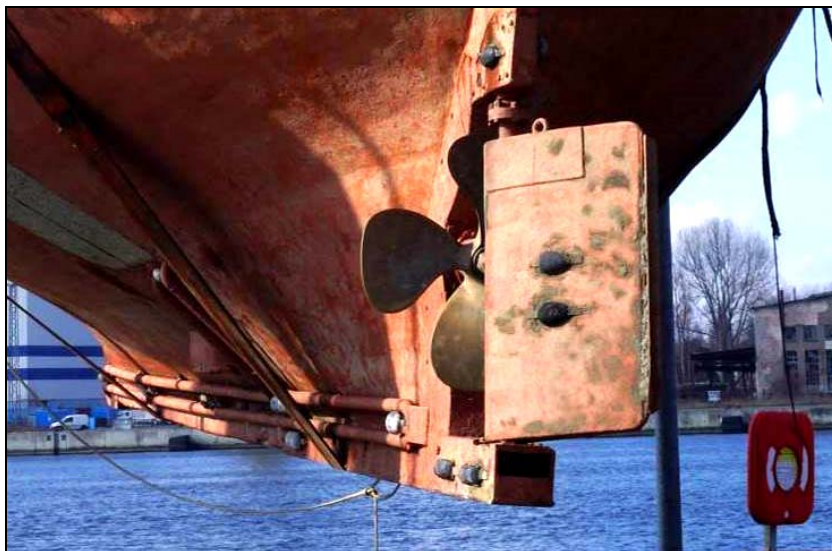
**Figure 22: Position of the rudder blade (unchanged during the salvage operation)**

*The rudder blade did not change its position during the salvage operation and was found according to the information in the DENEb's file (see Fig. 22).*

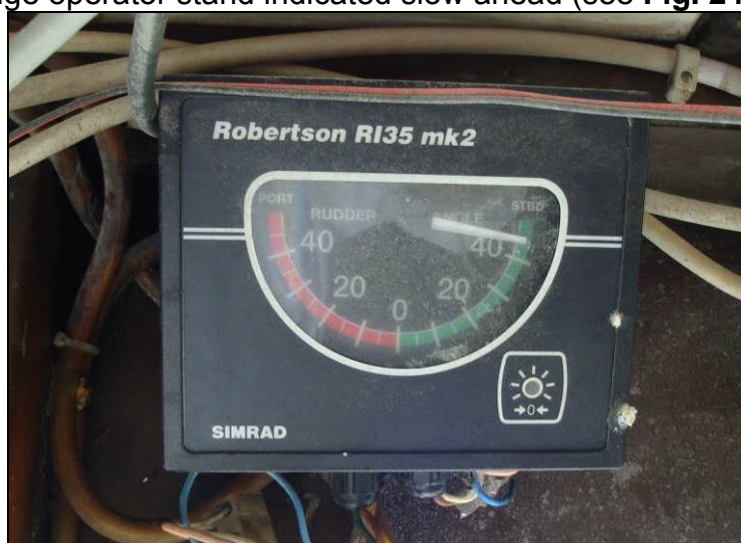
**Figure 23: Rudder position indicator (wheelhouse on the FV CONDOR)**

It was striking that the rudder was set to (hard to?) starboard and starboard max. (about 45°) was displayed on the rudder position indicator (see **Fig. 23**). The engine lever on the bridge operator stand indicated slow ahead (see **Fig. 24**).

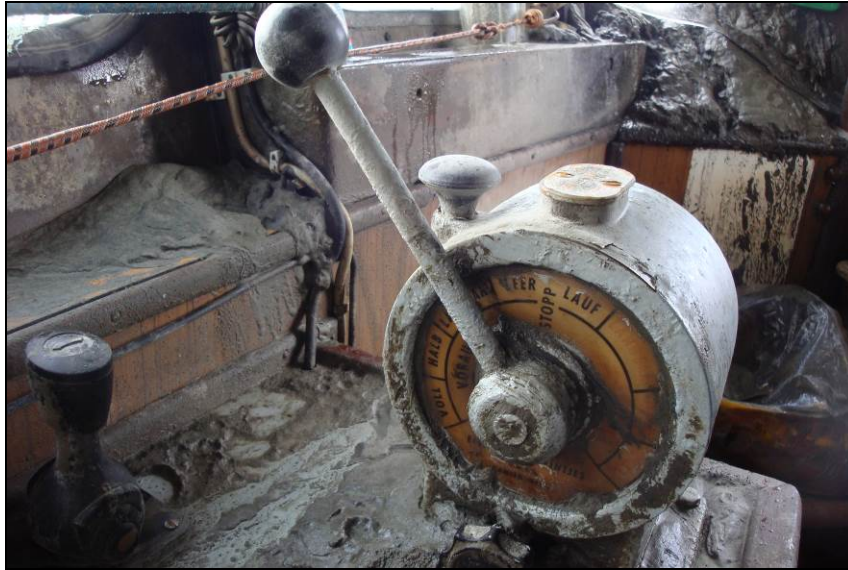
**Figure 24: Control lever (wheelhouse on the FV CONDOR)**

The fishing vessel's screw could be rotated freely and exhibited no damage. (The free rotation seemed illogical at first because a decoupled engine and the rate of speed slow ahead did not seem to be compatible. However, an inquiry with the expert commissioned with assessing the engine during the further course of the investigation revealed that the hydraulic coupling of the engine is designed (i.e. intended) to trigger the idling of the drive shaft as soon as the engine – for whatever reason – switches off.)

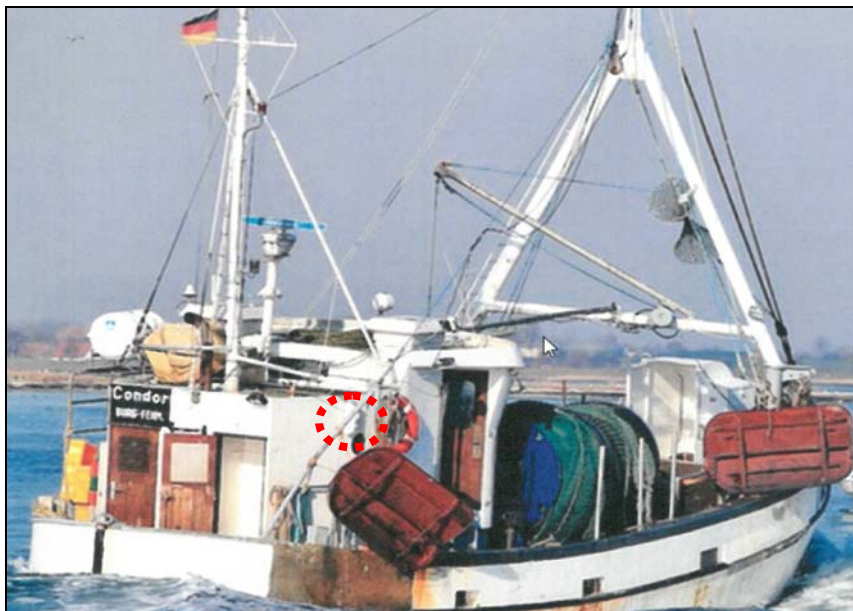
**Figure 25: FV CONDOR – mounting position of the EPIRB**

The ship's files of the German Shipping Administration indicate that the EPIRB (SAILOR SGE 406 II Satellite GPS) on board the FV CONDOR was last inspected by an authorised service company in October 2015. The beacon itself, the associated hydrostatic release unit and the mount were in good condition at that time. The EPIRB was mounted aft of the deckhouse on the starboard side of the fishing vessel (see red marking below in **Fig. 25**).

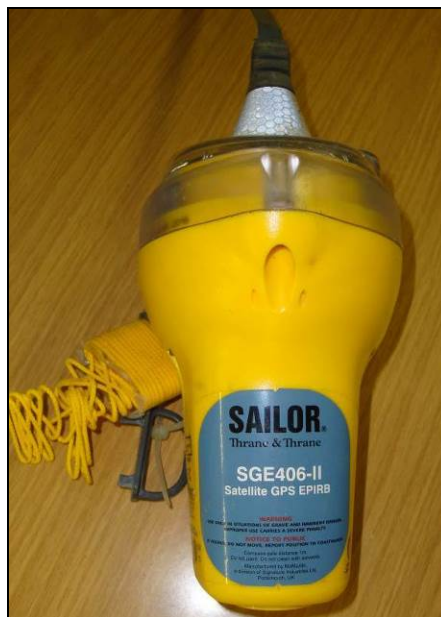
**Figure 26: FV CONDOR'S EPIRB**

The salvage company detected the EPIRB, which exhibited no damage, at the scene of the accident on the surface of the water during the salvage operation and handed it over to the BSU after the fishing vessel arrived in Hohe Düne, Rostock.

- (1) watertight integrity and pressure test carried out and passed;
- (2) internal battery's electrical voltage measured and stands at 5.5 V (more than 9 V required for proper functioning);
- (3) test battery installed in the EPIRB, test routine started and completed successfully;
- (4) mount inspected and no functional or mechanical defects evident;
- (5) EPIRB disassembled and no signs of water ingress;
- (6) the lanyard<sup>24</sup> belonging to the EPIRB (see photograph below in **Fig. 31**) was rolled up and wrapped in plastic film, meaning it could not have caught on the fishing vessel.

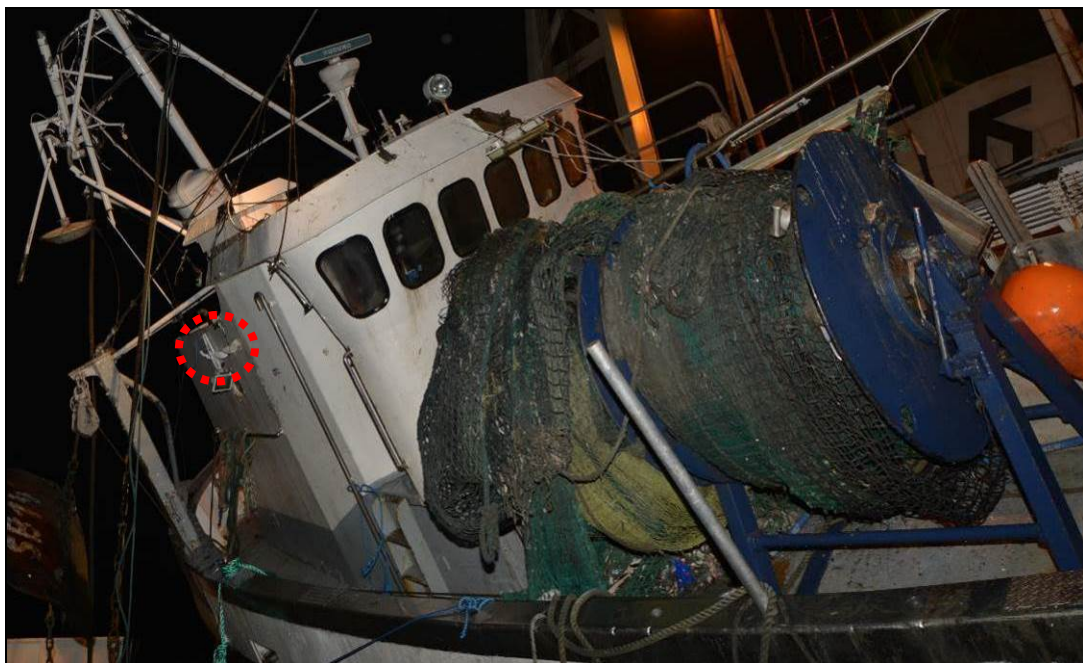
**Figure 27: FV CONDOR immediately after salvage (empty EPIRB mount visible)**

MRCC Bremen advised that it had not received an EPIRB signal from the FV CONDOR on the day of the accident or afterwards in response to an inquiry of the BSU made after the accident. Since the fishing vessel was lying on her starboard side on the seabed, it was not possible to conclude from the divers' video recordings whether the EPIRB had detached itself from the mount (as per its design) after the fishing vessel foundered.

It was not possible to clarify why the EPIRB, which apparently only floated to the surface in direct connection with the fishing vessel's salvage operation, failed to reach the surface of the water on the day of the accident. That the hydrostatic release unit failed on the day of the accident and was only activated 'coincidentally' by mechanical forces acting on the fishing vessel during the salvage process cannot be ruled out. Since the actual hydrostatic release unit could not be found, investigating this hypothesis further was not possible.

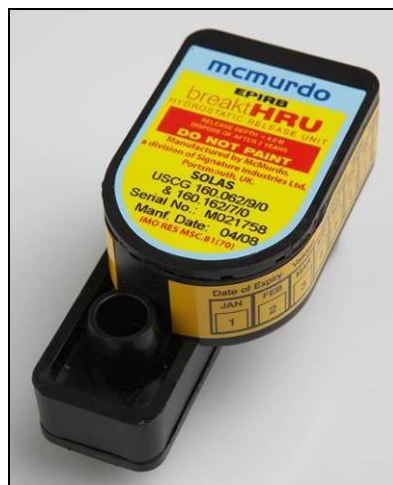
**Figure 29: Example of a hydrostatic release unit<sup>22</sup>**

<sup>22</sup> The module belonging to the FV CONDOR's EPIRB could not be found.

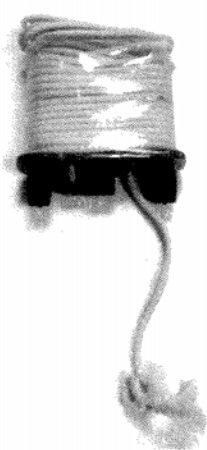
**Figure 31: Extract 2 from the EPIRB manufacturer's assessment report**

The long activation runtime is more than double of what you would expect at 20c air temperature @ 119H. This duration could be attributed to the unit being held in a relatively warm sea water temperature, at least for the initial 4 days while under water. From this, there may have been an issue with the EPIRB catching in nets or deck equipment.

The lanyard of the EPIRB has been discounted of causing the beacon to remain under water as this was found to be still wound and wrapped in its plastic sleeve so couldn't have caused the EPIRB to become tangled and prevent it from reaching the surface.

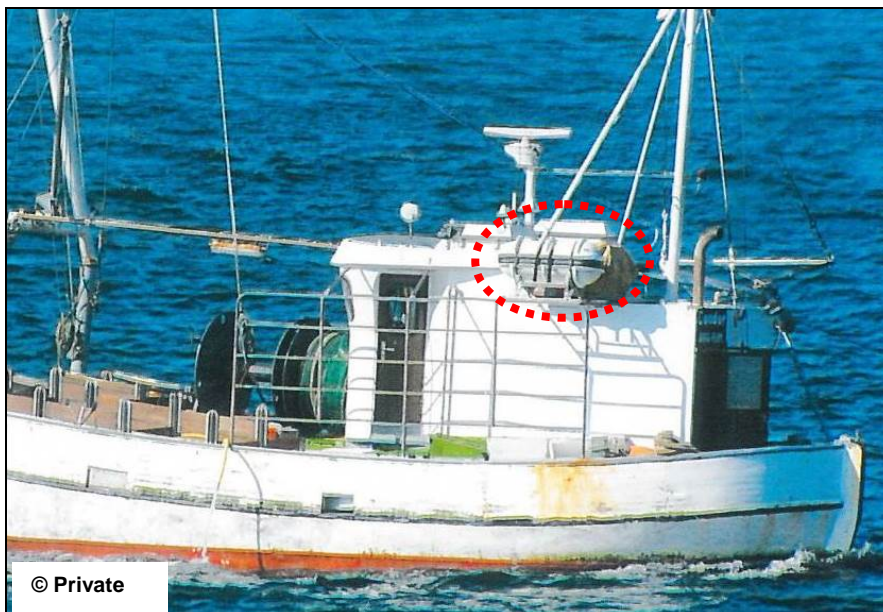
**Figure 33: Position of the liferaft on board the FV CONDOR**

As is common for rescue equipment of this type regardless of manufacturer, the liferaft is tightly packed in a barrel-shaped container consisting of two hard shells. This container was stored on the side of the CONDOR on the upper edge of the deckhouse's port side in a specially designed mount (see **Fig. 33**).

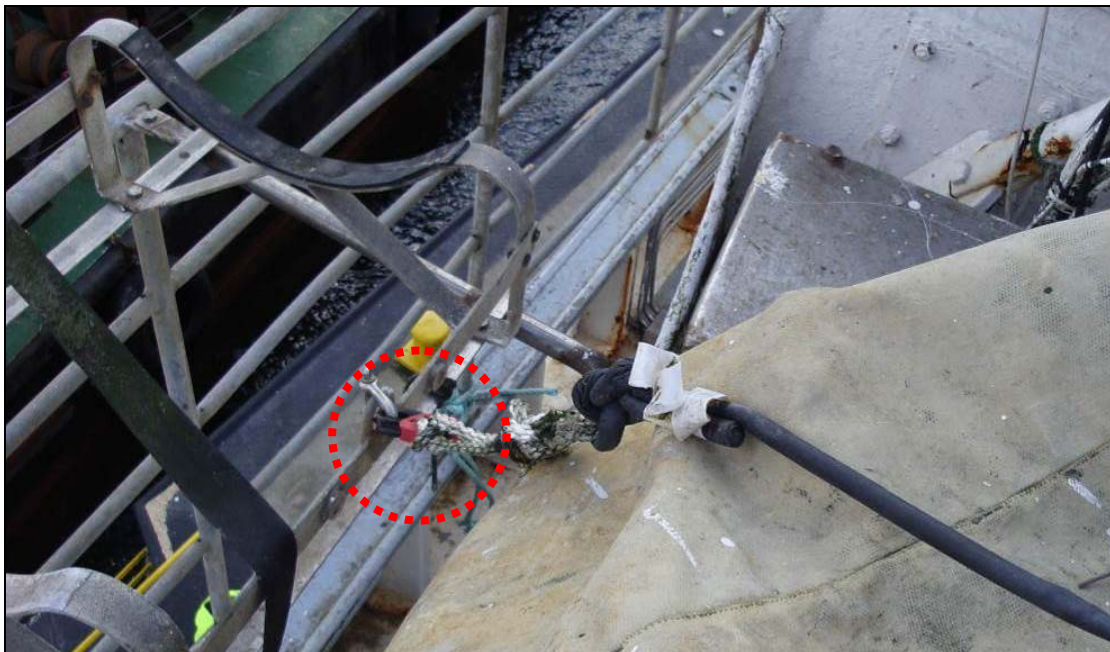
The container of the CONDOR's liferaft was connected to the fishing vessel by a combined painter/release cord in accordance with requirements (see red marking in **Fig. 35 f.** below). This cord has two functions. Firstly, it ensures the liferaft's container does not drift away from the distressed vessel due to wind and swell after it enters the water. A weak link (see red marking in **Fig. 35 f.** below) in the area of the connection between the liferaft and vessel ensures a foundering vessel does not drag the liferaft down with her. The second function of the painter/release cord is to trigger the inflation process by a sharp tug on the cord, which is completely out of the container. The pressure that builds up inside the container causes the two shells that form the housing to open and the liferaft is able to inflate.

**Figure 35: Liferaft's mount and painter/release cord**

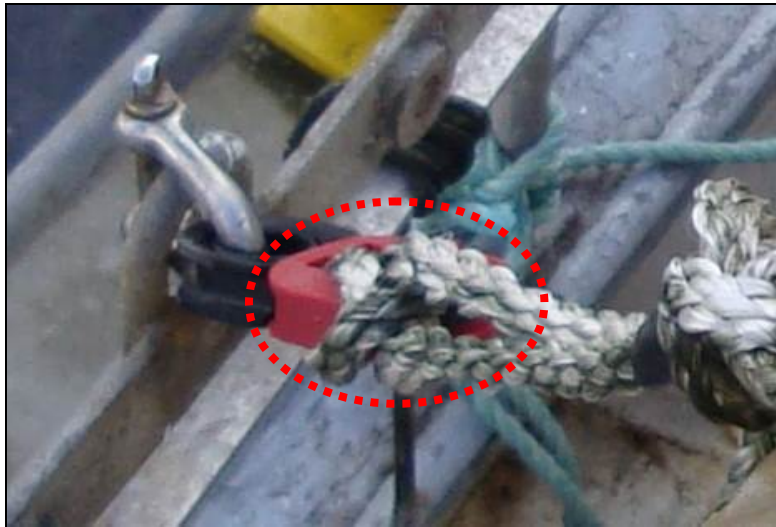
**Figure 36: Close-up of painter/release cord connection with liferaft mount**

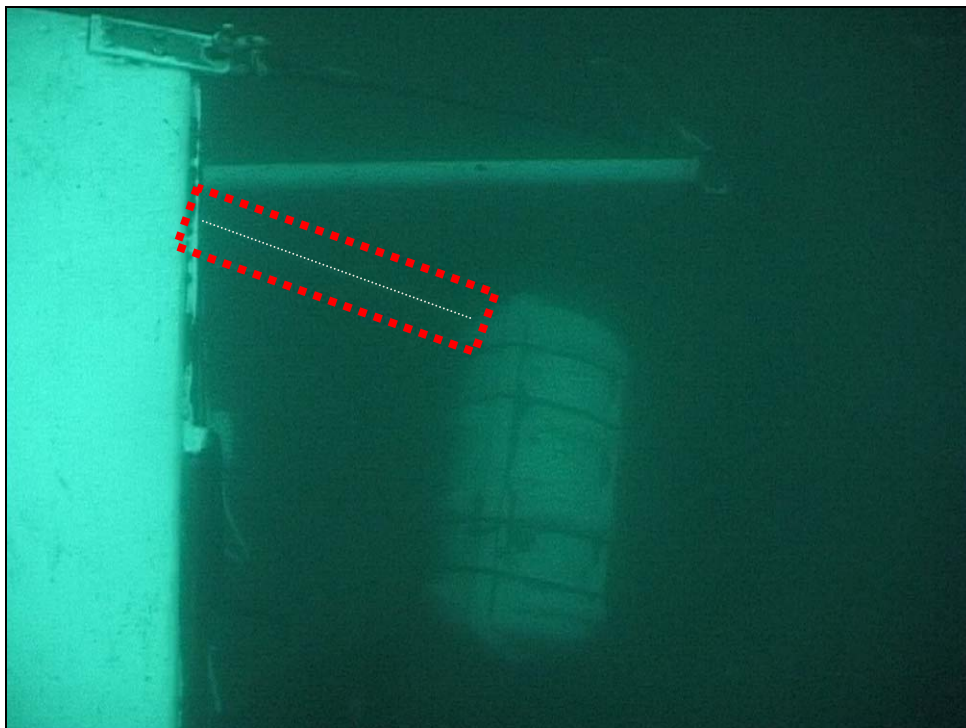
A liferaft could not be located on the surface of the water during the search and rescue activities after the fishing vessel foundered. Instead, it was found during the first dives on the wreck of the fishing vessel that the liferaft had detached from the mount and was floating in the water behind the aft edge of the deckhouse attached to the fishing vessel by the taut painter/release cord. (See **Fig. 37 f.** and especially the red marking in **Fig. 38**. The course of the line, which is barely visible in the murky water, is highlighted by a white dotted line in **Fig. 38** for better illustration.)

**Figure 38: Liferaft next to the wreck of the CONDOR with line connection to the fishing vessel (extract from the DENEb's dive video – 12 February 2016)**

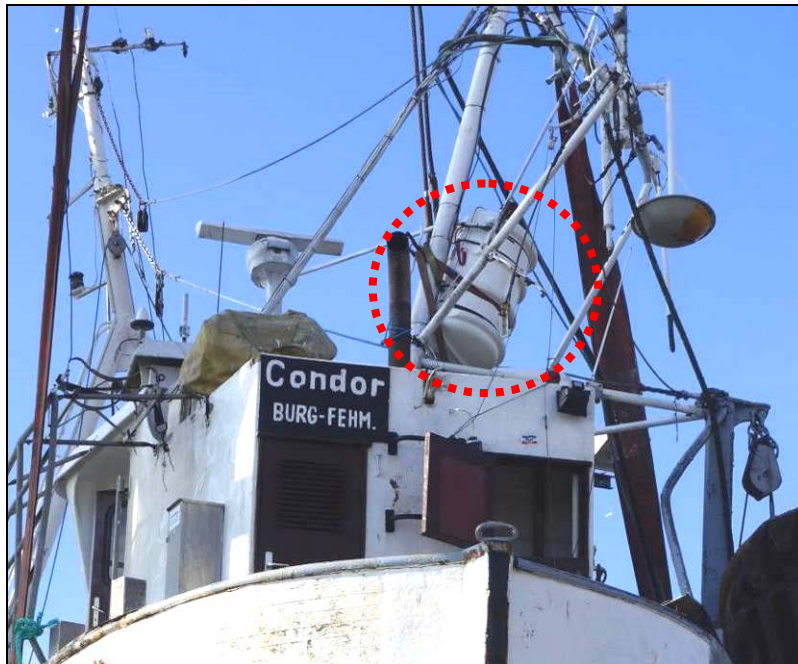
The BSU instructed the salvage company to carefully salvage the liferaft when lifting the fishing vessel. The company complied with this request and provisionally attached the liferaft to a mast on the roof of the wheelhouse before lifting the fishing vessel.

**Figure 39: FV CONDOR (arrival in Rostock; liferaft provisionally attached to the mast)**

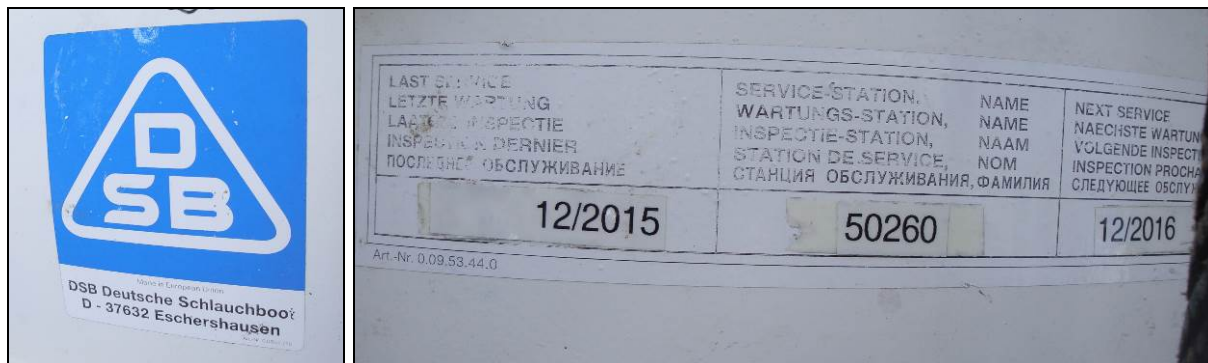
The BSU first viewed the liferaft on the roof of the fishing vessel on 8 March 2016 after the fishing vessel was put ashore on the buoy yard pier in Hohe Düne, Rostock. The outside of the container did not exhibit any damage. Affixed to the surface of the container were references to the manufacturer of the liferaft, the last and the next service dates, and a number indicating the service station at which the liferaft was last serviced (see **Fig. 40**).

**Figure 40: Information about the manufacturer and service interval on the FV CONDOR's liferaft**

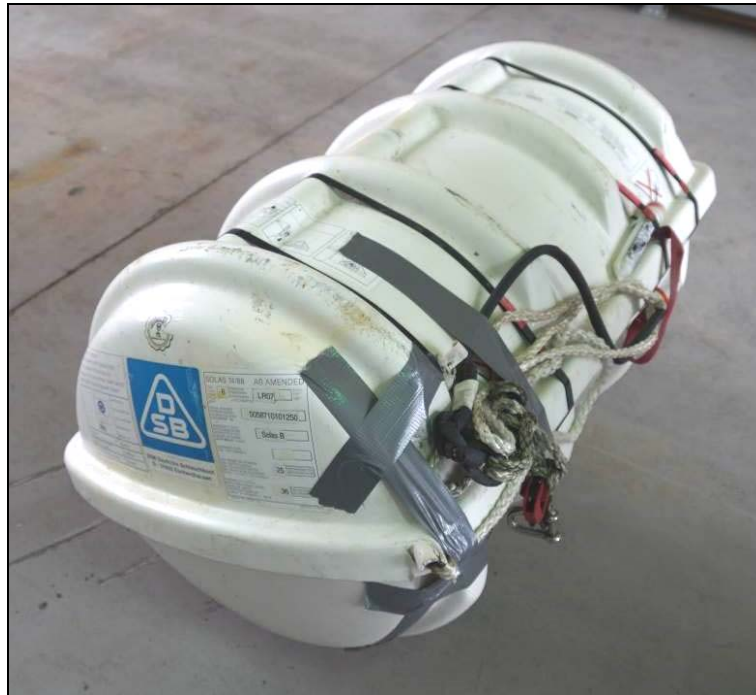
Figure 42: Liferaft before further examination<sup>25</sup>

<sup>25</sup> Note by the BSU: The grey adhesive tape visible in the figure was applied to the container only for transport purposes after the fishing vessel arrived in Rostock.

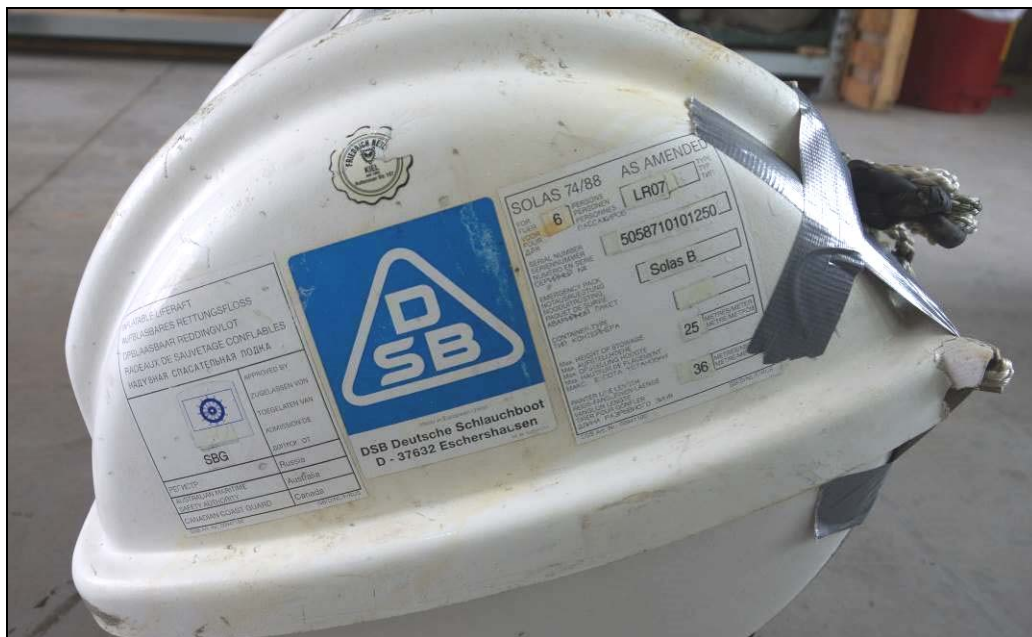
Figure 43: Information about type approval, manufacturer and technical data on the liferaft's container

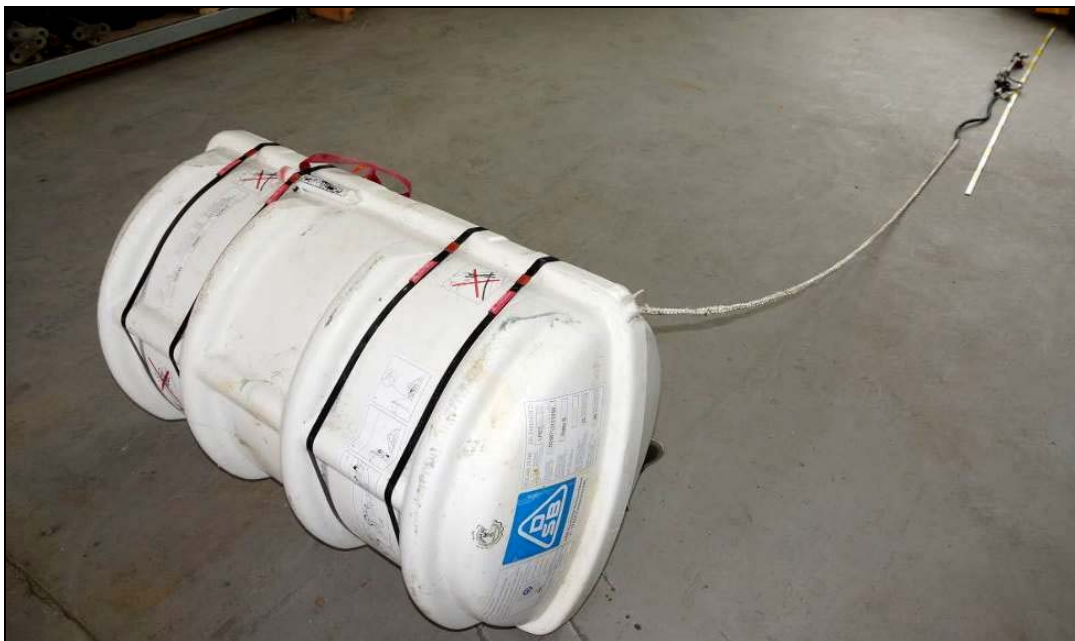
The subsequent external assessment of the liferaft in the presence of DSB re-confirmed that the 36-m-long painter/release cord was obviously caught in the container. It could not be pulled out further (3.50 m) even with physical effort (see **Fig. 44 f.**), even though this should normally have been a very smooth process, as confirmed by DSB.

**Figure 44: Maximum possible extraction length of the painter/release cord**

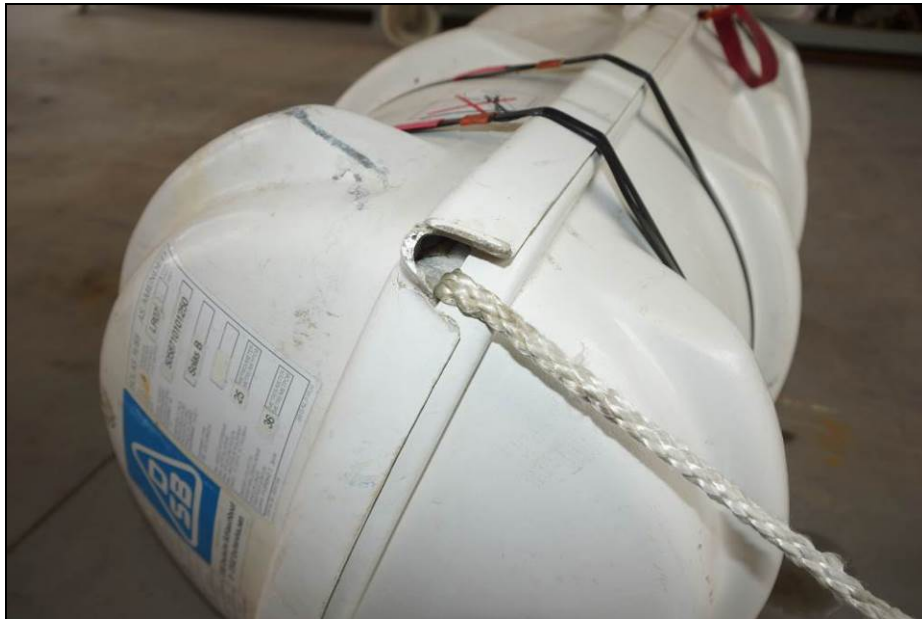
**Figure 45: Painter/release cord's exit point from the container  
(cord cannot be pulled out with muscular force)**

It was established beyond doubt that the cord snagged because of the faulty manner in which the last cord section was made ready and, in particular, the painter sachet inside the container. The tensile loaded cord is designed to glide freely out of the opening in the container, thus enabling the liferaft's inherent buoyancy to propel it to the surface after its mount opens hydrostatically, but was undoubtedly obstructed because the service was evidently carried out improperly (cord not made ready properly within the container). Accordingly, the liferaft was unable to float to the surface of the water and inflate.

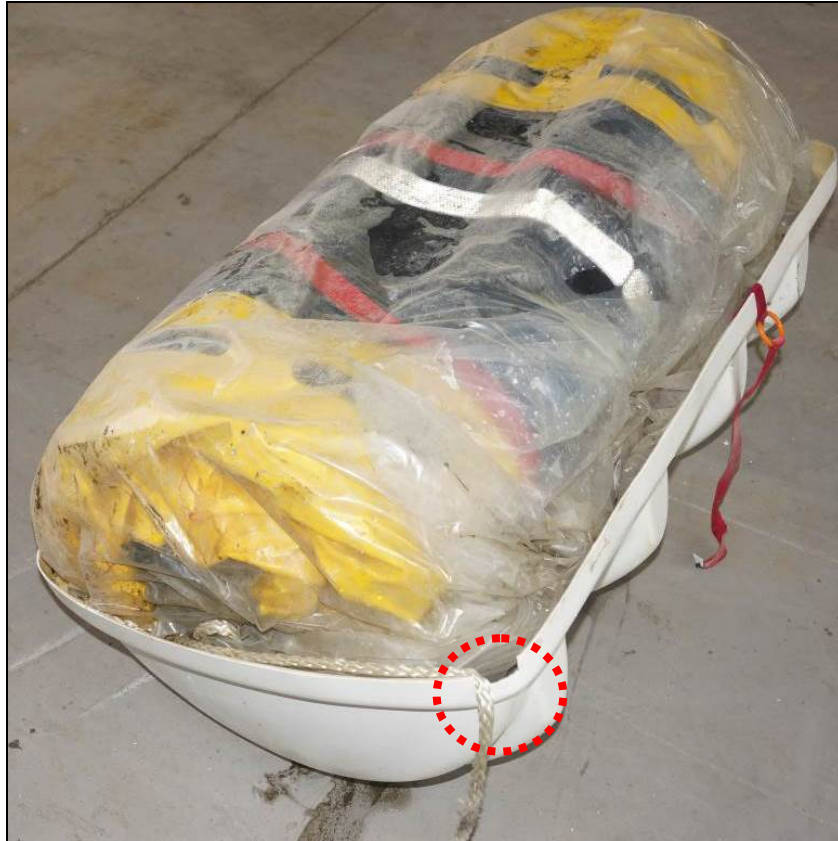
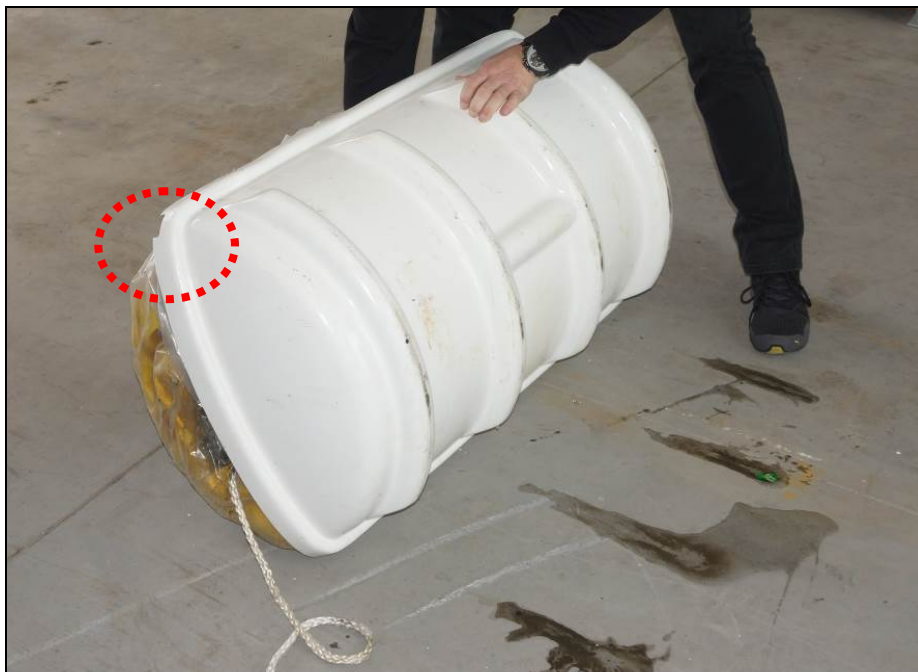
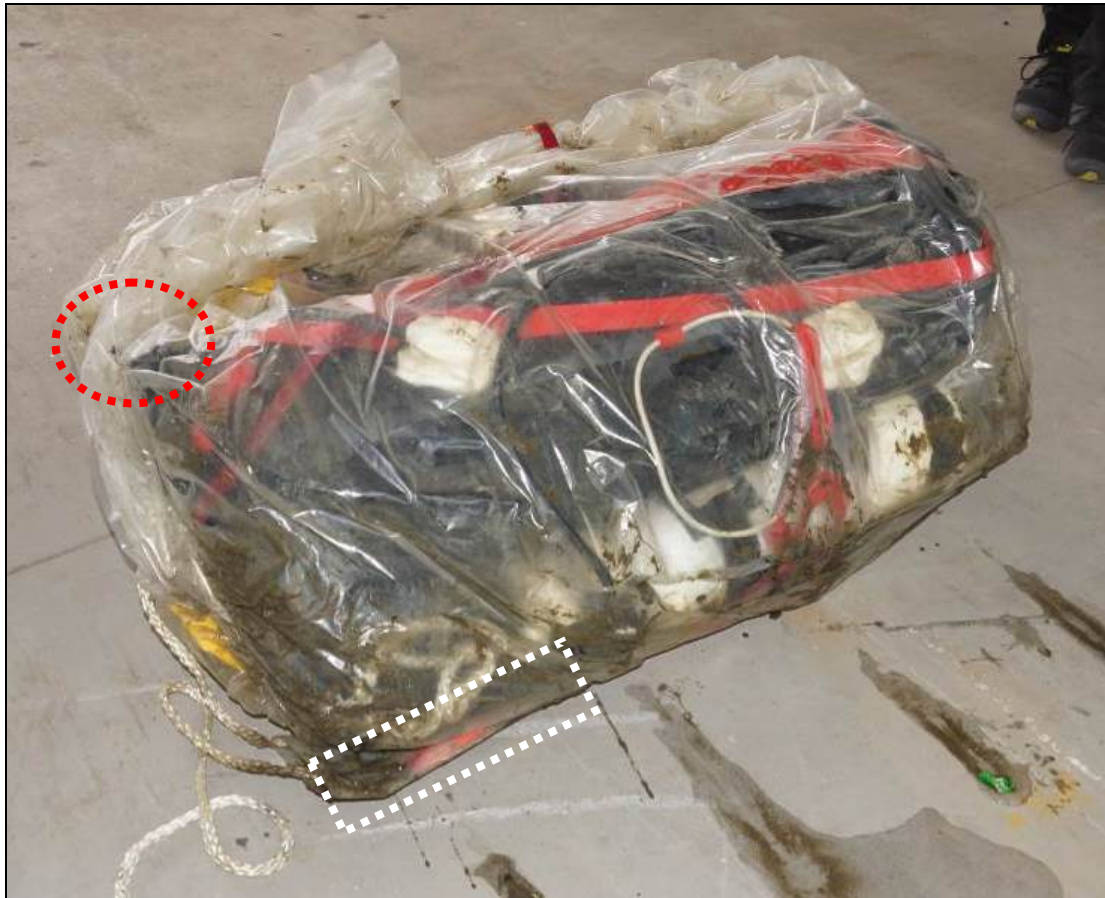
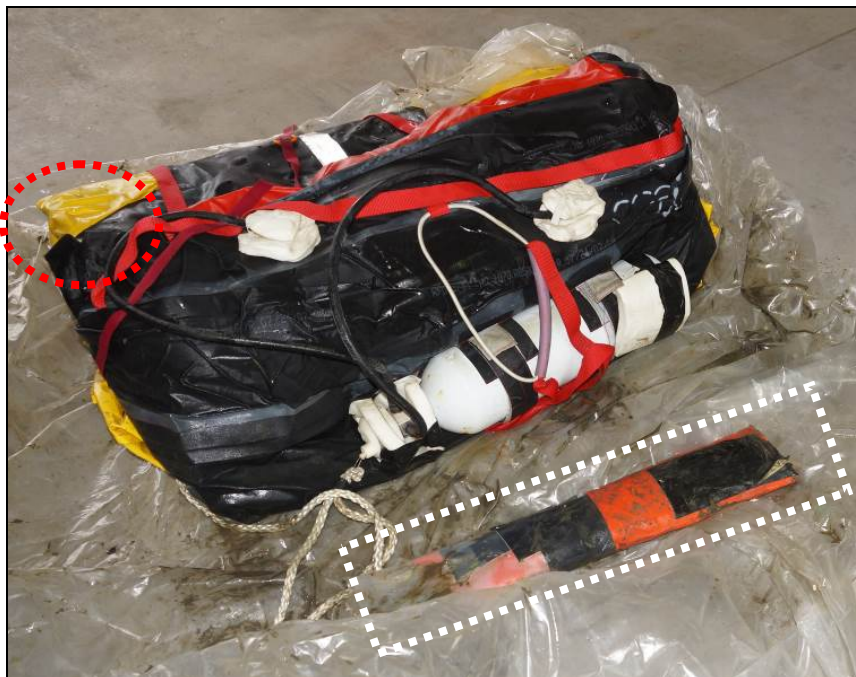
To illustrate the above, **Figs. 46 ff.** below show the position of the opening for the painter/release cord in the container housing marked in red and the position of the painter sacht in white.

**Figure 46: First photograph after removing the top half of the container**

**Figure 47: Liferaft tipped carefully out of the container**

**Figure 48: Liferaft rotated 180° compared to Fig. 46**

**Figure 49: Intended position of the opening in the container compared to position of the painter satchel after removal of the liferaft's protective plastic covering**

The BSU believes that this technical aspect suggests that during the last service a longer section of cord glided out of the sachet unintentionally, which – because it could not be put back into the sachet – was then stored next to/in front of the sachet when the liferaft was packed in the container. When tension was applied to the cord due to the liferaft's buoyancy after it was released, a direct transfer of force from outside the container to the painter sachet was not possible but rather the tractive force acted on the section of cord in front of/next to the sachet or the ball that had developed there. This section of cord caught inside the container between the tightly packed liferaft and housing. Inevitably, the cord was then unable to escape from the sachet. In other words, the painter/release cord was unable to run out and the liferaft was held underwater by the obstructed cord.

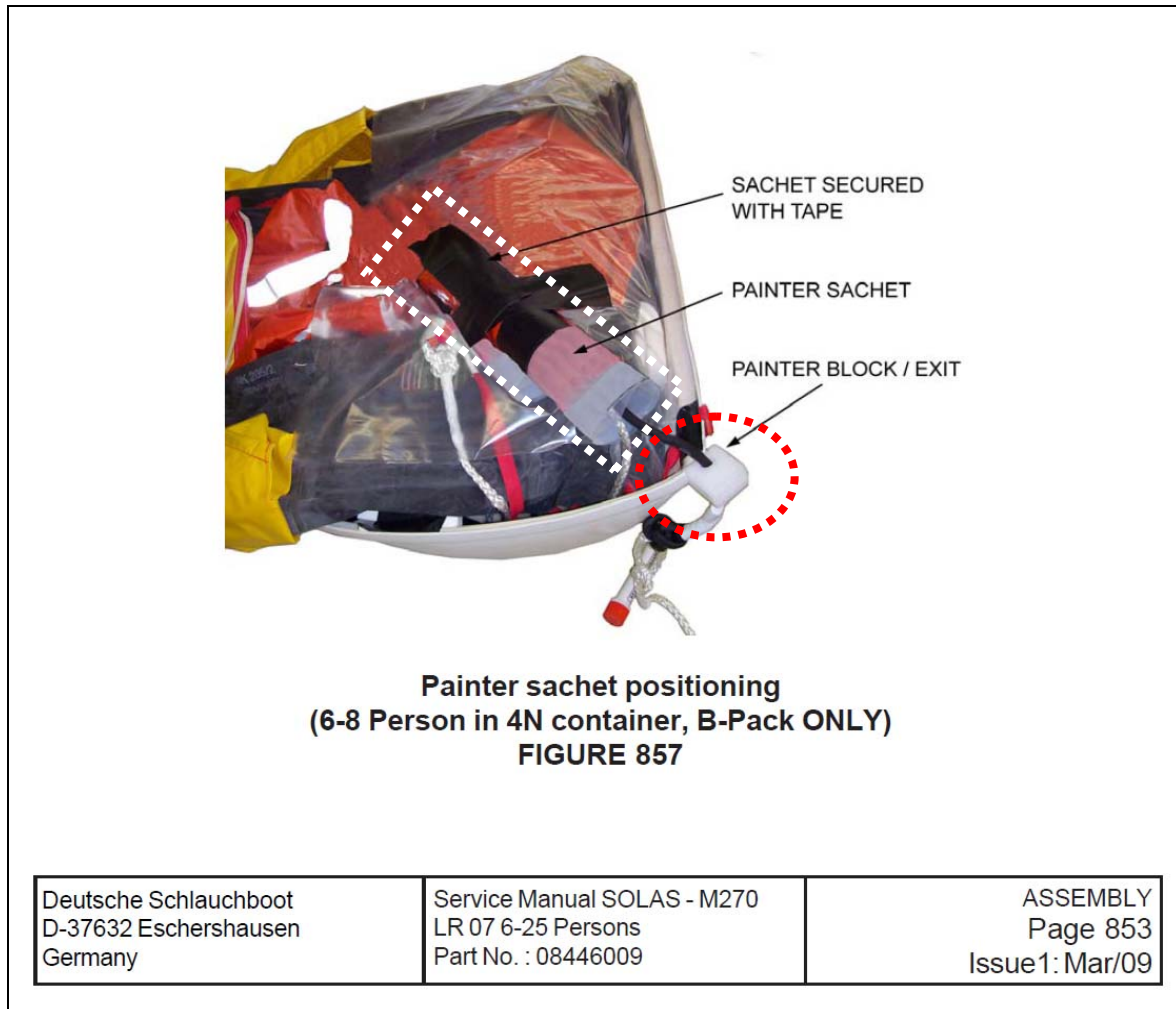
The figure taken from the manufacturer's service manual showing the correct arrangement of the painter sacht inside the container (see **Fig. 50** below (or Figure 857 on page 853 of the service manual)) clearly shows that the actual stowage of the sacht in the liferaft involved in the accident did not comply with the manufacturer's instructions.

**Figure 50: Extract 1 from the service manual – manufacturer's instructions for positioning the painter sacht when packing the liferaft**

**Fig. 50** shows very clearly that the manufacturer has deliberately positioned the painter sacht within the container so as to allow the painter/release cord to escape from the container as quickly as possible. It stands to reason that this manner of stowing the painter sacht is essential to ensure the painter/release cord can escape from the tightly packed container smoothly and without catching.

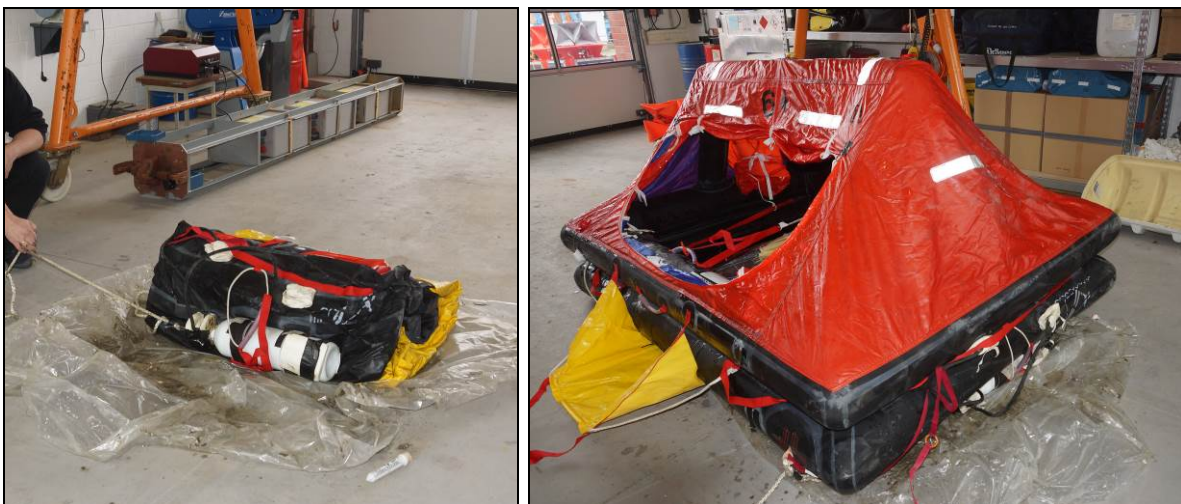
For the sake of completeness, after reviewing the issue with the cord, the liferaft was removed from the container and its inflation process activated by pulling on the release cord. The liferaft inflated as per its design very quickly and without any problems (see **Fig. 52** below) and was then ready for use.

**Figure 52: Manual activation of the inflation process**

The ensuing assessment of the liferaft revealed no indication of any technical defects. The required items of equipment were also present.

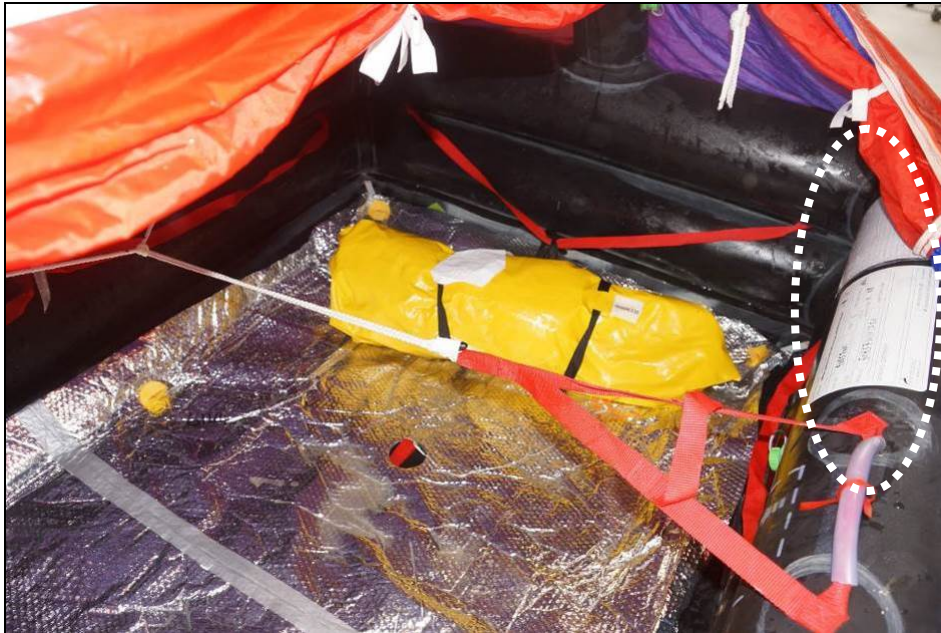
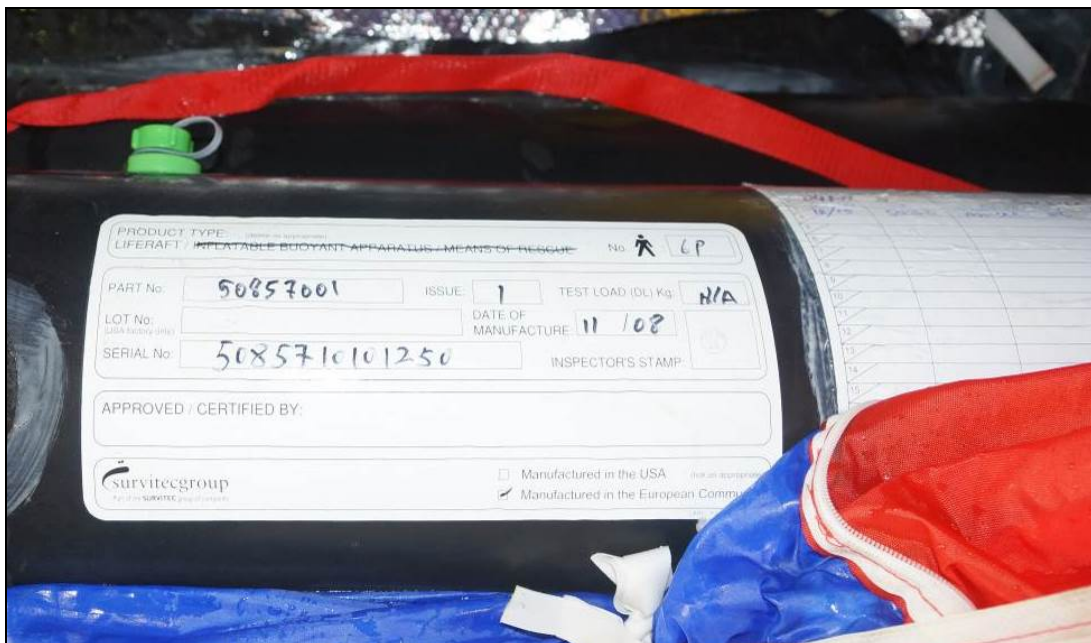
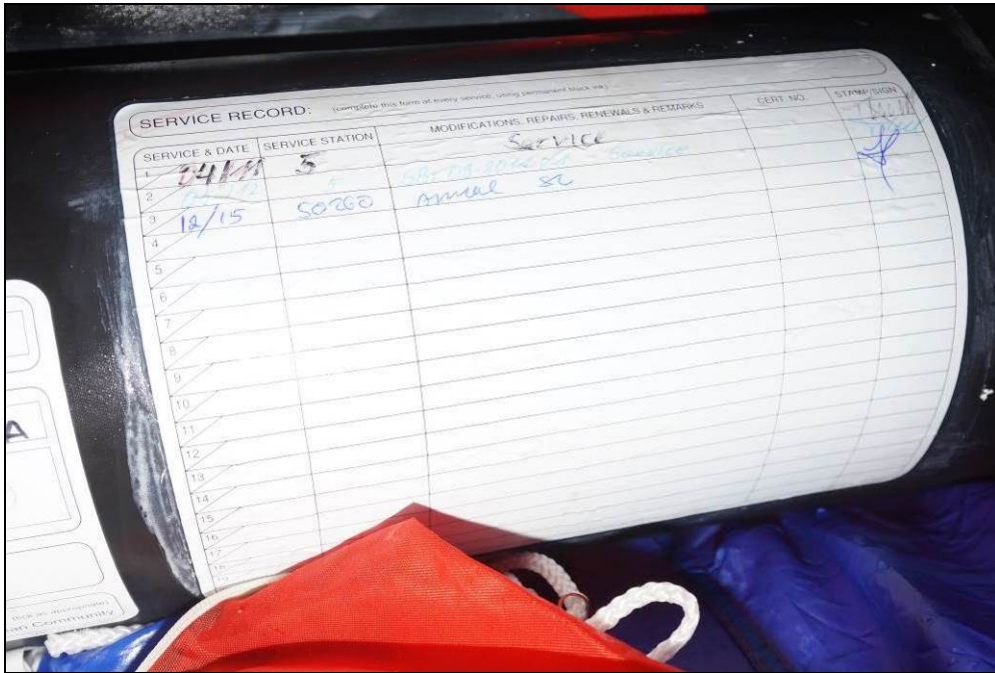
As notified in the preliminary discussion, an entry for the service carried out in December 2015 was found inside the liferaft.

**Figure 53: References to serial number/manufacturer/completed services**

**Figure 54: Close-up of manufacturer information and serial number**

**Figure 55: Close-up of the service record in December 2015**

Making the entry at the position in question proves that the liferaft was actually removed from the container when it was serviced.

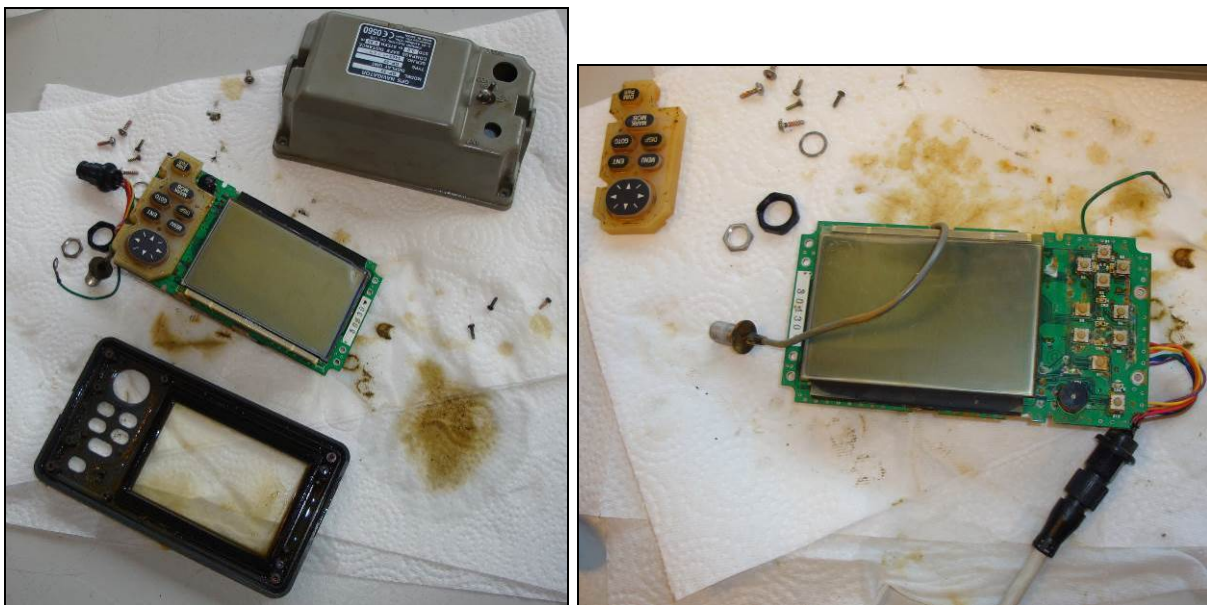
Nevertheless, FURUNO offered to inspect the device in its own workshop with regard to any data that might still be available. During the ensuing inspection, which was attended by two BSU investigators in addition to the FURUNO engineer, the housing of the GPS receiver was carefully opened. A voltage measurement on the internal battery revealed that it had indeed completely discharged in the meantime. The engineer's attempts to reactivate the GPS receiver by connecting it to an external power source also failed. The main circuit board of the unit's electronics was evidently irrevocably destroyed by the exposure to the seawater, meaning it was impossible to obtain track data from the GPS receiver.

**Figure 59: Attempt to analyse the GP-32 GPS receiver by FURUNO's service department**

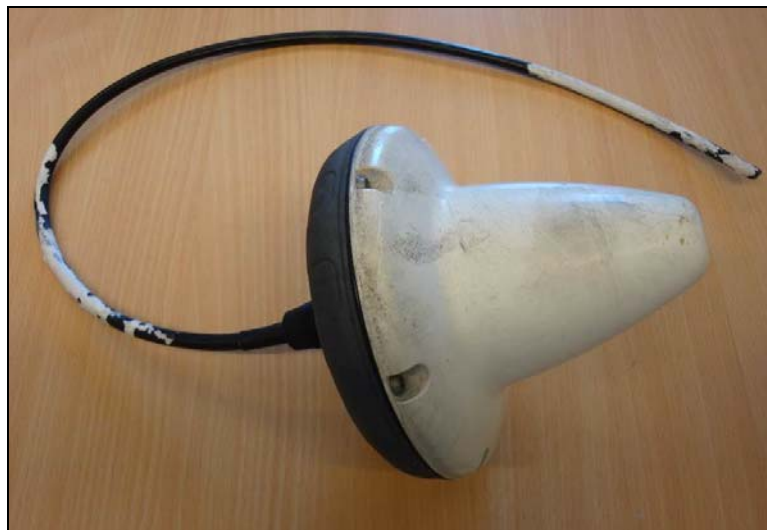
**Figure 62: The BLE antenna exhibiting no visible damage**
