**Bundesstelle für Seeunfalluntersuchung**  
**Federal Bureau of Maritime Casualty Investigation**  
Federal Higher Authority subordinated to the Ministry of Transport  
and Digital Infrastructure

## **Investigation Report 44/16**

**Very Serious Marine Casualty**

**Foundering of the fishing vessel CONDOR  
on 6 February 2016 about 3.5 nm east of the  
Baltic Sea Island of Fehmarn**

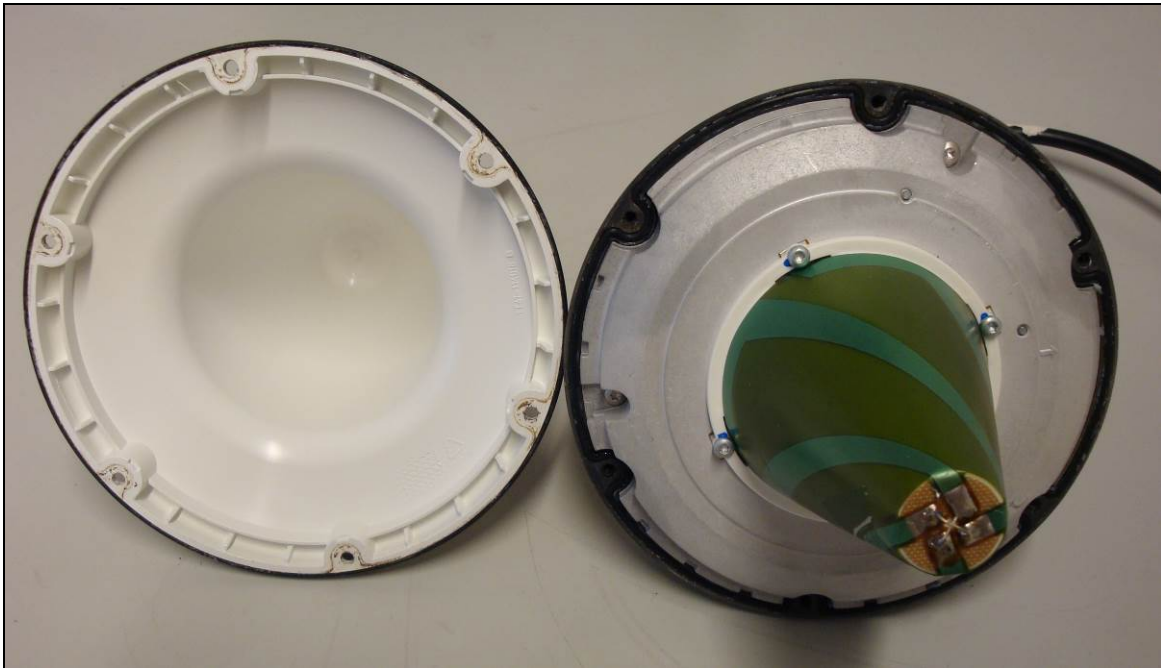
Although the antenna is basically not designed to withstand a prolonged period of submersion in water, when it opened the housing the BSU found that no moisture had reached the interior of the antenna (see **Fig. 63** below). This vastly improved the chance of obtaining usable information from the antenna's memory.

**Figure 63: Opened antenna housing without any traces of moisture**

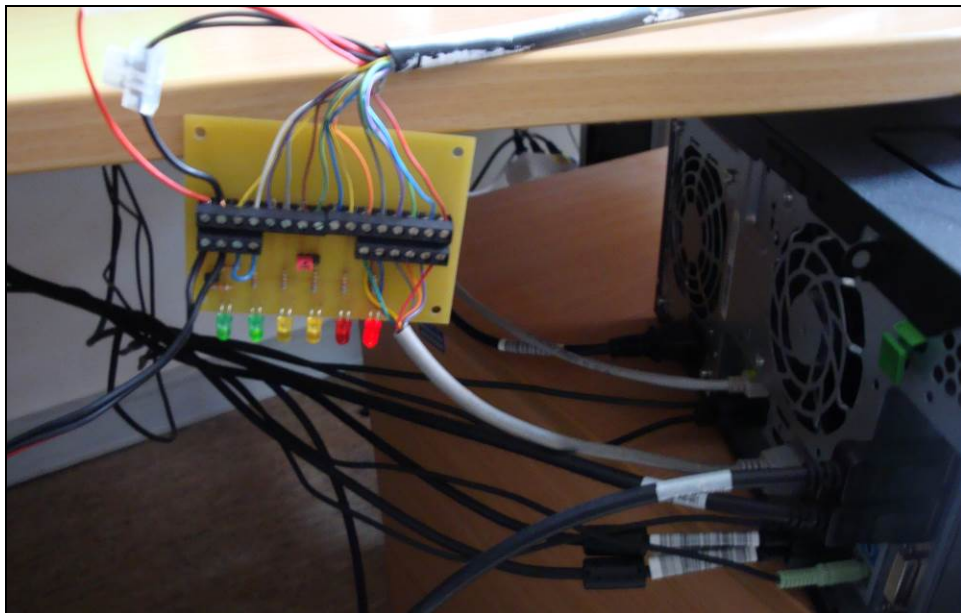
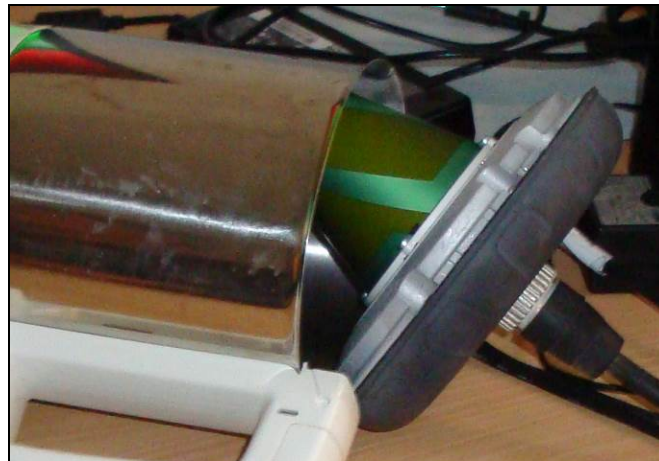
Figure 64: Technical preparatory measures for reading the antenna data (1)

On 14 June 2016, the service company read the data stored in the antenna in the presence of two investigators at the BSU. To this end, the antenna was connected to a special printed circuit board, which in turn was connected to a computer. In addition, an adjustable power supply unit was connected to the board to power the antenna's electronics (see **Fig. 64 f.**).

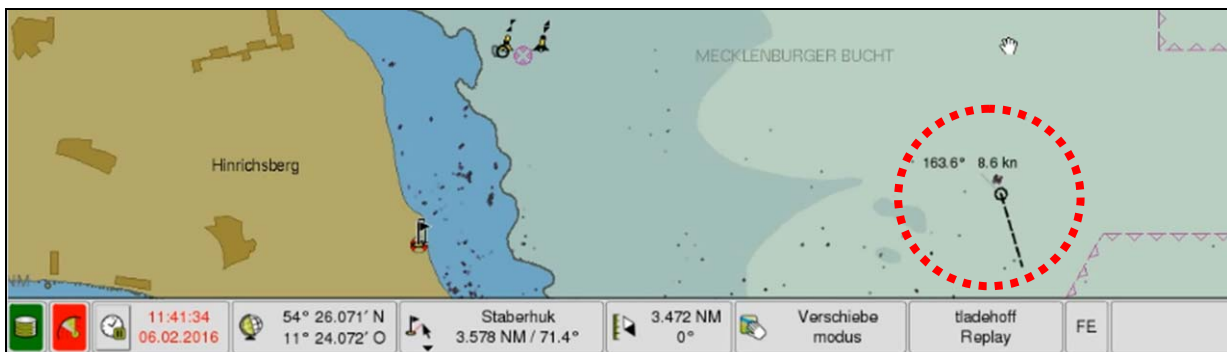
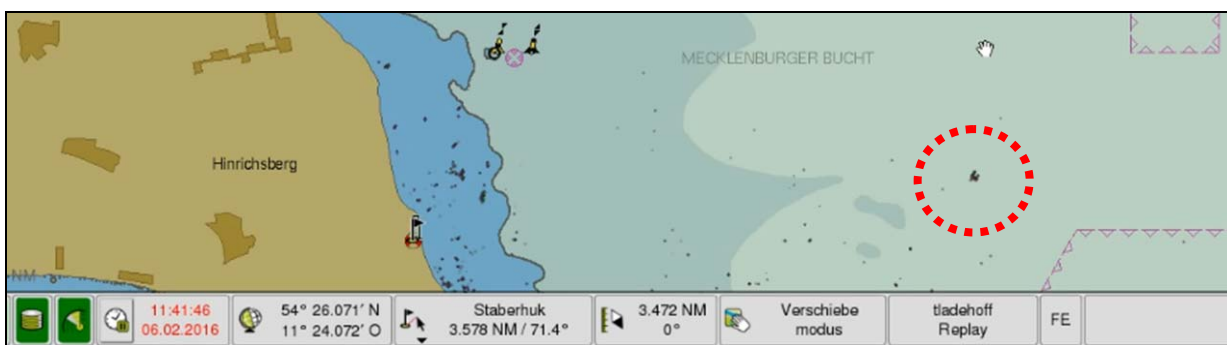
*The sudden acceleration at 114134 is probably a false measurement caused by the foundering and ensuing loss of a real radar measurement. The tracking method searches for a suitable radar object in each radar scan and then allocates its measurement data to the track. However, if a ship founders, then she disappears from the radar screen completely and therefore no radar object is found at the predicted position.*

*The tracker does not give up immediately in such a case, instead the target is extrapolated further on the old course and the search area gradually expanded. In the case of extremely small targets, a temporary loss of measurement may occur even without a foundering incident due to fluctuations or shadowing. In the event of the FV CONDOR foundering, no suitable echo was found even after several radar scans and the search area was therefore already unusually large.*

*Finally, sea clutter (radar echo from swell) was allocated, which was found a little to the south and most likely had nothing to do with the incident. The radar installation at Staberhuk is extremely sensitive and our automatic threshold filters always try to detect radar objects up to the detection limit. That many false measurements are recorded in the process is normal. However, complex filters prevent false measurements from immediately appearing on the screen as targets. Only when a target exhibits comprehensible behaviour for an extended period will the track be shown on the display system. However, once a track has reached this state, the tracker will attempt to follow the target for as long as possible (after all, a ship cannot normally simply disappear), even in the event of a sudden course alteration or brief concealment by a shadow. The track is aborted only if no comprehensible behaviour is exhibited for an extended period or if no measurements are found at all. This is obviously the case at 114146 in the recording under review. [...]"<sup>32</sup>*

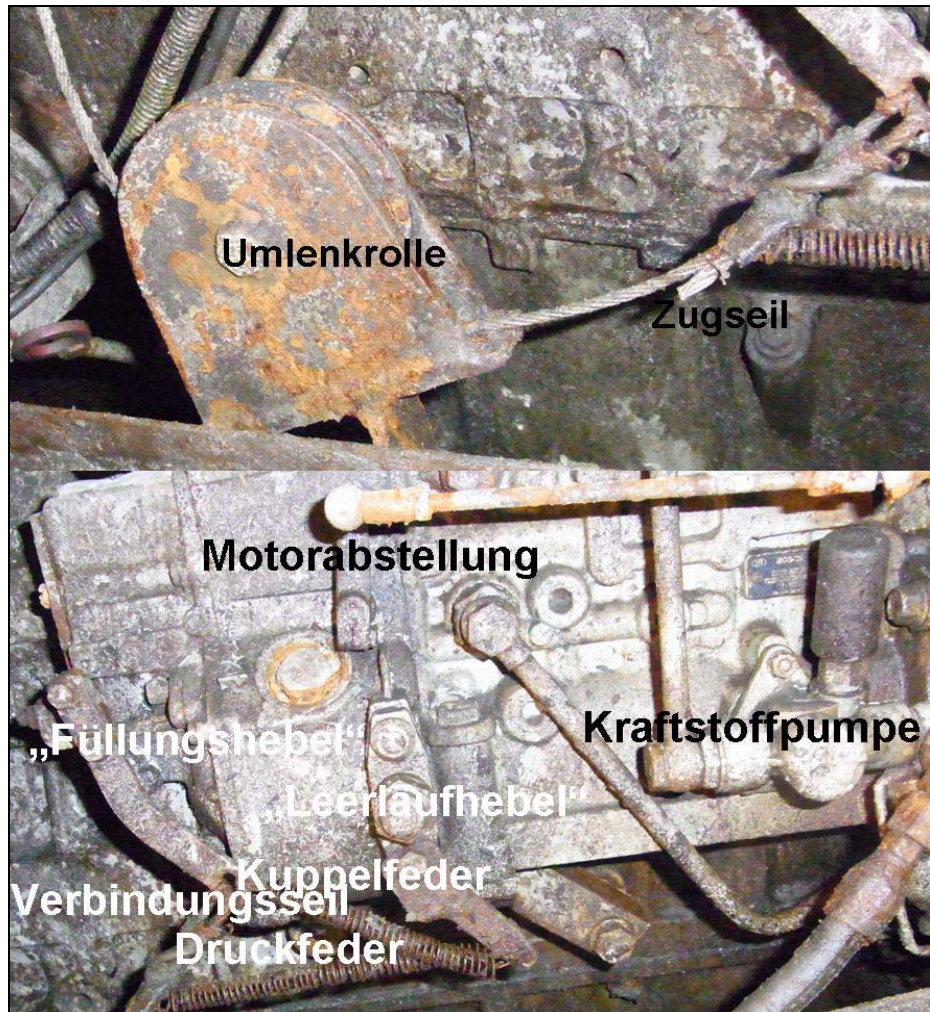
**Figure 92: Traction cable with pulley and injection pump**

The traction cable for the engine control system was not torn off and still firmly connected to the engine's injection pump. The guide pulley and the filling and idling lever on the injection pump were movable.

*The lever to stop the engine was still in the operating position. Accordingly, the engine was not switched off from the bridge before the accident.*

*The cable for the engine control was not pulled tight. Since the speed governor pulls the traction cable tight in normal operation when the engine is running, a slack traction cable is not indicative of engine control failure when the engine is stationary.*

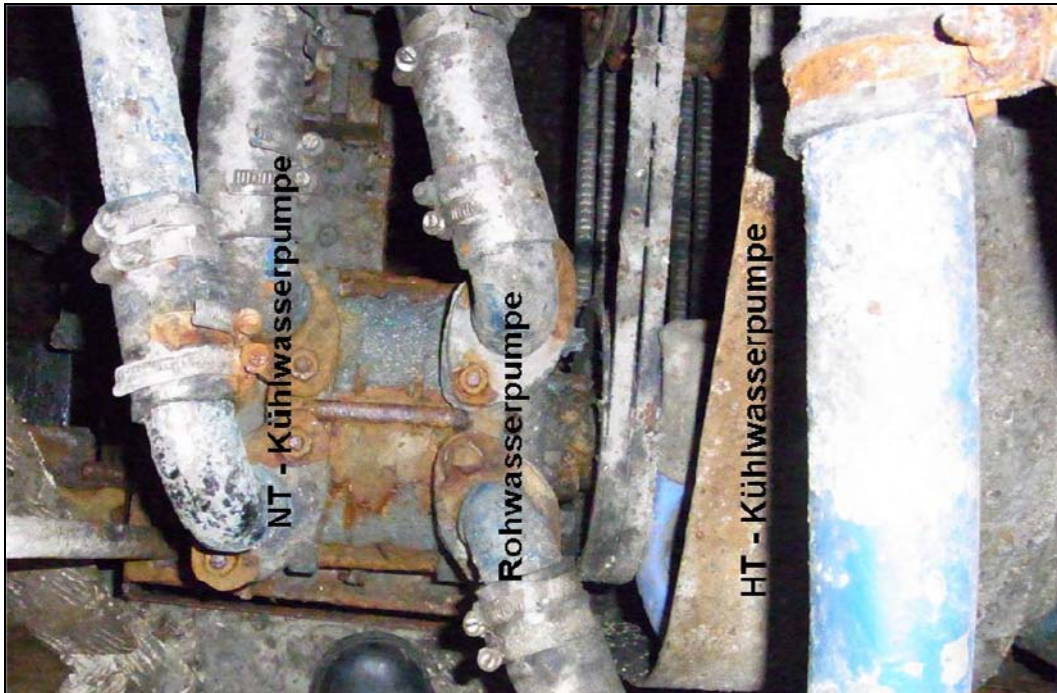
**Figure 93: Cooling water pumps and piping**

*The cooling water pipes and pumps exhibited considerable corrosion in places but no mechanical damage or other anomalies indicative of failure or leakage could be found. The pump V-belt drives were complete and tensioned.*

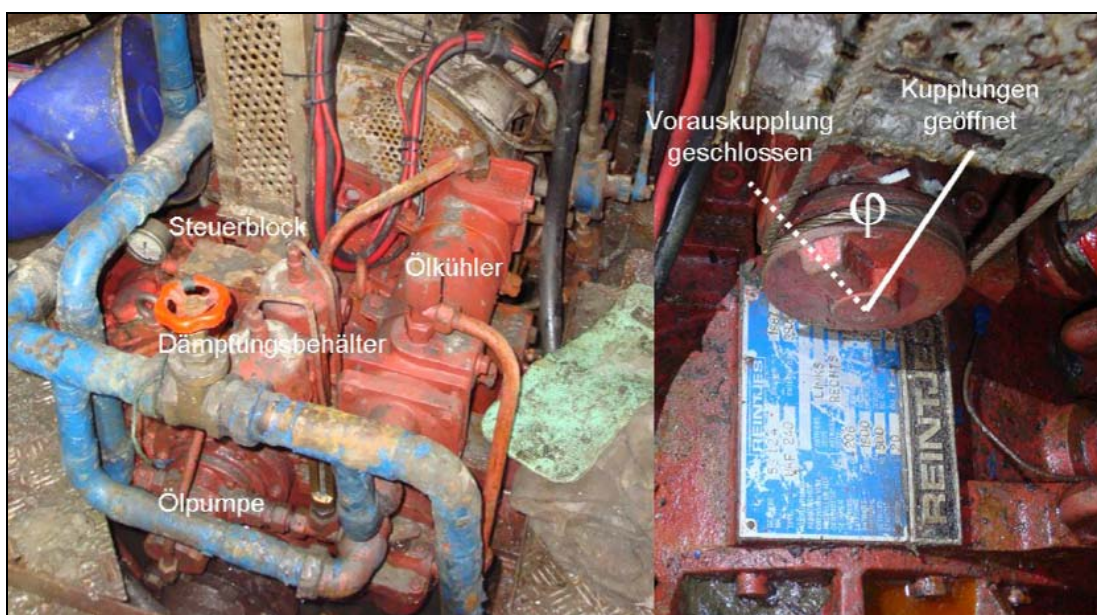
**Figure 94: Transmission block with control unit**

*Neither the piping nor the transmission unit exhibited mechanical damage or other anomalies indicative of a failure.*

*The traction cable for the transmission control was not torn off and still firmly attached to the drive roller of the control valve on the transmission motor.*

*The smoothness of the transmission unit could not be checked, as corrosion in the engine prevented it from rotating.*

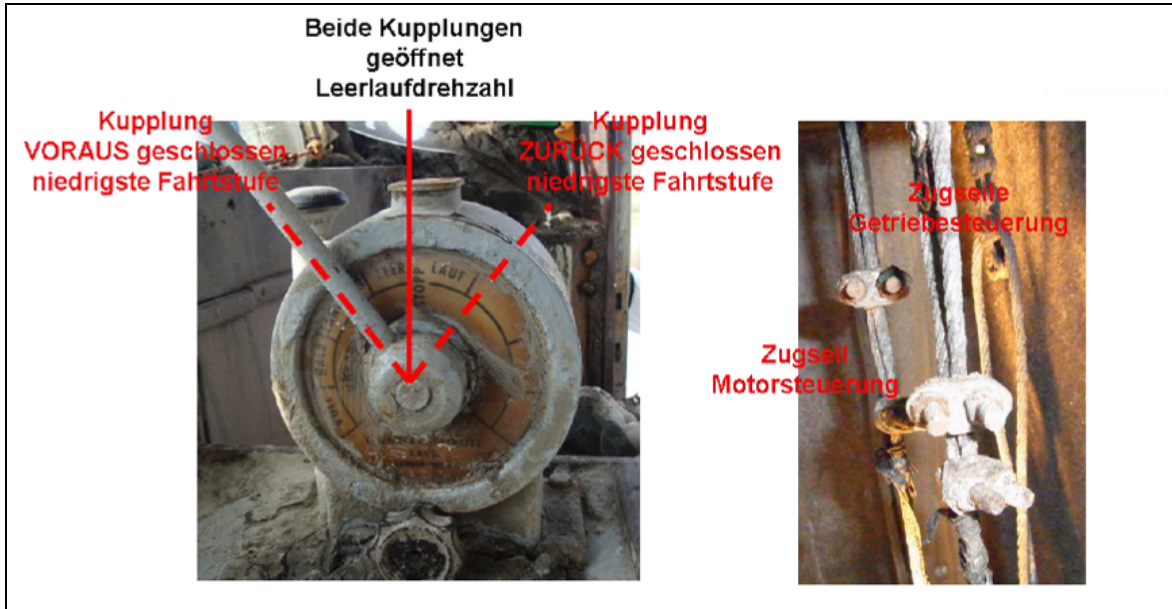
**Figure 95: Control system in the bridge console**

The control lever at the bridge operator stand was in the 'coupling ahead closed and lowest speed' position (coupling speed).

The traction cables for the engine and transmission control were firmly connected to the control lever at the bridge operator stand. The ends of the two cables for the transmission control exhibited a difference in height of about 4 cm. This corresponds approximately to the distance on the circumference of the wheel at the 4/3-way control valve on the transmission unit.

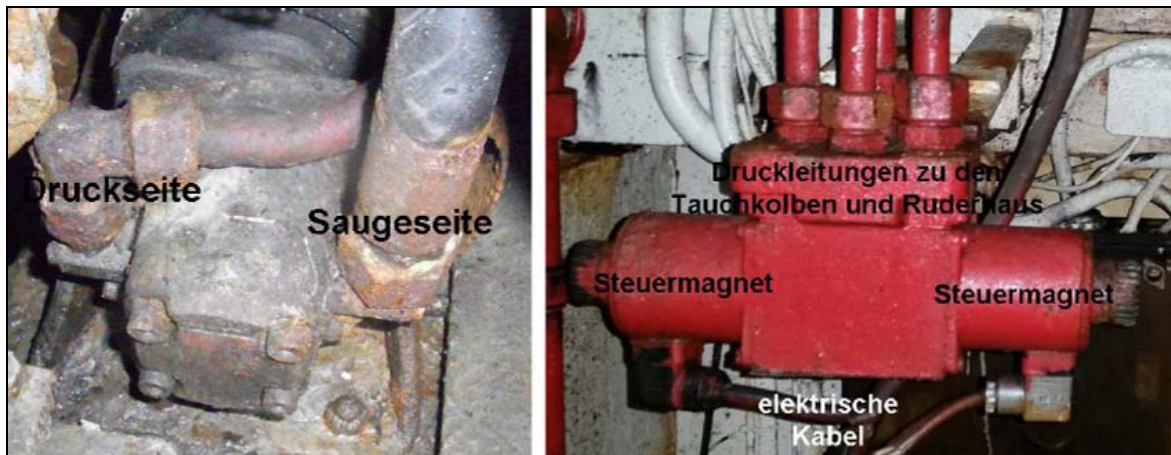
**Figure 96: Hydraulic pump and steering gear control valve**

The piping and the pump exhibited only minor corrosion and were in relatively good condition. No mechanical damage or other anomalies indicative of a failure or leakage could be found. The pump's V-belt drive was complete and the belts tensioned.

The electrical cables for the control solenoids were undamaged and the connections exhibited no leaks or other anomalies indicative of a short circuit or other faults.

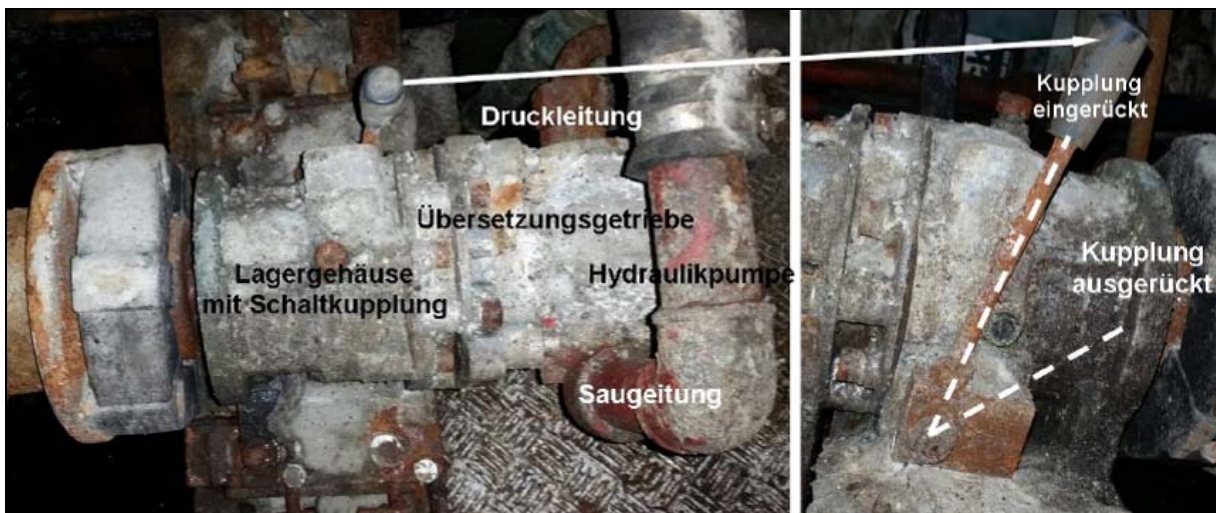
Figure 97: Winch hydraulic pump with drive

The hydraulic pump and the piping were corroded but no mechanical damage or other anomalies indicative of a pump failure or pipe leakage could be found.

The clutch coupling to the transmission gear for the hydraulic pump was engaged. The shift lever moved easily and the coupling engaged and disengaged audibly and perceptibly.

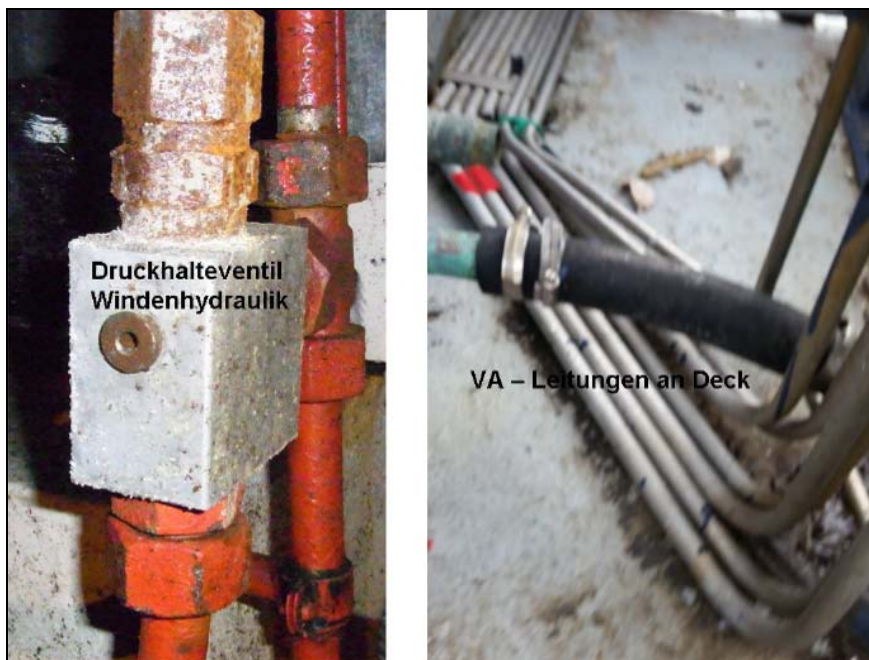
Figure 98: Pressure control valve and hydraulic lines on deck

The piping in the engine room was made of steel and on deck mainly of stainless steel. Although the pressure control valve exhibited heavy corrosion on the bolting, no mechanical damage or other anomalies indicative of leakage or valve failure could be found.

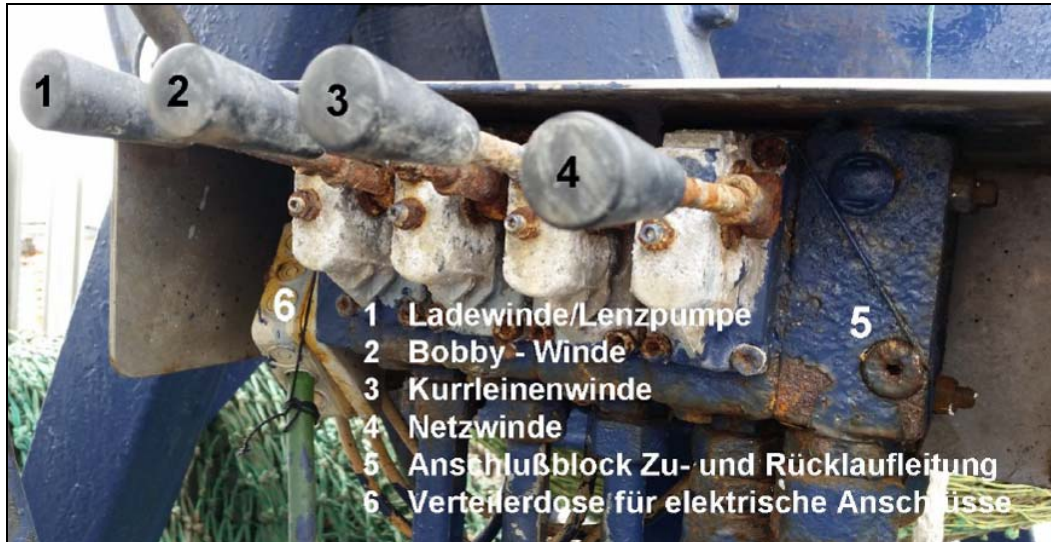
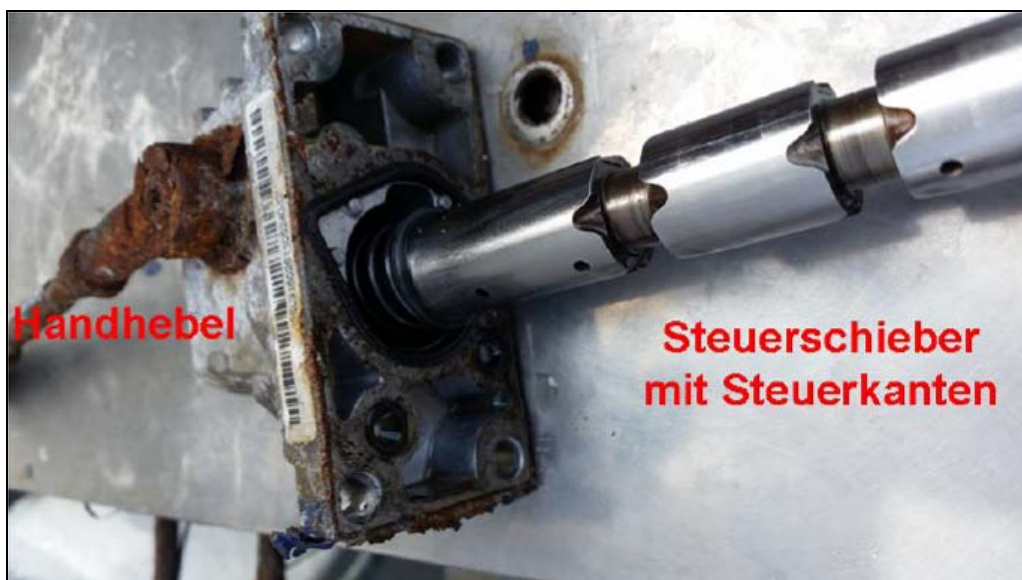
The 4/3-way winch control valves positioned on deck exhibited heavy corrosion but no mechanical damage or other anomalies on the surface of the control sliders indicative of a valve failure could be found. The valves moved easily and after deflection were centred again perfectly to the middle position by the springs.

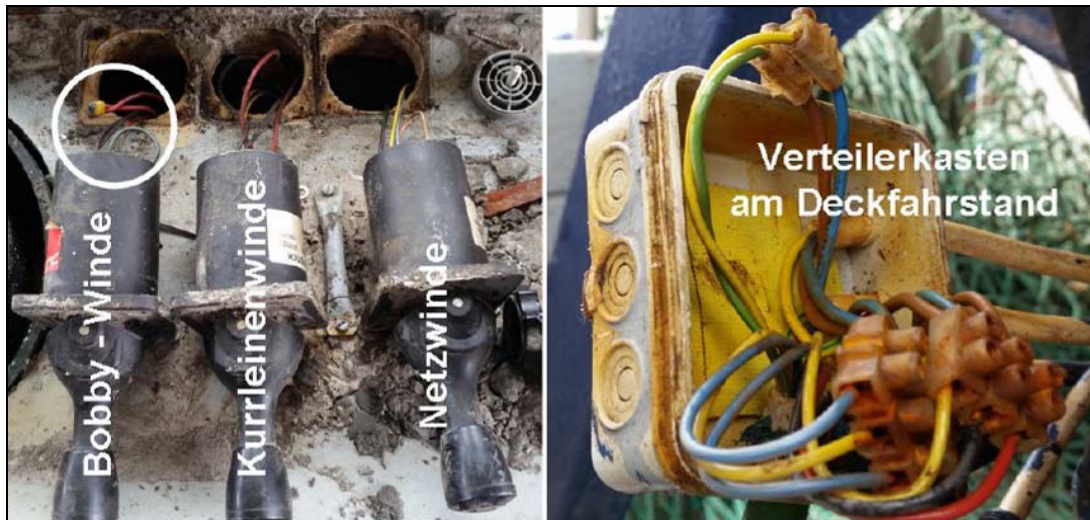
**Figure 101: Electrical winch control**

The toggle switches in the wheelhouse for the electrical control of the 4/3-way winch valves exhibited corrosion on the plugs as a result of prolonged exposure to seawater. Corrosion caused a cable to break off during the electrical test of the switches.

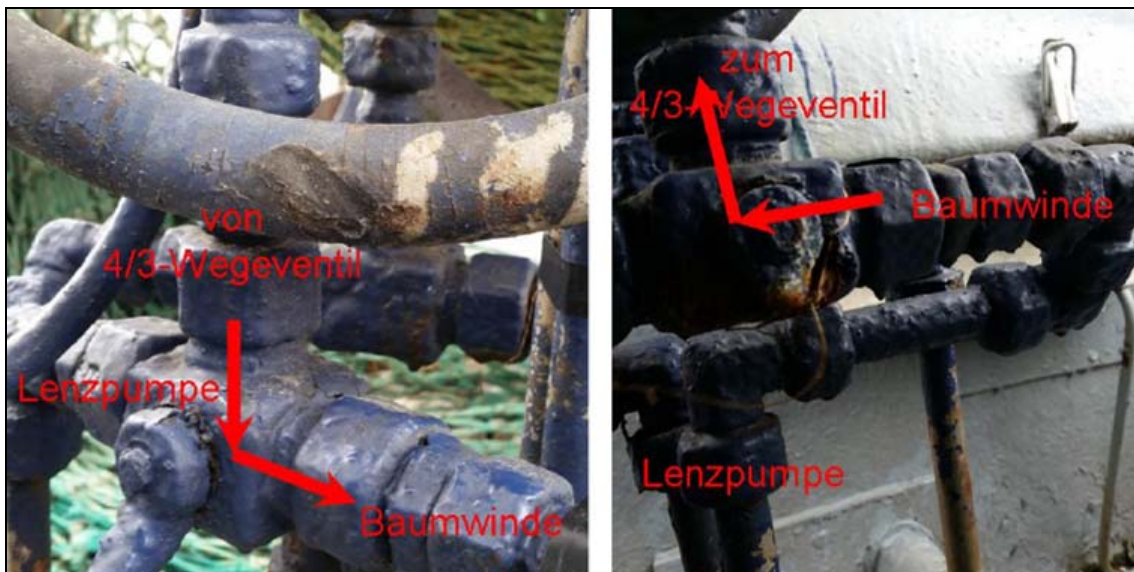
**Figure 102: Position of the changeover valves in the net-winding winch lines**

The distributor box at the deck operator stand was dry and no traces of seawater could be found. All switches and cable connections were electrically tested (resistance test with 600 V crank inductor). All contacts were electroconductive. Taking into account the effects of the seawater, the cable insulation values were satisfactory.

The 3-way changeover valves in the feed and return lines connected the net-winding winch to the 4/3-way control valves. The feed and return lines to the bilge pump were closed.

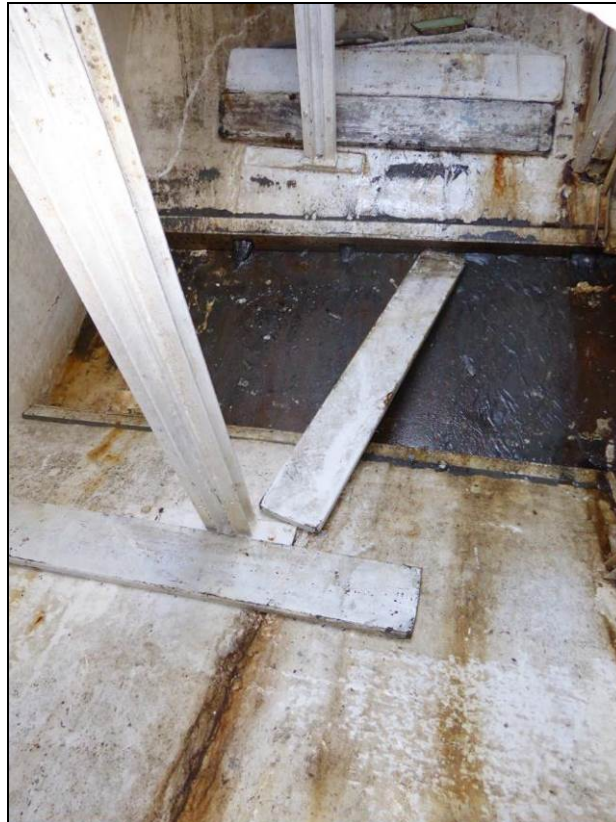
**Figure 104: FV CONDOR's fish hold (not used on the day of the accident)**

- *as already noted in the salvage report, no underwater leakage was found on the fishing vessel. During the salvage operation, water could be pumped out without new water replacing it;*
- *damage to the starboard side of the shell plating and port side in the area of the forward mast's base was caused by salvage slings;*
- *the structure of the visible wood planking with GRP coating, the equipment on deck and the deckhouse leaves a positive impression;*
- *both masts are severely damaged due to the salvage operation;*
- *the fish hurdles on deck, the bulwark with openings, the tanks in the engine room and the fresh water tank in the fore section are measured;*
- *the fish hold is inspected. It is clean and without fish. There is nothing to suggest it had been used to store fish on the day of the accident.*

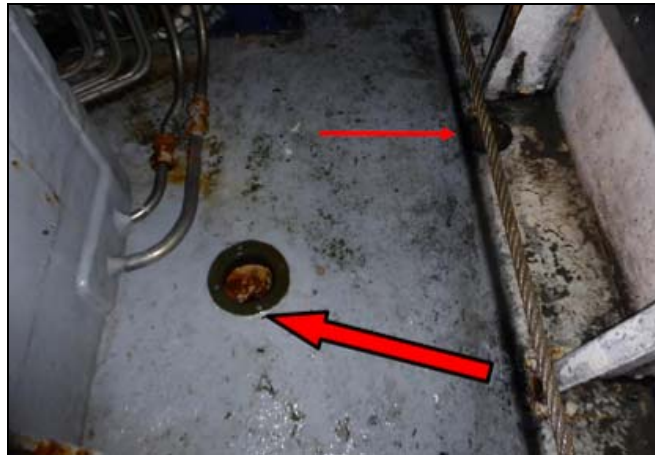
**Figure 105: Tank opening on the starboard side**

- two tank openings on the starboard side of the main deck next to the superstructure are open. One tank opening cap is lying on deck. The salvage company sealed both openings temporarily during the salvage operation;

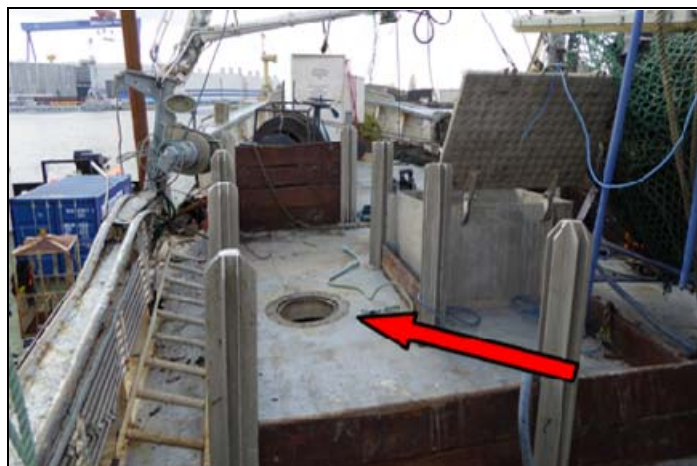
**Figure 106: Absent bolting between the deck and fish hold**

- bolting ( $\varnothing$  350 mm) between the deck and fish hold is absent;

The following calculation aims to evaluate the possible impact of the fish hold flooding because the facts available leave open the possibility that the round fish hold bolting (Ø 350 mm) was either missing or torn off by the fish chute when the vessel capsized.

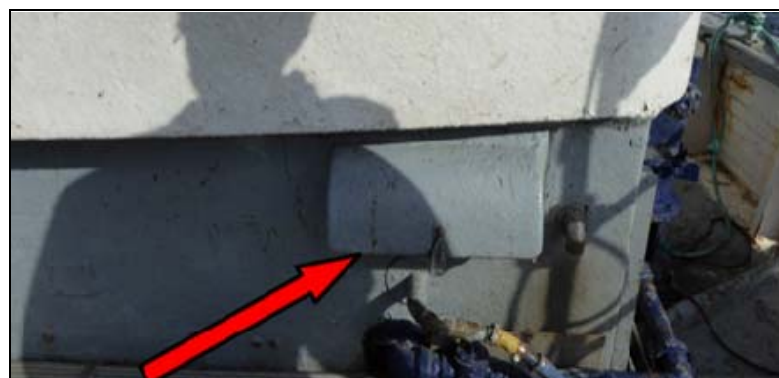
**Figure 107: Inlet air flap at forward edge of wheelhouse**

- the inlet air flap on the port side of the lower forward edge of the superstructure is not closed;

A below calculation aims to determine the angle from which the engine room starts to flood over the port side.

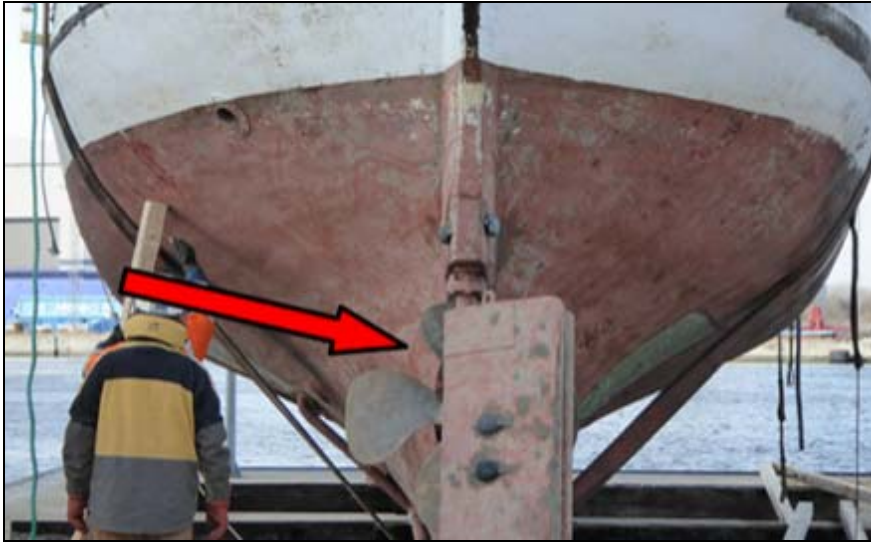
**Figure 108: Position of the rudder blade at the time of the accident**

- the rudder is turned 37° to starboard;

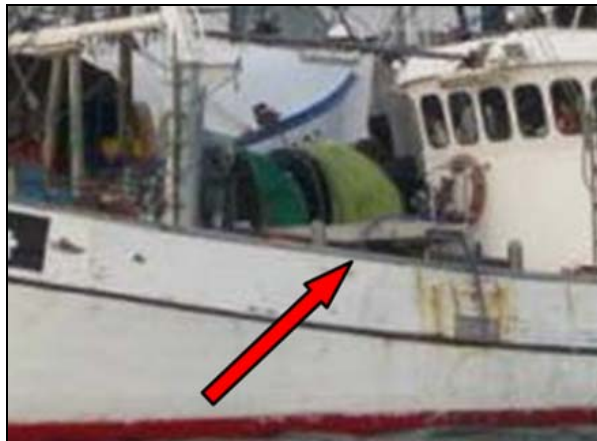
**Figure 109: Usual position of the fish chute on an older photograph**

- the fish chute is absent. The DENEK discovered it 25 m south of the wreck while searching for the vessel;

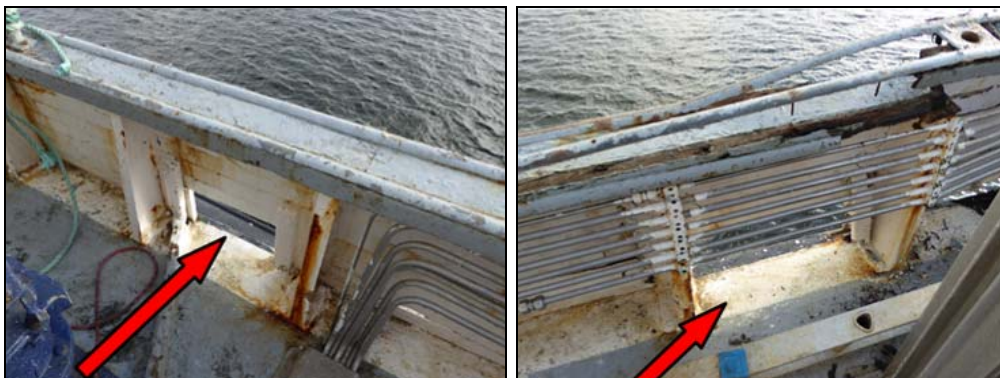
**Figure 110: Freeing port openings on the port side**

- two washboards for freeing port openings on the port side are missing;

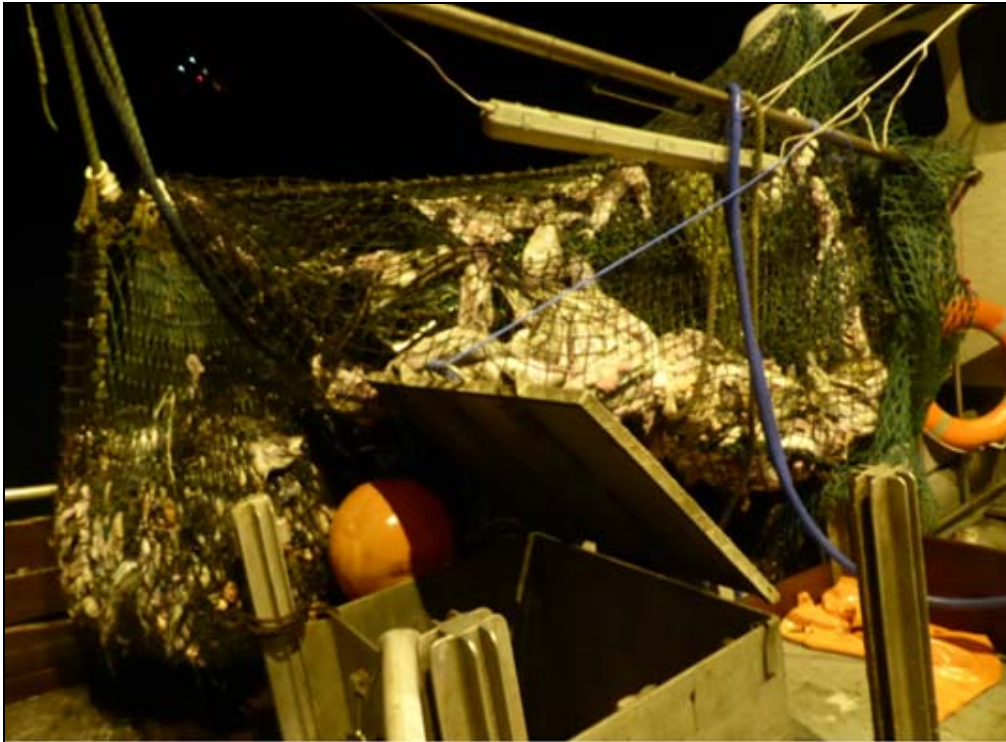
Mainly filled with cod, the net's situation immediately after the salvage operation is that the net's codend is hanging in the bobby runner about 0.30 m above deck still closed and filled with fish. A large amount of cod is also found in the remaining part of the net, which is lying on the net drum during the salvage operation. The salvage company cut the nets open.

**Figure 111: Net's codend filled with fish immediately after the fishing vessel was salvaged**

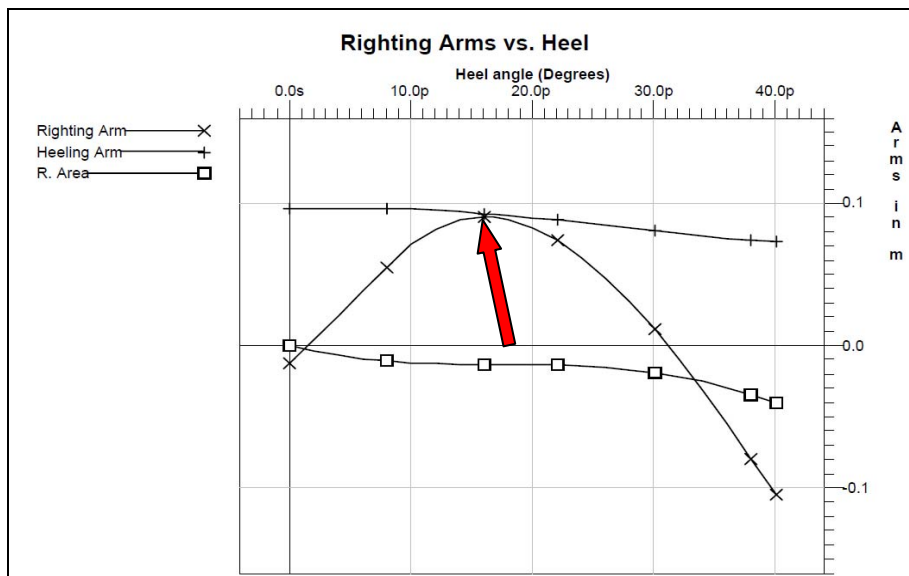
**Figure 131: Righting lever arm curve calculated for the FV CONDOR on the day of the accident**

In this load condition and weighing a total of 59.37 t, the FV CONDOR has an initial list of 1.45° to port at the time of the accident. The value of the initial stability GZ is 0.485 m and the range of stability has an angle of 31° to port and 33° to starboard.

A turning circle to the starboard side produces a heeling arm **to the** port side from the centrifugal force. The heeling arms calculated here from this centrifugal force are greater than the fishing vessel's righting levers in the entire angular range to the port side. This means that the fishing vessel capsizes in the turning circle toward the port side.

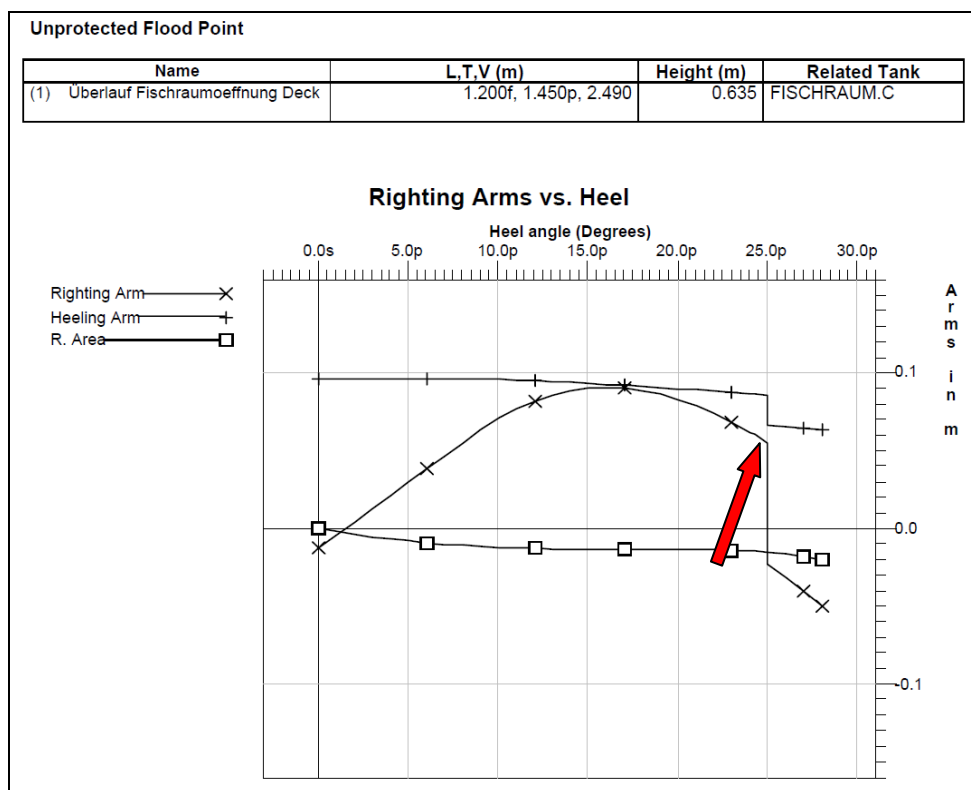
**Figure 132: Impact on the righting lever arm curve of water ingress in the fish hold**

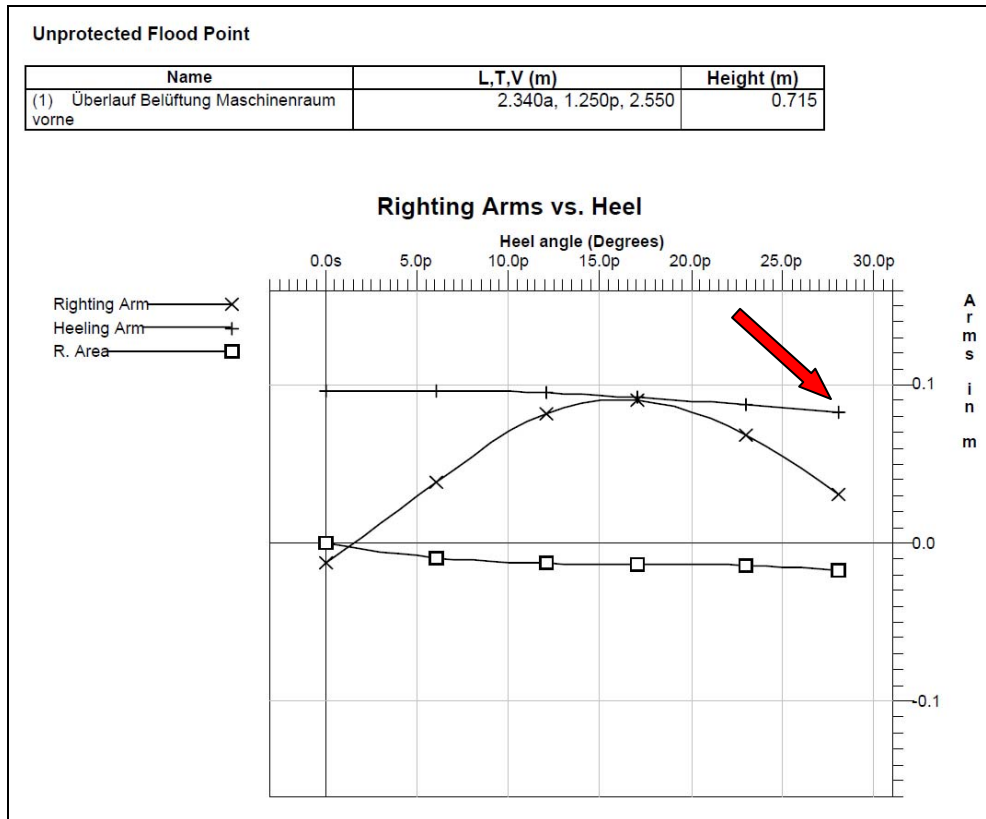
**Figure 133: Impact on the righting lever arm curve of water ingress in the engine room**

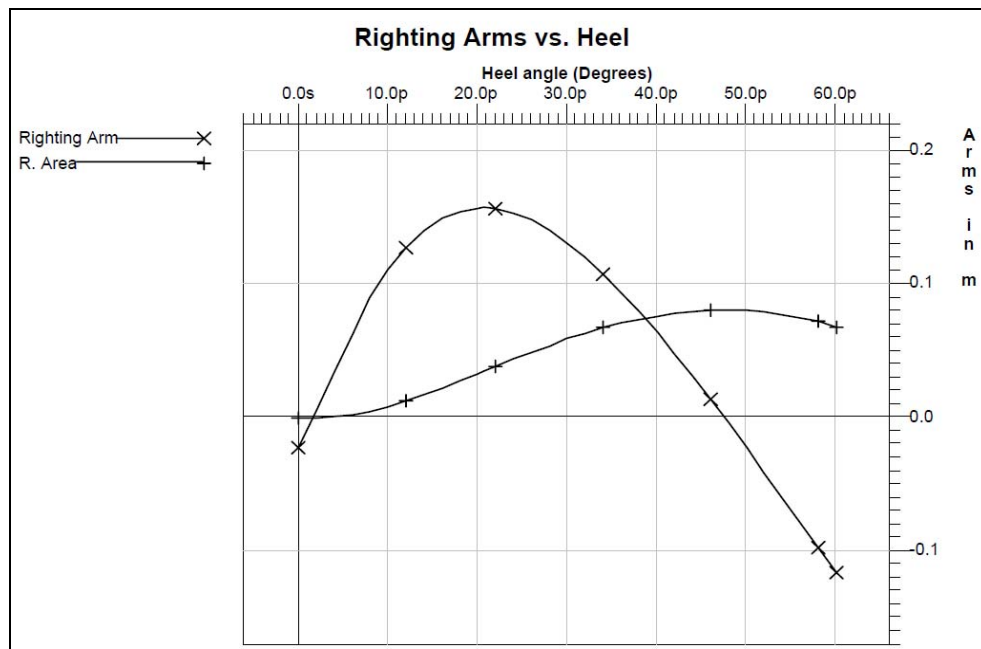
**Figure 135: Righting lever arm curve of the FV CONDOR – load case 1**

Limit	Min/Max	Actual	Margin	Pass
(1) Area from 0.00 deg to 30.00	>0.0550 m-R	0.059	0.004	Yes
(2) Area from 0.00 deg to 40.00	>0.0900 m-R	0.076	0.014	No
(3) Area from 30.00 deg to 40.00	>0.0300 m-R	0.017	0.013	No
(4) Righting Arm at 30.00 deg or MaxRA	>0.200 m	0.131	0.069	No
(5) Angle from 0.00 deg to RAzero	>60.00 deg	48.00	12.00	No
(6) GM Upright	>0.350 m	0.819	0.469	Yes

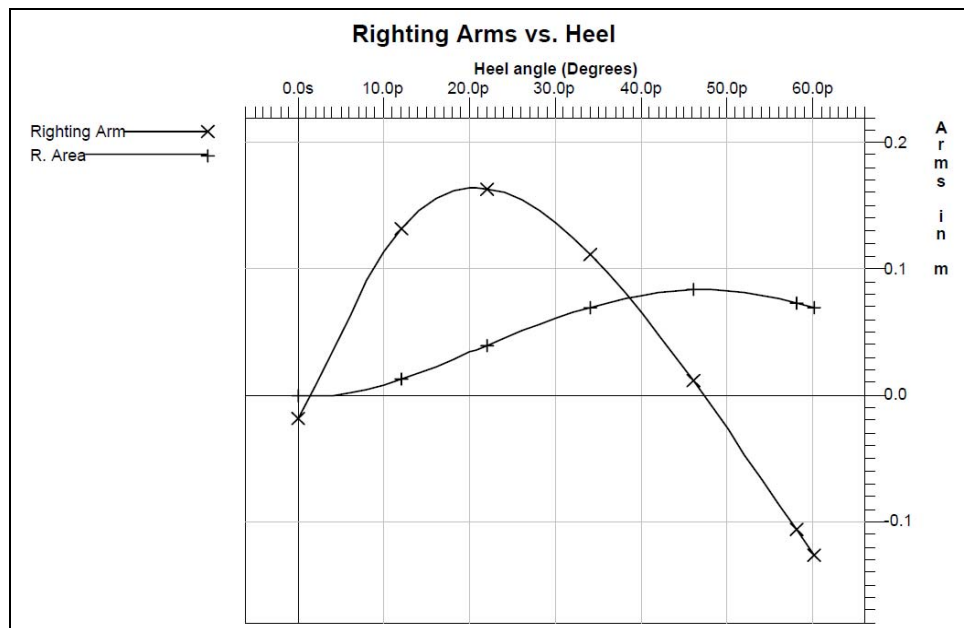
**Figure 138: Righting lever arm curve of the FV CONDOR – load case 2**

Limit	Min/Max	Actual	Margin	Pass
(1) Area from 0.00 deg to 30.00	>0.0550 m-R	0.062	0.007	Yes
(2) Area from 0.00 deg to 40.00	>0.0900 m-R	0.080	0.010	No
(3) Area from 30.00 deg to 40.00	>0.0300 m-R	0.018	0.012	No
(4) Righting Arm at 30.00 deg or MaxRA	>0.200 m	0.137	0.063	No
(5) Angle from 0.00 deg to RAzero	>60.00 deg	46.00	14.00	No
(6) GM Upright	>0.350 m	0.786	0.436	Yes

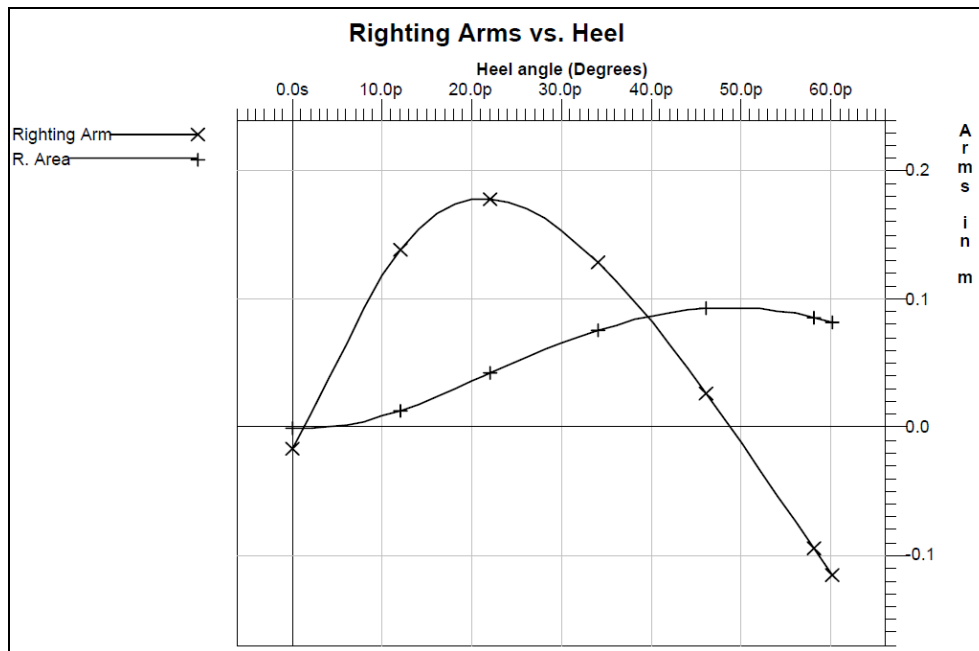
**Figure 141: Righting lever arm curve of the FV CONDOR – load case 3**

Limit	Min/Max	Actual	Margin	Pass
(1) Area from 0.00 deg to 30.00	>0.0550 m-R	0.066	0.011	Yes
(2) Area from 0.00 deg to 40.00	>0.0900 m-R	0.087	0.003	No
(3) Area from 30.00 deg to 40.00	>0.0300 m-R	0.021	0.009	No
(4) Righting Arm at 30.00 deg or MaxRA	>0.200 m	0.153	0.047	No
(5) Angle from 0.00 deg to RAzero	>60.00 deg	48.00	12.00	No
(6) GM Upright	>0.350 m	0.782	0.432	Yes

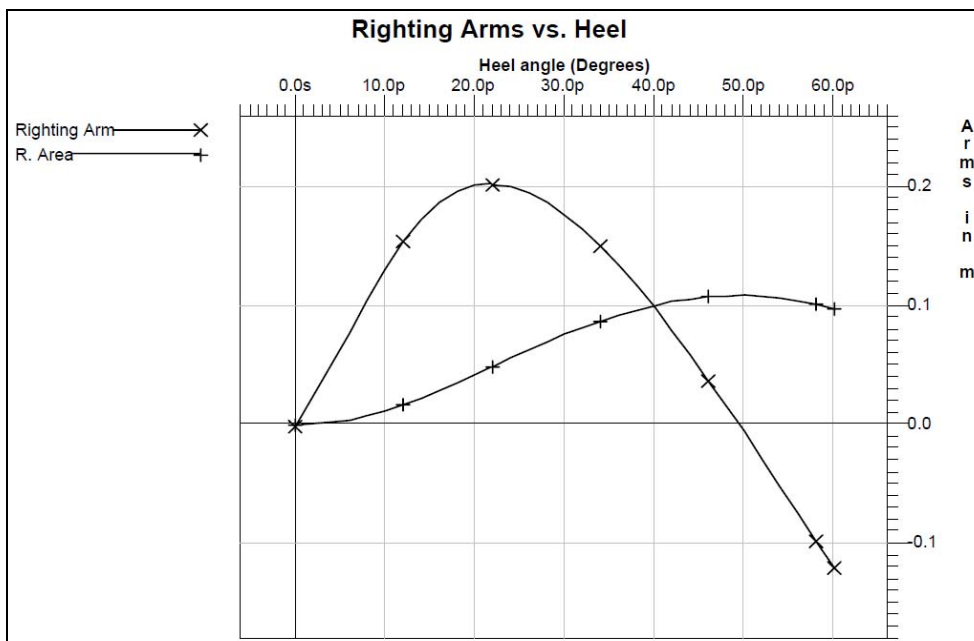
**Figure 144: Righting lever arm curve of the FV CONDOR – load case 4**

Limit	Min/Max	Actual	Margin	Pass
(1) Area from 0.00 deg to 30.00	>0.0550 m-R	0.076	0.021	Yes
(2) Area from 0.00 deg to 40.00	>0.0900 m-R	0.101	0.011	Yes
(3) Area from 30.00 deg to 40.00	>0.0300 m-R	0.025	0.005	No
(4) Righting Arm at 30.00 deg or MaxRA	>0.200 m	0.177	0.023	No
(5) Angle from 0.00 deg to RAzero	>60.00 deg	48.00	12.00	No
(6) GM Upright	>0.350 m	0.764	0.414	Yes
