Investigation Report 459/15

Serious Marine Casualty

**Collision on the Lower Elbe
between MV EENDRACHT and
MV TRANSCAPRICORN
on 26 November 2015**

14 July 2017

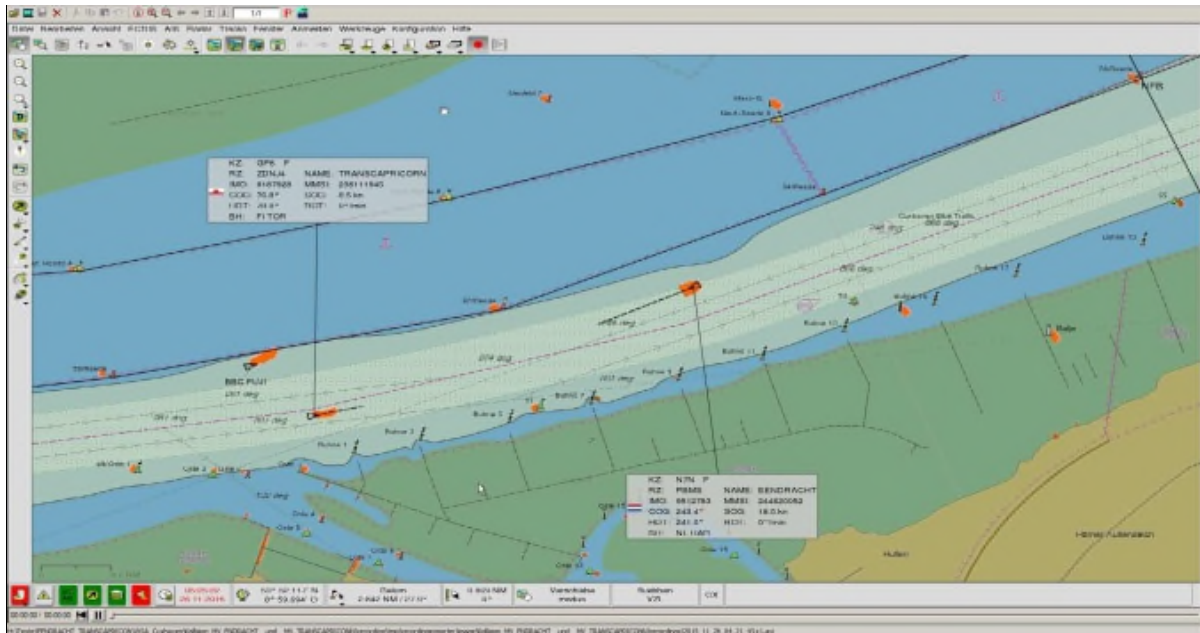
Figure 15: VTS at 052522

The TRANSCAPRICORN keeps her course on the starboard side of the dredged channel, while the EENDRACHT continues toward the dredged channel and the TRANSCAPRICORN. The vessels approach one another at a relative speed of 27 kts.

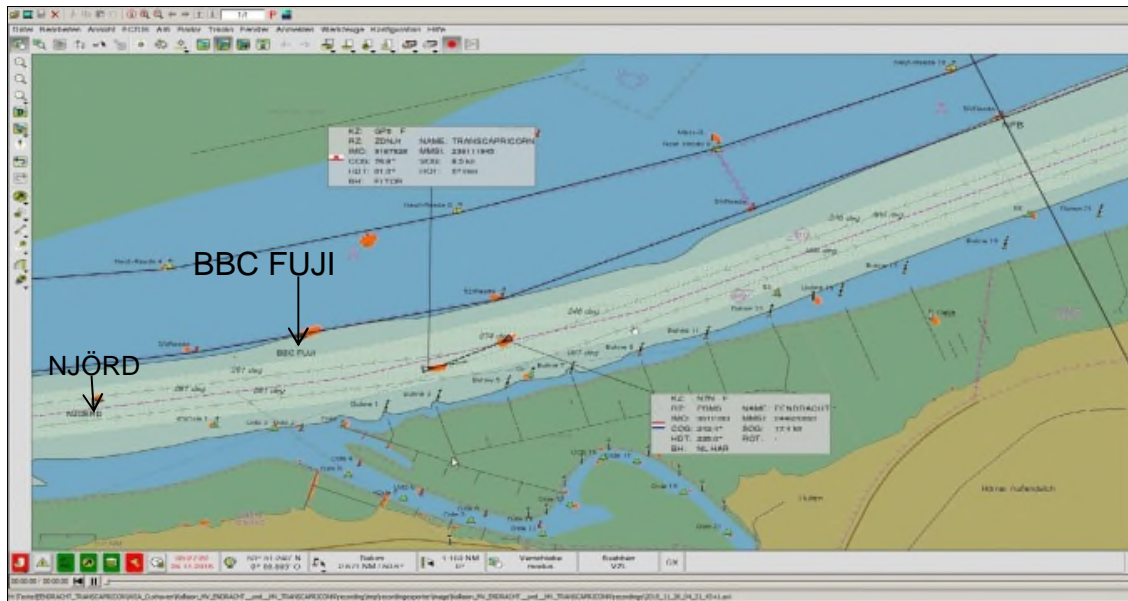
Figure 17: VTS at 052722

The EENDRACHT sails into the dredged channel and crosses the radar reference line. The collision is imminent.

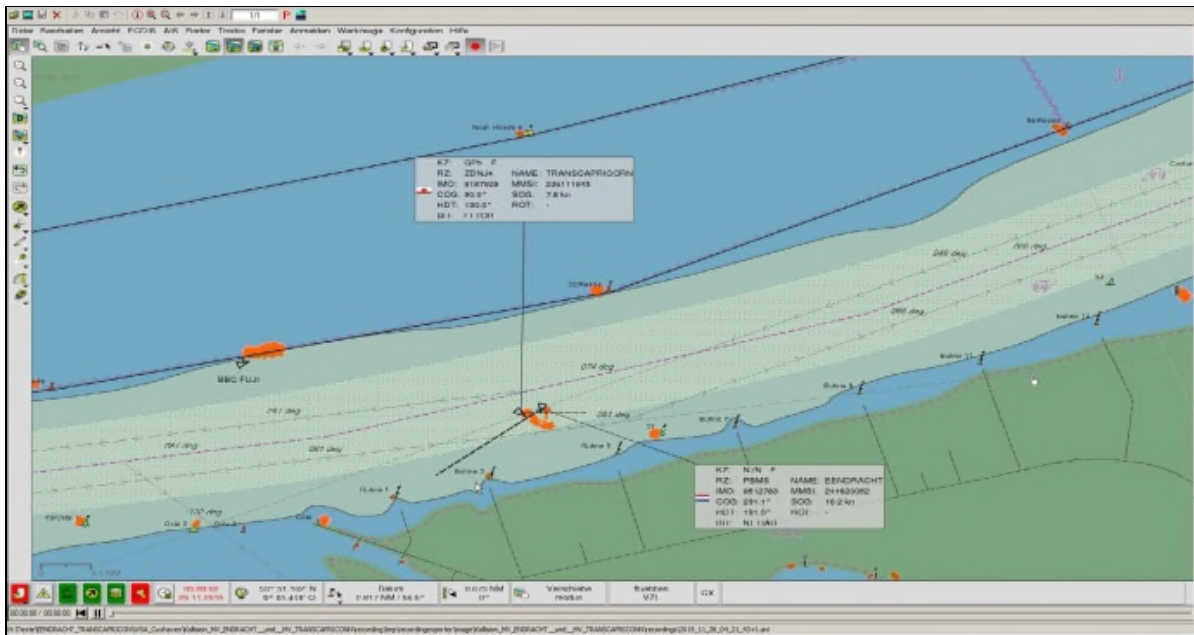
Figure 19: VTS at 052802, collision

At 052633 (see Figure 23), the distance between the two prows is calculated at 1,004.4 m on a constant bearing. It would have been necessary to respond immediately to prevent the collision. About 30 seconds later, the EENDRACHT's master switched to manual steering. Contrary to the intended course alteration to starboard, the EENDRACHT turned to port, however. This meant that a collision with the TRANSCAPRICORN, which according to the audio recordings on the VDR set her rudder to hard to starboard at 052724, was unavoidable. It was now a matter of preventing more severe damage and keeping the collision angle acute. The vessels collided at 052804. The EENDRACHT and TRANSCAPRICORN scraped past each other with the starboard and port side respectively. The impact caused material damage to the side of each vessel.

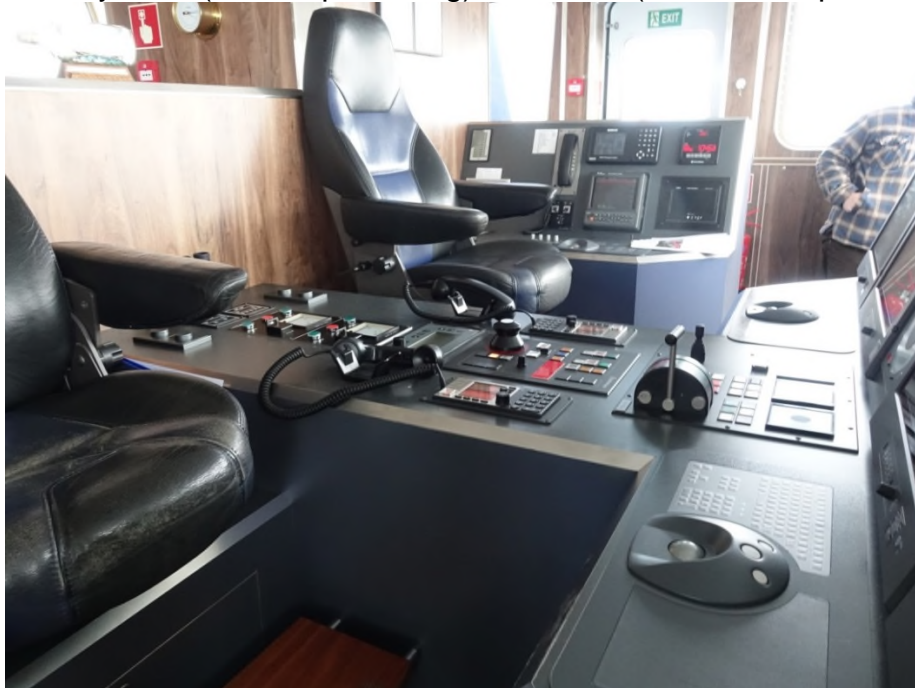
The control console is only accessible from the sides. There is no separate position for the helmsman. It is only possible to perform this task sitting down, so as to operate the rotary knob (follow-up steering) or buttons (non-follow-up steering).

Figure 28: Control console with command positions (conning)

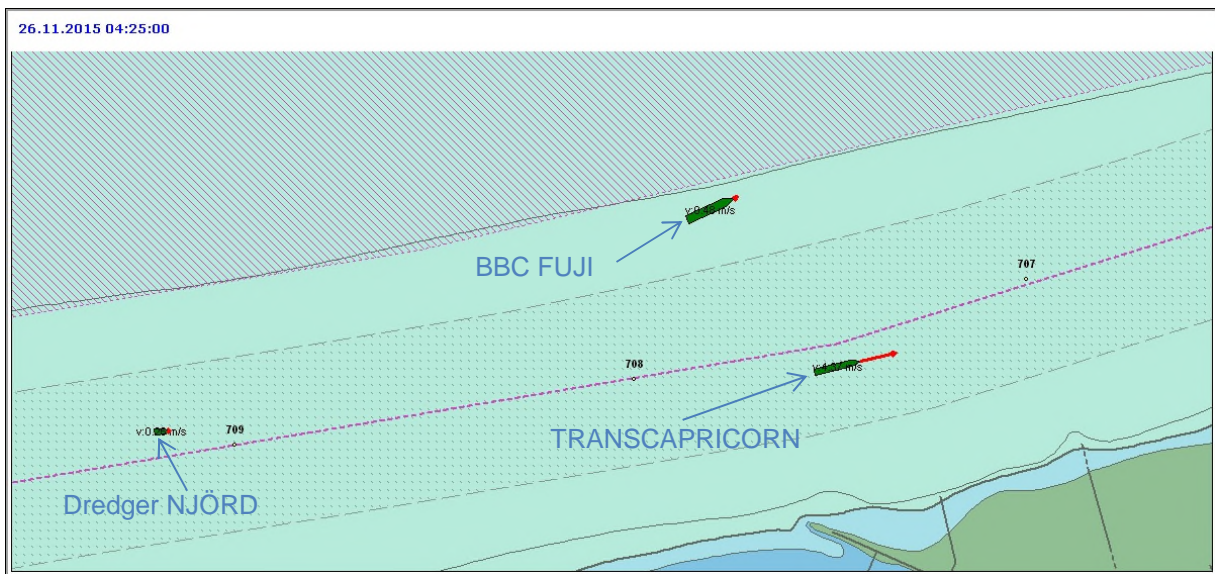
Figure 33: BAW at 052500

The NJÖRD is a flushing dredger and requires special consideration during water injection operations. The original intention was to pass the NJÖRD to port and the BBC FUJI to starboard. Instead, the EENDRACHT steered extremely close to the middle of the fairway (radar reference line) and a close-quarters situation – during which the master decided to switch to manual steering – with the TRANSCAPRICORN rapidly developed in the immediate vicinity.
