Investigation Report 470/15

Less Serious Marine Casualty

**Collision between the EMSMOON
and Friesenbrücke
railway bridge
at Weener, Ems,
on 3 December 2015**

23 February 2017

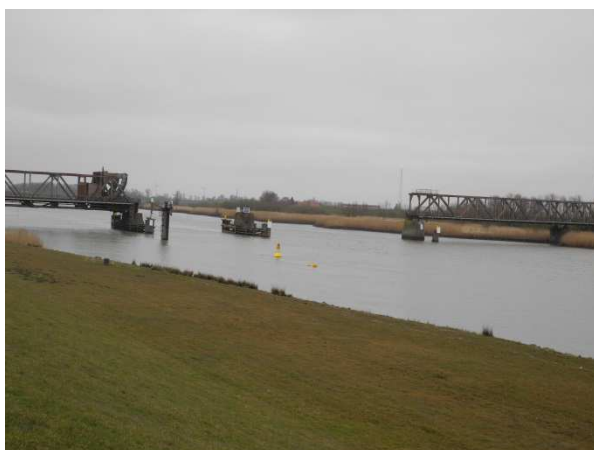
Figure 4: Bridge passage

The BSU recorded the new situation at the Friesenbrücke Bridge at Weener on 18 March 2016. In the meantime, the middle section of the bridge had been lifted out and a new lighting system installed. Seen from the southern side, the left-hand pier of the small passage (24 m) is now painted white and floodlit by the existing light. The large passage (46.6 m) is equipped with a new table sign, a new radar reflector, new floodlighting, and a new Blz. 4s warning beacon on both sides. The signal board belonging to the rail operator is removed (or out of operation on the northern side). The middle section and signal board are at the grounds of the Meyer Werft shipyard.

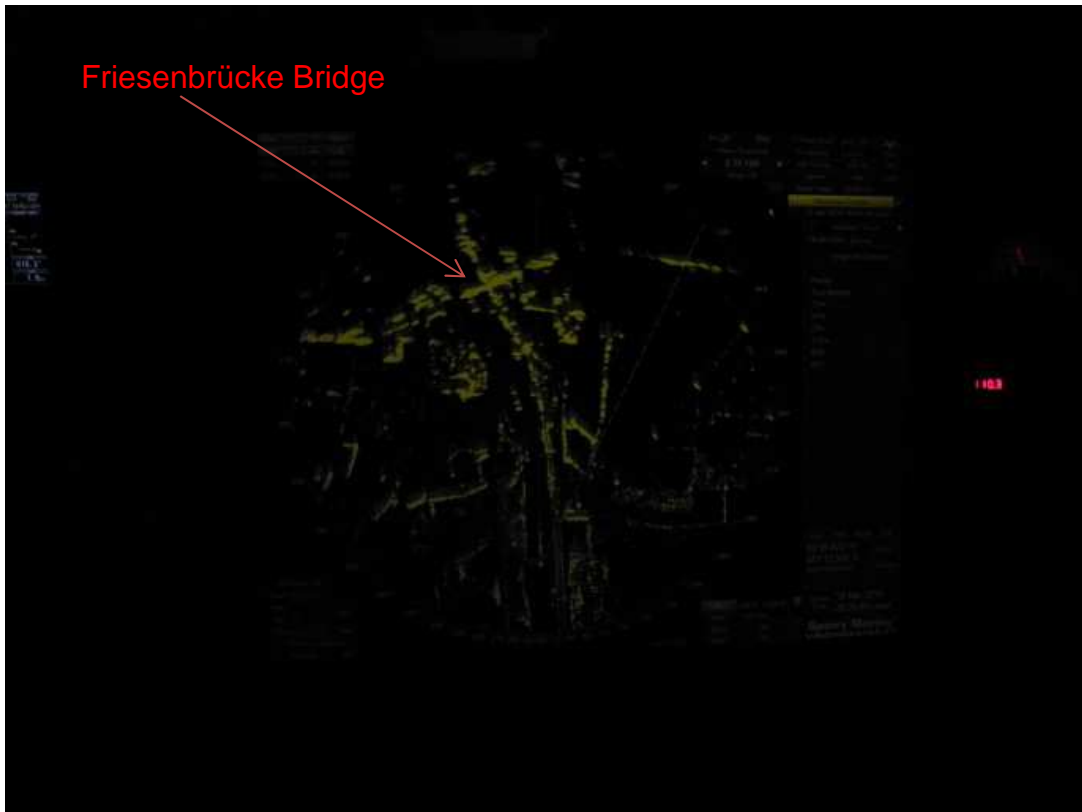
Figure 9: Range of 0.75 nm at the high-voltage power line

The two radar images below show the curvature at the high-voltage power line at radar ranges of 0.5 and 0.75 nm. The high-voltage power line was an informal reporting point used by pilots for the bridge keeper when the bridge was still intact. The lighting system has now been changed and the bridge signals are extinguished. The middle section of the Friesenbrücke Bridge has also been lifted out in the meantime. Therefore, the wider middle passage was taken in the interest of safety.

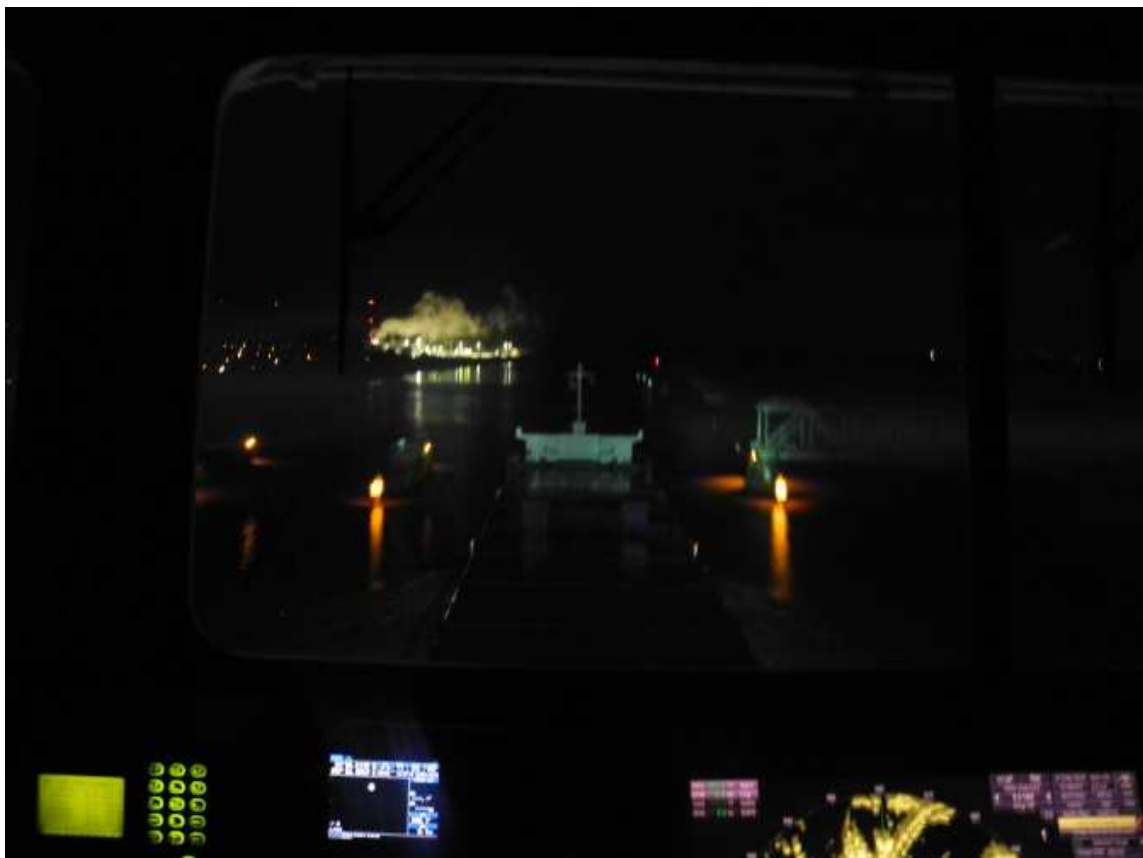
Figure 13: New middle passage

With regard to the survey, it should be noted first that the factory lighting in the background also interferes with the new lights severely and the radar systems do not display the passages until relatively late. Furthermore, the ship's position in the fairway cannot be kept in an aft current.

⁷ During the BSU's survey with the EMSMOON, observers on the bridge (see Figures 13 and 17) felt that the illuminated factory with its bright clouds of steam covered the Friesenbrücke Bridge's lattice structure from a distance and was definitely in the field of vision of the Friesenbrücke Bridge. Furthermore, the wing searchlights were also disruptive when they were directed at the signal board at the lock in Papenburg or the Jann-Berghaus Bridge. The signals were concealed by the glare and could no longer be differentiated. With her deck lighting turned on, the dredger HEGEMANN 3 was also a considerable source of interference lighting in the EMSMOON's field of vision if the searchlight shone in the direction of the EMSMOON. No technical measurements of the general light situation that prevailed on the day of the accident were made. Of significance is how the light situation is perceived by the observer.

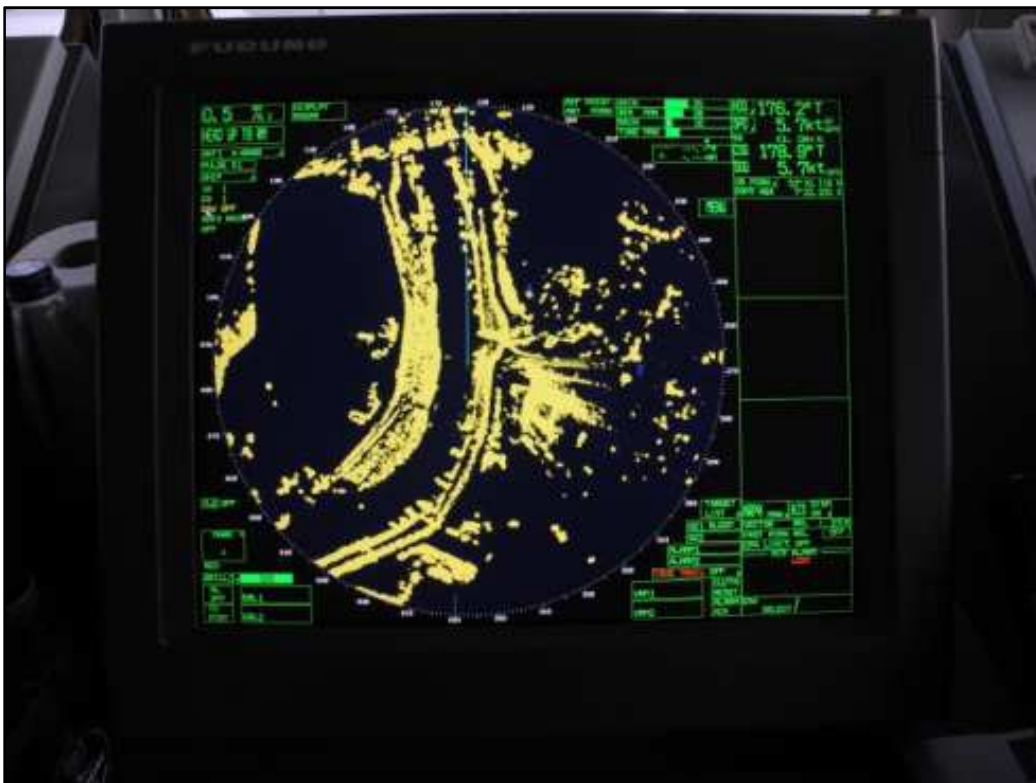
Figure 21: Friesenbrücke Bridge, range of 0.5 nm – large passage visible

The FRIESLAND was neither equipped with a log, which could measure the STW, nor with a river radar. The X-band radar system had an antenna length of 8 feet. The antenna length is important for the horizontal concentration. The antenna is located at a height of about 8 m above the water. Consequently, it was not possible to compare the radar systems with the EMSMOON and measure the current. Speed log measurements are reportedly inaccurate due to the river bed and shallow water depths. Viewed from the north, the passages of the Jann-Berghaus Bridge at Leer and the Friesenbrücke Bridge were displayed well on the radar system at a range of up to 0.5 nm. In the case of the Friesenbrücke Bridge, only the large passage is displayed at a distance of about 0.5 nm. The two passages are only clearly visible at the edge of the 0.25-nm radar range.

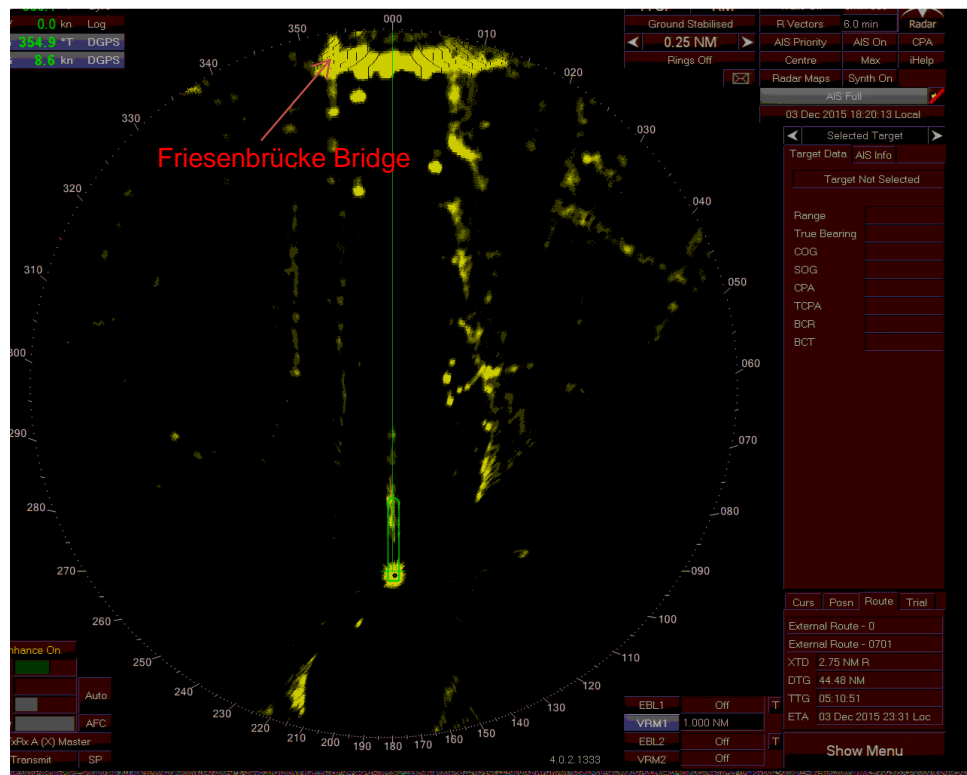
Figure 33: Friesenbrücke Bridge at 182013 (8.6 kts)

The Friesenbrücke Bridge is visible for the first time at 182013. The bascule bridge's passage can be surmised at 182113.

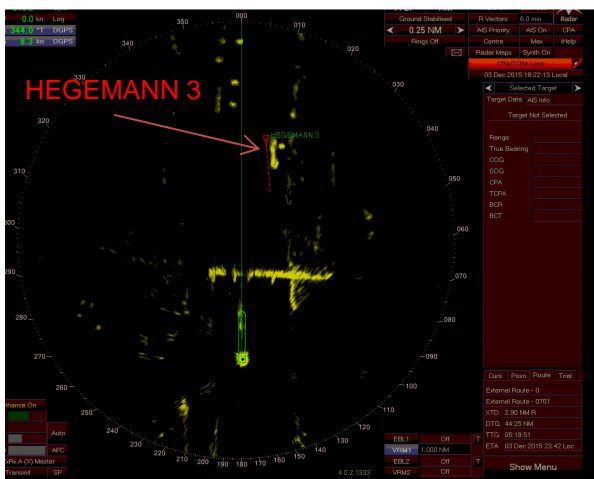
Figure 35: Friesenbrücke Bridge at 182213 (8.3 kts)

Two openings on the bridge can be seen at 182213 (one minute before the collision). The dredger HEGEMANN 3 is shown as an AIS target. The EMSMOON collides with the bascule bridge at 1823.

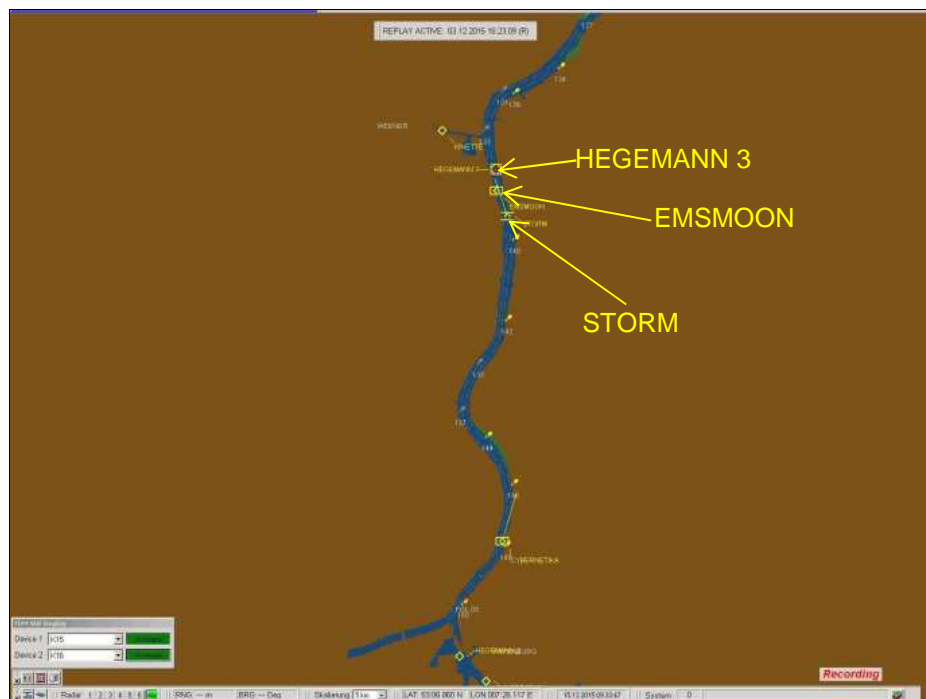
Figure 42: VTS at 182309 (collision with Friesenbrücke Bridge)

The STORM is located 3.5 cbl astern when the EMSMOON makes the fourth report and only 2.5 cbl astern during the collision.

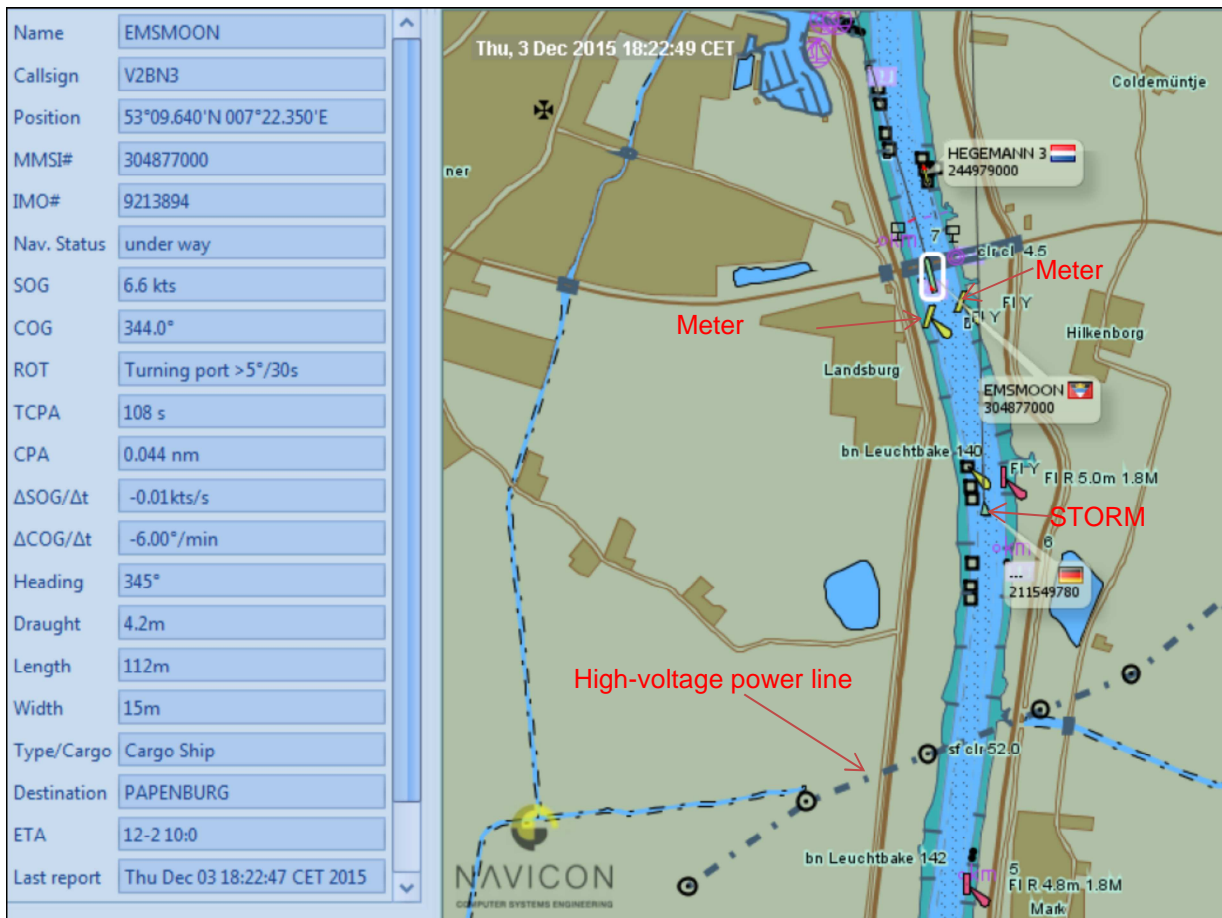
Figure 47: AIS at 182249 (6.6 kts)

The speed was barely reduced up until the impact with the Friesenbrücke Bridge. It drops rapidly due to the absorption of the lattice structure.

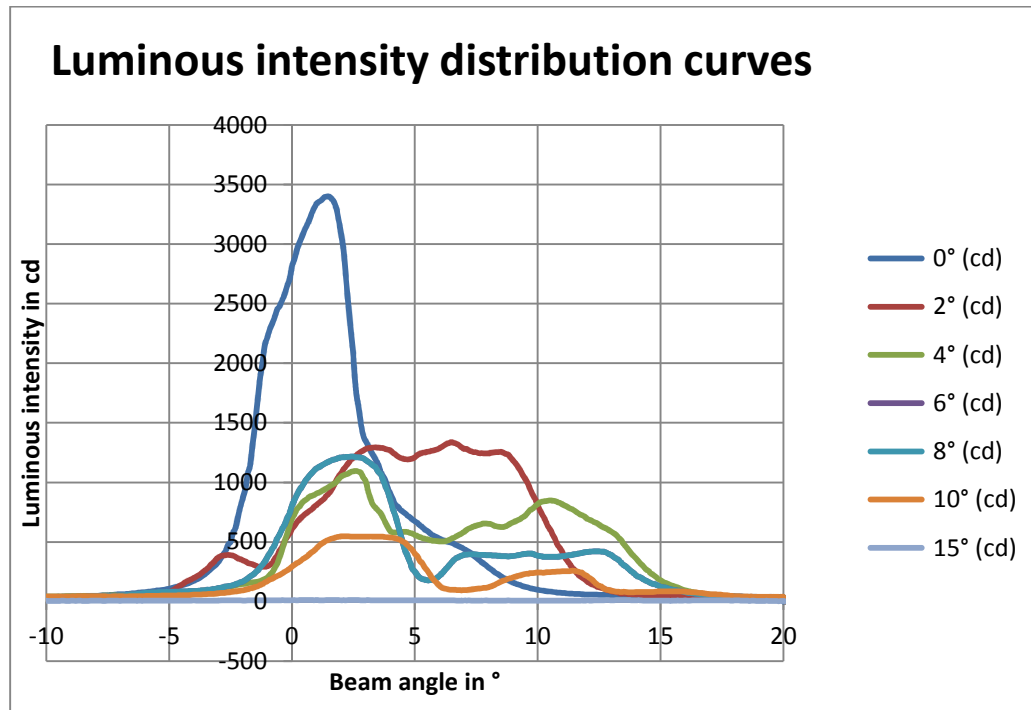
Figure 56: Luminous intensity distribution curves of white signal light during the day

The white signal light has a beam angle of 17.8° and a range of 1.0 nm during daylight hours.

@ $\alpha = 0^\circ$	Luminous intensity	Beam angle
I_{\max}	2814 cd	2.1°
$I_{\text{FWHM}} 0.5 \cdot I_{\max}$	1407 cd	4.4°
$I_{\text{FTM}} 0.1 \cdot I_{\max}$	281.4 cd	17.8°
Maximum range	1.0 nm

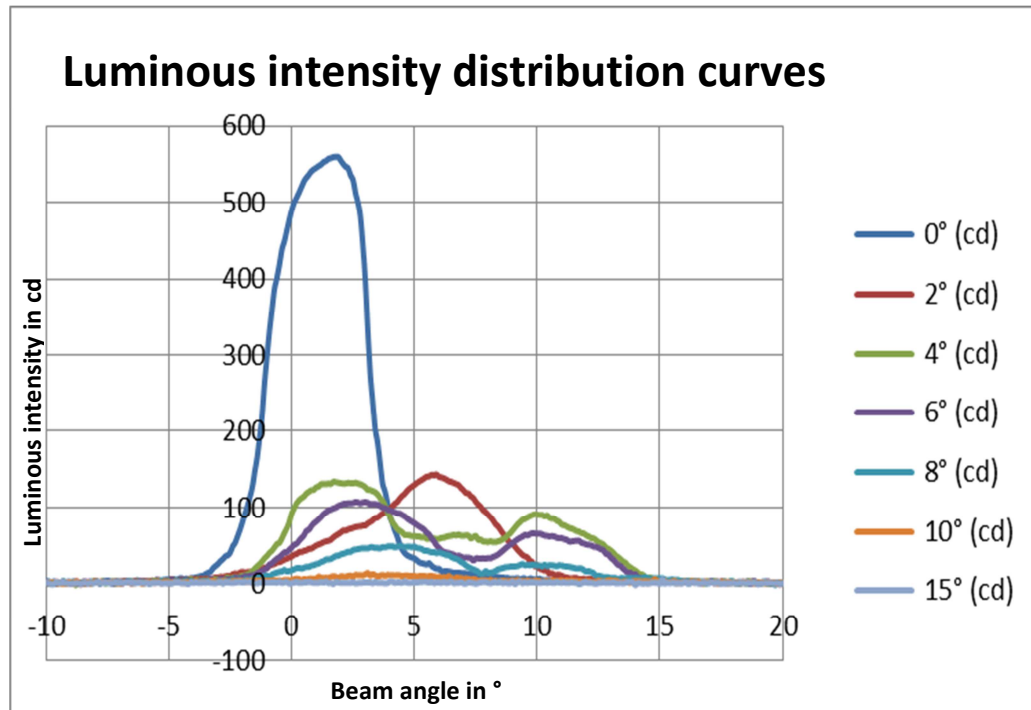
Figure 57: Luminous intensity distribution curves of red signal light during the day

The red signal light has a beam angle of 15.2° and a range of less than 1.0 nm during daylight hours.

@ $\alpha = 0^\circ$	Luminous intensity	Beam angle
I_{\max}	490 cd	2.7 °
$I_{\text{FWHM}} 0.5 \cdot I_{\max}$	245 cd	4.4 °
$I_{\text{FWTM}} 0.1 \cdot I_{\max}$	49 cd	15.2 °
Maximum range	<1.0 nm

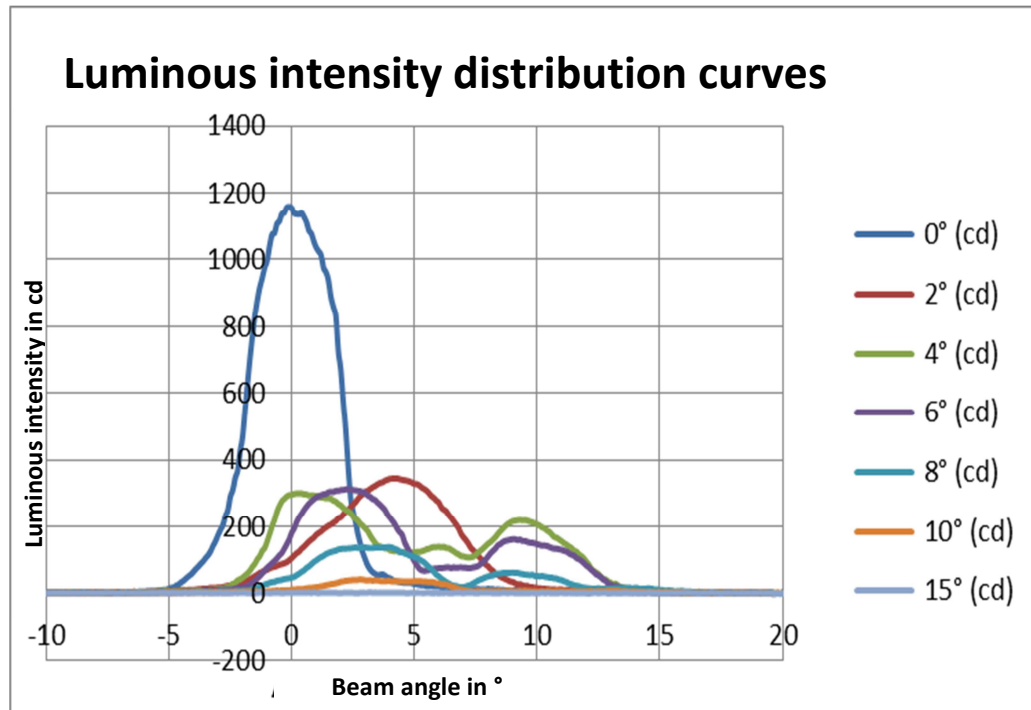
Figure 58: Luminous intensity distribution curves of green signal light during the day

The green signal light has a beam angle of 15.1° and a maximum range of 1.0 nm during daylight hours.

@ $\alpha = 0^\circ$	Luminous intensity	Beam angle
I_{\max}	1154 cd	0.2 °
$I_{\text{FWHM}} 0.5 \cdot I_{\max}$	577 cd	3.9 °
$I_{\text{FWTM}} 0.1 \cdot I_{\max}$	115 cd	15.1 °
Maximum range	1.0 nm

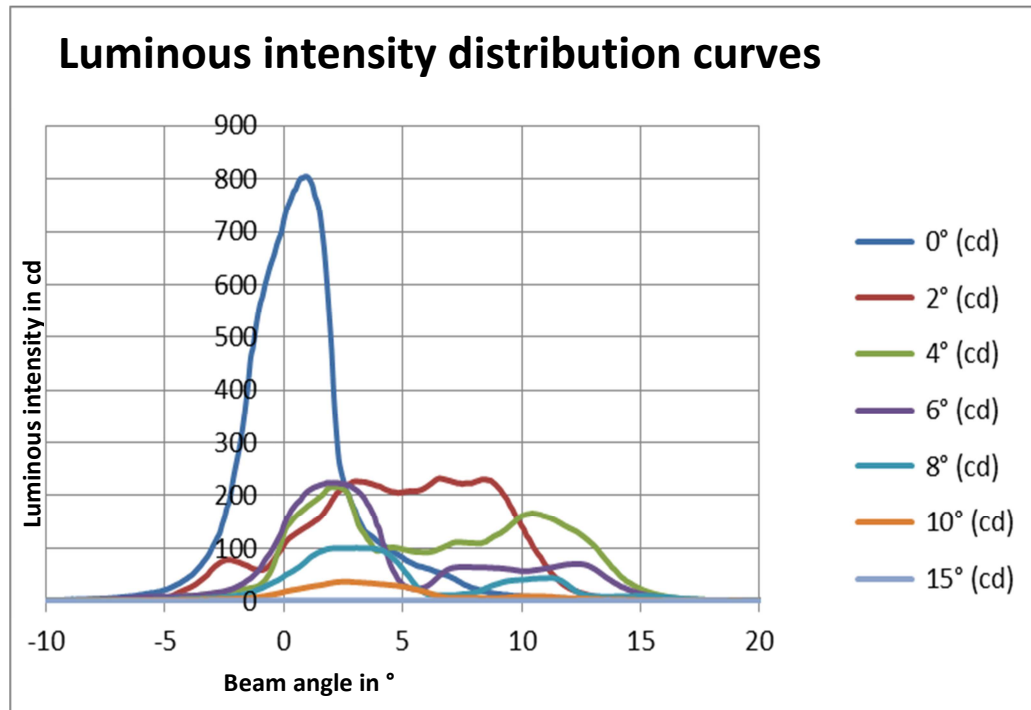
Figure 59: Luminous intensity distribution curves of white signal light at night

The white signal light has a beam angle of 17.1° and a maximum range of 9 nm at night.

@ 0°	Luminous intensity	Beam angle
I_{\max}	723 cd	1.5 °
$I_{\text{FWHM}} 0.5 \cdot I_{\max}$	361 cd	3.8 °
$I_{\text{FWTM}} 0.1 \cdot I_{\max}$	72.3 cd	17.1 °
Maximum range	9.0 nm

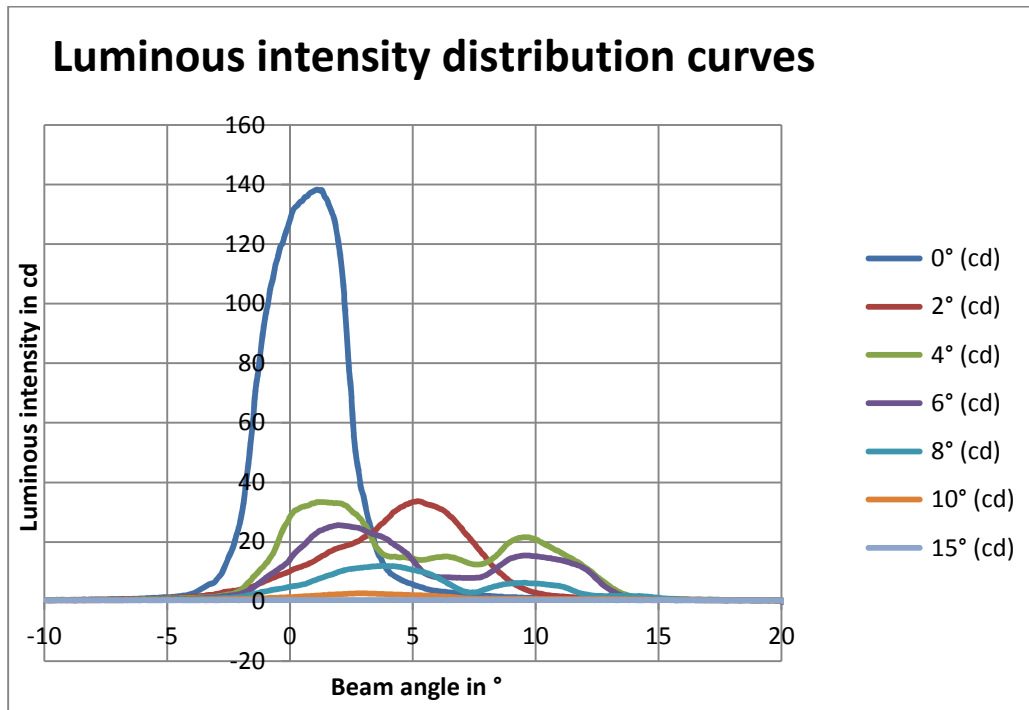
Figure 60: Luminous intensity distribution curves of red signal light at night

The red signal light has a beam angle of 14.4° and a maximum range of 6 nm at night.

@ $\alpha = 0^\circ$	Luminous intensity	Beam angle
I_{\max}	128 cd	1.8 °
$I_{\text{FWHM}} 0.5 \cdot I_{\max}$	64 cd	4 °
$I_{\text{FWTM}} 0.1 \cdot I_{\max}$	12.8 cd	14.4 °
Maximum range	6.0 nm

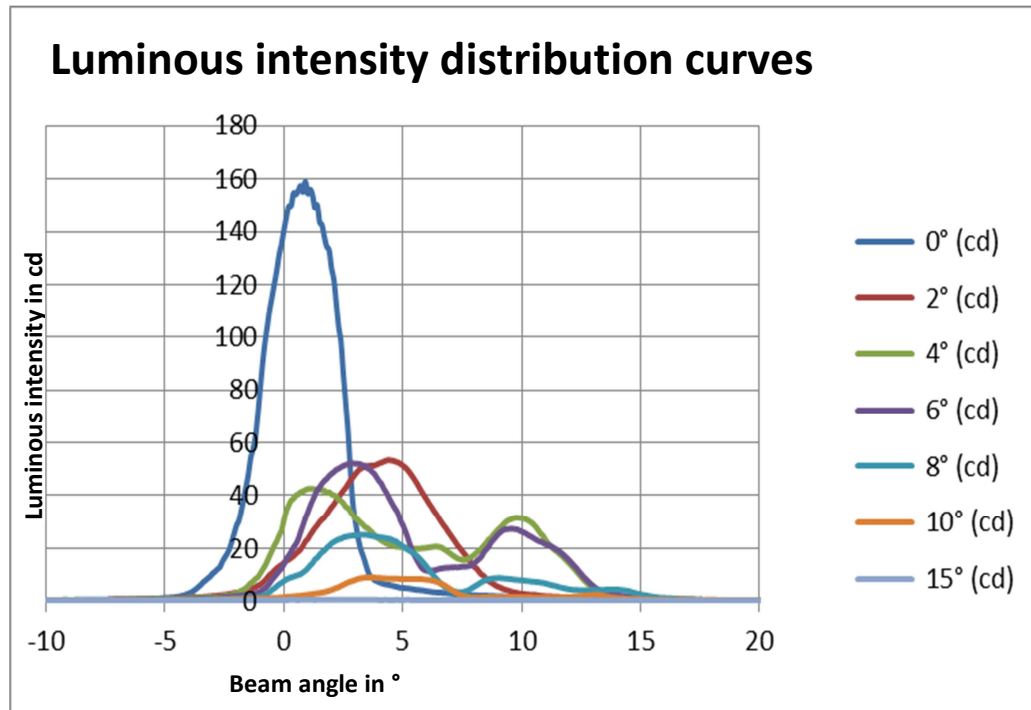
Figure 61: Luminous intensity distribution curves of green signal light at night

The green signal light has a beam angle of 14.8° and a maximum range of 6 nm at night.

@ $\alpha = 0^\circ$	Luminous intensity	Beam angle
I_{\max}	140 cd	1.6 °
$I_{\text{FWHM}} 0.5 \cdot I_{\max}$	70 cd	3.8 °
$I_{\text{FWTM}} 0.1 \cdot I_{\max}$	14.0 cd	14.8 °
Maximum range	6.0 nm

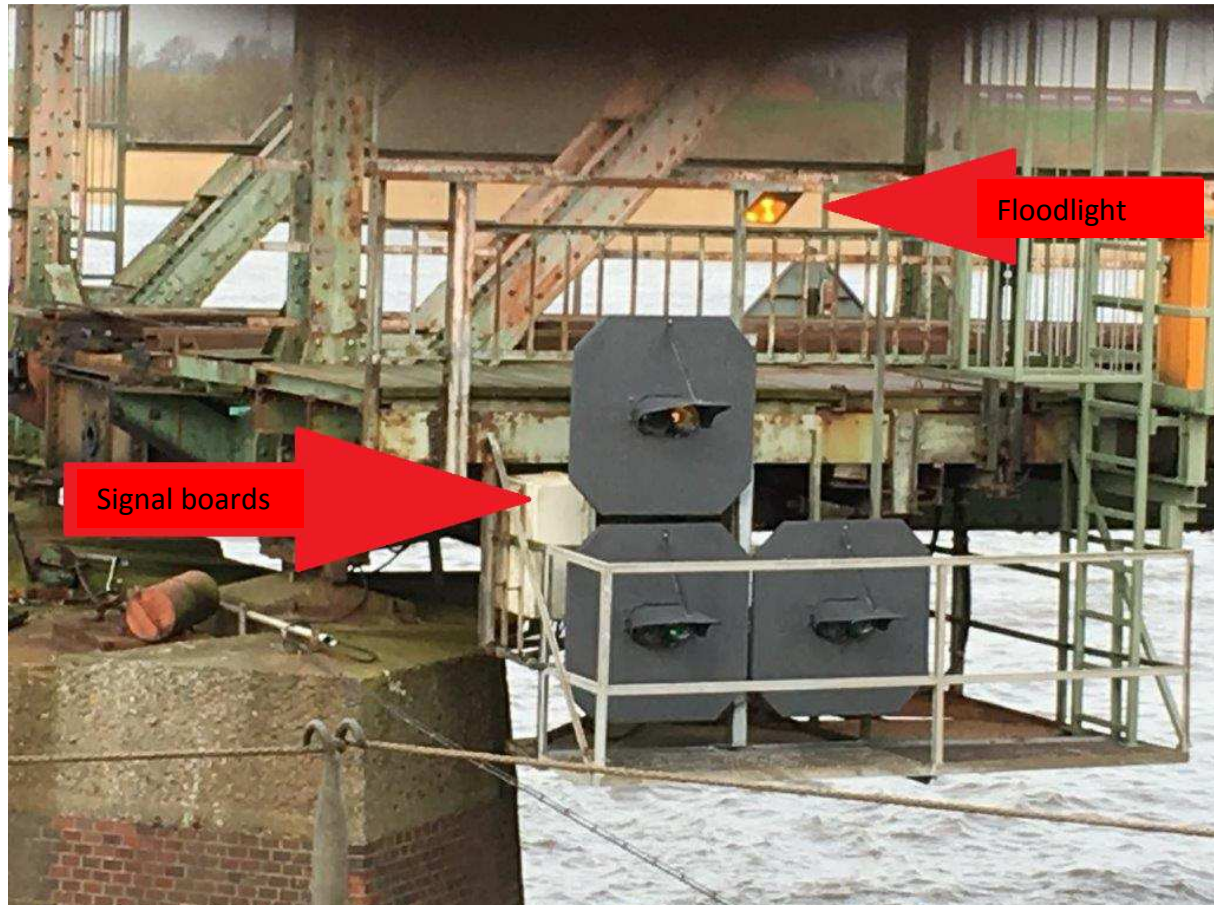
Figure 69: Signal boards with dual-element lighting units

Several floodlights provided the lighting in the background of the Friesenbrücke Bridge. These lights were installed slightly higher than the signal boards at an angle of about 45° on the opposite side of the bridge (when approaching from the south) as notice board illumination (Figure 69:). After analysing the range and dispersion angle of the lighting in the background, it is reasonable to assume in a worst-case scenario (signal board directly in field of vision with lighting in background) that the lighting in the background reduces the range of the signal lights and thus diminishes visibility when approaching the bridge from the south.

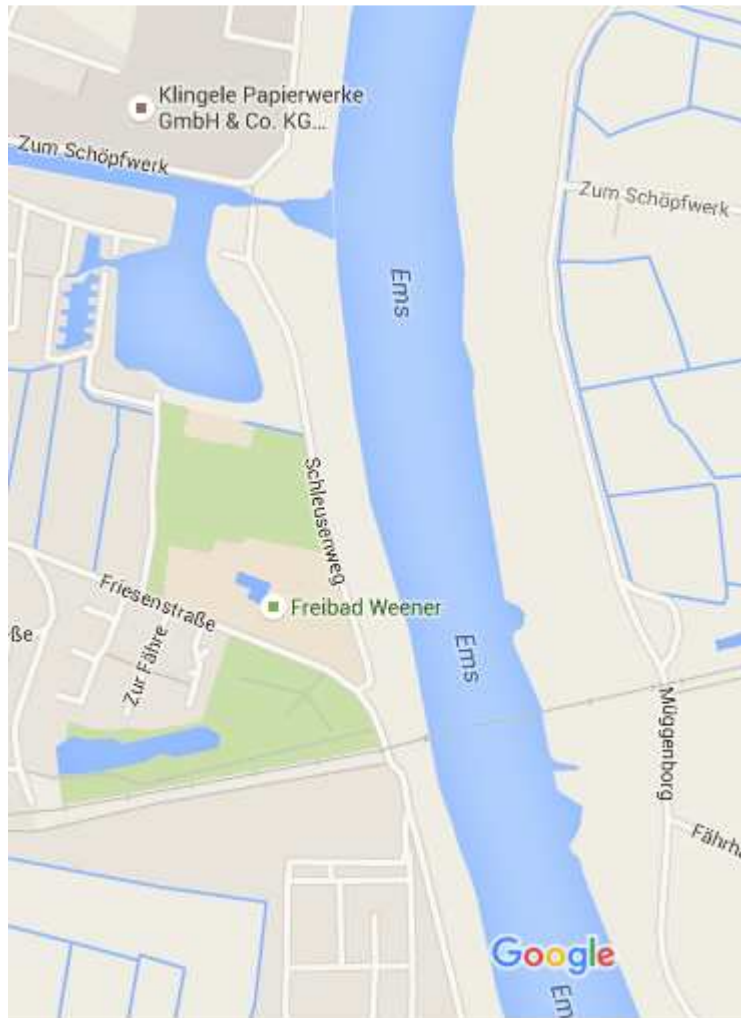
Figure 71: Klingele paper mill

For the assessment of the measurement results, the background and interference lighting was first examined in more detail. The interference lighting was mainly due to the Klingele paper mill (Figure 71:), which represents the greatest source of interfering light in the vicinity. As can be seen clearly on Figure 70:, this source of interference is not in the direct field of vision when approaching the bridge and was therefore ignored in the following consideration.

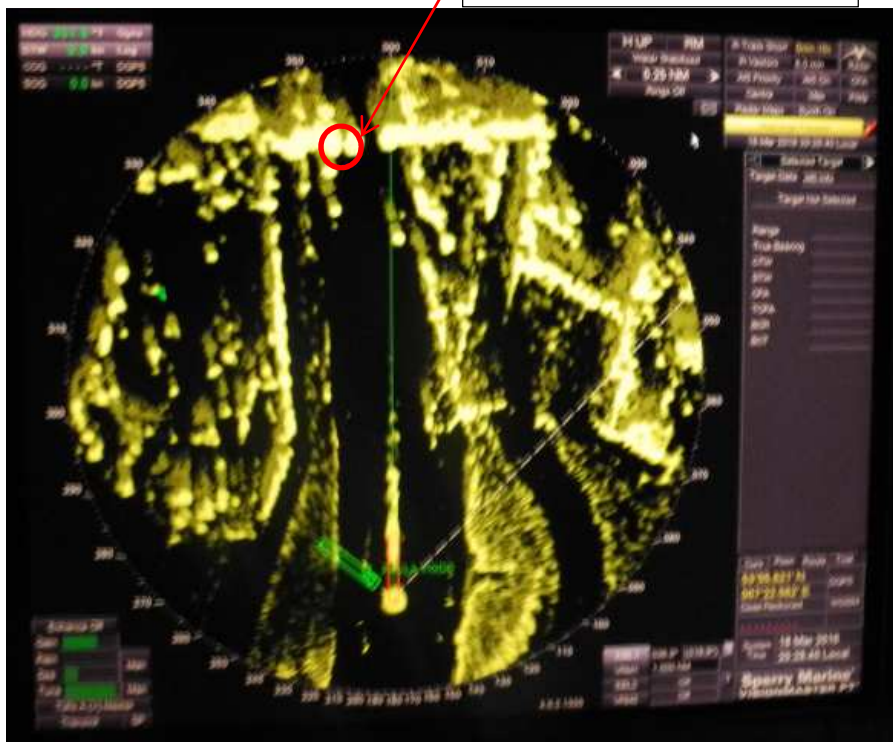
Figure 4: Comparative image (voyage on Emsmoon – 18 March 2016) showing the bridge after the accident

Although the Sperry VisionMaster FT radar system was poorly adjusted and exhibited technical deficiencies, it was clearly able to display the bridge and show that the passage was not open (see Figures 3 and 4). However, this would require that the Emsmoon's bridge team carefully observe the screen, as well as inwardly absorb and process all the consecutive images. It is questionable whether the range of 0.25 nm can be regarded as reasonable for a river voyage at more than 8 kts, as in addition to the insufficient potential warning time (123 s), it is also necessary to consider the extremely confined manoeuvring space, in particular. The distance from which it could be determined with the radar system that the bridge is not open is too short to take appropriate action to prevent an accident.
