Investigation Report 499/15

**Serious Marine Casualty**

**Grounding of the  
multipurpose ship  
BBC MAPLE LEA  
on 17 December 2015  
in Lake Saint-Louis, Canada**

14 March 2017

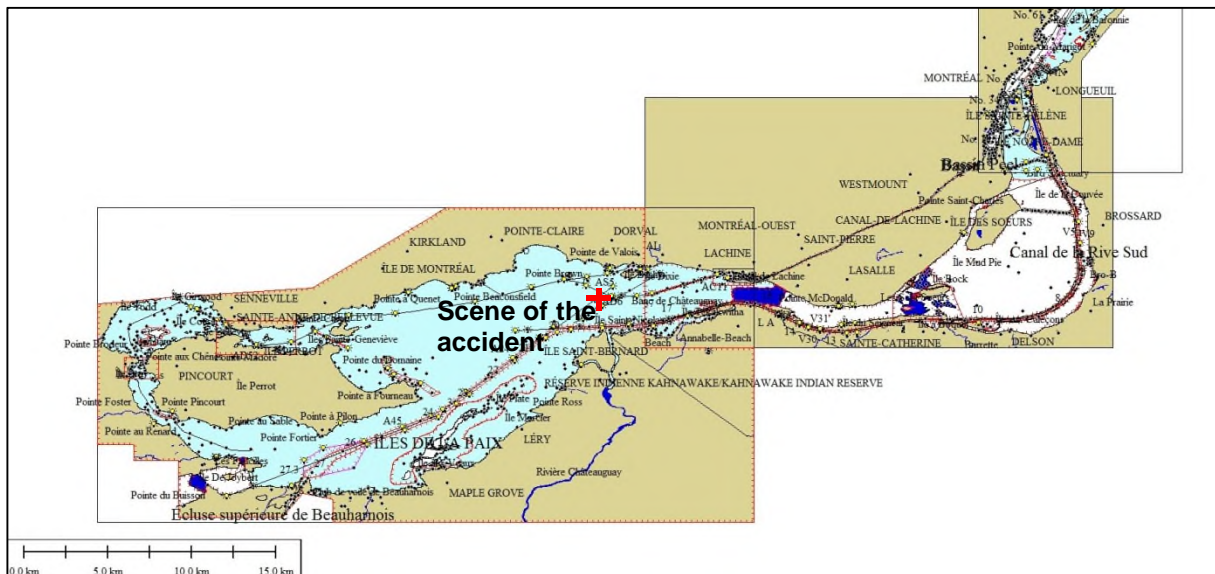
Figure 2: Nautical chart

Type of marine casualty:	Serious marine casualty, grounding
Date, time:	17 December 2015, 0755 <sup>2</sup>
Location:	Lake Saint-Louis, Canada
Latitude/Longitude:	φ 45°24.11' N λ 073°47.00' W
Ship operation and voyage segment:	Lake passage
Place on board:	Bow thruster
Human factors:	Yes, human error
Consequences:	Bow thruster damaged; spill of up to 10 l of hydraulic oil

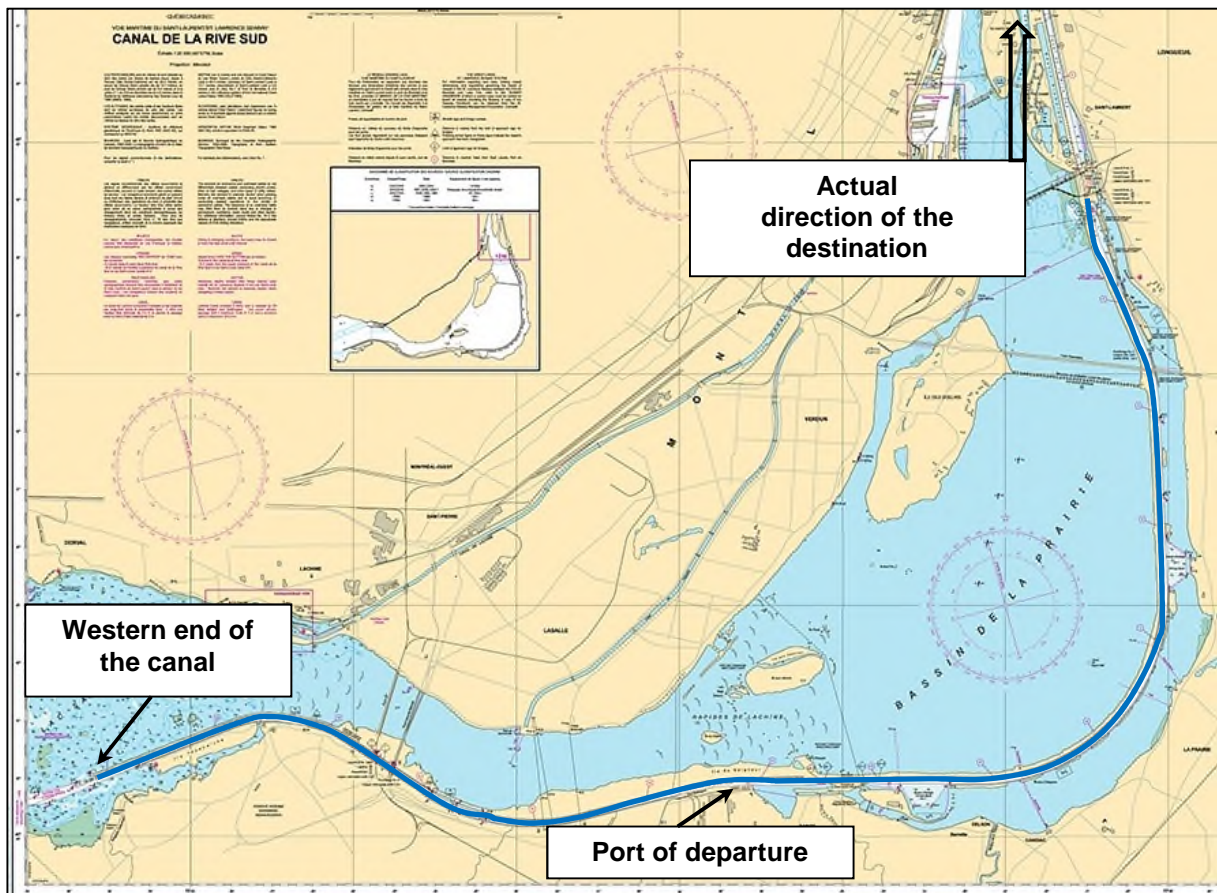
Figure 3: Nautical Chart CA1429 – Canal de la Rive Sud

Since the Canal de la Rive Sud (marked blue in Figure 3) is just under 100 m wide, the BBC MAPLE LEA had to first sail the canal in a westerly direction so as to be able to subsequently turn in an open area not bound by banks on each side and then sail back toward Montreal.

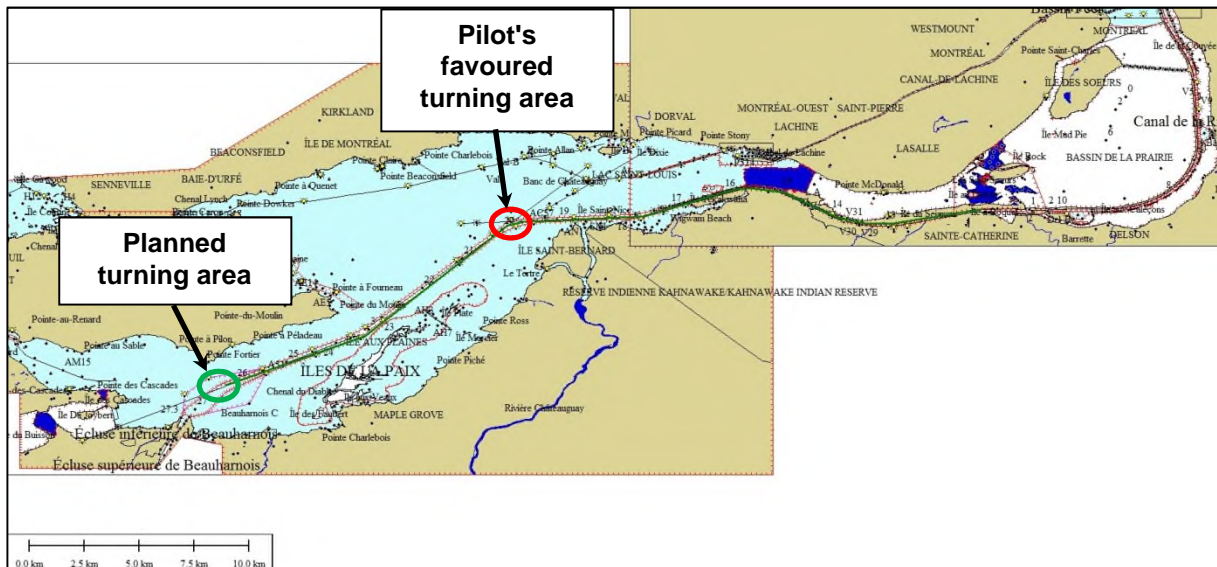
Figure 4: Original voyage planning of the BBC MAPLE LEA

the master that the ship should be turned shortly beyond the western end of the canal in the fairway after buoy A13 (see Figure 4).

The area off the lock at Beauharnois south-west of buoy pair A51/A52 was designated for a turning manoeuvre in the BBC MAPLE LEA's original voyage planning (see Figure 4). Including the anchorage area, this area would have had a section stretching 1 nm and water depths of more than 10 m throughout available (see Figure 14).

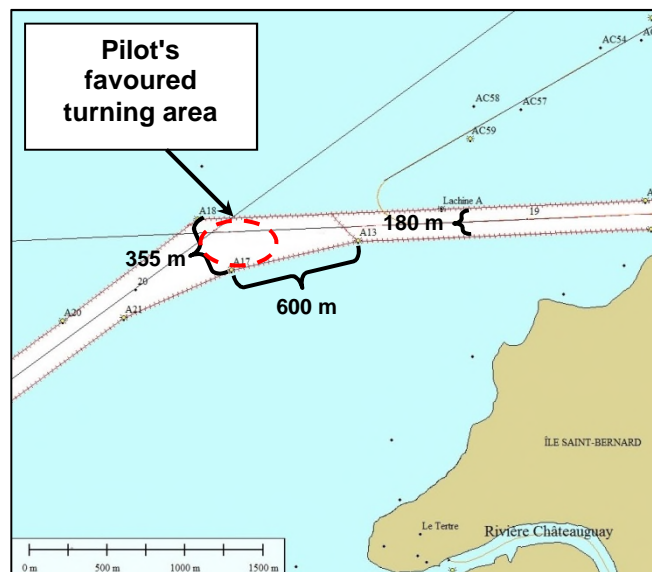
Figure 5: Pilot's favoured turning area

The course of the fairway changes to a south-westerly direction west of buoy A13, causing it to widen to 355 m maximum between buoy pair A17/A18 (see Figure 5).

The depth of water in this area drops rapidly outside the fairway. The depth west of buoy A18 plotted in the official paper chart is 6.2 m (see Figure 7). The electronic nautical chart used by VTS Beauharnois Traffic shows 7.3 m in this area (see Figure 13). The BBC MAPLE LEA's forward and aft draughts stood at 7.8 m and 8 m respectively, whereas the water depth in the turning area originally earmarked stood at between 9.5 m and 10.5 m.

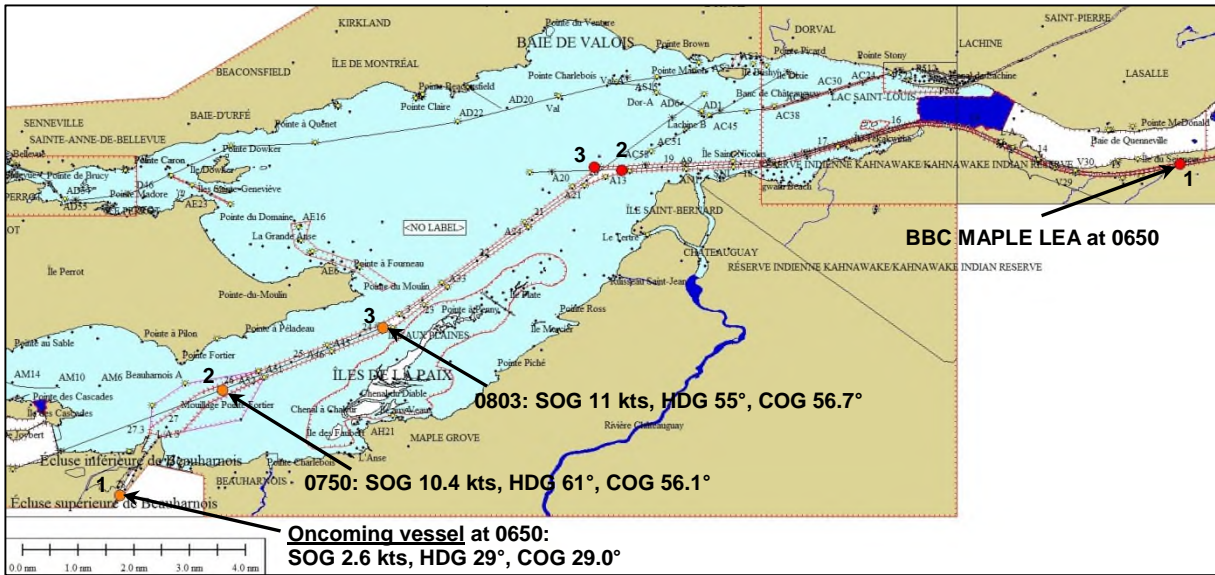
Figure 10: Positions of the oncoming vessel before and after the accident

The BBC MAPLE LEA's VDR also recorded position data, courses and speeds of ships in the vicinity. The bulk carrier with which the BBC MAPLE LEA's pilot discussed the turn at buoy A13 was still south of the lock at Beauharnois at the time of the discussion (see Figure 10). When the BBC MAPLE LEA began the turning manoeuvre, the other ship was north of the lock. She then sailed toward the BBC MAPLE LEA on a north-easterly course. After the grounding, at 0803, the distance between the two ships was still more than 4 nm.

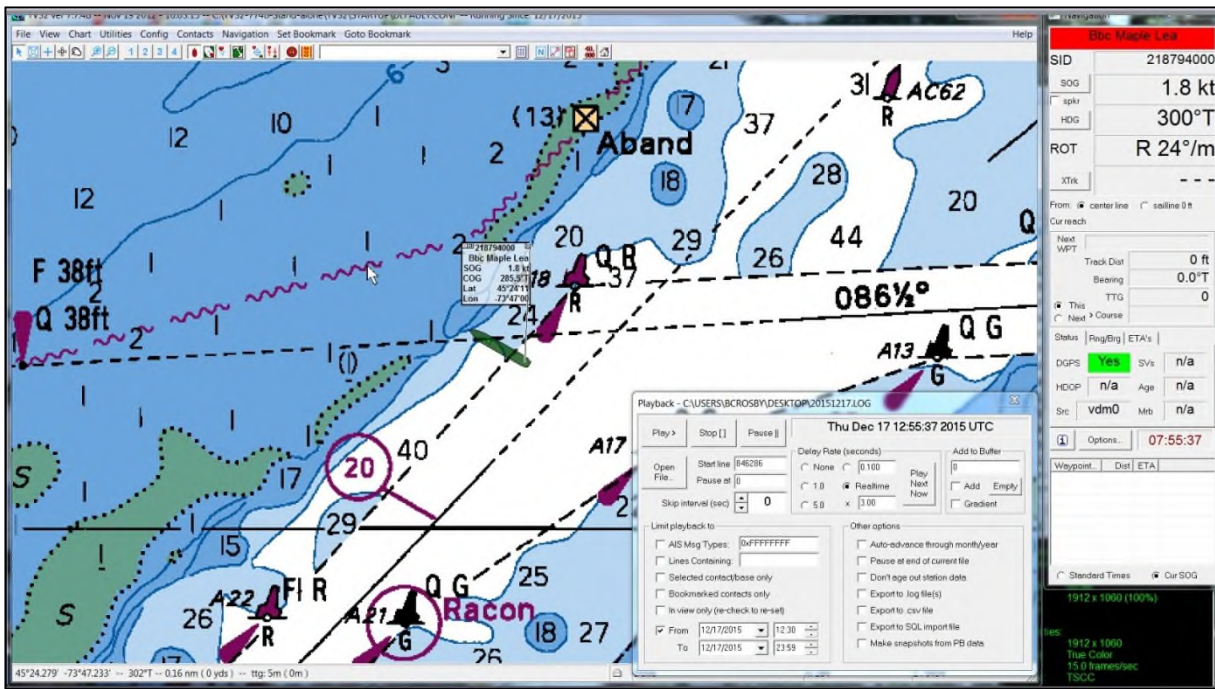
Figure 13: AIS recording at 075537 (time of accident)

The AIS recordings of the VTS were provided to the BSU in the form of a video. The period covered is 073837 to 080530. The AIS recordings are superimposed over an electronic nautical chart, which shows the depths in feet rather than in metres. One foot is equal to 0.3048 m. The charted depths north and west of buoy A18 (scene of the accident: 20 or 24 ft) are equivalent to 6.096 m and 7.3152 m.

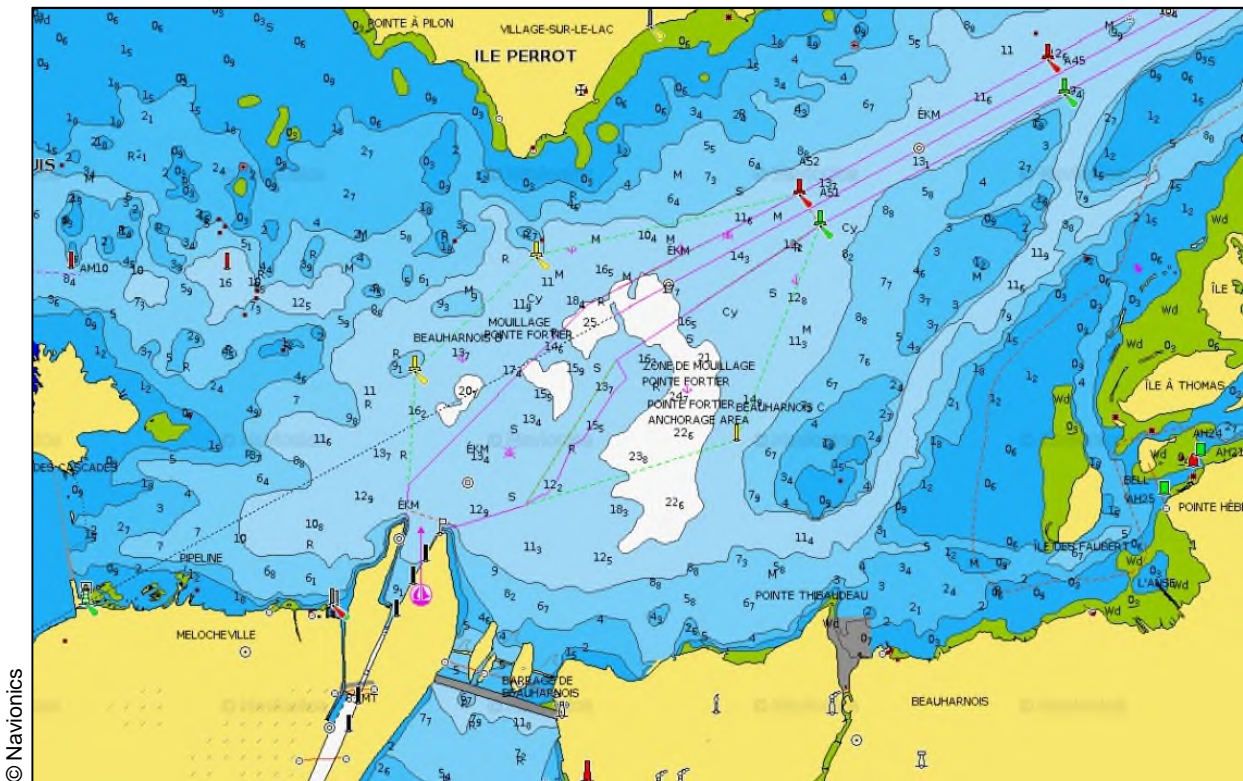
Figure 14: Originally planned turning area

Indeed, turning there would have entailed a detour of 13 nm (6.5 nm in each direction) as compared to turning west of buoy A13, as proposed by the pilot. Accordingly, the BBC MAPLE LEA would have been underway 45 minutes longer in each direction based on a speed of 8.7 kts. However, the master told the pilot that he was reportedly not in a hurry ("I have no rush," see Spreadsheet 1) and in so doing made clear that from the perspective of the ship there was no reason to turn sooner and thus in the narrower fairway. The pilot was adamant about his favoured option and did not encounter any further objections. From the perspective of the BSU, this discussion is not open to challenge because the ship's command of the BBC MAPLE LEA was entitled to trust their experienced pilot with knowledge of the local area. Moreover, VTS Beauharnois Traffic did not object to the announcement of the pilot that he intended to turn at buoy A13, as long as this was co-ordinated with the later oncoming bulk carrier. Accordingly, the BSU concludes that the fairway section west of A13 determined by the pilot was generally suitable for turning manoeuvres. However, turning off the lock at Beauharnois would have posed a lower risk due to the larger sea room.
