Interim Investigation Report

pertaining to Investigation Report 408/17

**Grounding of the bulk carrier
MV GLORY AMSTERDAM on
29 October 2017 about 1.6 nm
North of the North Sea Island of Langeoog**

29 October 2018

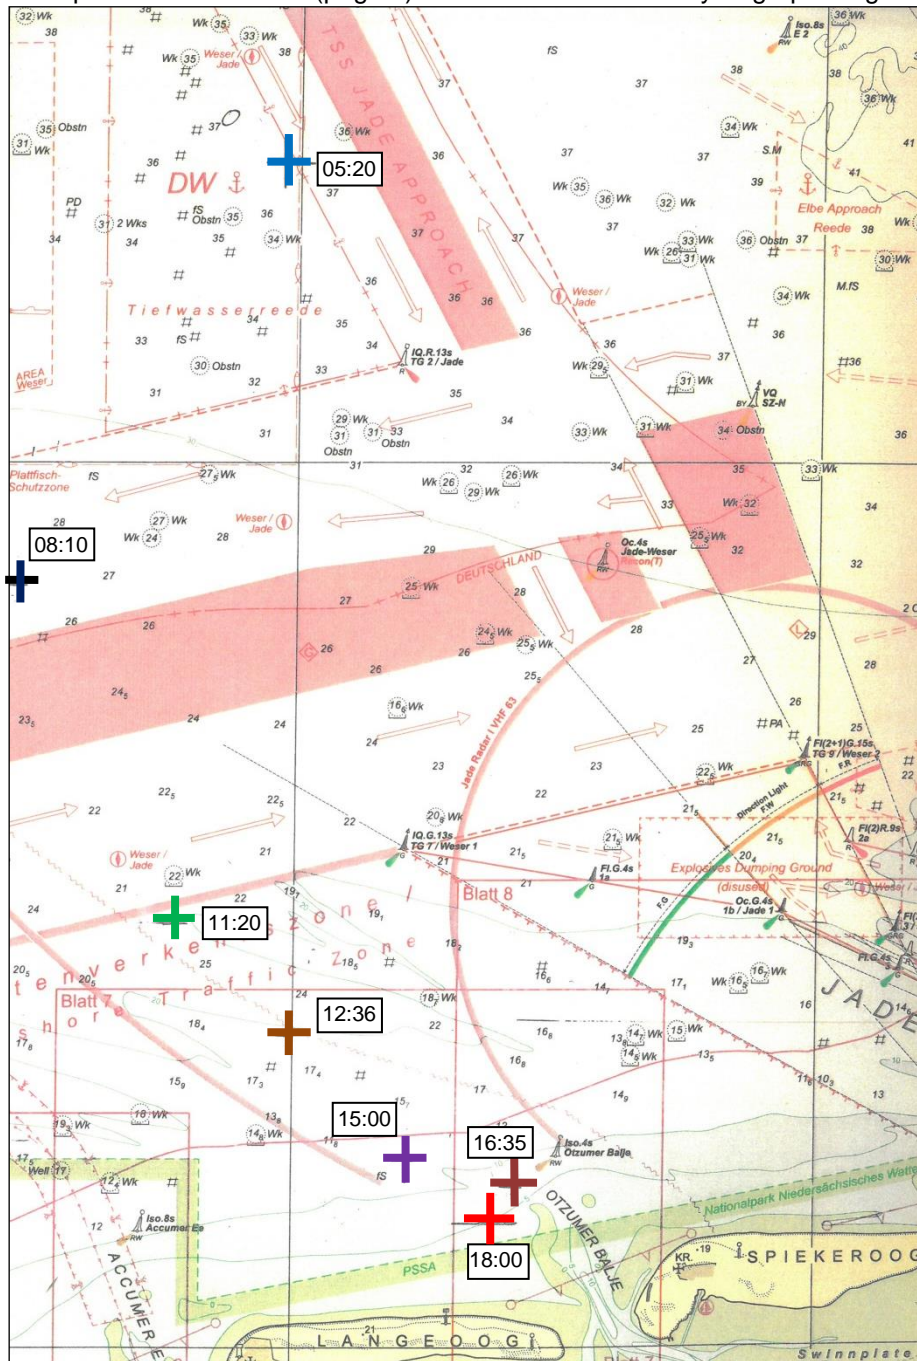
Figure 2: Scene of the accident

Type of accident:	Serious marine casualty
Date/Time	29 October 2017, about 1800 ¹
Location:	North Sea, 1.6 nm north of Langeoog
Latitude/Longitude:	Approx. φ 53°47.2'N λ 007°35.9'E
Voyage segment:	Drifting from the anchorage although two anchors were dropped
Consequences:	Grounding; damages to the rudder; no injuries, no environmental pollution

- 05:20** GLORY AMTERDAM starts to drift form her original anchoring position
- 08:10** Emergency tug NORDIC reaches the GLORY AMSTERDAM
- 11:20** Federal police helicopter begins first attempt (unsuccessful) to winch the boarding team off the NORDIC
- 12:36** NORDIC started her first attempt to establish a towing connection to the distressed vessel
- 15:00** Towing connection between NORDIC and distressed vessel established (parted at 15:46)
- 16:35** Federal police helicopter lowered boarding team Baltic Sea on the distressed vessel
- 18:00** Distressed vessel strands in the area of the 5-m-depth-line
